PRELIMINARY REPORT
RAILROAD
CSX Transportation Roadway Worker Fatality
Estill, South Carolina
November 30, 2018
RRD19FR002

The information in this report is preliminary and will be either supplemented or corrected during the course of the investigation.

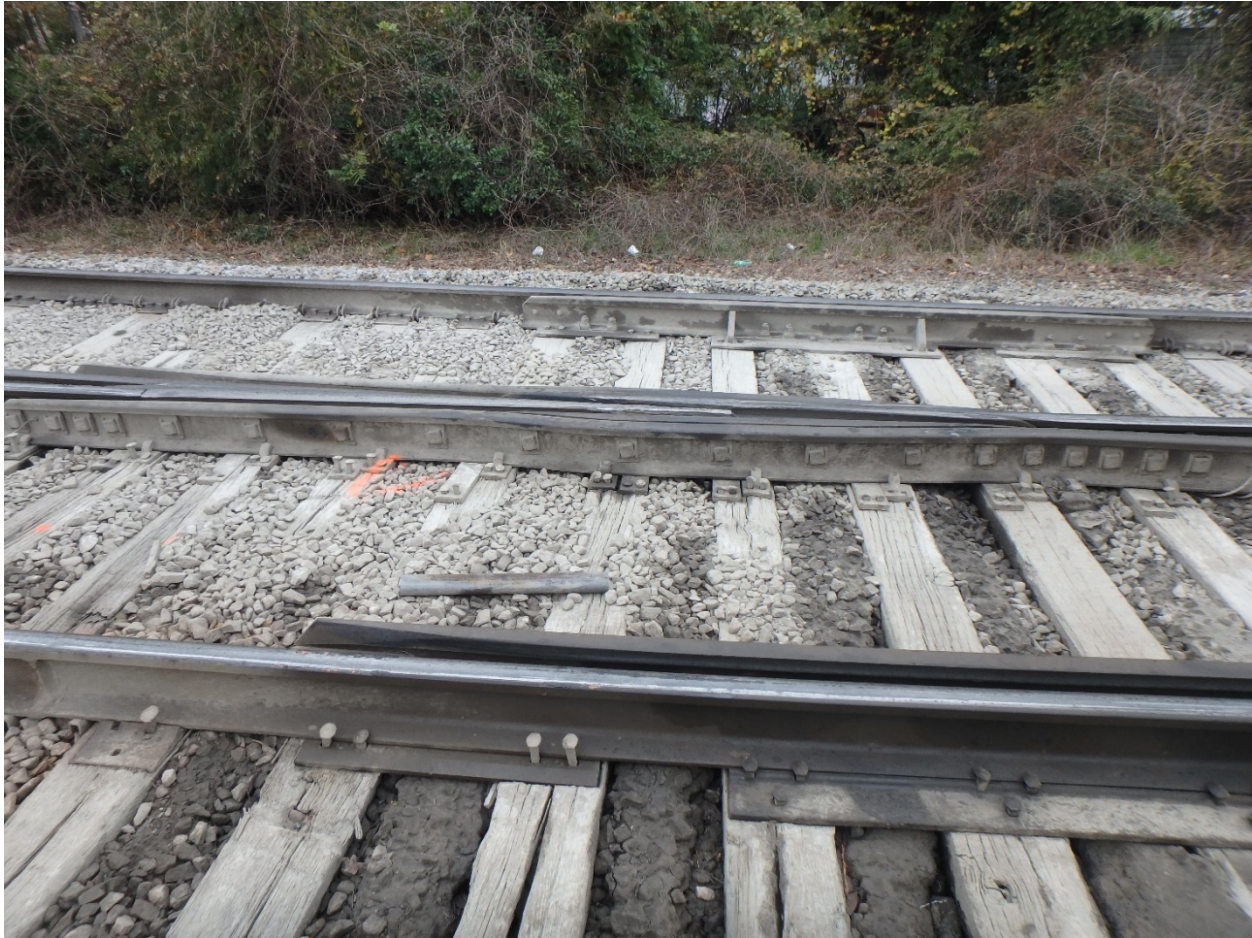
The roadway work group consisted of a track welder and one additional roadway worker who was assigned as a watchman/lookout.¹ The welder had been tasked to repair the surface of a track frog in the switch at the North End Estill Siding switch.² (See figure 1.) During interviews, the watchman/lookout stated that prior to the accident the welder had told him that the work was complete. The welder and the watchman were both headquartered in Yemassee, South Carolina. The welder had about 10 years of railroad service, and the watchman had about 4 years of railroad service.

Figure 1. Photo of track frog at the accident location.
