PRELIMINARY REPORT

Derailment of Union Pacific Railroad Train UEBLTG 20

Fort Worth, Texas

RRD19FR007

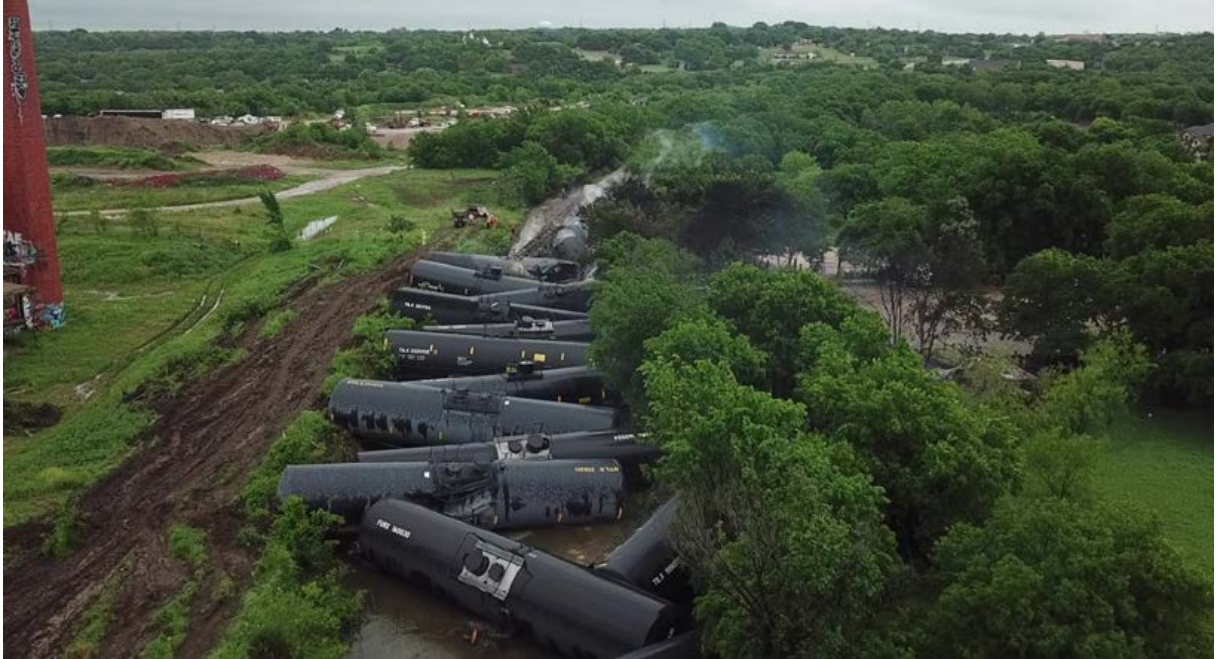
The derailment of the train occurred near milepost 48.8 on the UP Midlothian Subdivision. Of the 96 loaded tank cars, 25 derailed. The derailed tank cars were No. 17 through No. 41. Three tank cars were breached; the three tank cars leaked 74,000 gallons of denatured ethanol. The released ethanol ignited and formed pool fires. The local police evacuated between 6 and 10 nearby homes; some residents refused to evacuate. Some of the released ethanol entered a nearby tributary of the Trinity River. No individuals were injured. However, three horses in a barn were killed and three horses were injured.

Figure 1. Accident scene.

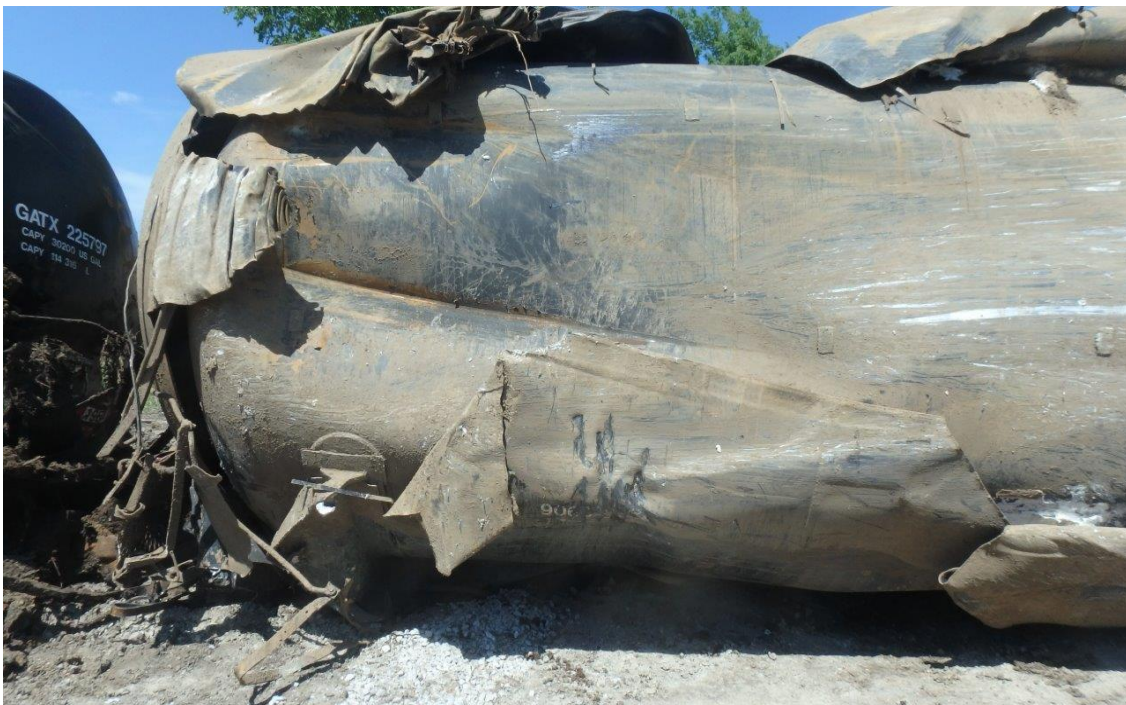
- Seven DOT-117J100W tank cars: fabricated from 9/16-inch thick heads and shells and equipped with jackets, head shields, ceramic-fiber thermal protection blankets, and top and bottom fittings protection.
- One DOT-111A100W tank car: fabricated from 7/16-inch thick head and shell with no jacket, no thermal protection, no head shield, and no top fitting or bottom outlet protection.
- Investigators confirmed that at least three of the derailed tank cars were breached and released denatured ethanol:
 - One DOT-117R100W tank car with a shell tear around a bent body bolster and valves that were torn from the top fittings flange.
 - One DOT-117R100W tank car that sustained a puncture in the shell.
 - One DOT-111A100W tank car with punctured head and shell and an open bottom outlet valve.

Figure 2. DOT-117J100W tank car, which sustained impact damage, but did not release denatured ethanol.
