# PRELIMINARY REPORT

### Union Pacific Conductor Fatality

**Northlake, Illinois**

**RRD20LR003**

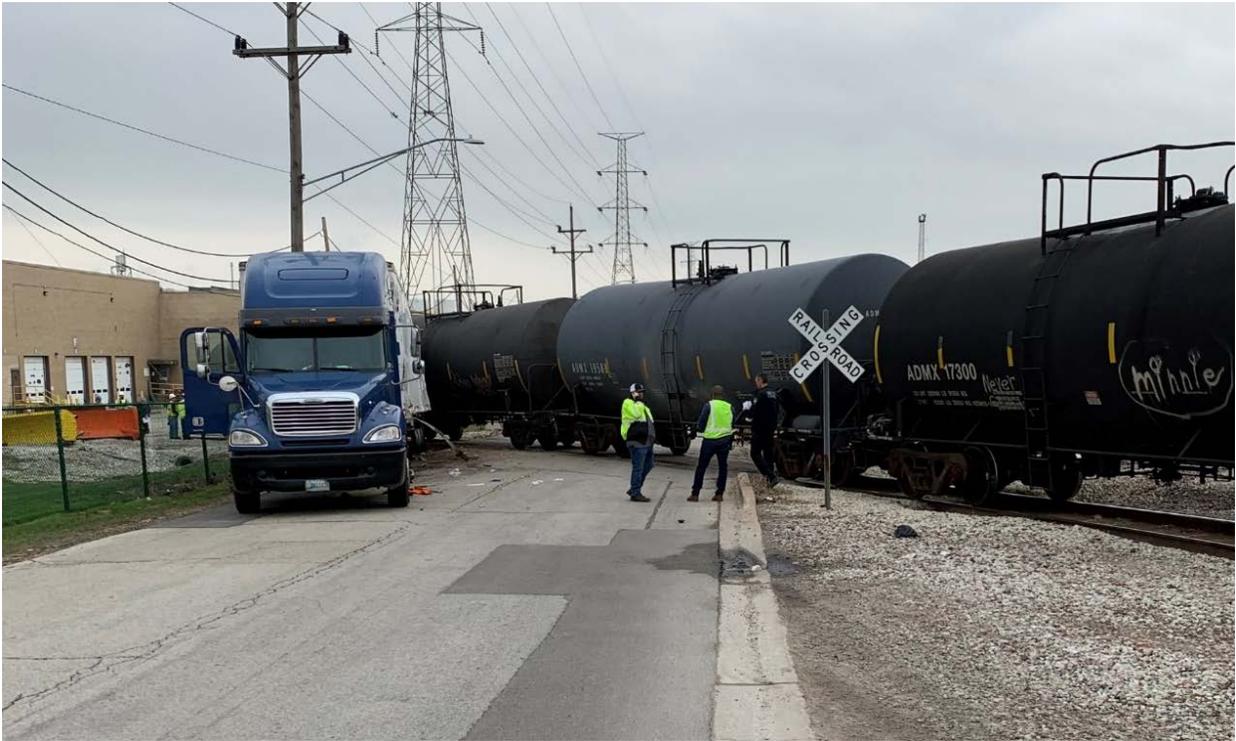
On April 23, 2020, at 10:02 a.m. local time, Union Pacific (UP) train YPR64 was shoving rail cars into an industry track just outside of the Proviso hump yard in Northlake, Illinois, when it struck a tractor semi-trailer (truck) at a public highway-rail grade crossing.<sup>1</sup> The UP train consisted of two locomotives and four rail cars. The conductor, who had been remotely controlling the movement of the train from the end rail car, died in the collision as the train entered the grade crossing at Railroad Avenue. Preliminary information from the event recorder indicates that the train was traveling at about 10 mph when it struck the truck, which was traveling forward at an estimated speed of 25 mph.

**Figure 1.** Final resting position of the truck and train. (Source: Union Pacific Railroad)

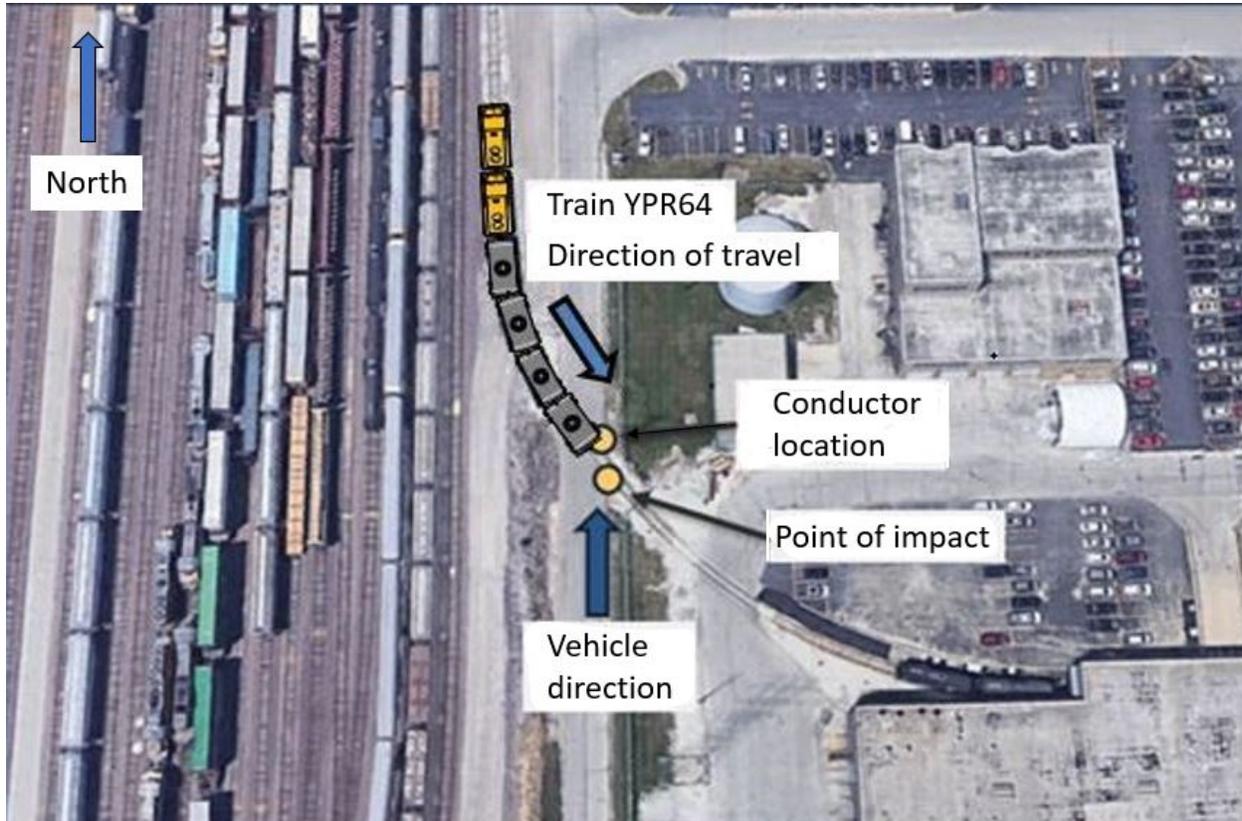
The crew for train YPR64 consisted of a trainee and two remote control locomotive operators (RCO), of which the conductor was one. At the time of the accident, the second RCO was in the cab of the front locomotive, and the trainee was in the cab of the second locomotive. The crew was shoving the train from the yard tracks to the industry tracks of a nearby building. The conductor had been on the opposite side of the rail car from the approaching truck. The rear of the rail car collided with the trailer of the truck. The highway-rail grade crossing where the accident occurred was equipped with crossbucks.<sup>2</sup> Preliminary information acquired from a video surveillance camera that monitored the rail yard indicates that a railroad employee was not on the ground to provide warning at the grade crossing, a violation of UP operating rules.<sup>3</sup>

**Figure 2.** Aerial view of the accident scene. (Source: Google Earth)
