Sinking of the US Cargo Vessel *El Faro*

Illustrated Digest

This digest of the National Transportation Safety Board's (NTSB's) Marine Accident Report **NTSB/MAR-17/01** contains a description of the accident and safety issues, and summarizes some of the safety recommendations intended to prevent such an accident from happening again. The full report and docket can be found at www.ntsb.gov.

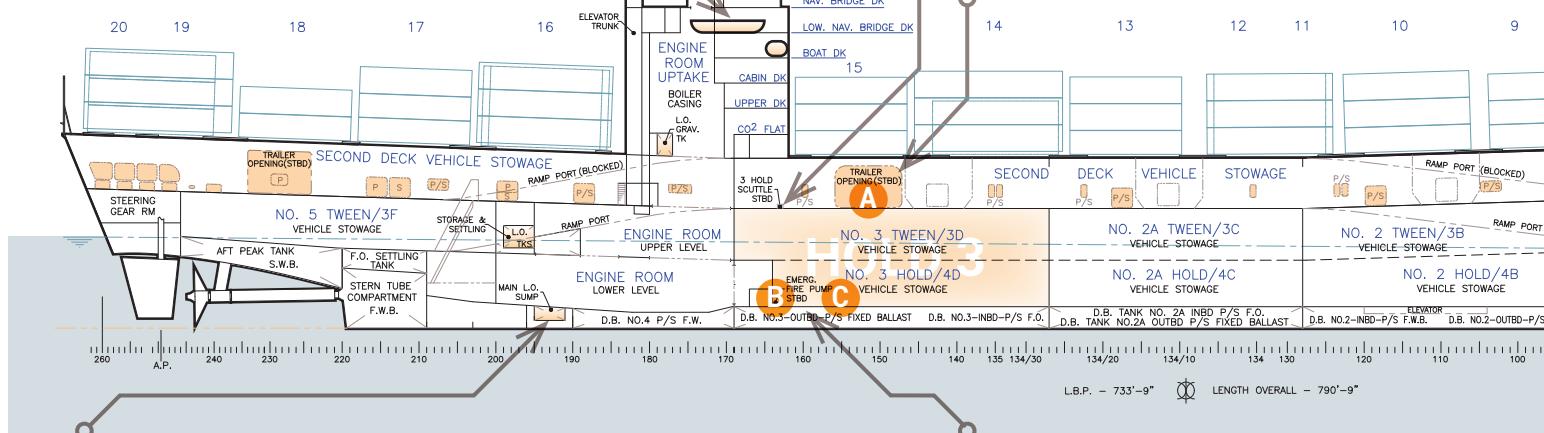
According to logbook entries, the level of lube oil in the sump had been kept at 25 or 26 inches for most of the 2 years before the accident. In rough seas, this could lead to loss of propulsion (see Loss of lube oil suction, p. 7).

Seawater could flow onto *El Faro*'s second deck through openings, including large openings in the starboard side **A** through which trailers were loaded. The deck was partially enclosed, so seawater could temporarily accumulate before draining off.

Cargo hold 3 housed the emergency fire pump, which was connected to a seawater inlet pipe **B** (photo at left is of *El Yunque*'s emergency fire pump and unprotected inlet piping). Similar components, although arranged differently, made up the corresponding system on board *El Faro*. Hold 3 was also used for vehicle stowage. **C**

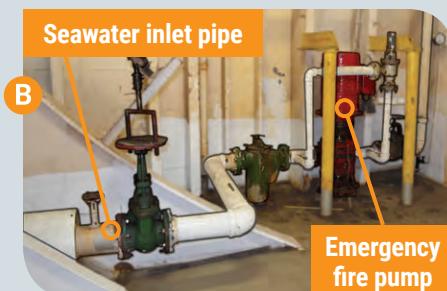
Scuttles are small hatches that allow crewmembers to transit between decks. However, the scuttles on the weather deck (second deck) had to be securely fastened to ensure the ship's watertight integrity. *El Faro* did not have remote open/close indicators for its scuttles (see Recommendations, p. 13).

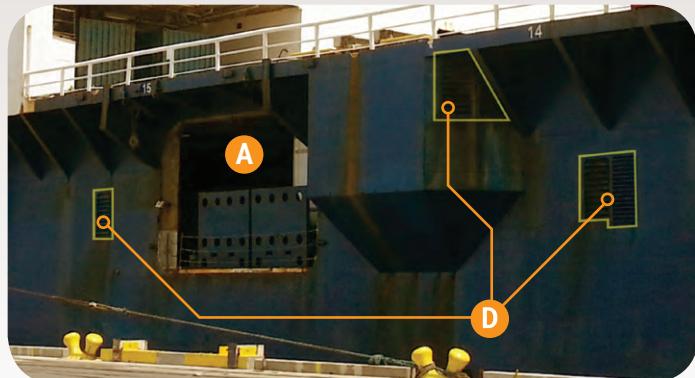
Louvered openings in the hull **D** allowed air to flow in and out of the cargo holds via ventilation ducts. These were required to be opened under way, but could have been shut in heavy weather. Pictured at left is the starboard side of *El Faro*, just above hold 3. Louvered vents are outlined in yellow and a large trailer opening **A** is also visible.

El Faro's certificate of inspection required that cargo hold ventilation closures be kept open at sea when the vessel was transporting vehicles with fuel tanks. In rough weather with a threat of downflooding, it was critical that crewmembers understood that such closures must be secured to prevent flooding (see *How the water got in*, p. 6).

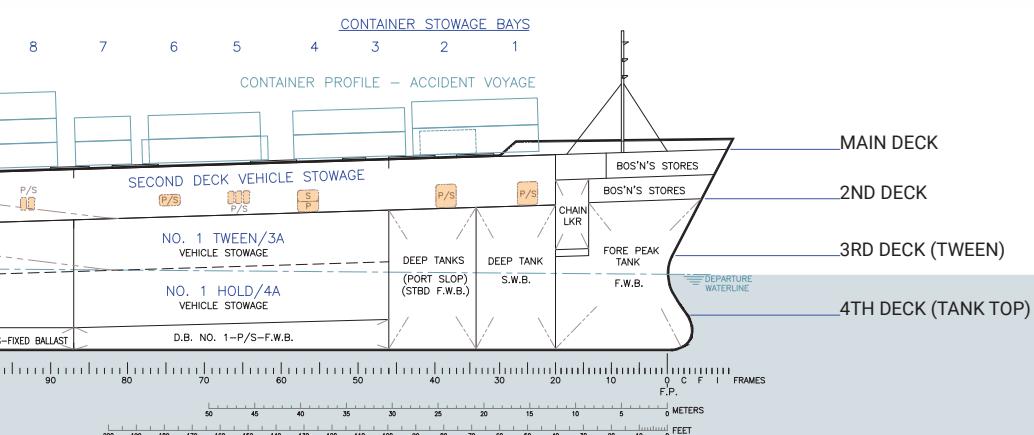
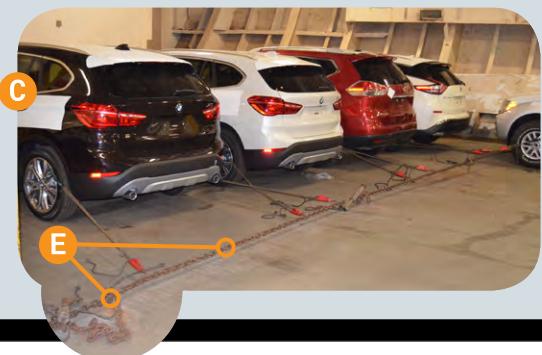
Instead of each automobile being secured to the deck at each corner, they were secured to a long chain across the width of the ship **E** (photo at left is from a similar lashing arrangement on board *El Yunque*). As the ship encountered heavy weather, vessel motion increased and lashings would have failed more easily as the deck became wet and the ship rolled (see How the water got in, p. 6).

At **0544**, the captain was heard on the VDR saying "We got cars loose," likely referring to automobiles that had broken free from their lashings. The automobile-lashing arrangement did not meet the requirements of the vessel's approved cargo-securing manual, making automobiles more likely to shift in heavy weather.

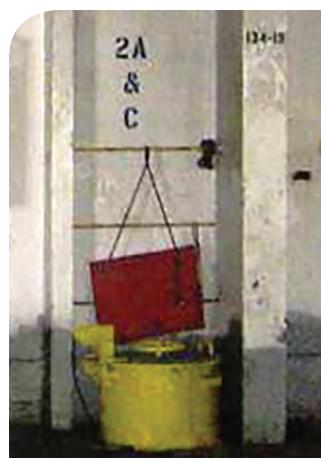
The crew found that a scuttle (small watertight hatch) on the second deck, starboard side, was open and seawater on deck was flowing over it and down into cargo hold 3. The ship's list to starboard was causing seawater to pool near the scuttle located on the starboard side. The captain told an engineer to begin transferring ballast water from the starboard ramp tank to the port ramp tank.

Second deck scuttle to hold 2A, similar to hold 3 scuttle
Photo: Herbert Engineering

El Faro's partially enclosed second deck had a number of scuttles that had to be closed and fastened ("dogged"). Flooding began through an open scuttle.

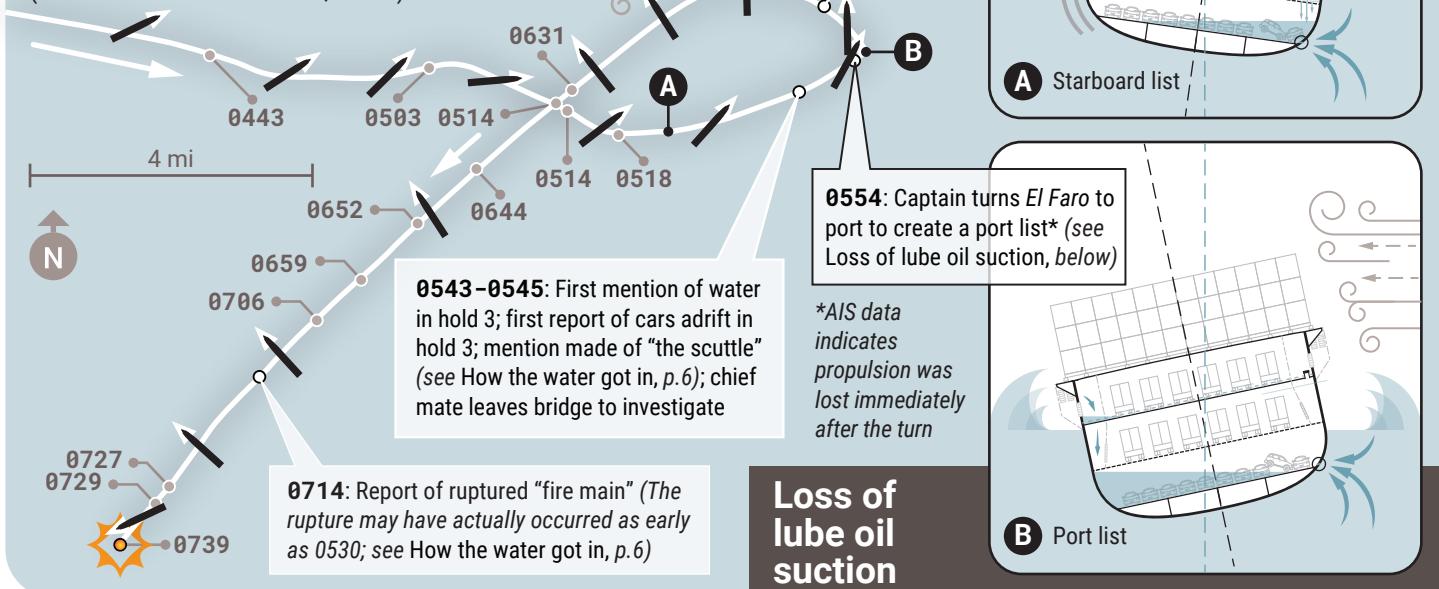
El Faro's captain and crew turned the vessel's bow into the wind several times. Then, at 0554, the captain ordered a turn to port to get the wind on the ship's starboard side, generating a port list. A few minutes later, El Faro lost propulsion (see Loss of lube oil suction, below).

At 0554, the captain ordered a turn to port to put the wind on the ship's starboard side, thereby generating a port list so the crew could better investigate the source of the flooding in cargo hold 3. This was also the most aggressive of several turns that followed the first conversation about oil levels at about 0440.

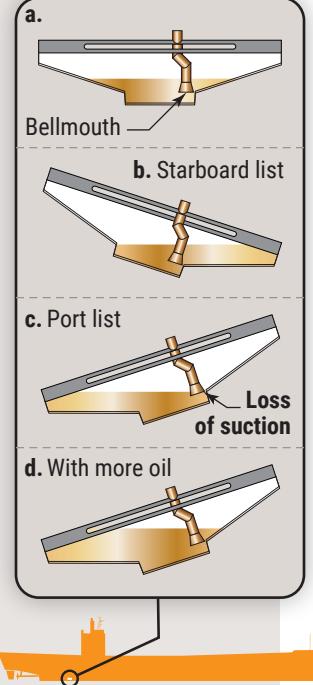
Because the bellmouth (intake) for the main propulsion engine lube oil pump was located toward the starboard side, it mattered whether the ship was listing to port or starboard. (The trim of the ship also affected the oil suction; forward trim was worse). It also mattered how much lube oil was in the sump.

Log books indicated no more than 26 inches of oil in the sump in the months before the accident (a). With this oil level, the bellmouth would not take in air (lose suction) with an 18-degree list to starboard (b), but would lose suction with an equivalent list to port (c). With 32 inches of oil in the sump, the bellmouth would continue to take in oil with the same 18-degree list to port (d) allowing normal functioning.

The loss of lube oil pressure would have triggered a protective device, the low lube oil pressure switch, which would have shut off the flow of steam to the main engine. (However, steam continued to flow to turbogenerators for lights and other systems.) To reset the switch, lube oil pressure would have to be restored. Without propulsion, El Faro could not maneuver and was at the mercy of the storm.

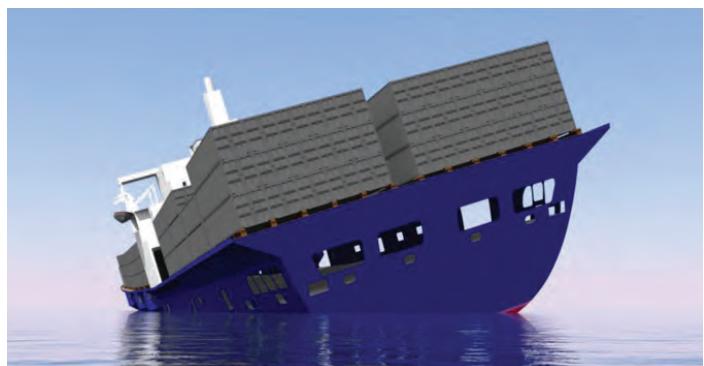
El Faro computer rendering in static surface water showing list to port of 18° with departure trim 5.8 feet by the stern due to flooding of hold 3 estimated at 20% and windheel.

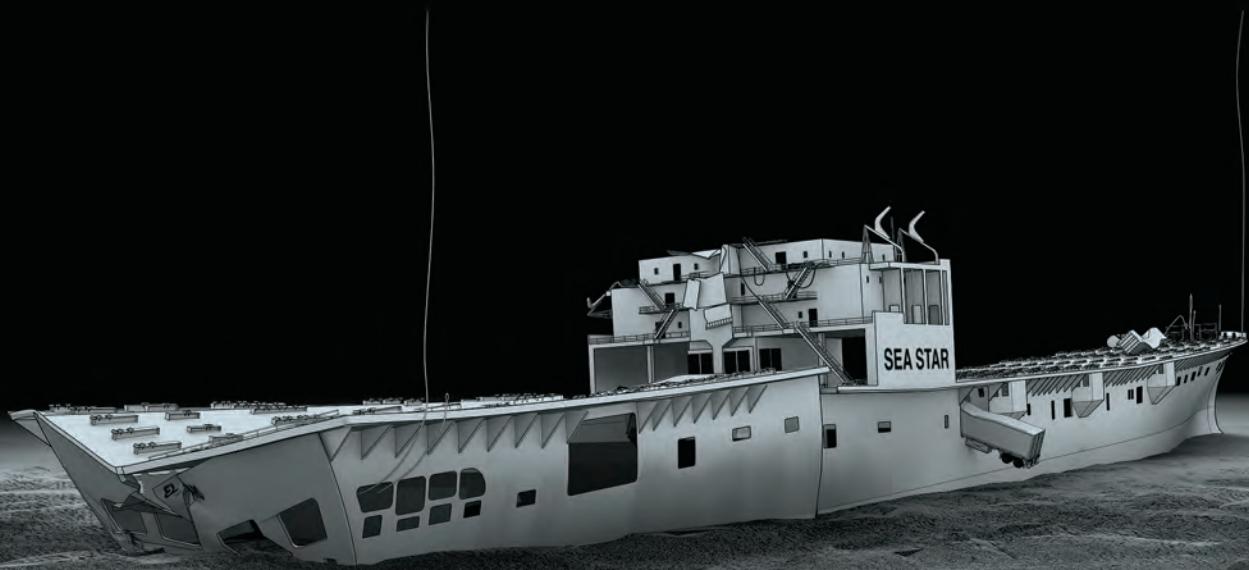
Artist's rendering of *El Faro* at final rest
based on data collected during search and recovery missions
