Airbag Performance in General Aviation Restraint Systems

Safety Study

NTSB/SS-11/01
PB2011-917001

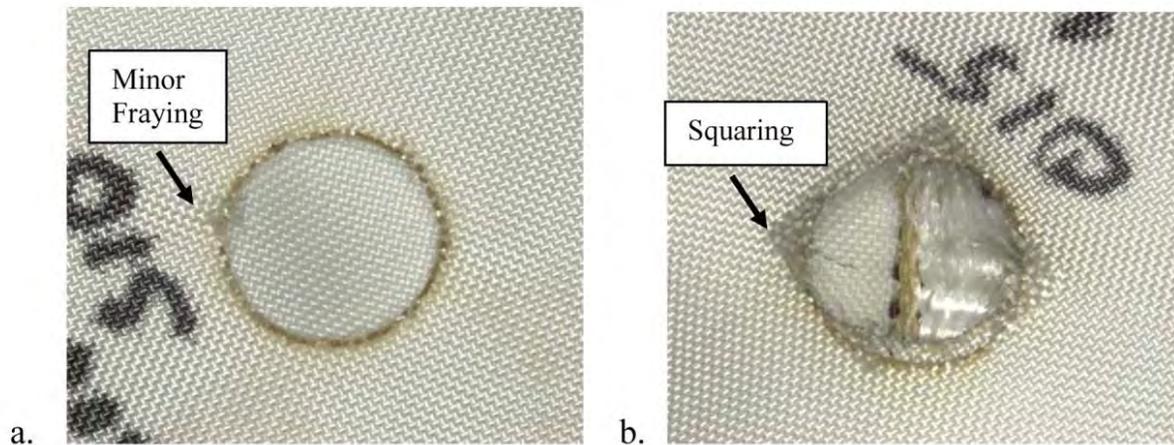
Figure 9. A pair of photographs showing vent holes from a Cirrus airbag. Photograph a. shows minor fraying, and photograph b. shows squaring. Squaring of the vent hole was used as one indicator that the airbag had sustained loads during the accident.

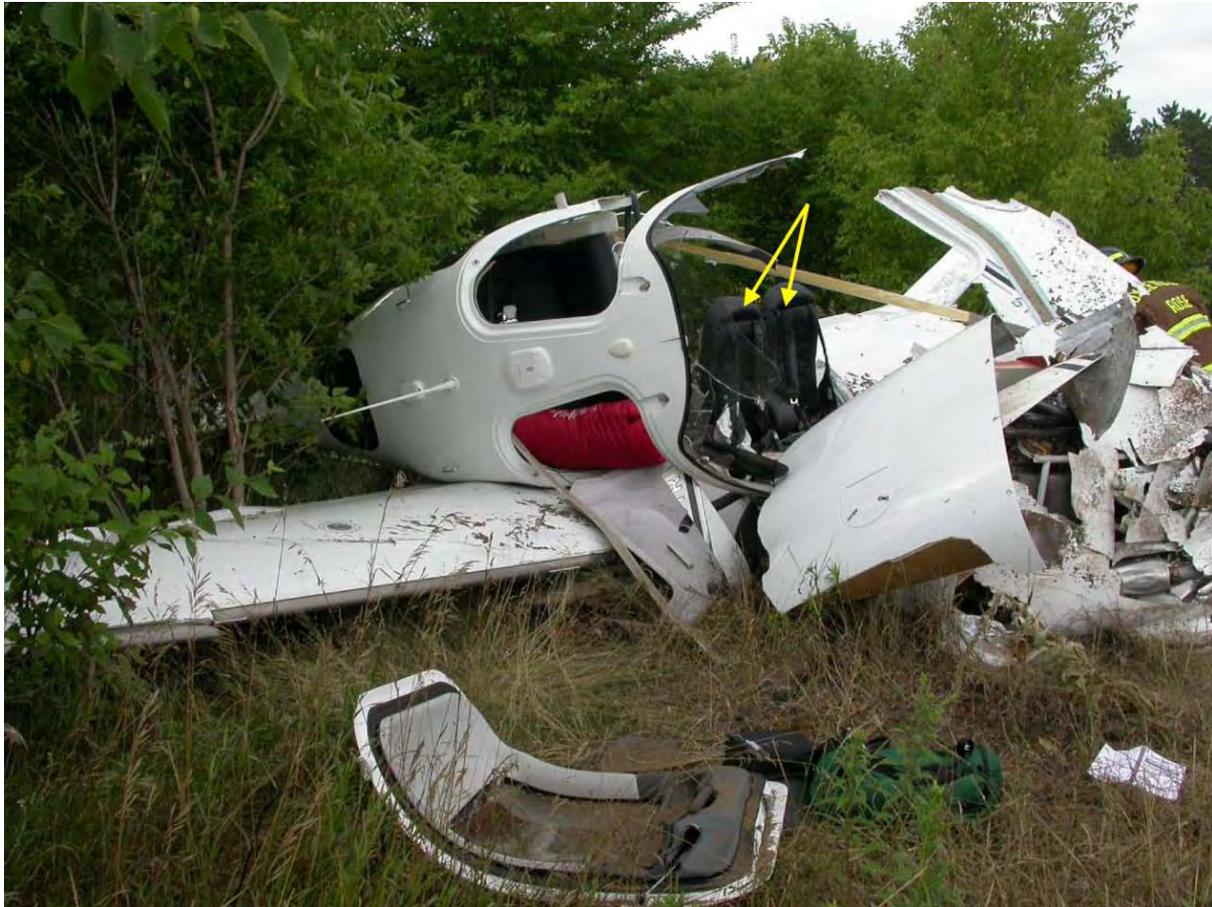
Figure 21. A photograph showing the final resting position of Cirrus SR22, N658CD, which crashed in Boyceville, Wisconsin. The photograph was taken facing the nose of the airplane. The two front row seats are denoted with yellow arrows.

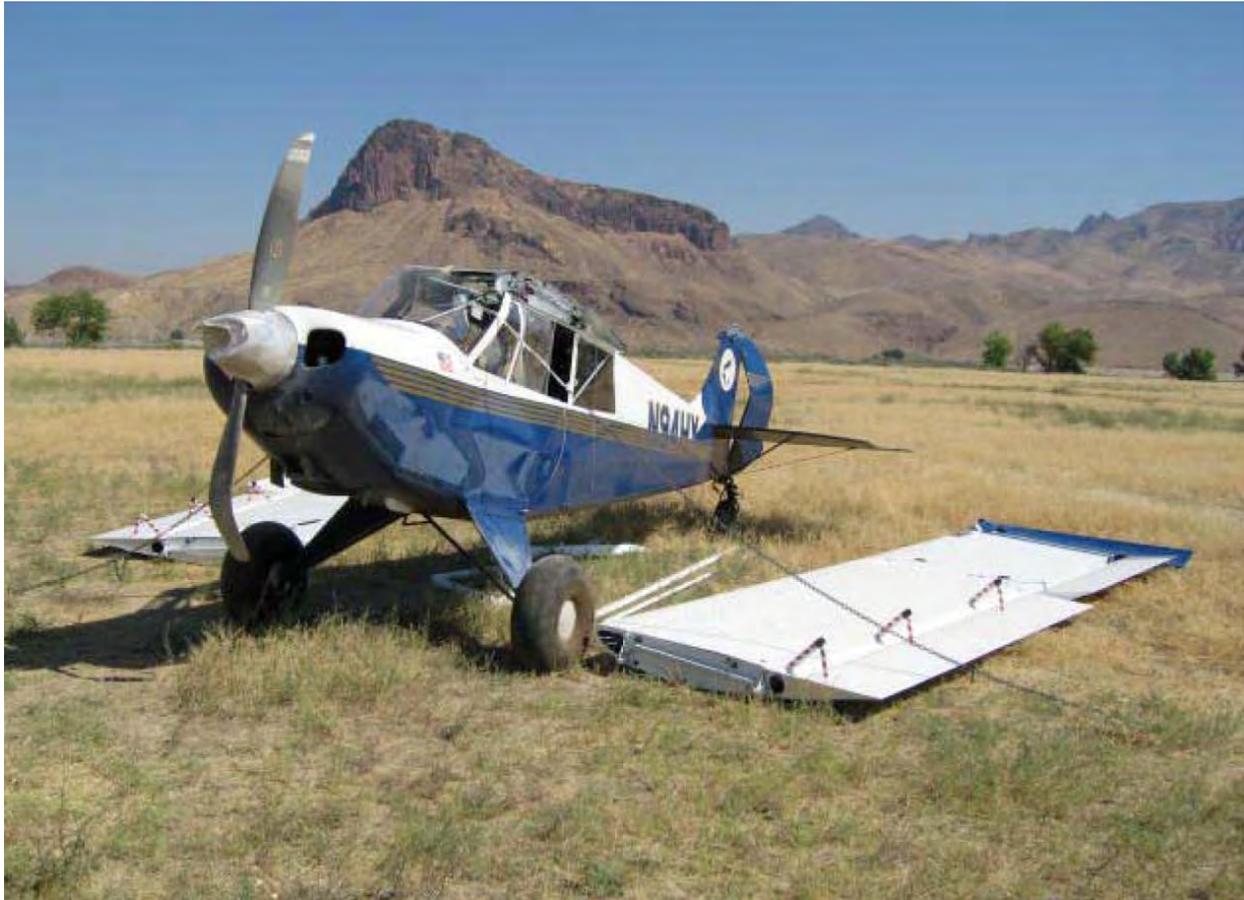
Figure 23. A photograph of the wreckage of Aviat Husky A-1B, N94HY, which crashed in Owyhee, Oregon. (The wings were removed postcrash during the recovery of the airplane.)

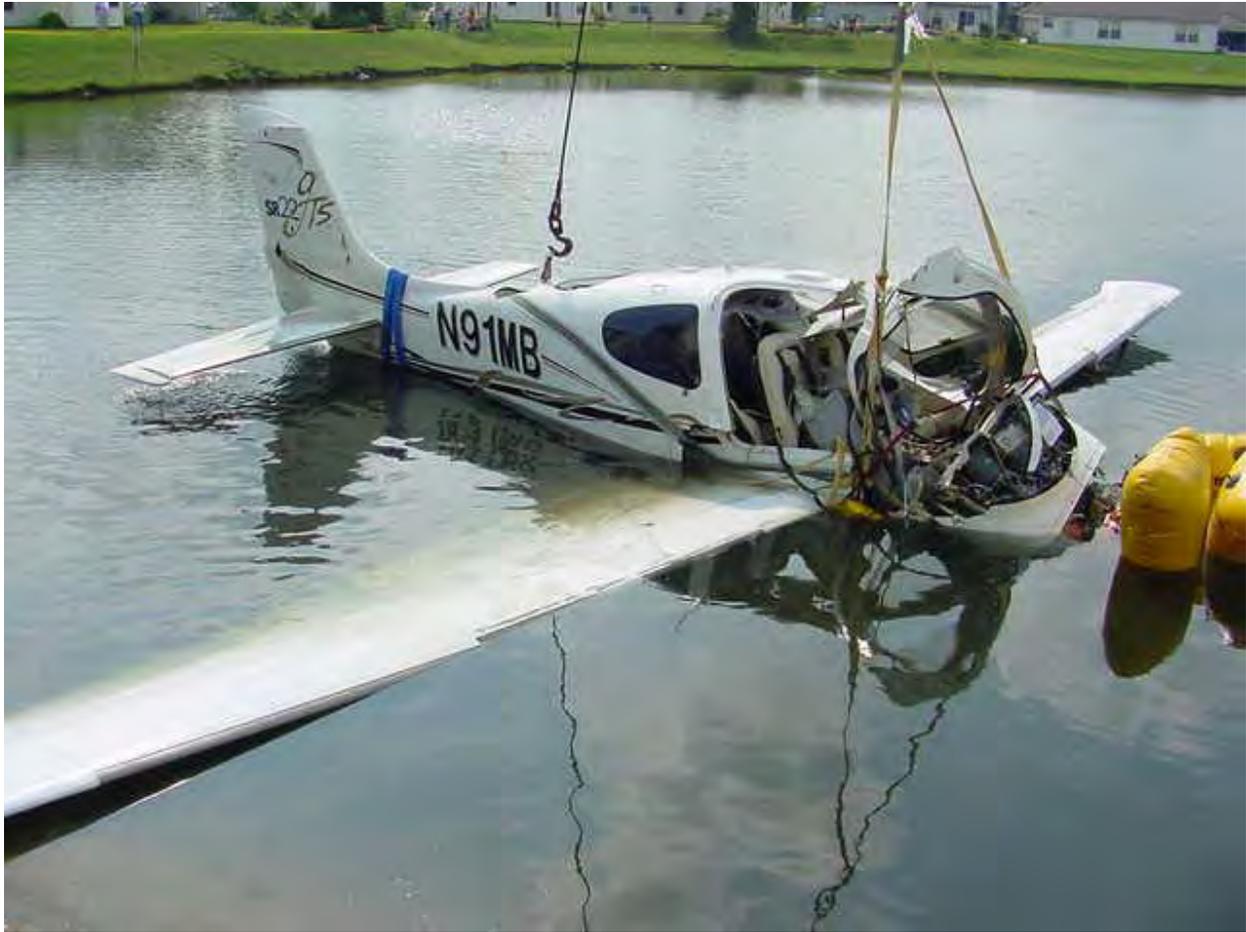
Figure 24. Photograph of Cirrus SR22, N91MB, as it was lifted from the water retention pond where it crashed in Indianapolis, Indiana. (NTSB accident identification number is CHI06FA245.)

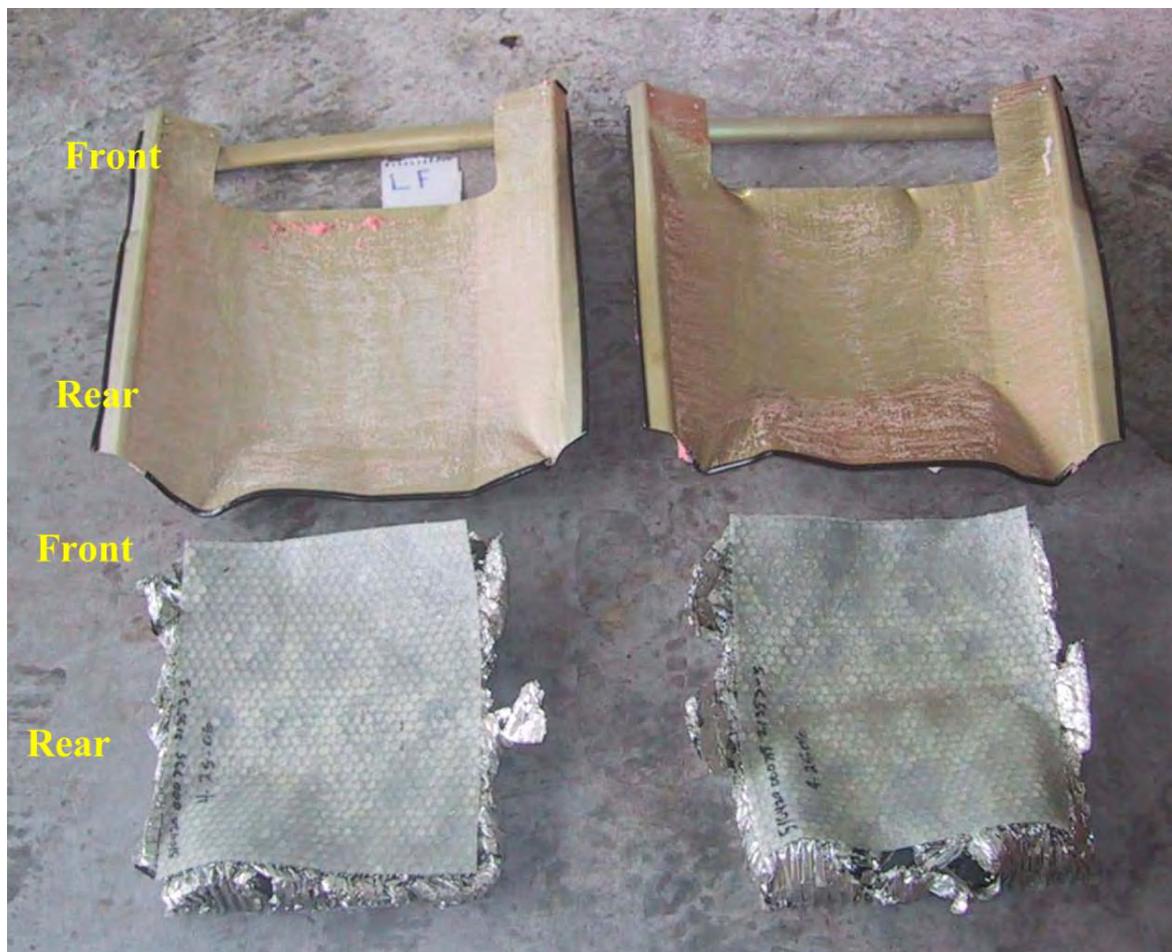
Figure 26. A photograph showing the seat pan and aluminum EAMs from the two front seats. The left front seat pan and EAM block are on the left side of the photograph. The front of both seat pans is toward the top of the photograph.

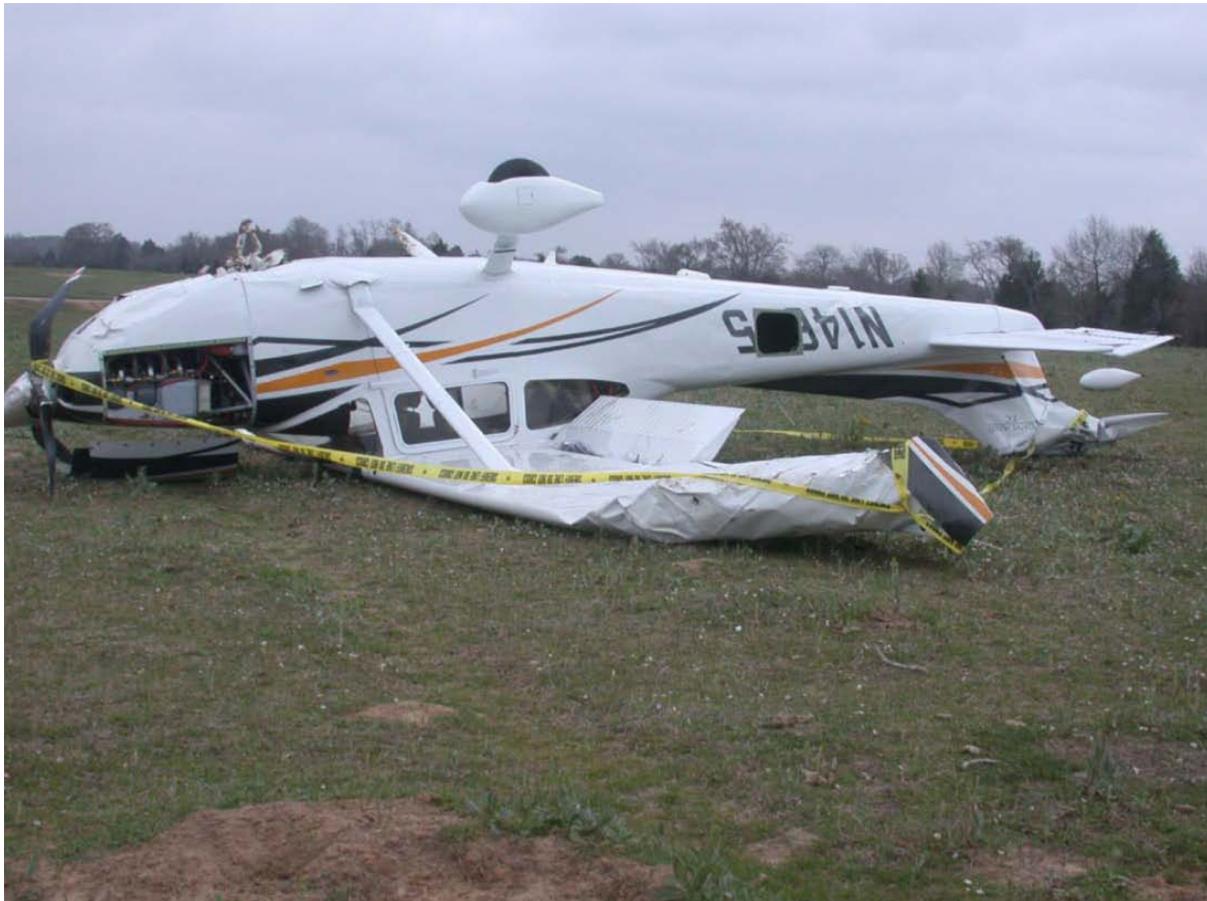
Figure 28. A photograph of the wreckage of Cessna T182T, N14685, which crashed in Athens, Texas.

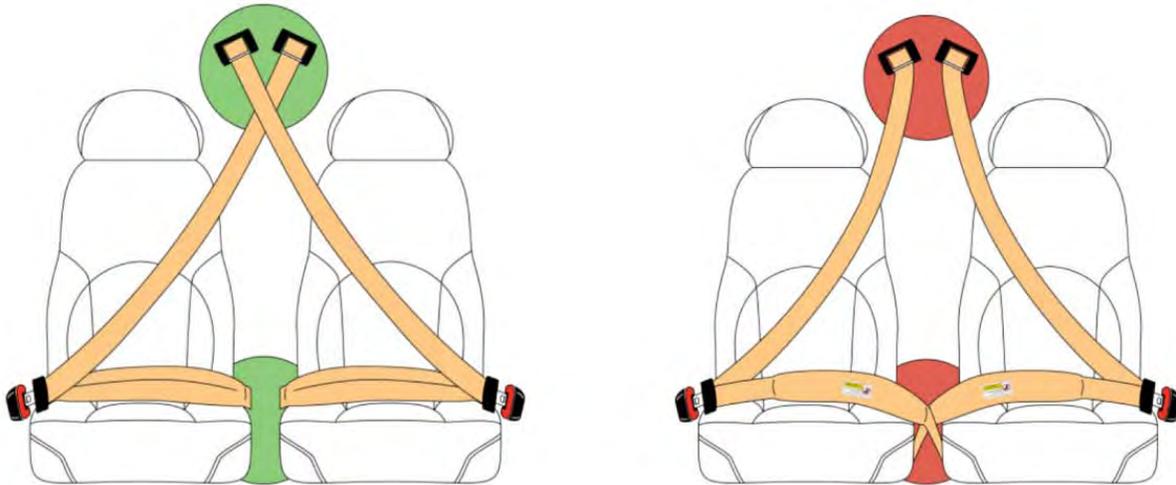
Figure 29. A pair of drawings showing pilot and front passenger seats and restraint configurations of a Cessna 172S. The correct latch configuration is shown on the left, and the incorrect configuration is shown on the right.

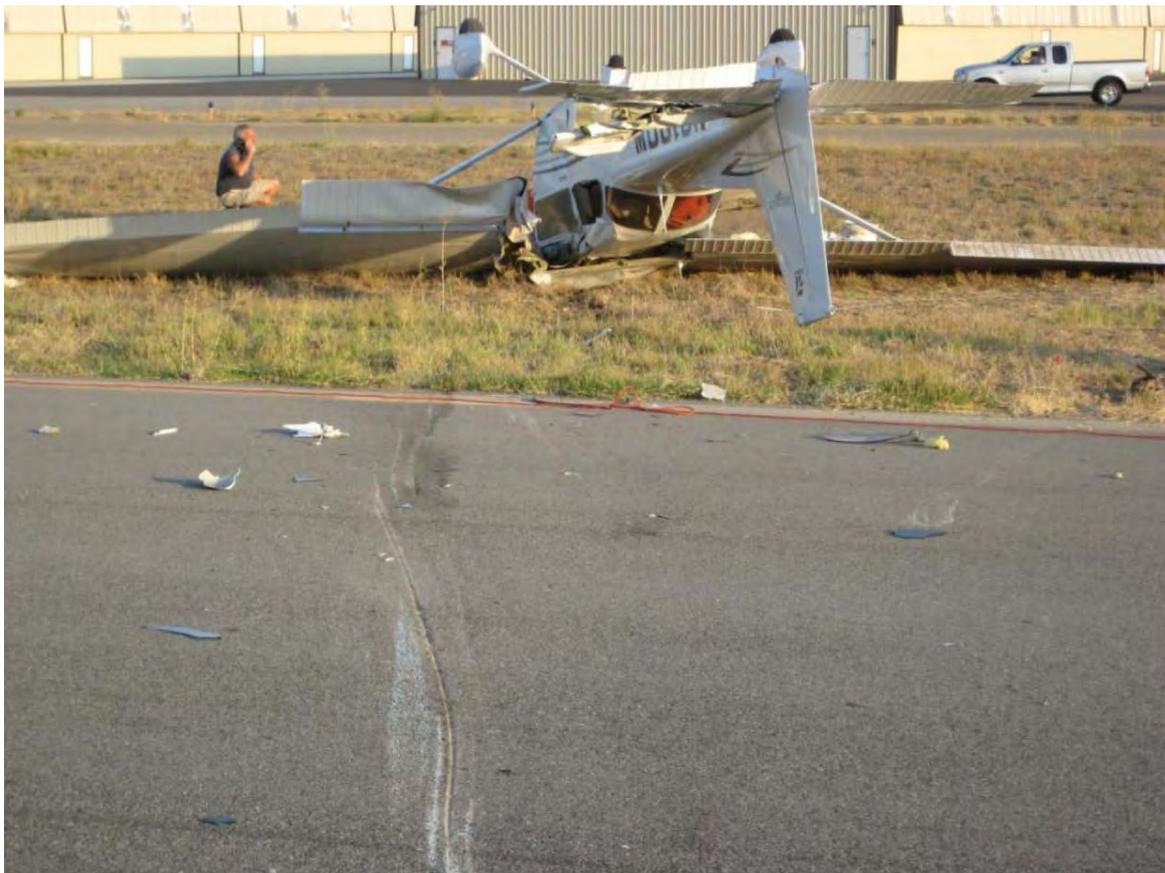
Figure 33. A photograph showing the final resting position of Cessna 172S, N2190W, which crashed in Fullerton, California.

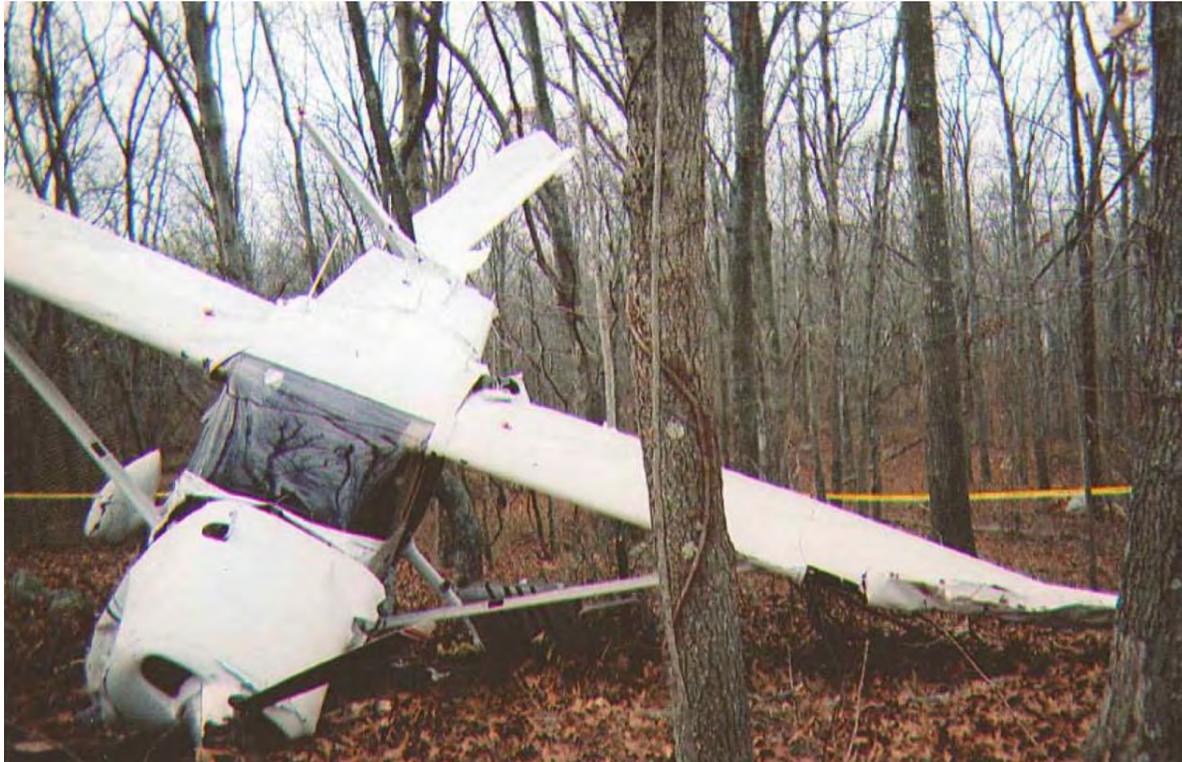
Figure 35. A photograph showing the final resting position of Cessna 172S, N2337F, which crashed in Groton, Connecticut.

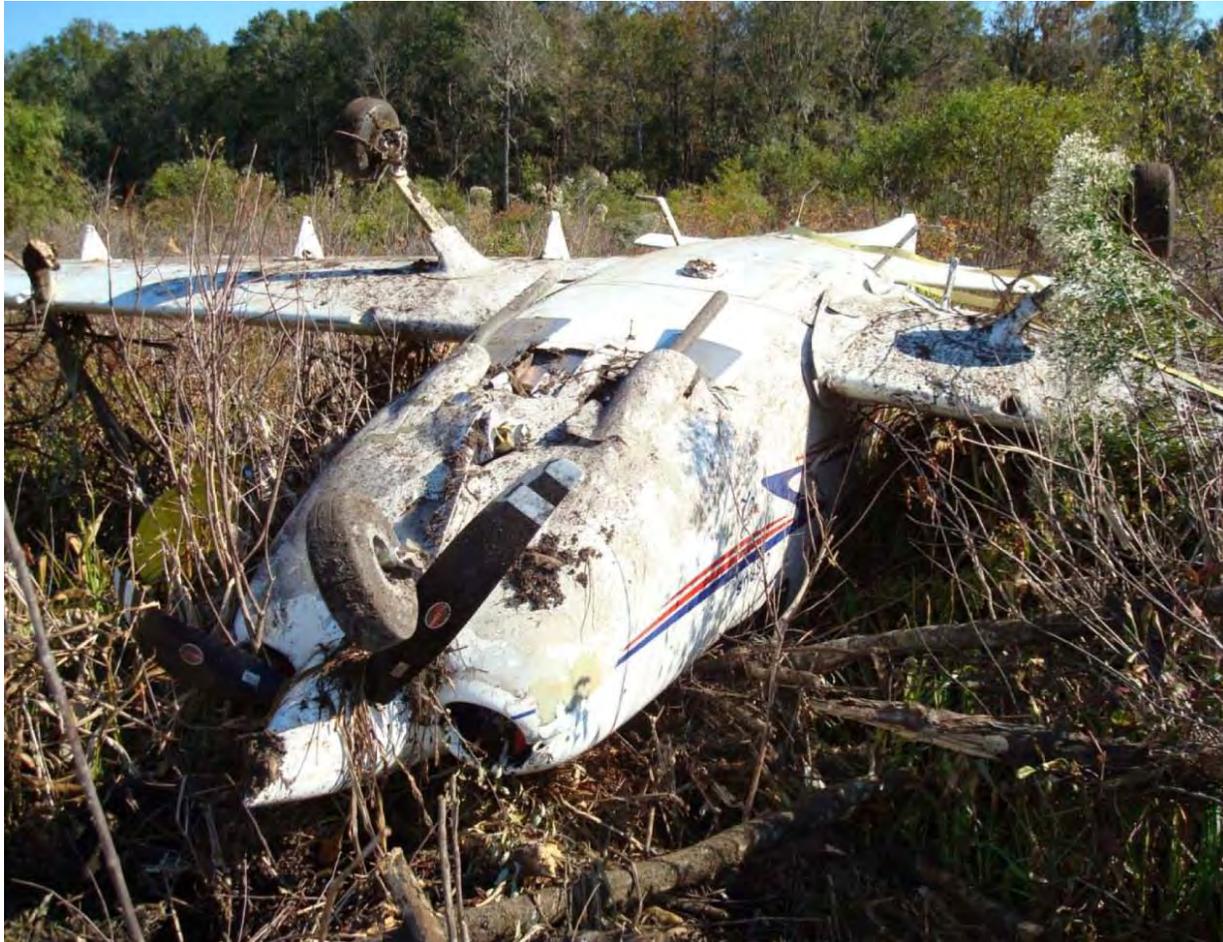
Figure 37. A photograph showing the final resting position of Cirrus SR20, N389CP, which crashed in Green Cove Springs, Florida.

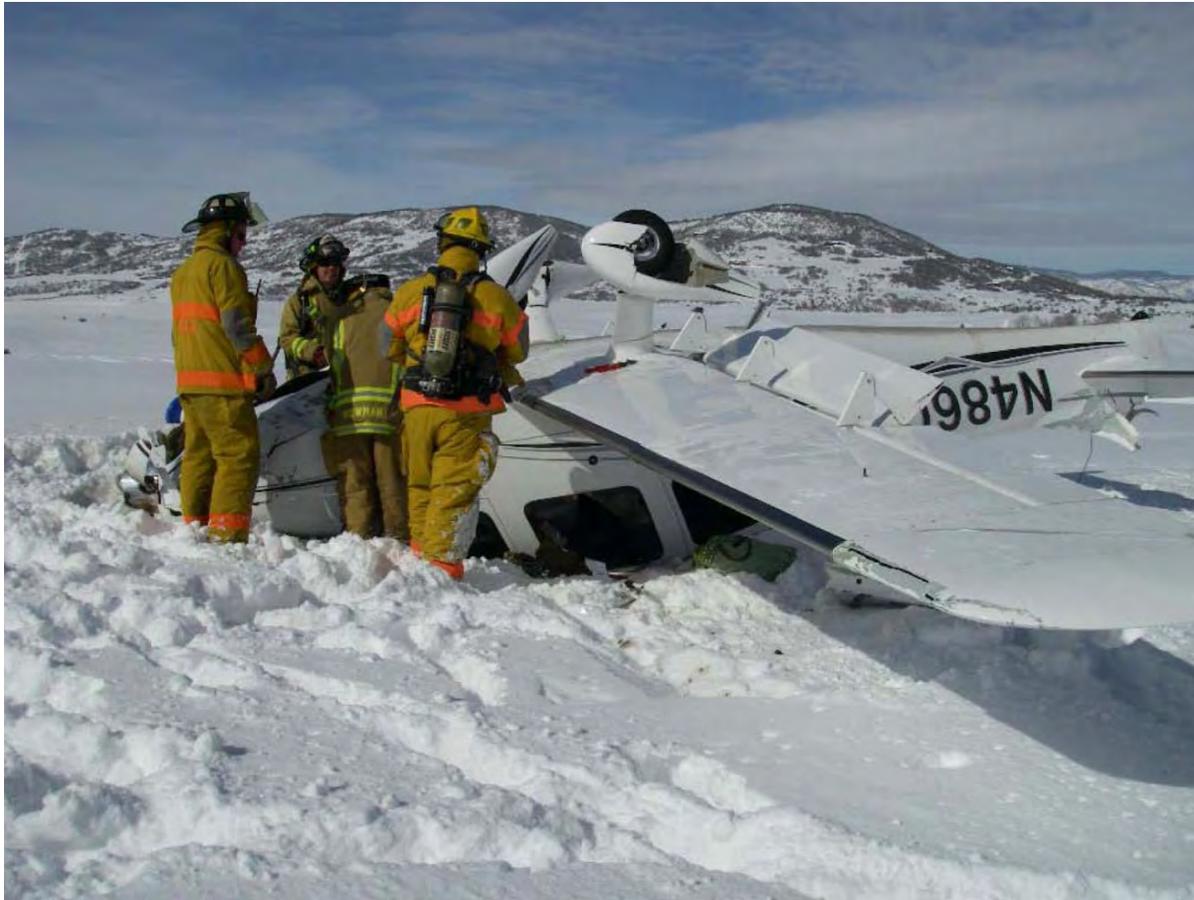
Figure 39. A photograph showing the final resting position of Cirrus SR22, N486CD, which crashed in Steamboat Springs, Colorado.

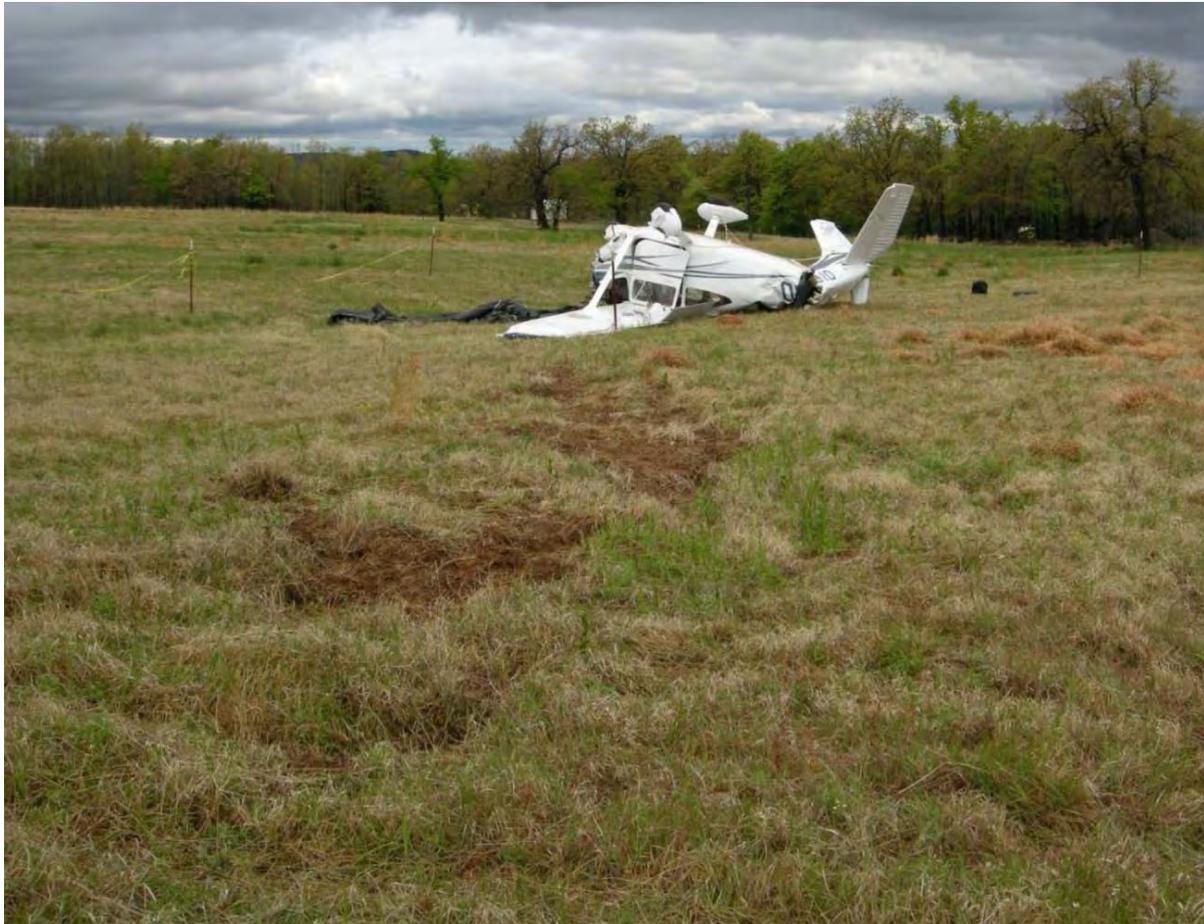
Figure 42. A photograph showing the final resting position of Cessna 182T, N1491D, which crashed in Stigler, Oklahoma. Two major impacts of the nose into the ground are visible in the foreground.

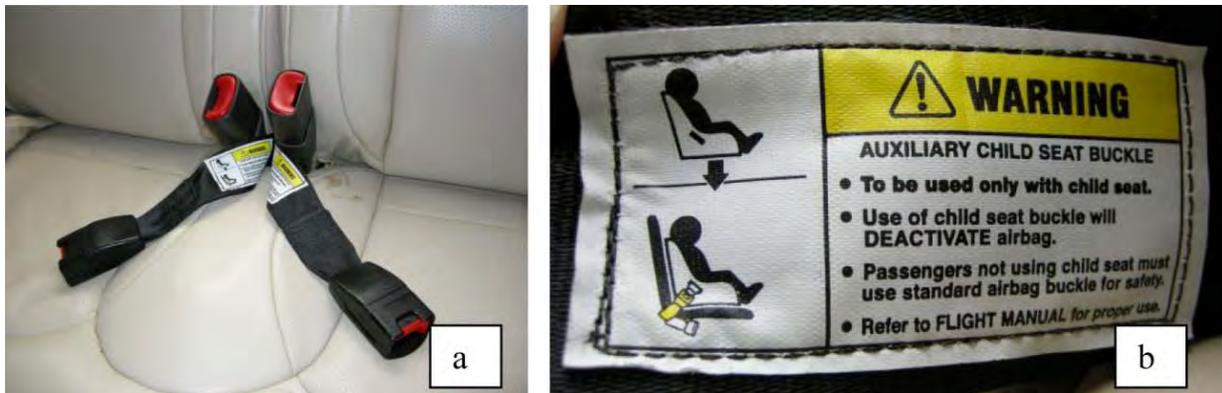
Figure 43. A pair of photographs showing seat belt buckles and a buckle label. Photograph a, on the left, shows the primary (top) and child seat (bottom) buckles for the rear seat occupants. Photograph b, on the right, shows the label stitched to the child seat buckles.

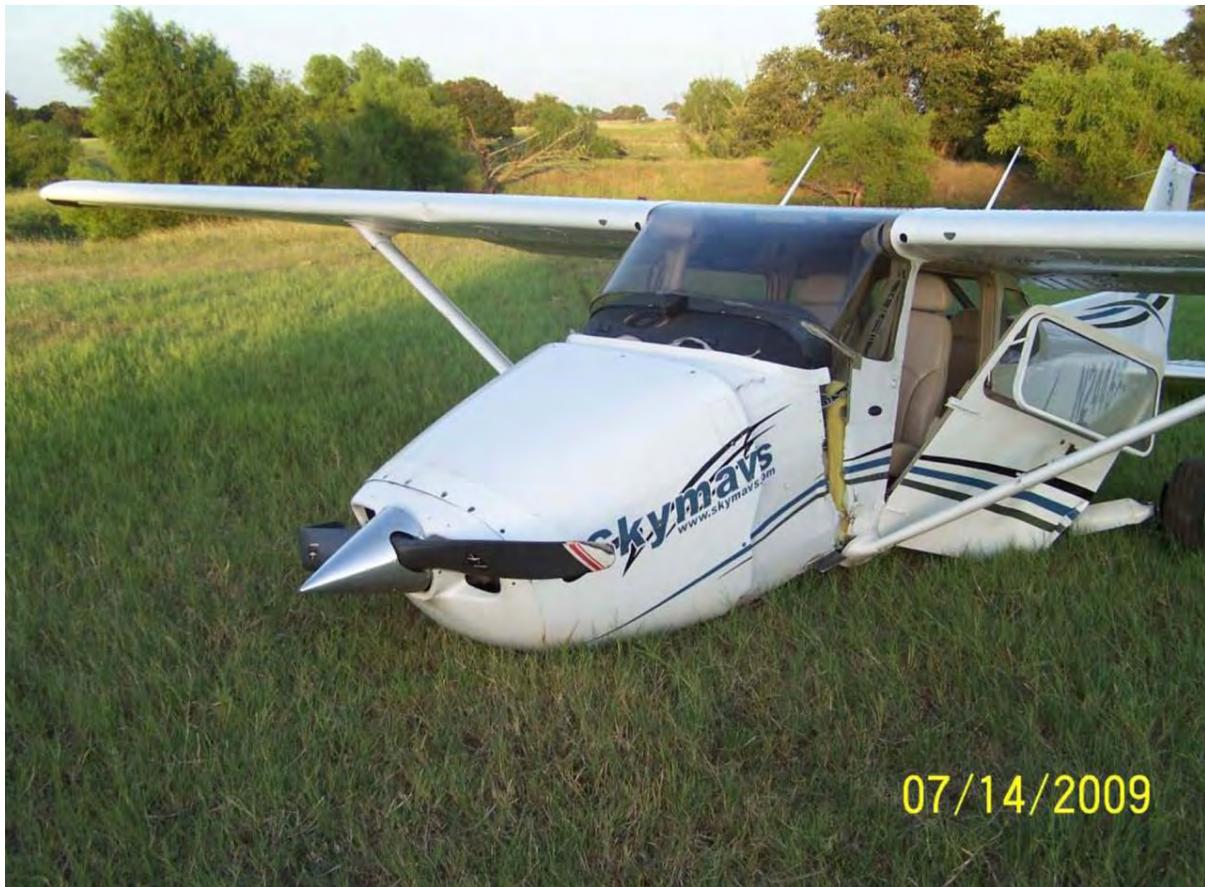
Figure 45. A photograph of the final resting position of Cessna 172SP, N2246F, which crashed in Boyd, Texas.
