Collision with Terrain During Takeoff
of Parachute Jump Flight
Beech King Air 65-A90, N256TA
Mokuleia, Hawaii
June 21, 2019

Accident Report

NTSB/AAR-21/02
PB2021-100909

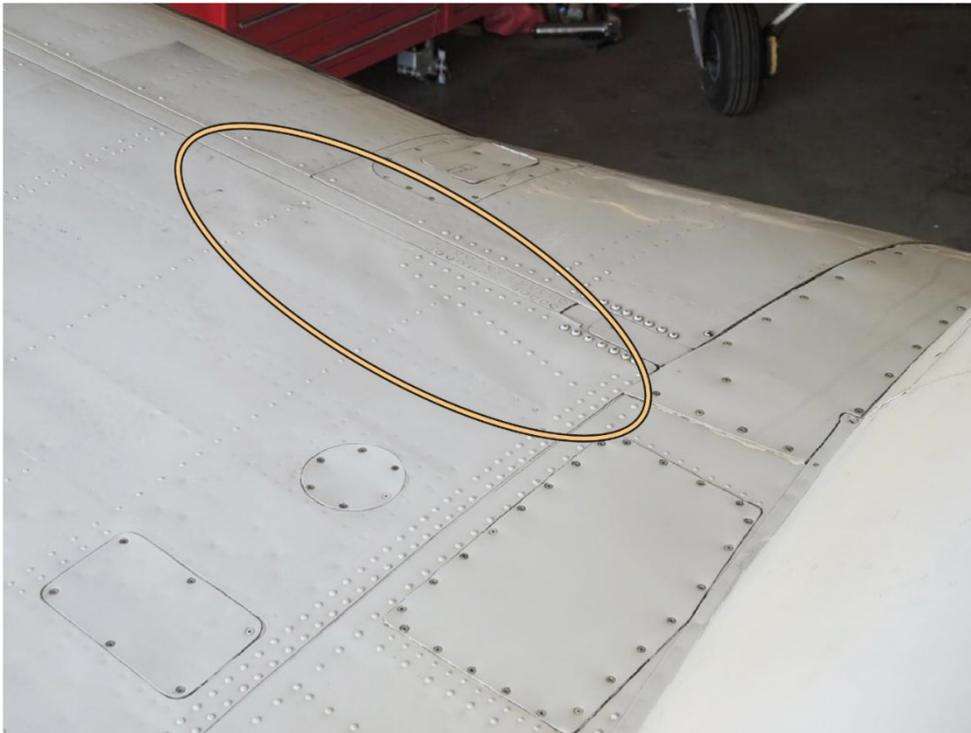
Figure 2. Wrinkles in the top skin of the left wing after the July 2016 accident

Photographs taken during the investigation of the July 2016 accident showed wrinkles in the top skin of the left wing immediately outboard of the engine and aft of the forward spar. The wrinkles, shown in figure 2, were consistent with compression buckling. The direction of wing twist indicated by the wrinkles was leading edge up for the wing tip.

The left aileron trim tab was found in the wreckage in the full left-wing-down position; this position compensated for the aerodynamic effects resulting from damage likely sustained during the July 2016 accident that was not subsequently repaired.⁵³ The possible effects of this left wing anomaly included a reduction in the aileron deflection that would be available for maneuvering, higher drag, and/or higher stall speeds for that wing.

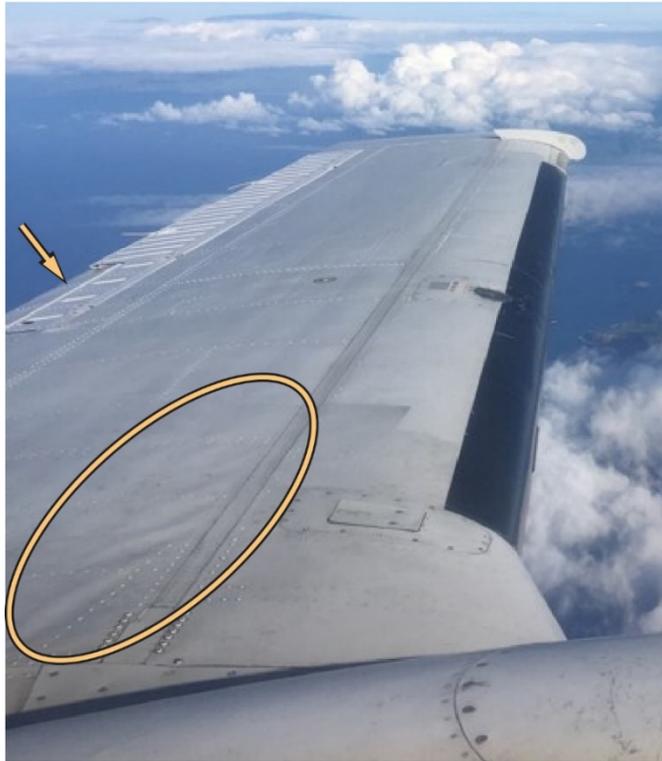
A video of the airplane from 2011 showed the trim tab on the left aileron close to the trailing, or normal, position, but the photographs taken during the 2016 accident investigation showed that the left aileron trim tab was deflected downward.³⁴ An in-flight photograph from the ferry flight to deliver the airplane from the US mainland to Hawaii in June 2017 also showed the deflection of the left aileron trim tab and wrinkled skin on the left upper wing, as shown in figure 3.³⁵

Note: The arrow indicates the aileron trim tab deflection, and the wrinkled skin is shown within the circle.

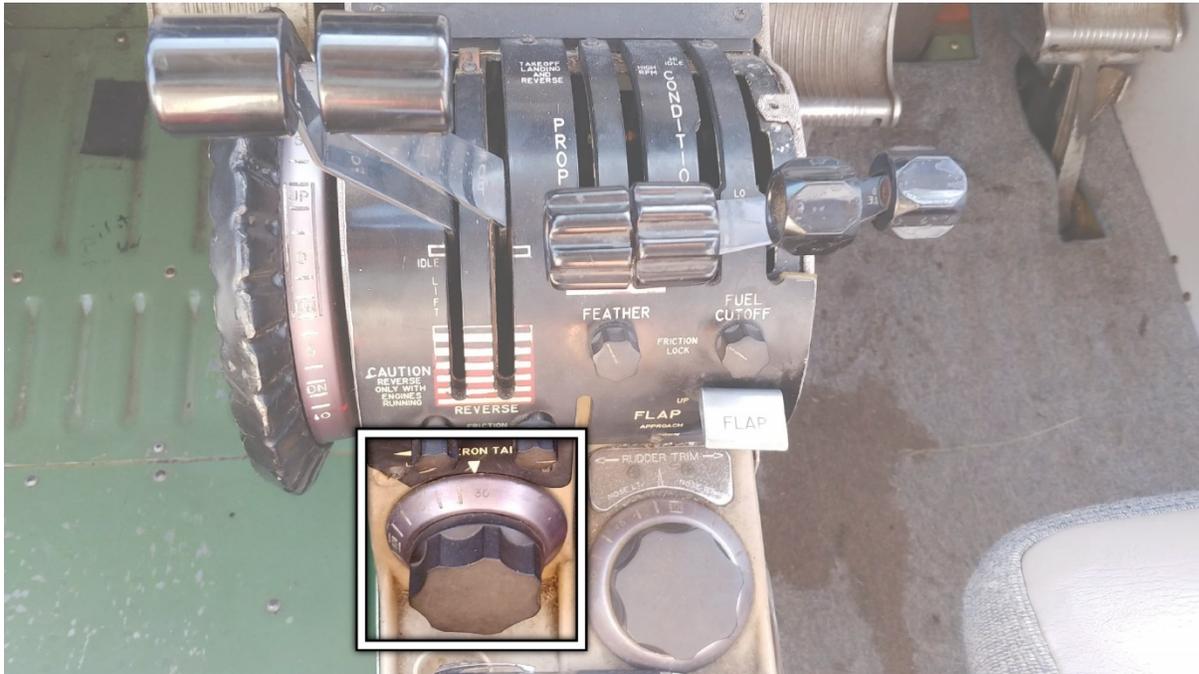
Figure 4. Aileron trim knob in its full left-wing-down position

A photograph that was taken during the investigation of the 2016 accident showed that the aileron trim knob was set to the full left-wing-down position during the accident flight. A November 2018 photograph, which was taken about 1.5 years after completion of the repairs resulting from the 2016 accident, also showed the aileron trim knob set to the same position, as shown in figure 4.

According to a former OPC pilot who trained multiple other pilots in the accident airplane (including the pilot who provided company training to the accident pilot), the accident airplane would not fly straight and level without full left-wing-down aileron trim. This former OPC pilot stated that the airplane owner was aware of this issue and told him that the condition had something to do with “the left wing being bent.”³⁶

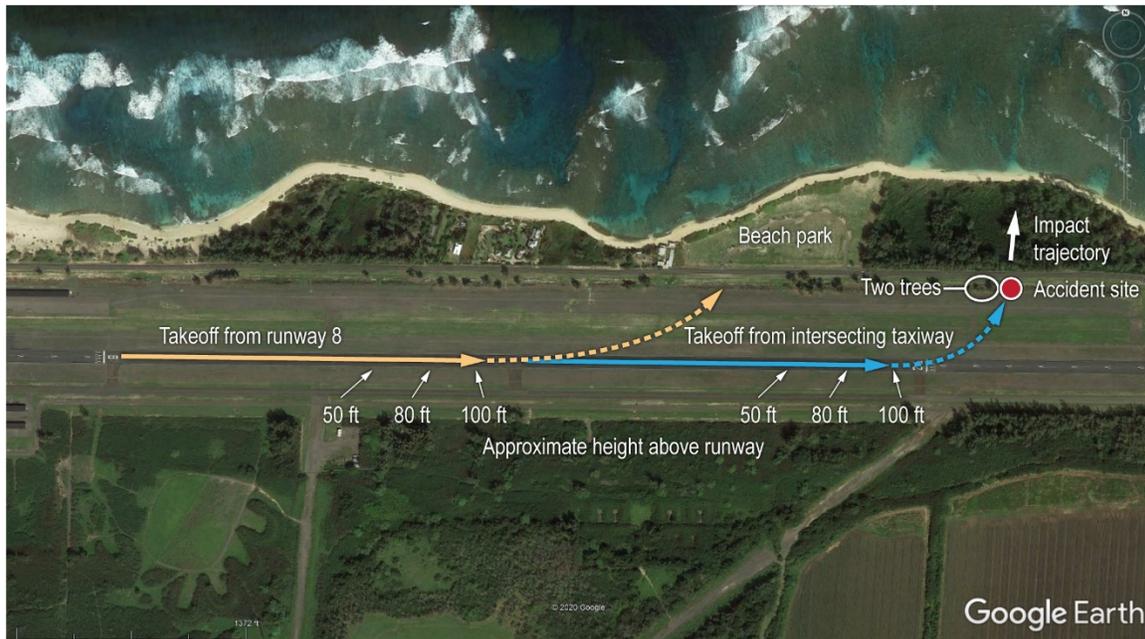
Figure 7. Comparison of the standard and accident takeoff flight trajectories

For the accident flight, there was no video or witness report indicating the airplane's location on the runway at the beginning of the takeoff roll. Because the accident location was directly under the flightpath (specifically, the location of the turn) of the previous flight, the NTSB determined that, for the accident flight, the pilot most likely followed a similar flight trajectory and performed a takeoff from the runway 8 intersection rather than the standard departure location, as shown in figure 7.

Note: The standard takeoff flight trajectory is shown in yellow, and the accident takeoff flight trajectory is shown in blue. The dotted blue line shows the calculated turn radius and not necessarily the accident flight's ground track. The location of the two trees, which were visible in the passenger video discussed in section 1.8.1, and the location of the accident site were used to determine the airplane's likely flight trajectory.
