PRELIMINARY REPORT

HIGHWAY

HWY20FH001

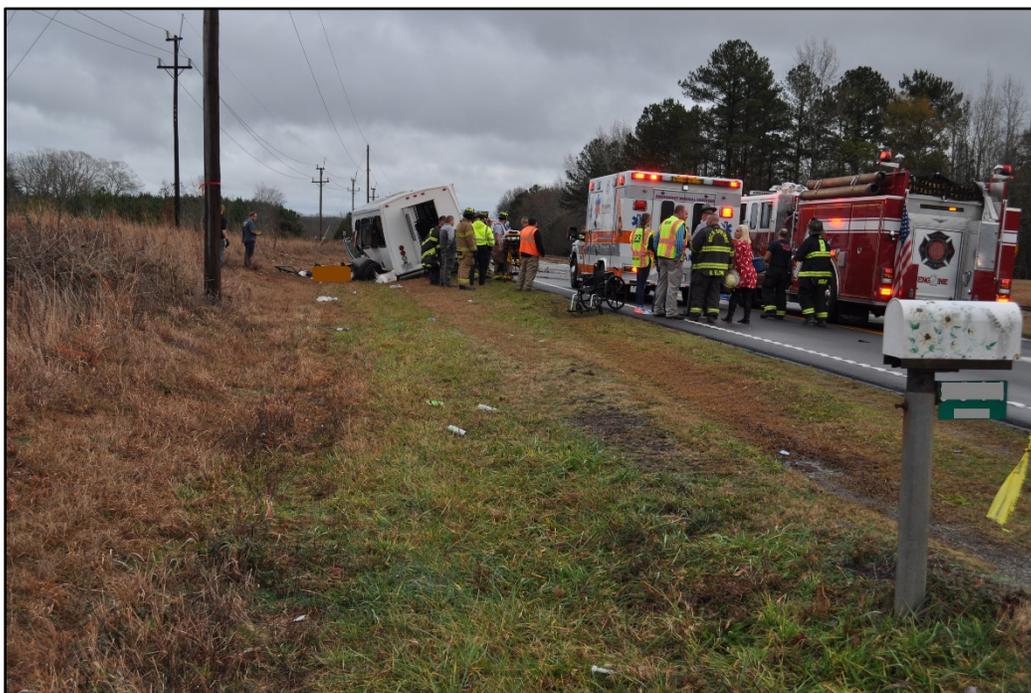
Figure 1. Westbound view of crash scene showing bus on grassy area and emergency vehicles and responders. (Source: Anderson County Coroner's Office)

Preliminary evidence indicates that all the bus's occupants were wearing restraints. The driver was restrained with a lap/shoulder belt and a supplemental airbag. Four passengers seated in the rear were restrained with lap-only belts. Two wheelchair-bound passengers were restrained by lap/shoulder belts; the wheelchairs were secured at the rear of the bus. As a result of the crash, one lap-belted passenger seated behind the driver was partially ejected and fatally injured. The bus driver and the 6 remaining passengers sustained minor to serious injuries.

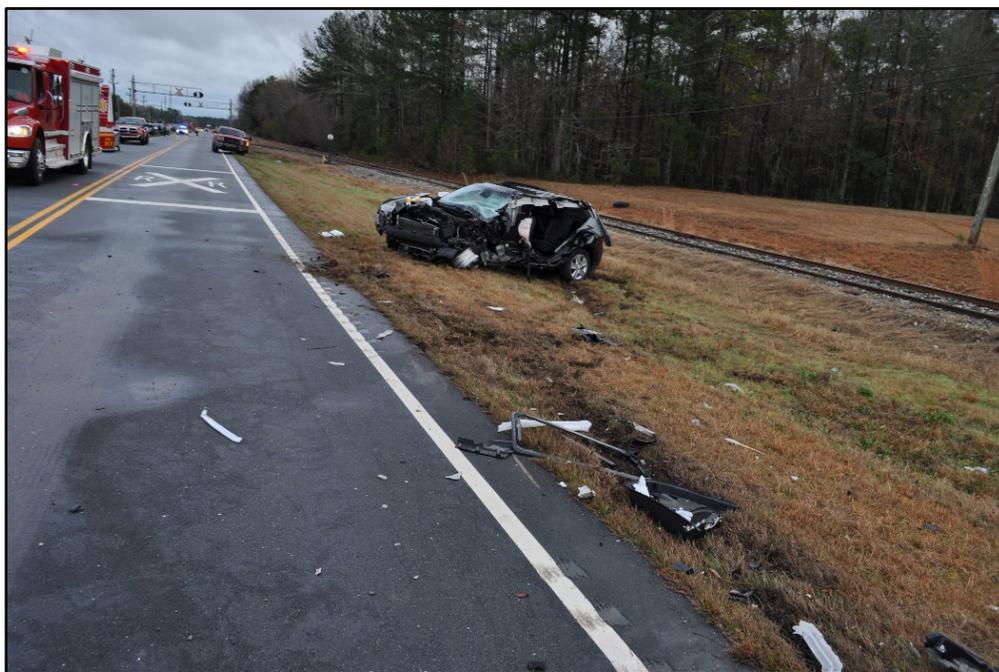
Figure 2. Westbound view of crash scene showing damaged SUV on grassy embankment. (Source: Anderson County Coroner's Office)

Preliminary information suggests that the SUV driver had been swerving completely across both lanes from shoulder to shoulder before striking the bus. According to data from the SUV's airbag control module, the driver was not wearing a seat belt. She was ejected during the crash and fatally injured. The NTSB has subpoenaed the SUV driver's cell phone records from the service provider and will review them over the coming weeks. Results of toxicology tests are pending.
