National Transportation Safety Board

Marine Accident Brief

Collision and Subsequent Sinking of Towing Vessel *Specialist*

Accident no.	DCA16FM033
Vessel name	<i>Specialist</i>
Accident type	Collision; sinking
Location	Hudson River at Tappan Zee Bridge, pier 31, Tarrytown, New York
Date	March 12, 2016
Time	0500 eastern standard time (coordinated universal time – 5 hours)
Injuries	3 fatalities
Property damage	Constructive total loss of vessel
Environmental damage	Oil sheen observed
Weather	Clear, 5-knot winds from the west, air temperature 34°F
Waterway information	Hudson River, Tarrytown, New York. At the time of the accident, the current was ebbing from the north at about 1.2 knots, and the water temperature was 39°F.

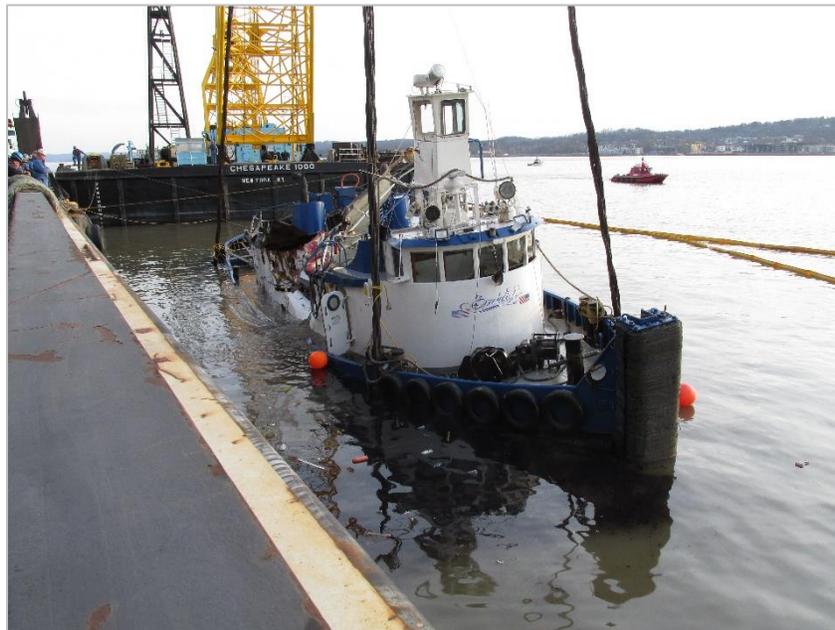
The *Specialist* being recovered after the accident. (Photo by US Coast Guard)

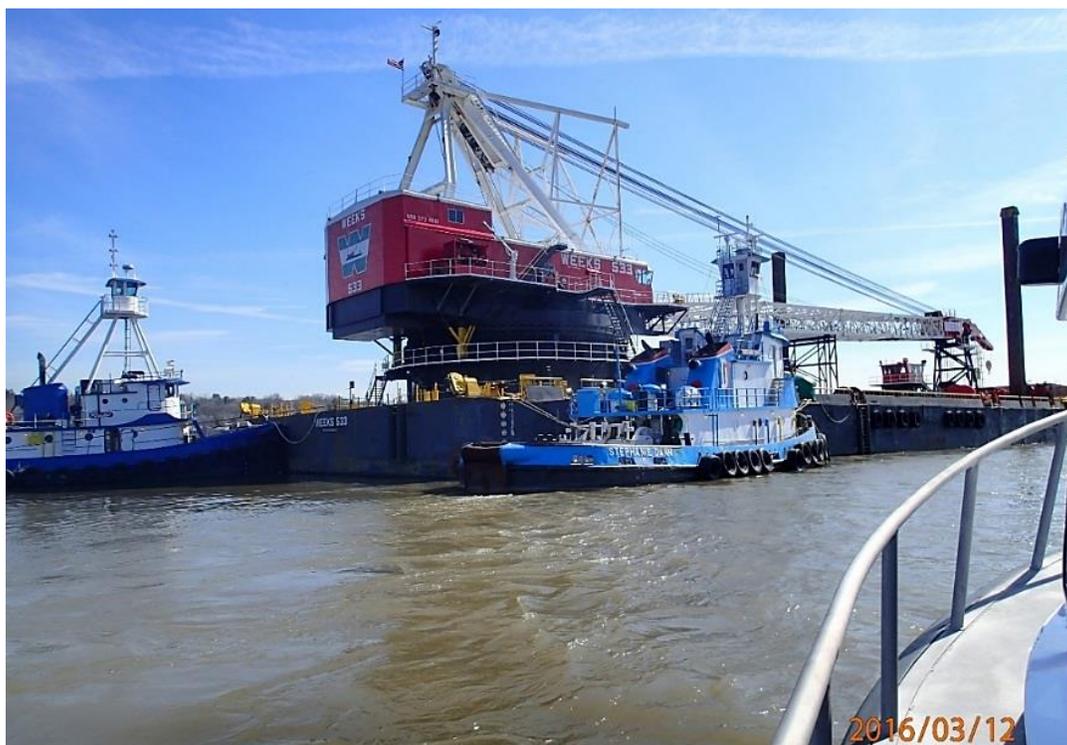
Weeks 533 with two tugboats after the accident. (Photo by Coast Guard)

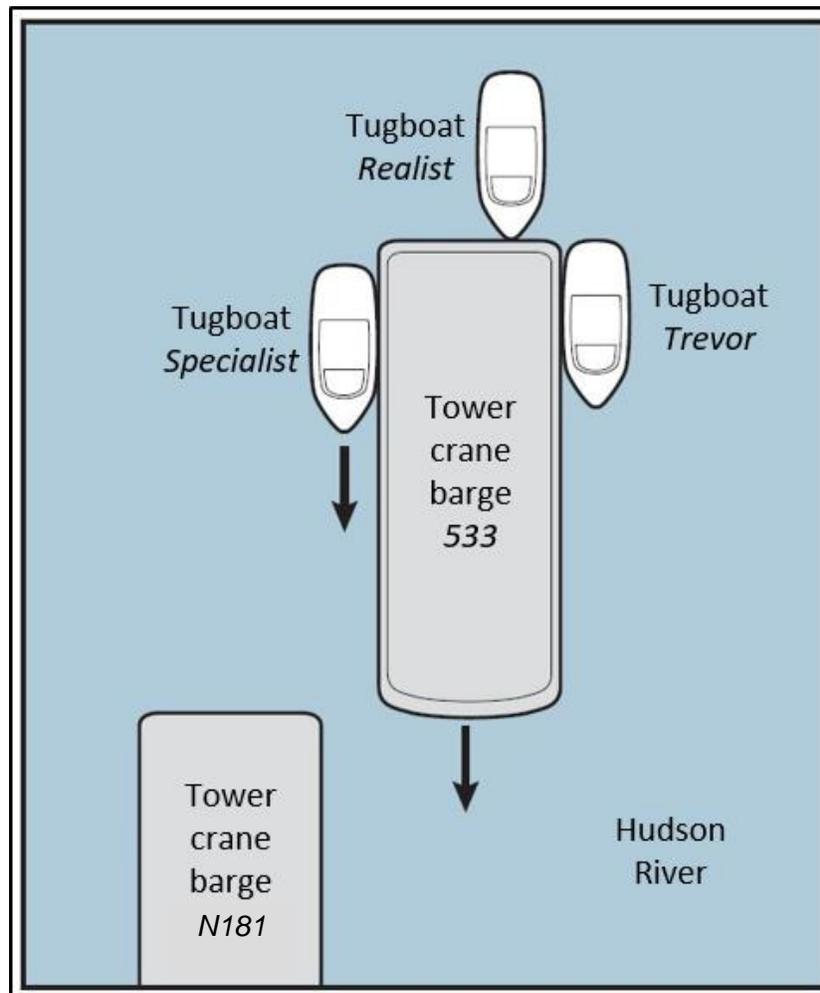
Diagram of the towing arrangement. (Image based on Coast Guard graphic)

Once the *Realist* came to assist, the *Specialist* deckhand texted, “The *Realist* captain is alone on the *Realist* so I have a feeling I’m gonna have to go over and steer . . . let alone pushing something that you can barely see around.” Based on pictures taken of the tower crane barge after the accident, with the configuration of tugboats alongside the barge, the crane presented obstructed visibility for operators even in the upper wheelhouse.

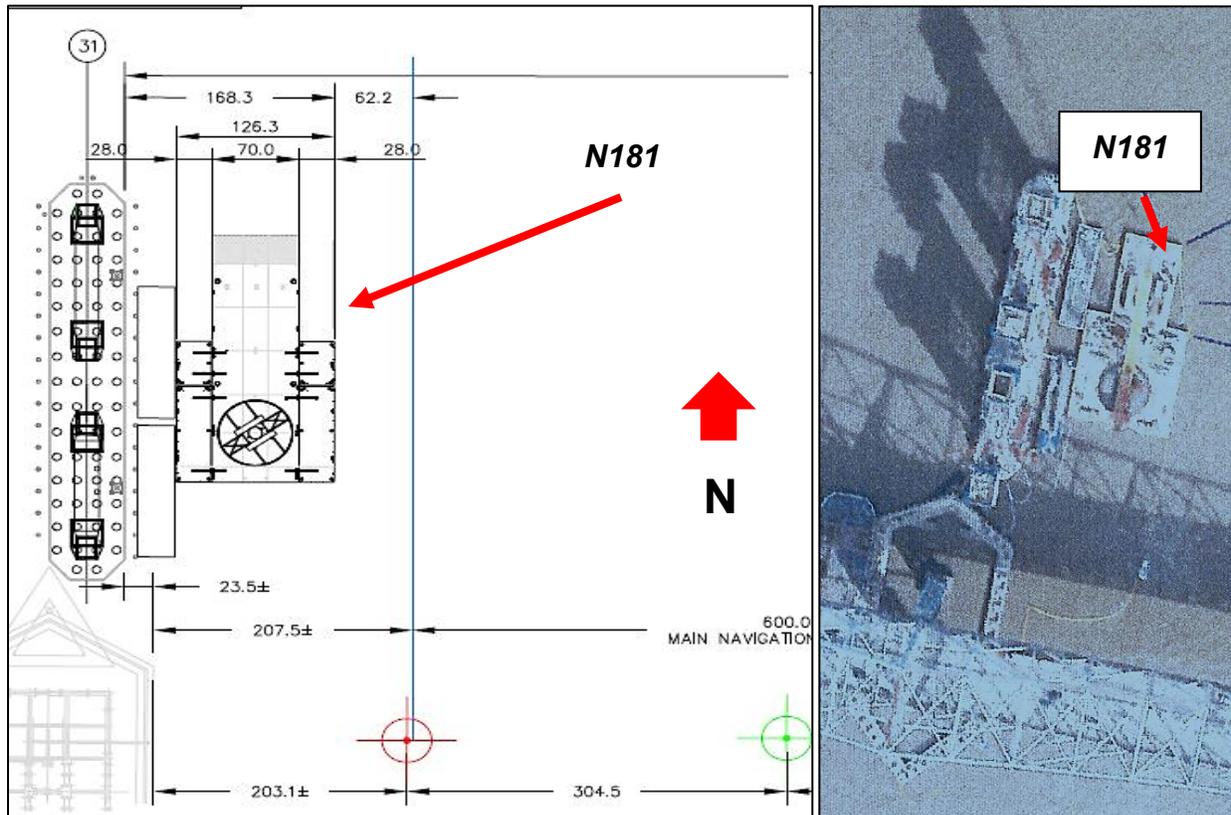
As part of the construction project, tower crane barge *Hank Hummel*—referred to as *N181*—was set up as a work platform and was located outboard of two other smaller deck barges to the east of pier 31 of the new bridge. The 70-foot-wide barge was constructed with 28-foot-wide sponsons on each side, with an overall width at the aft section of 126 feet, and was spudded to the bottom of the waterway. The aft section of the construction barge was 62 feet outside the navigable channel. The forward, starboard corner was 90 feet outside the channel. This arrangement differed from the arrangement identified in the Local Notice to Mariners, but the barges were outside the navigable channel. On the morning of March 12, about 21 workers were on or around the *Hank Hummel*.

Left, diagram of *N181*'s location at pier 31, as if seen from above. (Diagram by TZBC) Right, aerial photo of the area near pier 31. (Photo by WCPD)

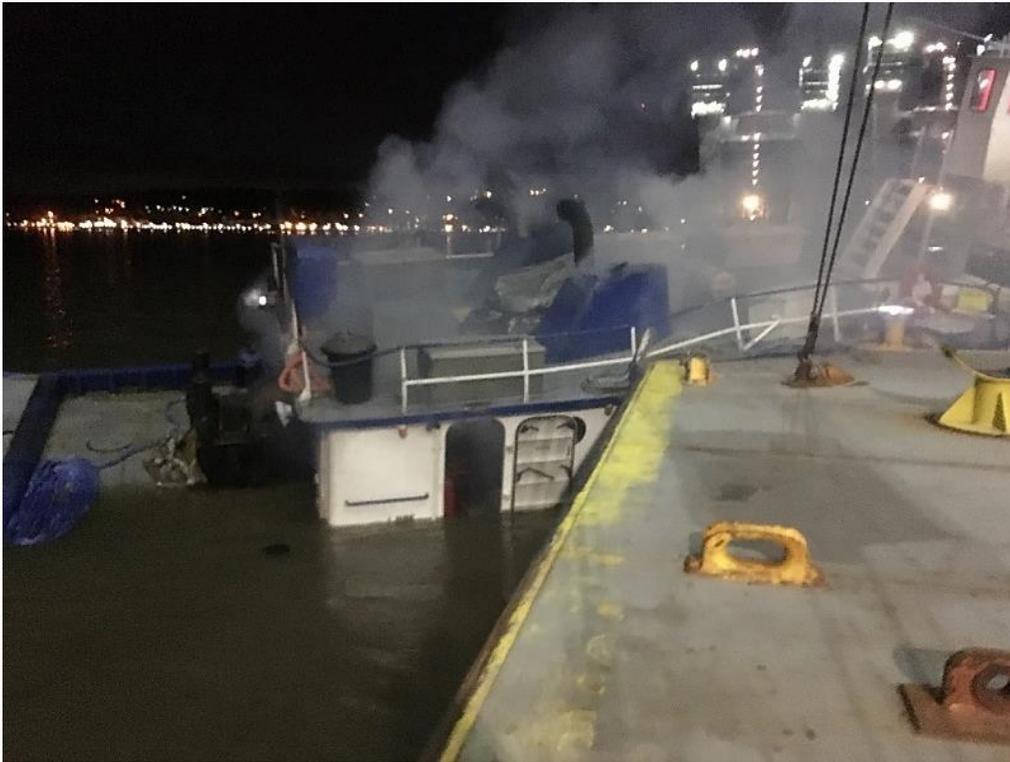
Before the flotilla could maneuver away from the spudded barge, the starboard side of the *Specialist* struck the forward starboard corner of *N181* at about 7.8 knots, causing significant damage to the *Specialist* above the waterline. The mate, who had been at the helm, jumped off the *Specialist* and onto the construction barge after the collision. The ebbing current pushed the *Specialist* into the raked bow of the construction barge and began pushing the tugboat under water. According to statements from the workers on *N181*, the mate returned to the tugboat to attempt to help a deckhand who was trapped inside and calling for help. The *Specialist* took on water through open doors and rapidly sank with the mate and two deckhands aboard. After the vessel sank, several workers from the construction barge saw the mate in the water, being swept away by the current. They threw life rings toward him but he was unresponsive. A nearby rescue boat recovered the mate about 100 yards from the accident site moments later and rushed him to shore; attempts to revive him were unsuccessful.

***Specialist*, moments after colliding with barge N181. (Photo by witness)**

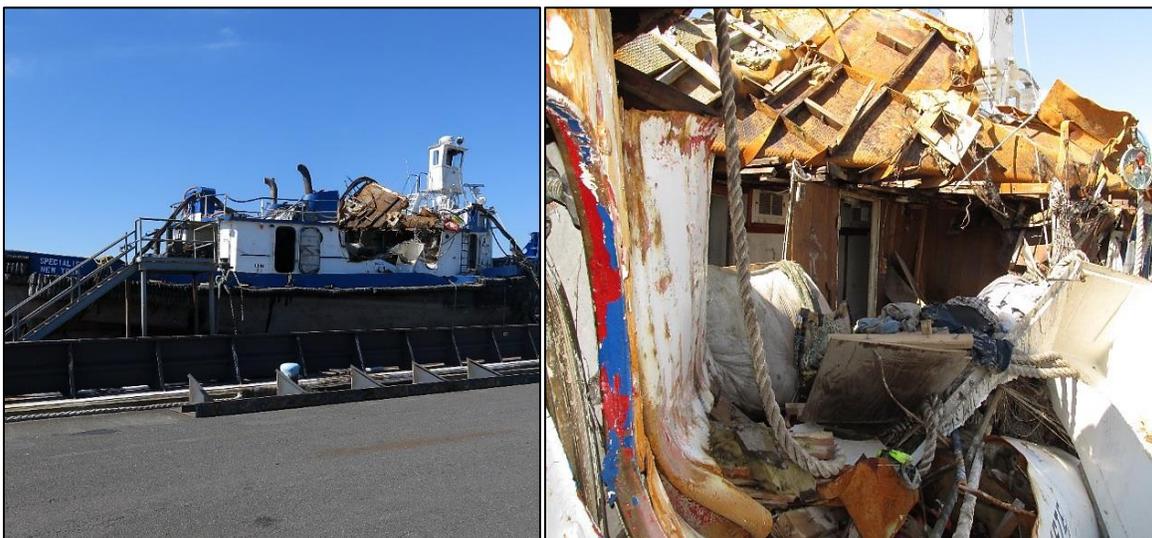
Left, damage to starboard side of the *Specialist's* superstructure after the accident. Right, damage to interior starboard sections of the *Specialist*.
