## Midair Collision Involving US Army PAT25 and PSA Airlines Flight 5342 Washington, DC January 29, 2025

Brian Soper  
Air Traffic Control Group Chairman

# Overview of Air Traffic Control (ATC)

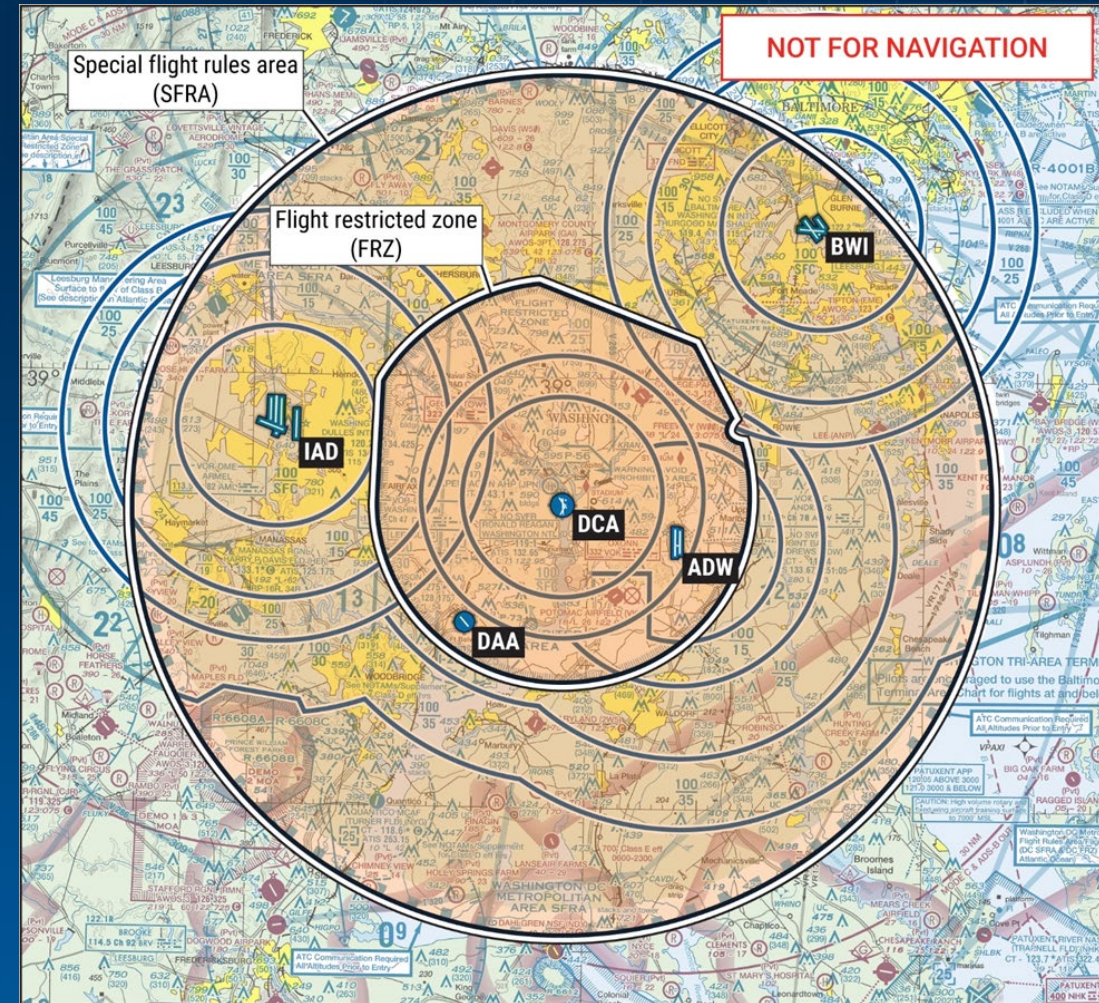
# Airspace Surrounding DCA

- Complex ATC operational environment with Special Flight Rules Area, Flight-Restricted Zone, and prohibited areas
- DCA tower's delegated airspace responsibility far more expansive than that of similar airports
- Extensive charted helicopter operating areas and routes

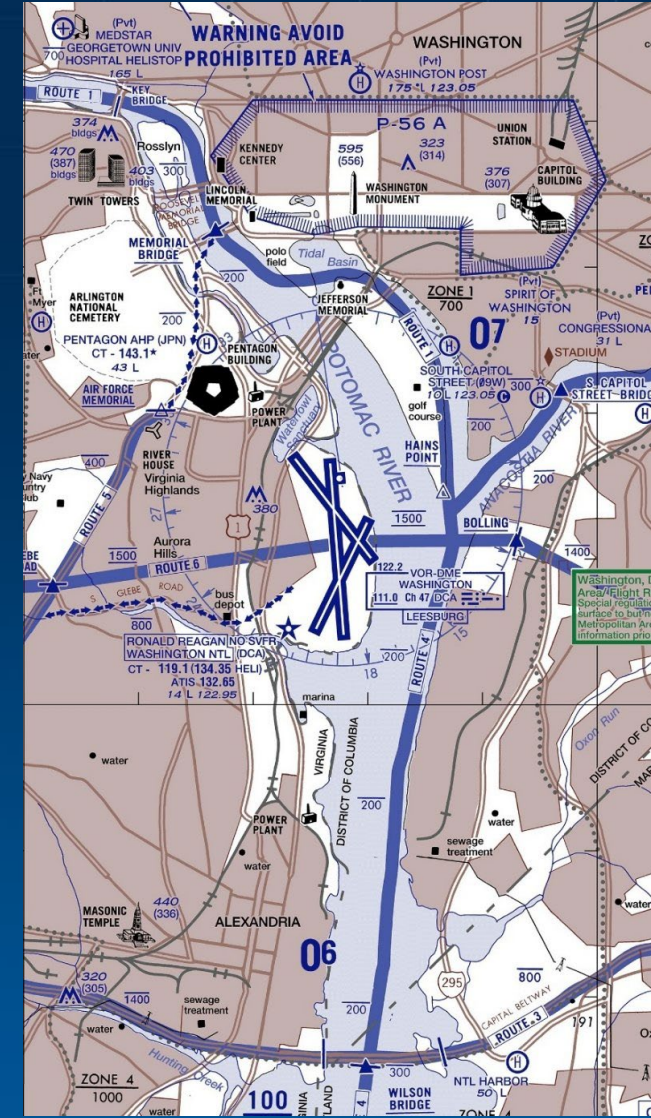
# Helicopter Route 4

- Established in 1986
- One of several charted routes to transition helicopters through DCA Class B airspace
- Posed proximal conflict to runway 33 approach and runway 15 departure corridors
  - Routes never procedurally separated
- Understanding and interpretations varied across user groups

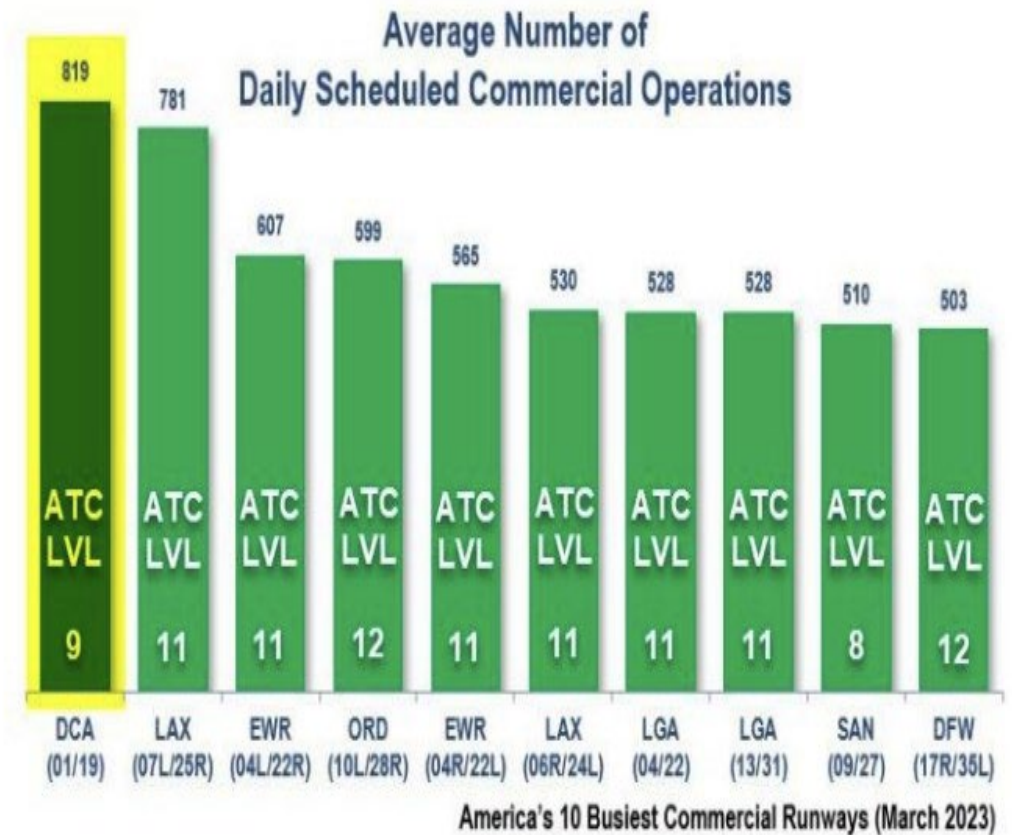
## DCA's Runway 01/19 Is The Busiest Runway In America

- DCA has busiest single runway in National Airspace System
- Capacity constrained airport
- Traffic flow managed through airport arrival rates, miles-in-trail spacing, and slot controls
- Limited surface area, complex geometry required “work-arounds” to avoid delays or gridlock
