National Transportation Safety Board

Aircraft Accident Investigative Update

On September 4, 2022, about 1509 Pacific daylight time, a De Havilland Canada DHC-3, N725TH, was destroyed when it impacted Mutiny Bay, near Freeland, Washington, and sank. The pilot and nine passengers were fatally injured. The airplane was operated as a Title 14 *Code of Federal Regulations* Part 135 scheduled flight. The US Coast Guard and Good Samaritans responded to the accident site.

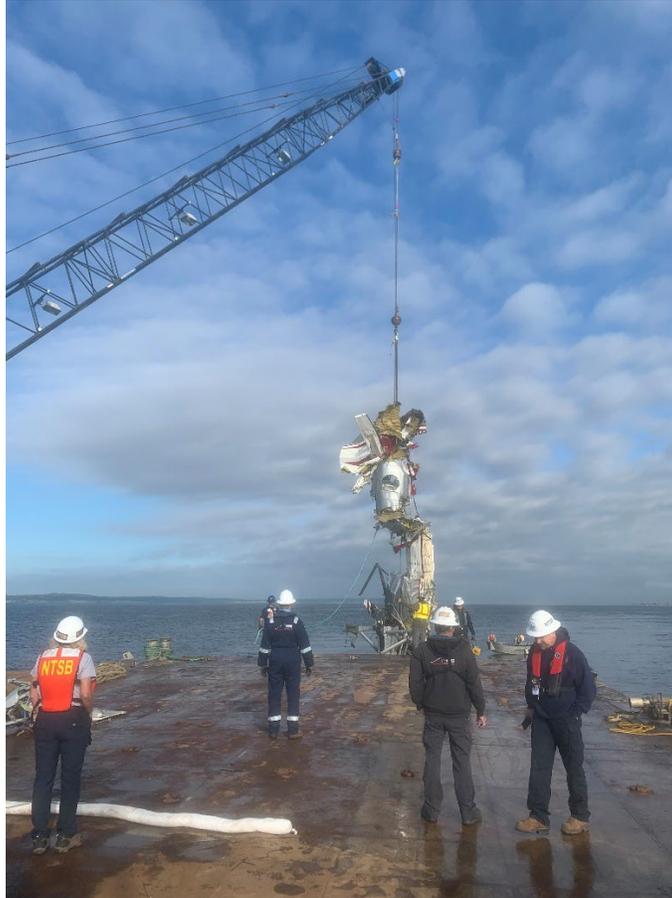
The wreckage recovery operation was completed by the US Navy's Supervisor of Salvage and Diving on September 30, with about 85% of the airplane recovered from the sea floor (see figure 1). The Systems group performed a field examination of the wreckage during the week of October 3, with follow-up activities in the NTSB Materials Laboratory October 18-19. The horizontal stabilizer actuator (also referred to as the trim jack) and both elevators were shipped to the NTSB's Materials Laboratory for further examination.

Figure 1. Main wreckage lift.

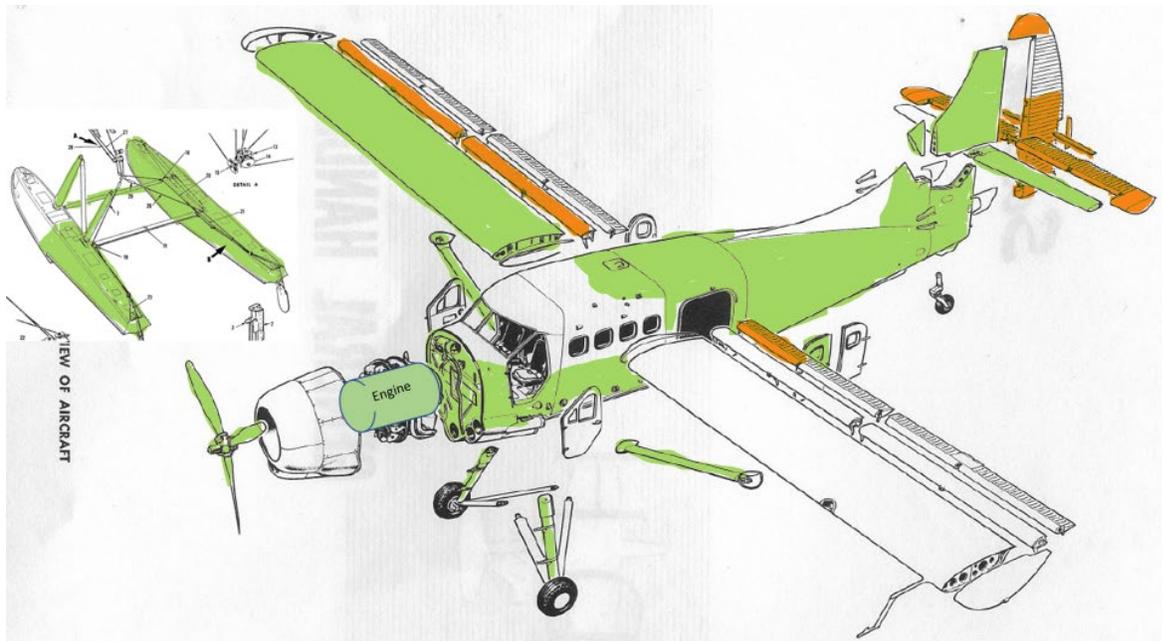
The airplane wreckage was heavily damaged due to water impact. Figure 2 depicts what was positively identified during the wreckage examination. The right horizontal stabilizer and the left wing were not recovered. Both were visually identified by a camera located on the remotely operated vehicle during the recovery operation, but both pieces shifted during one of the lifts and were unable to be located afterwards.

Figure 2. Recovered wreckage highlighted in green. Recovered flight controls highlighted in orange.

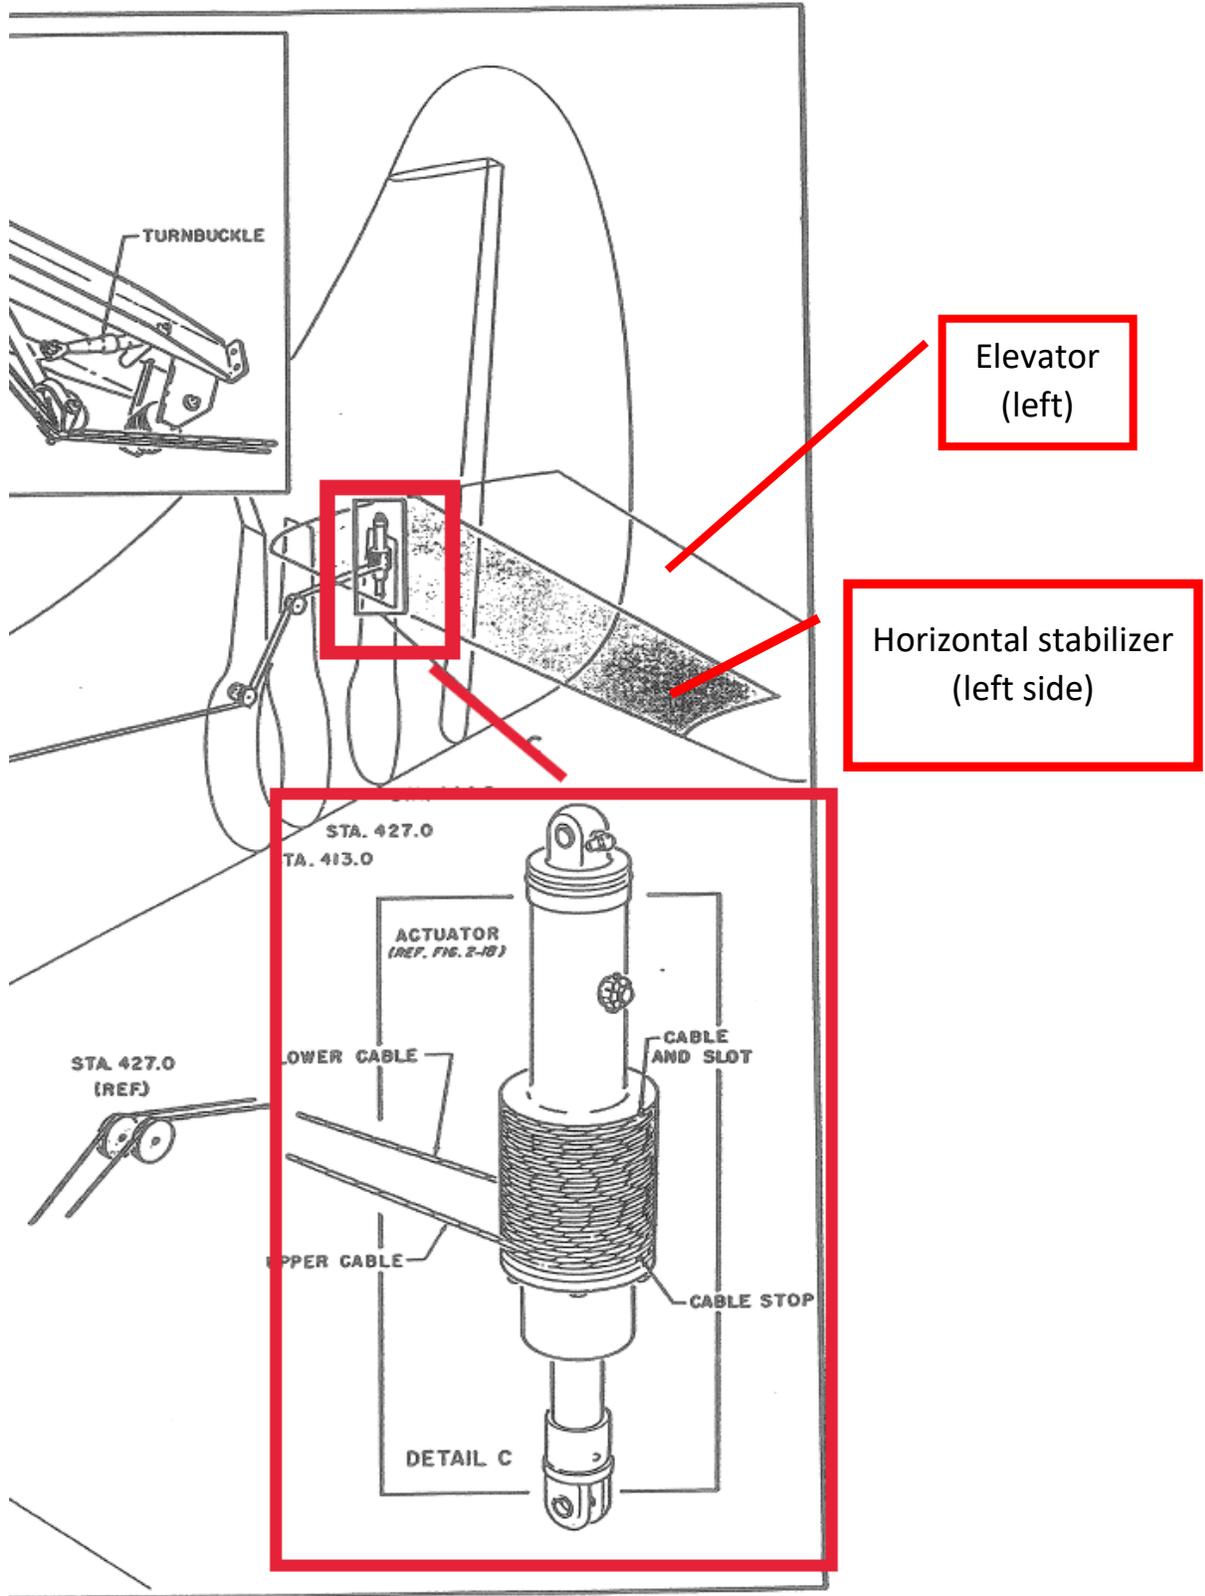
The Systems group found the horizontal stabilizer actuator (see figure 3) had separated into two pieces at a threaded assembly fitting. The actuator is part of the airplane's pitch trim control system. The pitch trim wheel, located in the cockpit, is used to manipulate the actuator through control cables that rotate the actuator, extending (lengthening) or retracting (shortening) the overall length of the actuator. This extension or retraction changes the incidence of the horizontal stabilizer, thereby providing a mechanism for the pilot to relieve elevator control force pressure.

Figure 3. Horizontal stabilizer actuator location (Source: Viking Air Limited).

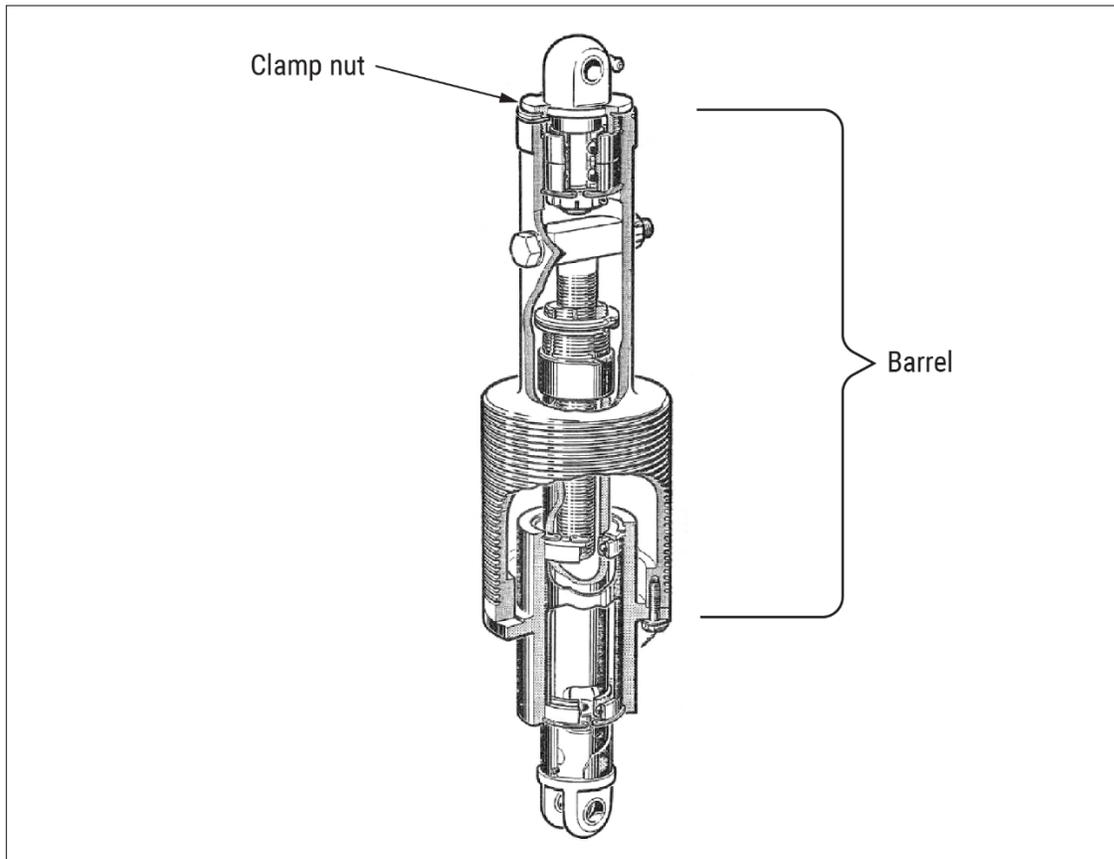
The actuator was found separated where the clamp nut threads into the barrel section (see figure 4). Examination of the threads inside the barrel and the threads on the clamp nut revealed that the two components separated by unthreading (that is, rotation of the barrel and/or clamp nut) as opposed to being pulled apart in tension. The upper portion of the actuator remained attached to the horizontal stabilizer, and the lower portion remained attached to its mount in the fuselage.

Figure 4. Horizontal stabilizer actuator clamp nut and barrel (Source: Viking Air Limited).

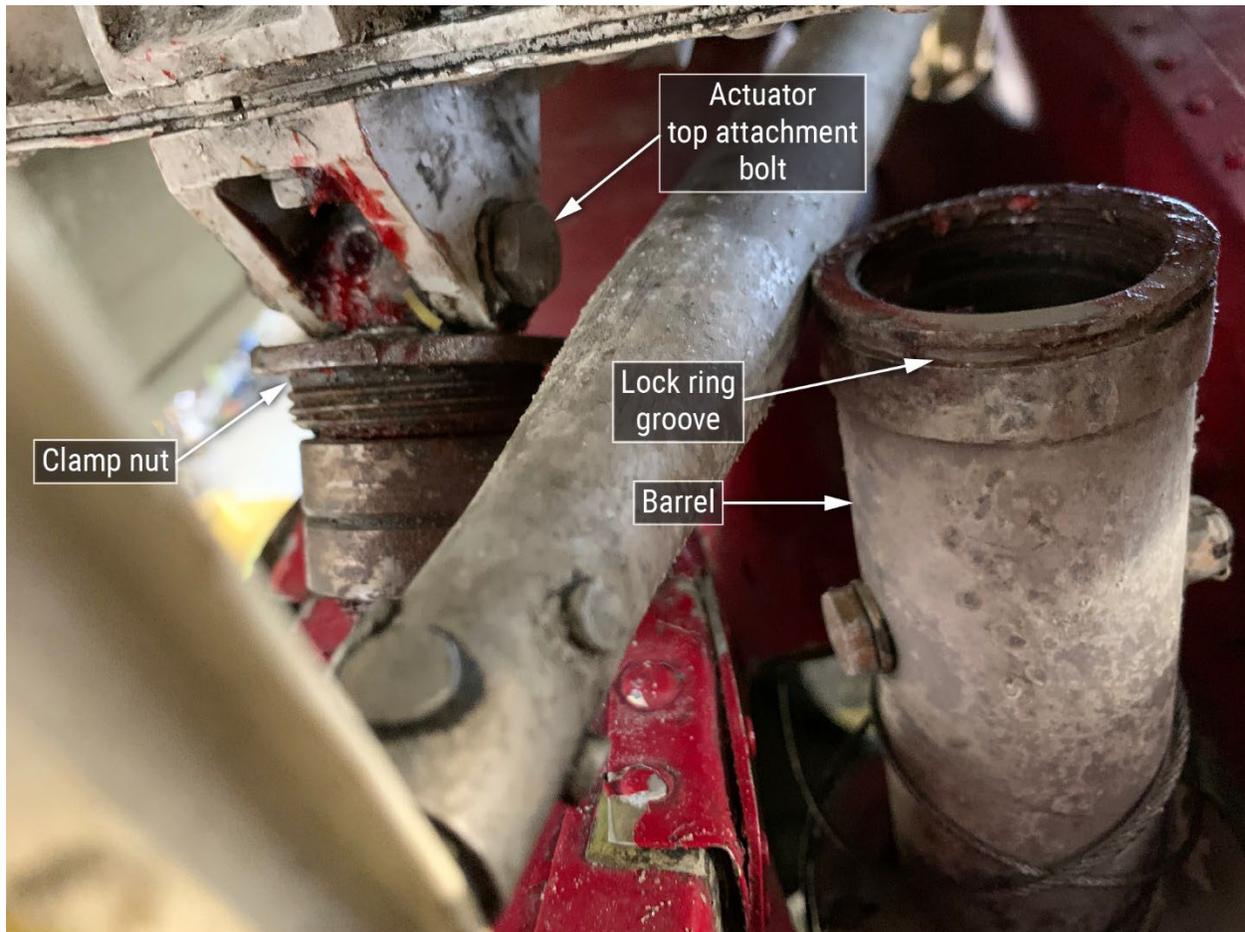
A circular wire lock ring is used to prevent the barrel and clamp nut from unthreading. The lock ring (see figure 6) is normally installed in the lock ring groove (see figure 5) and has a tang or

“pin” at one end (noted in figure 6) that is inserted into a hole in the lock ring groove. The tang continues into another hole in the clamp nut threads. The lock ring was not located in the wreckage.

Figure 5. Horizontal stabilizer actuator clamp nut and upper end of barrel section as found in the wreckage.

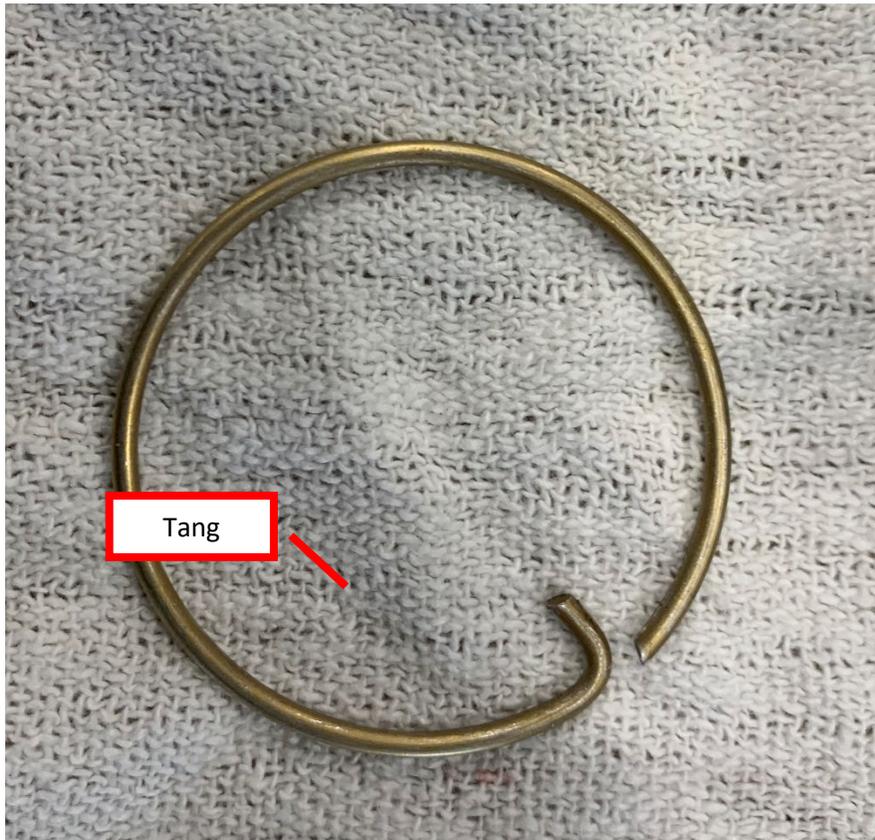
Figure 6. Exemplar lock ring.

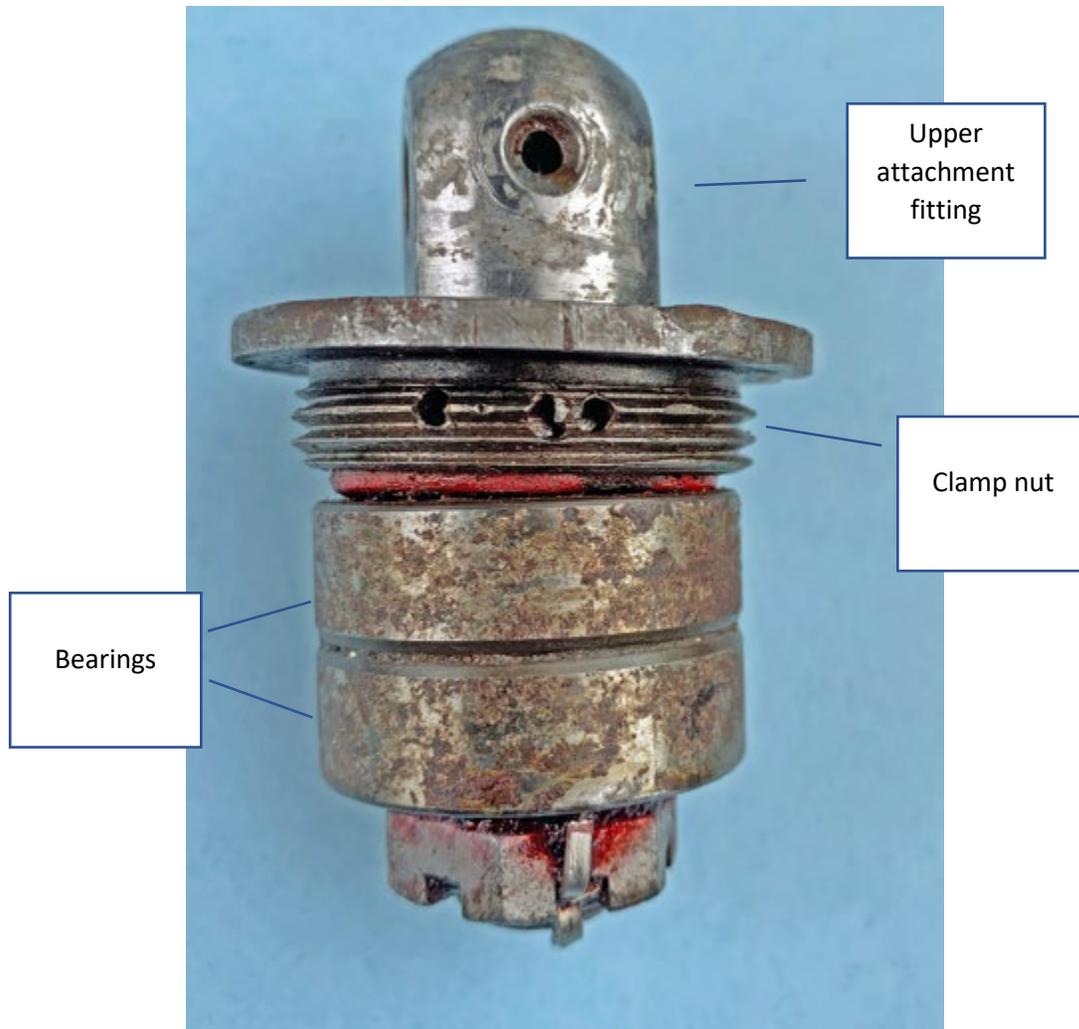
The manufacturer's assembly drawings for the horizontal stabilizer actuator call for a hole to be drilled into the clamp nut to accept the lock ring tang, after it has been threaded into the barrel during assembly. Postaccident examination of the airplane revealed that five holes had been drilled into the clamp nut threads; three holes were damaged such that they would not allow for the full insertion of the lock ring tang (see figure 7). This suggests that it may be possible for a lock ring to be partially installed, with the tang not fully seated in a hole in the clamp nut. Further, it might be difficult to visually determine if the lock ring is fully engaged in the clamp nut hole (depending on conditions such as lighting, viewing angle, and the presence of dirt or grease). Figure 8 shows two exemplar horizontal stabilizer actuators with a lock ring tang fully and partially installed, respectively.

Figure 7. Clamp nut from accident airplane.

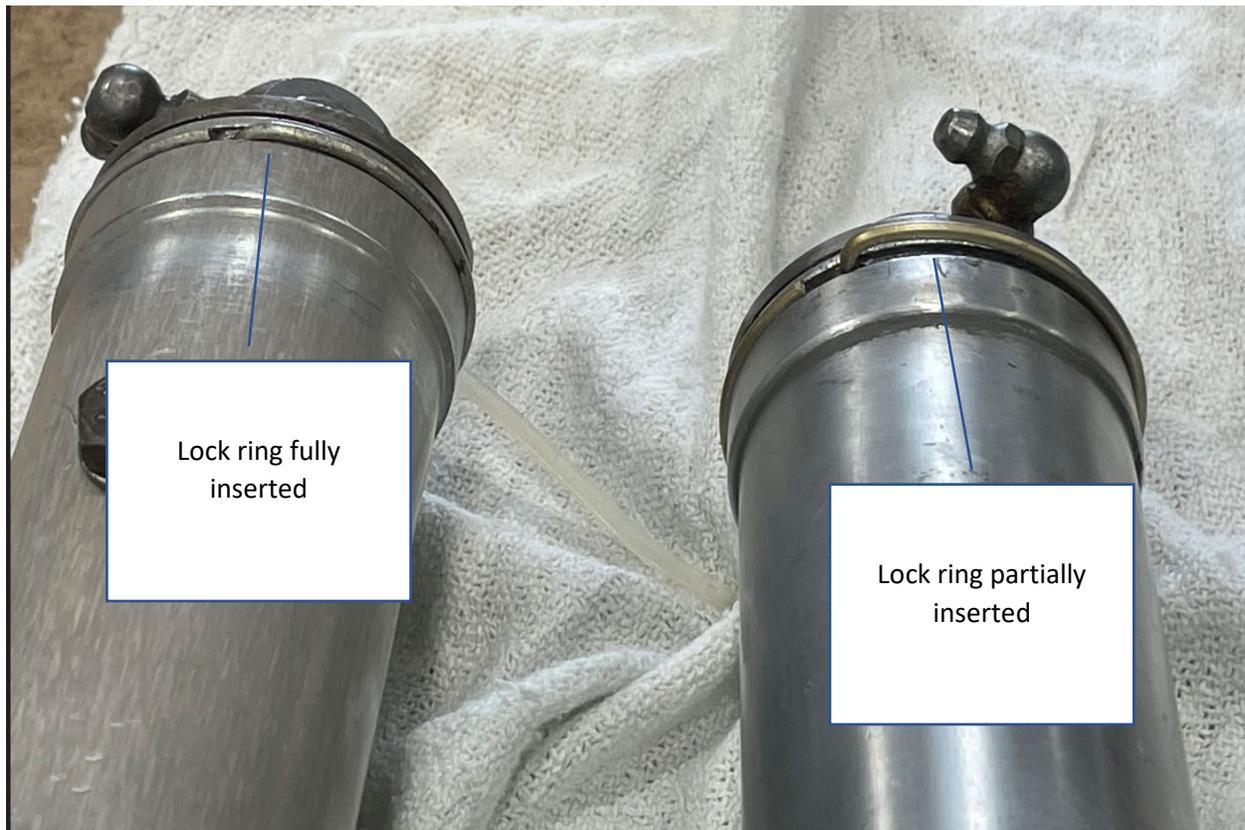
Figure 8. Exemplar horizontal stabilizer actuators and lock rings.
