# Aviation Investigation Preliminary Report

| <b>Location:</b> | Polykastro, Greece | <b>Accident Number:</b> | DCA26FA274 |
| <b>Date &amp; Time:</b> | July 10, 2026, 06:21 Local | <b>Registration:</b> | 9H-QEU |
| <b>Aircraft:</b> | Boeing 737 | <b>Injuries:</b> | 1 Serious, 154 None |

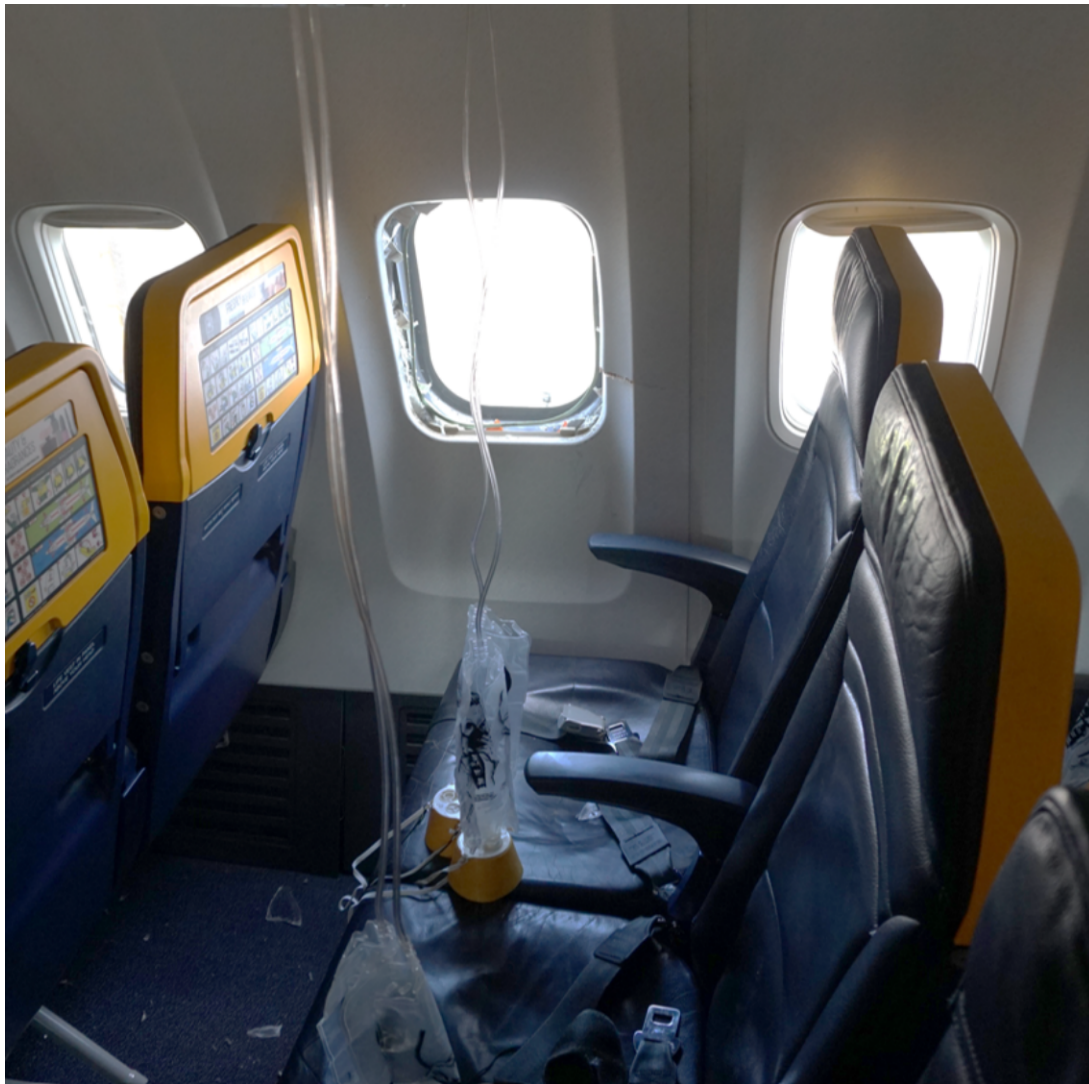
FA1 noticed some passengers were standing up and asking for help and responded to assist. The FA noticed that the passenger in seat 11F was partially lodged in a damaged cabin window, and that the entire window was missing. Other passengers were assisting and managed to pull the injured passenger back into the cabin. The FA then sat in seat 11B and donned an oxygen mask. That mask became detached and the FA used a different one.

**Figure 1:** View of the row 11 passenger cabin window from the interior, right side of the cabin.

Middle and outer passenger windowpane shards were found in the cabin area longitudinally between passenger rows 8 and 15. The interior sidewall panel surrounding the damaged passenger window at row 11, had a fracture at the lower aft vertical edge of the window that extended aft, to the nearest fuselage frame aft of the window edge.

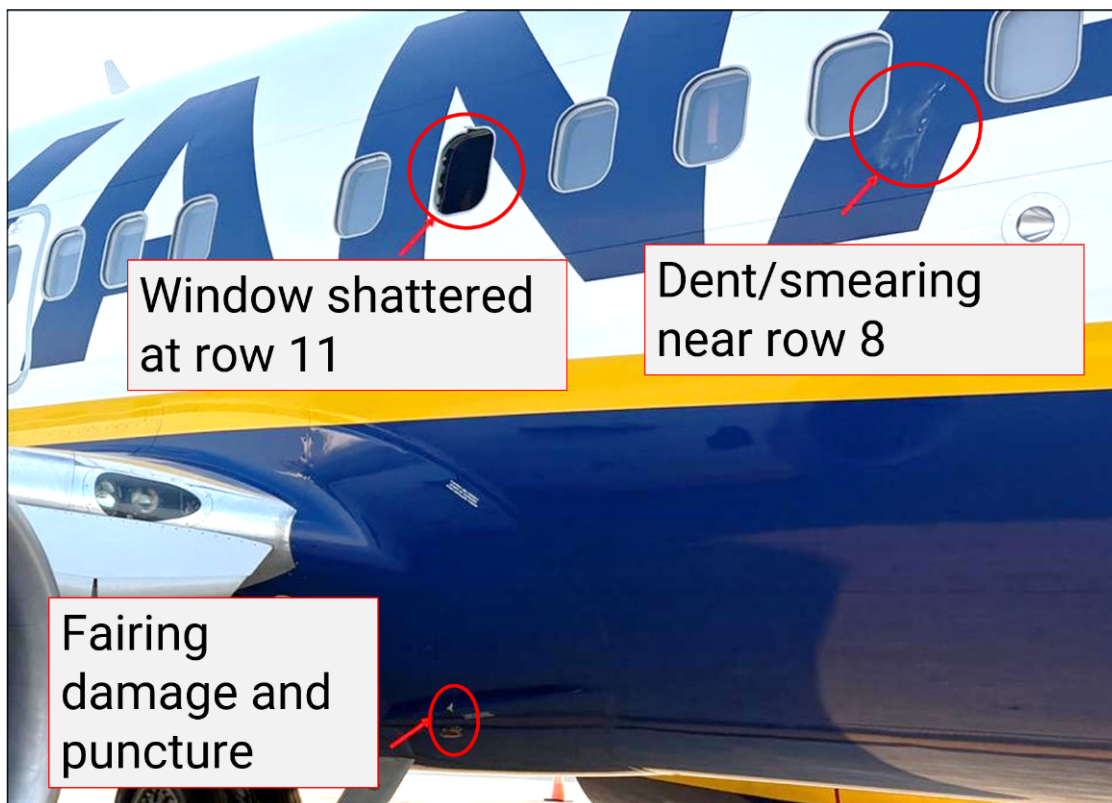
Examination of the airplane revealed that the No. 2 engine, an CFM International (a joint company between Safran Aircraft Engines and GE Aerospace) model CFM56-7B26, experienced a fan blade separation that resulted in engine fragments striking the fuselage and the right horizontal stabilizer. The pressurized section of the fuselage was penetrated 1) through the passenger cabin window located at row 11, as well as 2) lower lobe fuselage skin behind the right wing-to-body fairing, see figures 2 and 3. Additional impact damage was found on the right wing-to-body fairing, a dent with paint smearing on the fuselage window belt skin, a dent on a stringer common to the dented fuselage window belt skin, a gouge on the right horizontal stabilizer upper skin and a dent on the right horizontal stabilizer leading edge.

**Figure 2:** View of damage to right side of the fuselage.

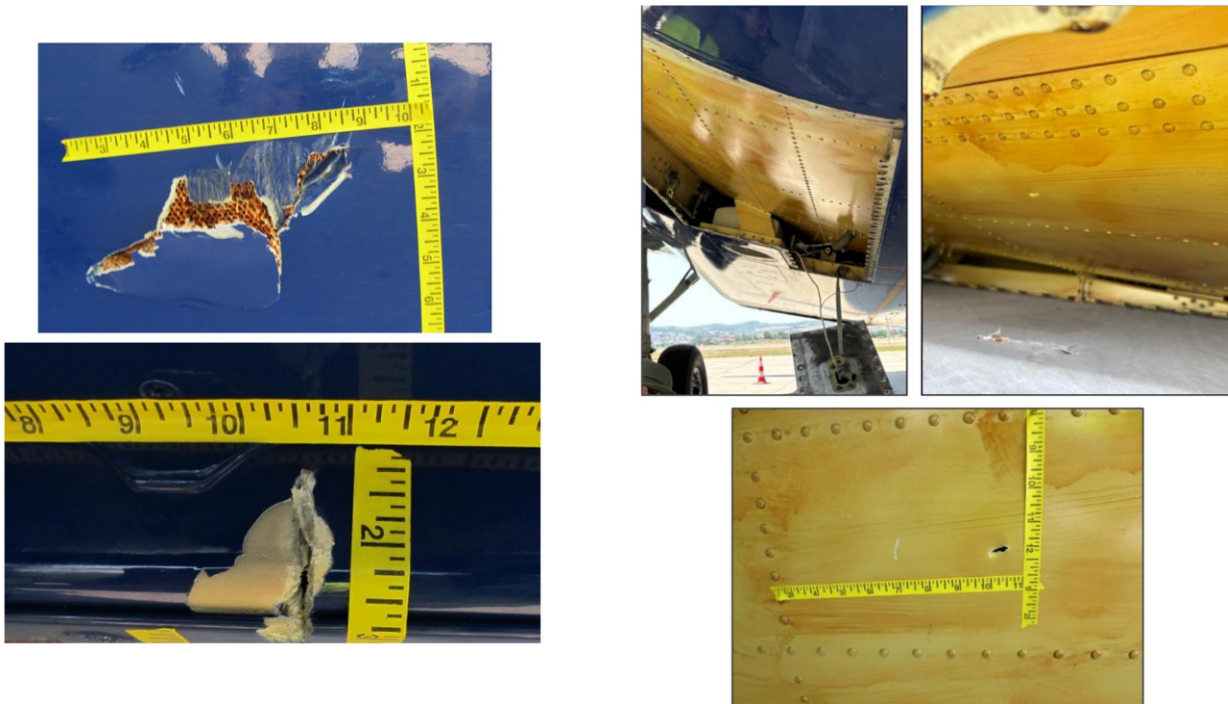
**Figure 3:** Fairing damage (left) and fuselage puncture behind fairing (right).

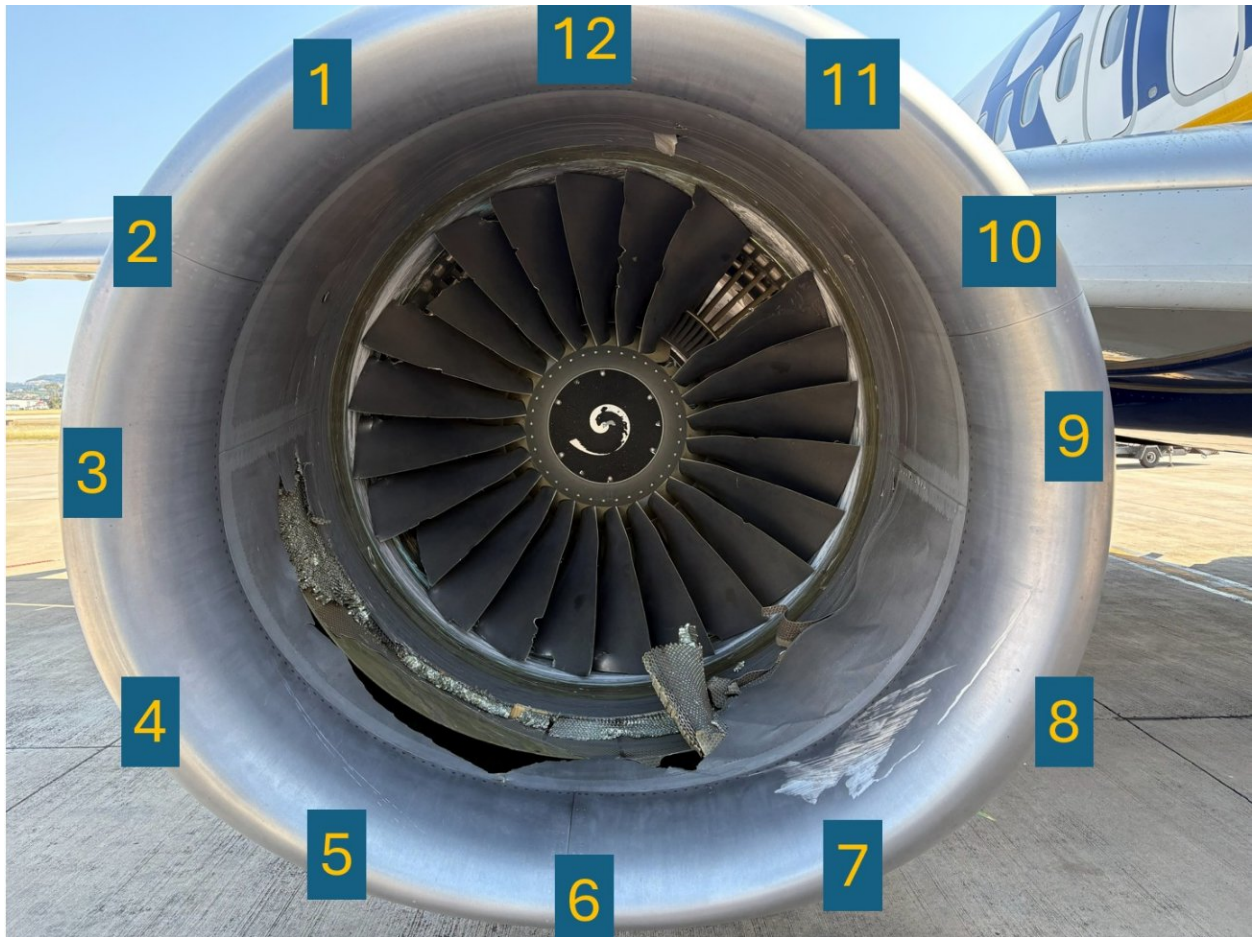
The inlet and fan cowl remained attached to the engine. The inlet cowl inner barrel exhibited impact damage, tearing, and/or missing material from the 3 to 9 o'clock (as viewed from the rear) positions, see figure 4. The inlet lip skin had a scrape mark at approximately the 7 o'clock position.

**Figure 4:** View of the No.2 (right) engine inlet. View is looking aft.

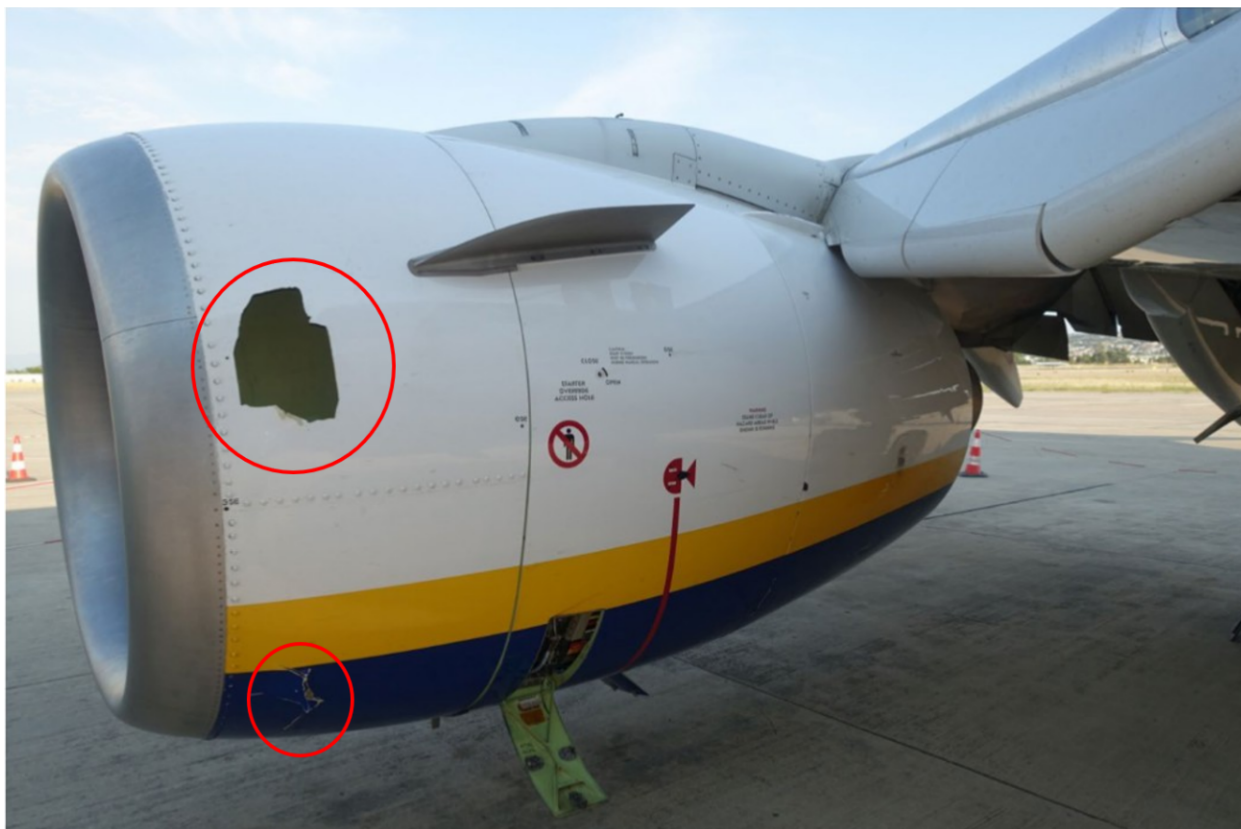
The inlet cowl outer barrel had a radial penetration, forward of the fan plane of rotation at the 9:30 position that measured approximately 14 inches circumferentially by 10 inches axially. A second inlet cowl tear and puncture was present forward of the fan plane of rotation at the 7 o'clock position that measured approximately 13 inches circumferentially by 10 inches axially, see figure 5.

**Figure 5:** No. 2 (right) engine inlet cowl outer barrel punctures.

Several of the aft bulkhead splice fasteners failed at the 9:00, 6:00, and 3:00 o'clock positions. The attach ring to aft bulkhead fasteners failed 360 degrees circumferentially and loose rivet tails were observed along the bottom of the inner barrel. Enhancements for fasteners, defined in Federal Aviation Administration airworthiness directive (AD) 2025-04-01, had not been incorporated on this inlet cowl hardware.

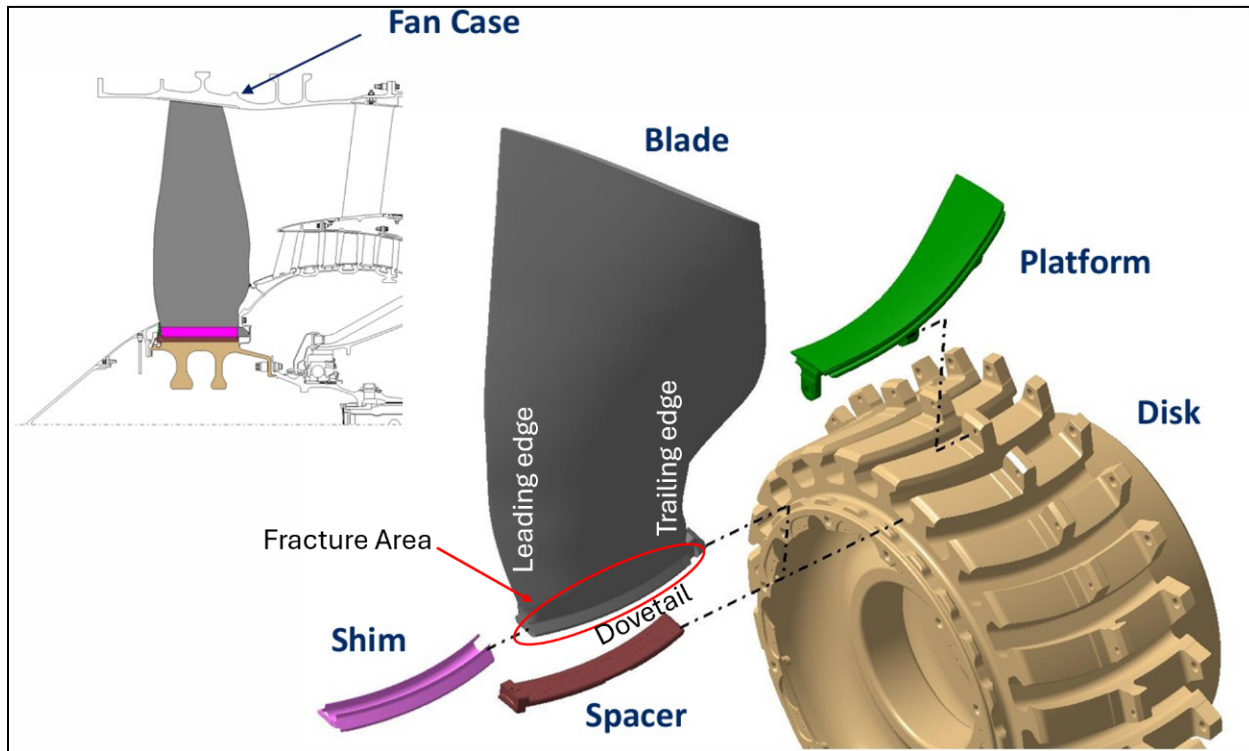
**Figure 6.** Graphic showing location of blades, shims, spacers, and platforms. The red circle denotes location of the fracture on blade No. 10. (Source Safran Aircraft Engines, fracture area annotated by NTSB).

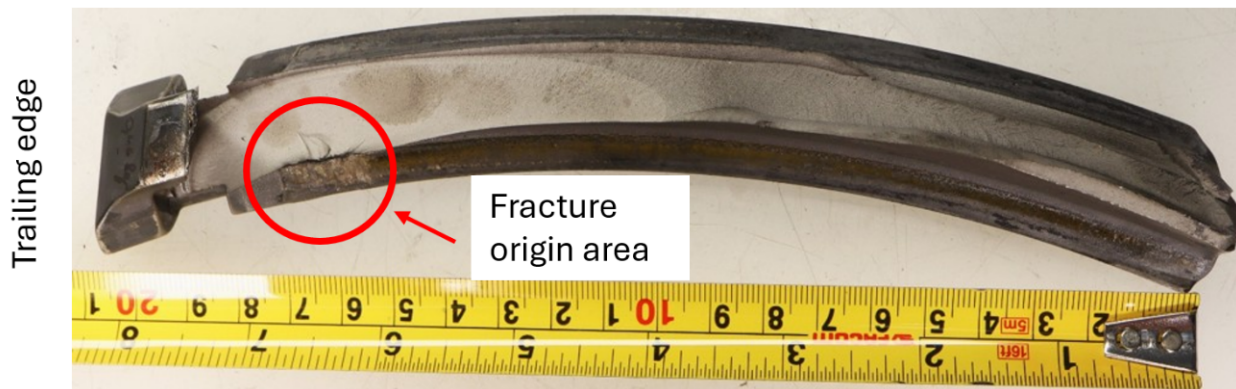
The No. 10 fan blade was fractured through the dovetail in the blade root as shown in figure 7. A portion of the fracture surface covering approximately 37 percent of the total fracture surface had relatively smooth features with a curving boundary, features consistent with fatigue. The fracture features were traced back to an origin area on the concave side of the blade near the trailing edge.

At the fatigue origin area located about 0.559 inch (14.2 mm) radially away from the root end face, ratchet marks were observed, consistent with multiple origins along an axial length of about 0.650 inch (16.5 mm). Heavy fretting damage was observed locally on the dovetail contact face adjacent to the origin area and in the same area on both sides of the associated shim.

**Figure 7.** Fracture surface on the No. 10 fan blade dovetail piece (Source Safran Aircraft Engines).

The fracture surface on the No. 10 fan blade dovetail piece was examined using a scanning electron microscope. The origin areas were damaged from fracture surface recontact and rubbing. However, fatigue striations were observed across the fatigue region from 0.008 inch (0.2 mm) deep to the boundary at a depth of 0.626 inch (15.9 mm).

Striation spacing was relatively coarse and unchanged across the fatigue region, consistent with fracture due to high amplitude fatigue (HAF). In aircraft engine fan blade fractures, HAF is associated with cyclic loading that occurs at frequencies greater than a flight cycle and at stress amplitudes that are larger than those typically associated with high-cycle fatigue (HCF).

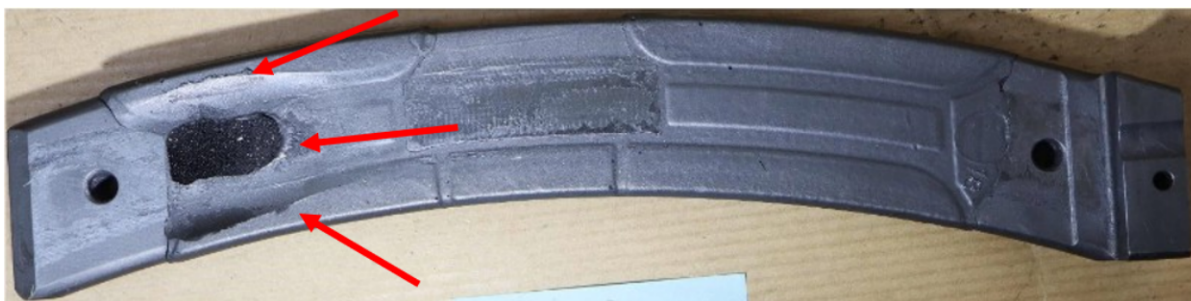
The No. 10 spacer exhibited an area of elastomer deterioration near the trailing edge end, see figure 8.

**Figure 8.** No. 10 spacer damage (Source Safran Aircraft Engines).
