National Transportation Safety Board

Aircraft Accident Investigative Update

On November 4, 2025, about 1714 eastern standard time (EST), United Parcel Service (UPS) flight 2976, a Boeing (McDonnell-Douglas) MD-11F airplane, N259UP, was destroyed after it impacted buildings and the ground shortly after takeoff from runway 17R at Louisville Muhammad Ali International Airport (SDF), Louisville, Kentucky. The 3 crewmembers aboard the airplane and 11 people on the ground were fatally injured, 2 people on the ground were seriously injured, and 21 people on the ground sustained minor injuries.¹ Flight 2976 was a domestic cargo flight operating under the provisions of Title 14 *Code of Federal Regulations (CFR)* Part 121 from SDF to Daniel K. Inouye International Airport (HNL), Honolulu, Hawaii.

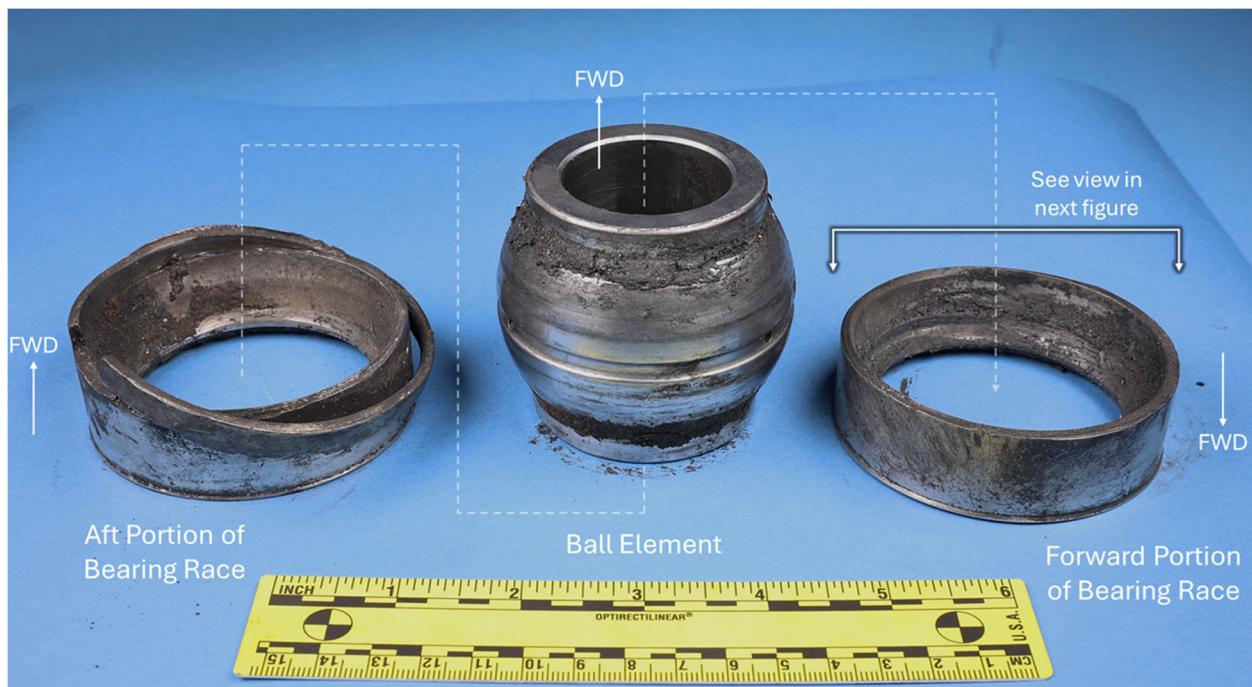
The NTSB Materials Laboratory in Washington, DC, has subsequently examined this spherical bearing assembly. Investigators observed that the interior surface of the bearing's race had fracture surfaces that showed evidence of fatigue cracking originating around the entire circumference at the edge of the design recess groove (a design feature on the interior surface of the race). The fatigue cracking extended through the thickness of the bearing race toward the exterior surface, encompassing about 75% of the fracture surface, with the remaining fracture surface consistent with overstress failure (see figures 2 and 3). Remnant grease-like material was found within the spherical bearing assembly (that is, between the ball element and the bearing race).

Figure 2. The accident spherical bearing assembly from the left pylon aft mount bulkhead showing the bearing race fractured into forward and aft portions.

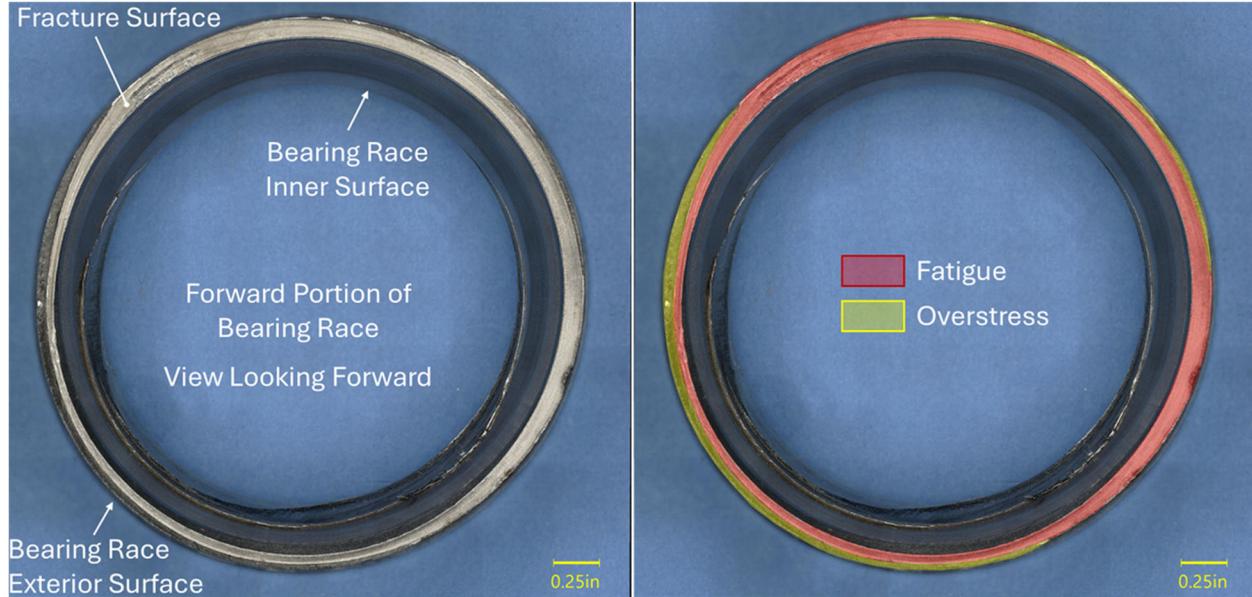
Figure 3. The forward portion of the fractured spherical bearing race from the left pylon aft mount bulkhead, with the right image showing the respective areas of fatigue and overstress.

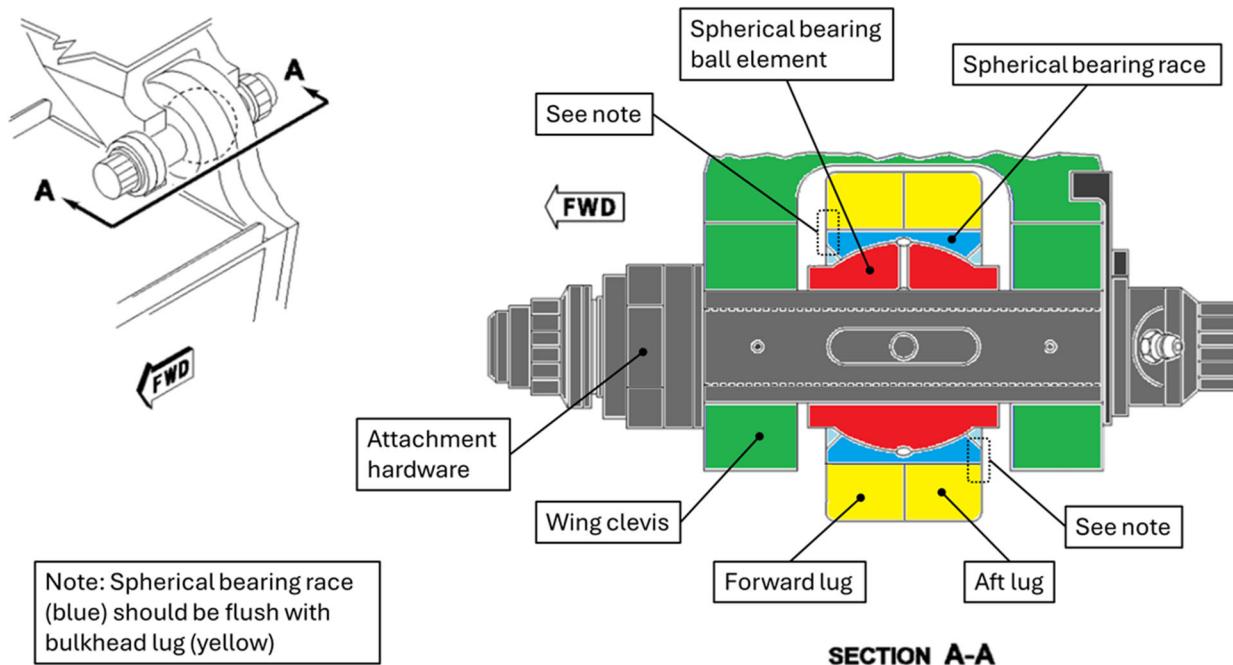
Per the Service Letter, the spherical bearing race is normally flush with the outer surface of the lugs (see figure 4). In the previously reported events, a total circumferential fracture of the bearing race, resulting in the bearing race splitting into two pieces, allowed for these two pieces to migrate in the forward and aft directions. The failure of these spherical bearing assemblies was visually identified by observing the displacement of the fractured bearing race pieces beyond the outer surface of the lugs. According to the Service Letter, a review of the spherical bearing failure by Boeing determined it would not result in a safety of flight condition.

The Service Letter stated that, for Boeing MD-11 airplanes, inspection of the spherical bearing assembly would be included in the general visual inspection (GVI) and detailed visual inspection of the pylon aft mount, normally at a repetitive 60-month interval. The Service Letter also stated that

the Boeing MD-11 aircraft maintenance manual was updated to include inspection of the spherical bearing race for evidence of migration, specifically by checking that the spherical bearing is not protruding forward or aft beyond the surfaces of the pylon aft mount lugs. Lastly, the Service Letter discussed a new configuration spherical bearing assembly, P/N S00399-523, which eliminated the design recess groove on the bearing race and recommended its installation in the event an installed spherical bearing is found to be unserviceable. However, the installation of spherical bearing assembly P/N S00399-1, to replace an unserviceable bearing, was not prohibited by the Service Letter.

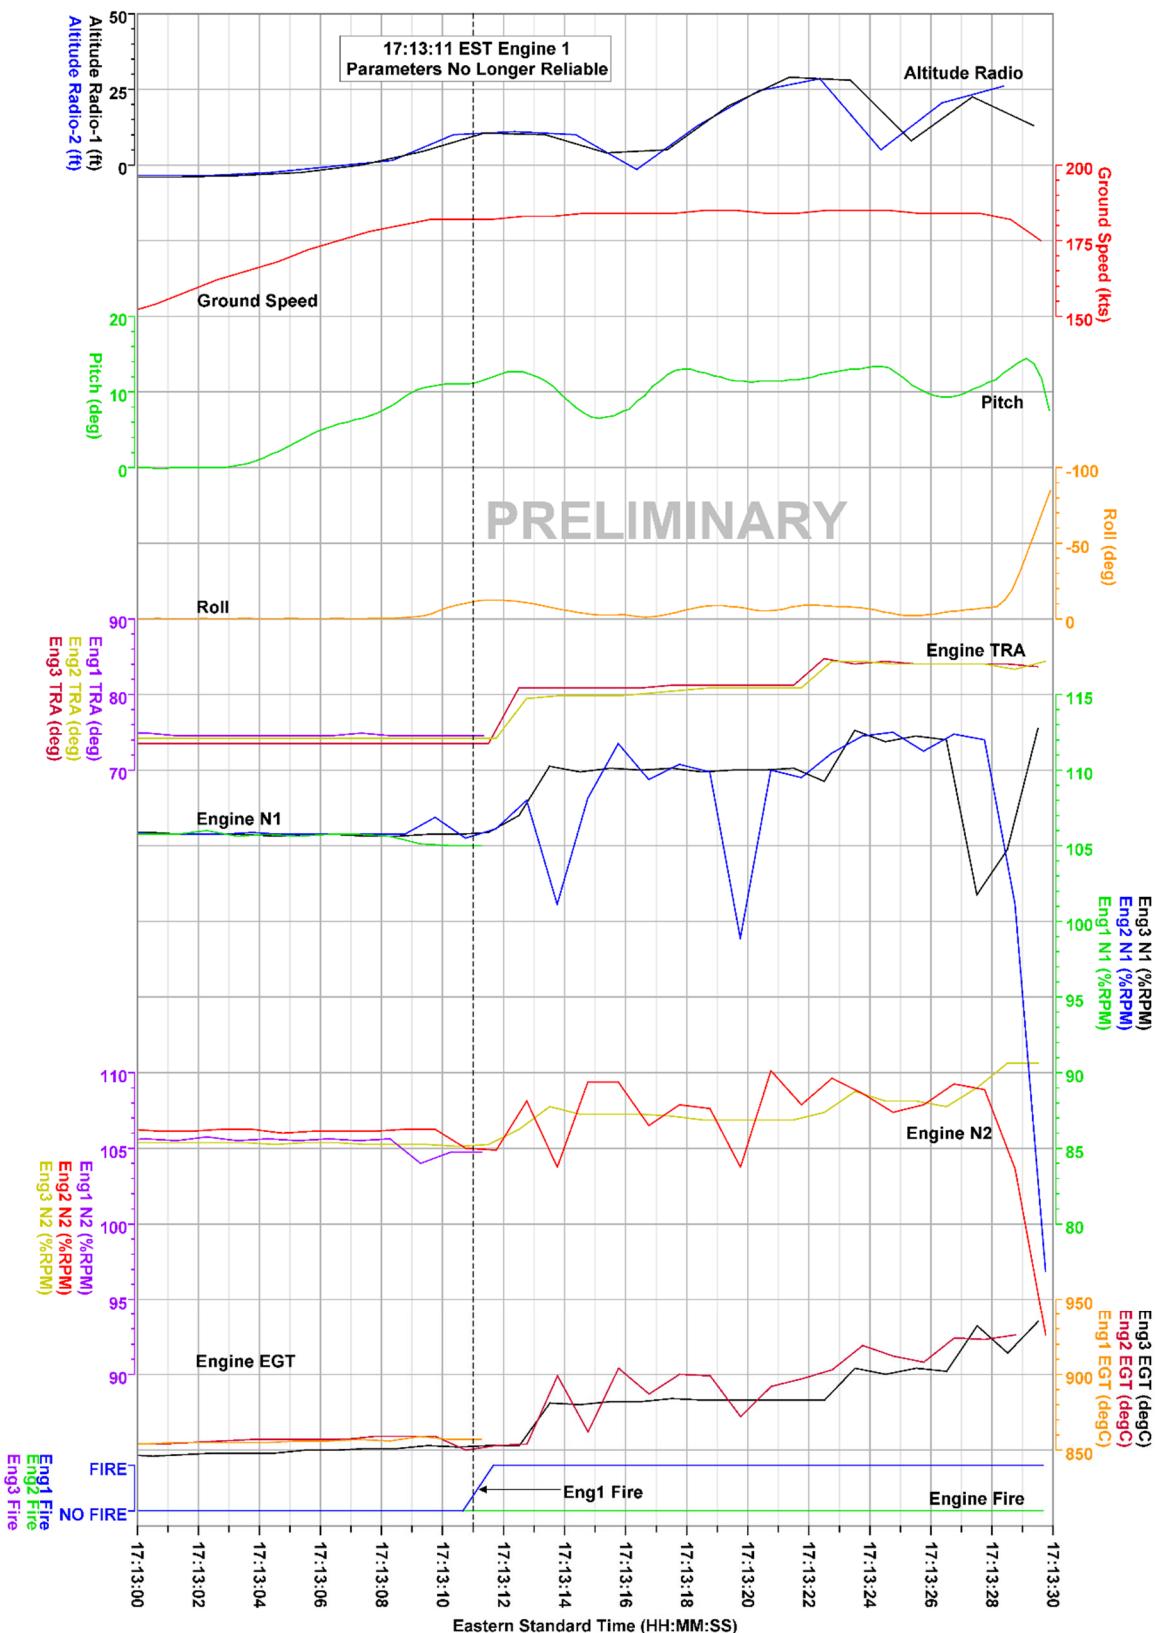
A preliminary review of data from the FDR showed nominal performance of the airplane and engines until about 1713:11, about 20 seconds before the end of recorded data, when the parameters from the No. 1 engine were no longer reliable (see figure 5). Shortly after 1713:11, the FDR showed that only the No. 1 engine fire parameter changed from "no fire" to "fire," and the throttle resolver angle (TRA) for the Nos. 2 and 3 engines increased. Subsequently, the speed values for the low-speed rotor (N1) and high-speed rotor (N2) for the No. 2 engine showed minor perturbations, while the N1 and N2 values for the No. 3 engine increased and remained steady until about 3 seconds before the end of recorded data. The airplane's groundspeed was about 184 kts from 1713:11 until about 3 seconds before the end of recorded data at 1713:30.

Figure 5. Preliminary FDR data plot for airplane and engine parameters for the last 30 seconds of recorded data for the accident flight.
