# Aviation Investigation Preliminary Report

| <b>Location:</b> | Miami, FL | <b>Accident Number:</b> | DCA26MA352 |
| <b>Date &amp; Time:</b> | September 6, 2026, 13:53 Local | <b>Registration:</b> | N1997A |
| <b>Aircraft:</b> | Boeing 767 | <b>Injuries:</b> | 5 Fatal, 3 Serious, 2 Minor |

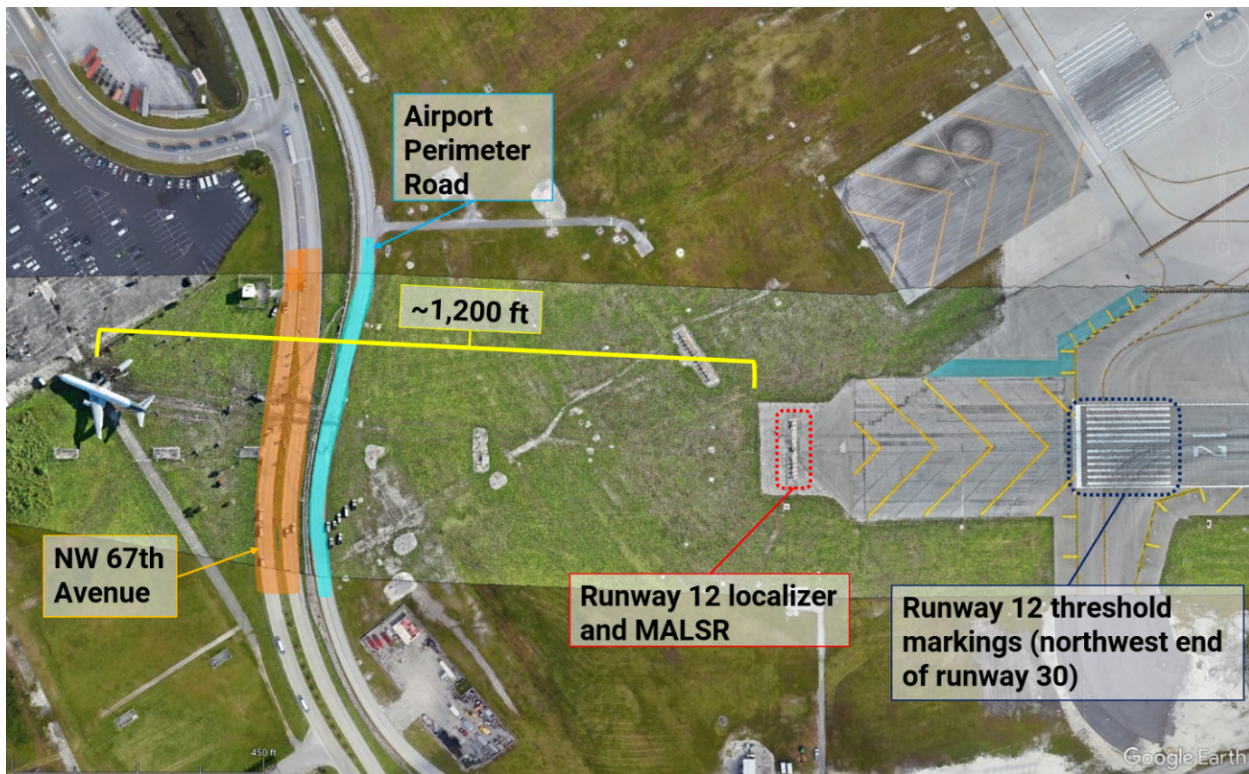
The accident airplane touched down about 3,750 ft past the threshold at a groundspeed of 160 kts. The airplane continued down runway 30, crossed the departure end of the runway at 113 kts, impacted the localizer and the Medium Intensity Approach Lighting System with Runway Alignment Indicator Lights (MALSR) at the northwest end of the runway at about 100kts, and departed the paved surface and onto the grass (see figure 1). The distance between the end of the paved surface to the location the accident airplane came to rest was about 1,200 ft.

The accident airplane impacted a chain link fence surrounding a parking lot and came to rest about 1,200 ft from the paved surface of runway 12/30. The captain egressed the airplane out of door 1L and the FO egressed out of the right cockpit window. About 1353 EDT, MIA ATCT/TRACON activated the alert phone in response to the accident. Miami-Dade Fire Rescue at MIA responded with 5 Aircraft Rescue and Fire Fighting (ARFF) units, with additional mutual aid resources dispatched following the initial response.

**Figure 1.** NTSB aerial imagery superimposed on a satellite view of the area of the runway excursion.

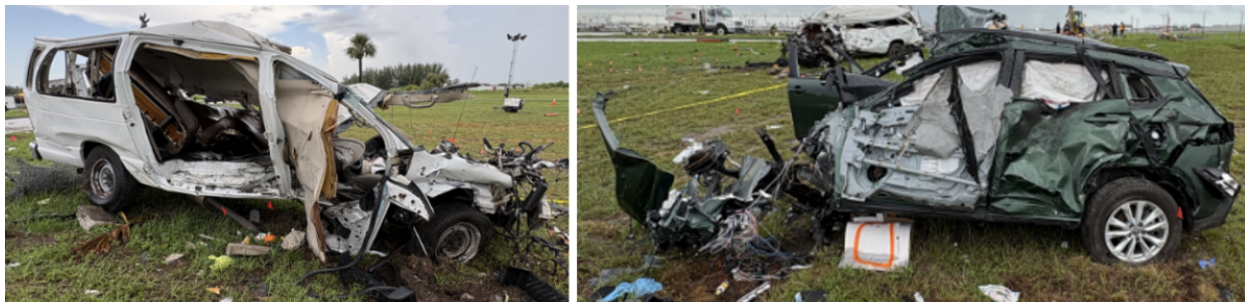
The last recorded groundspeed on the FDR was 65 kts, reached shortly after the accident airplane impacted an airport perimeter fence and traversed a public road (NW 67th Avenue). Prior to impacting the airport perimeter fence, the accident airplane impacted a Ford Econoline passenger van traveling on an airport perimeter road parallel to the perimeter fenceline (see figure 2). Of the seven occupants in the passenger van, five sustained fatal injuries and two sustained serious injuries. While traversing NW 67th avenue, the accident airplane impacted a Toyota Corolla Cross sport utility vehicle (SUV). The sole occupant in the SUV sustained serious injuries.

**Figure 2.** The impacted Ford Econoline van (left) and Toyota Corolla Cross SUV (right).

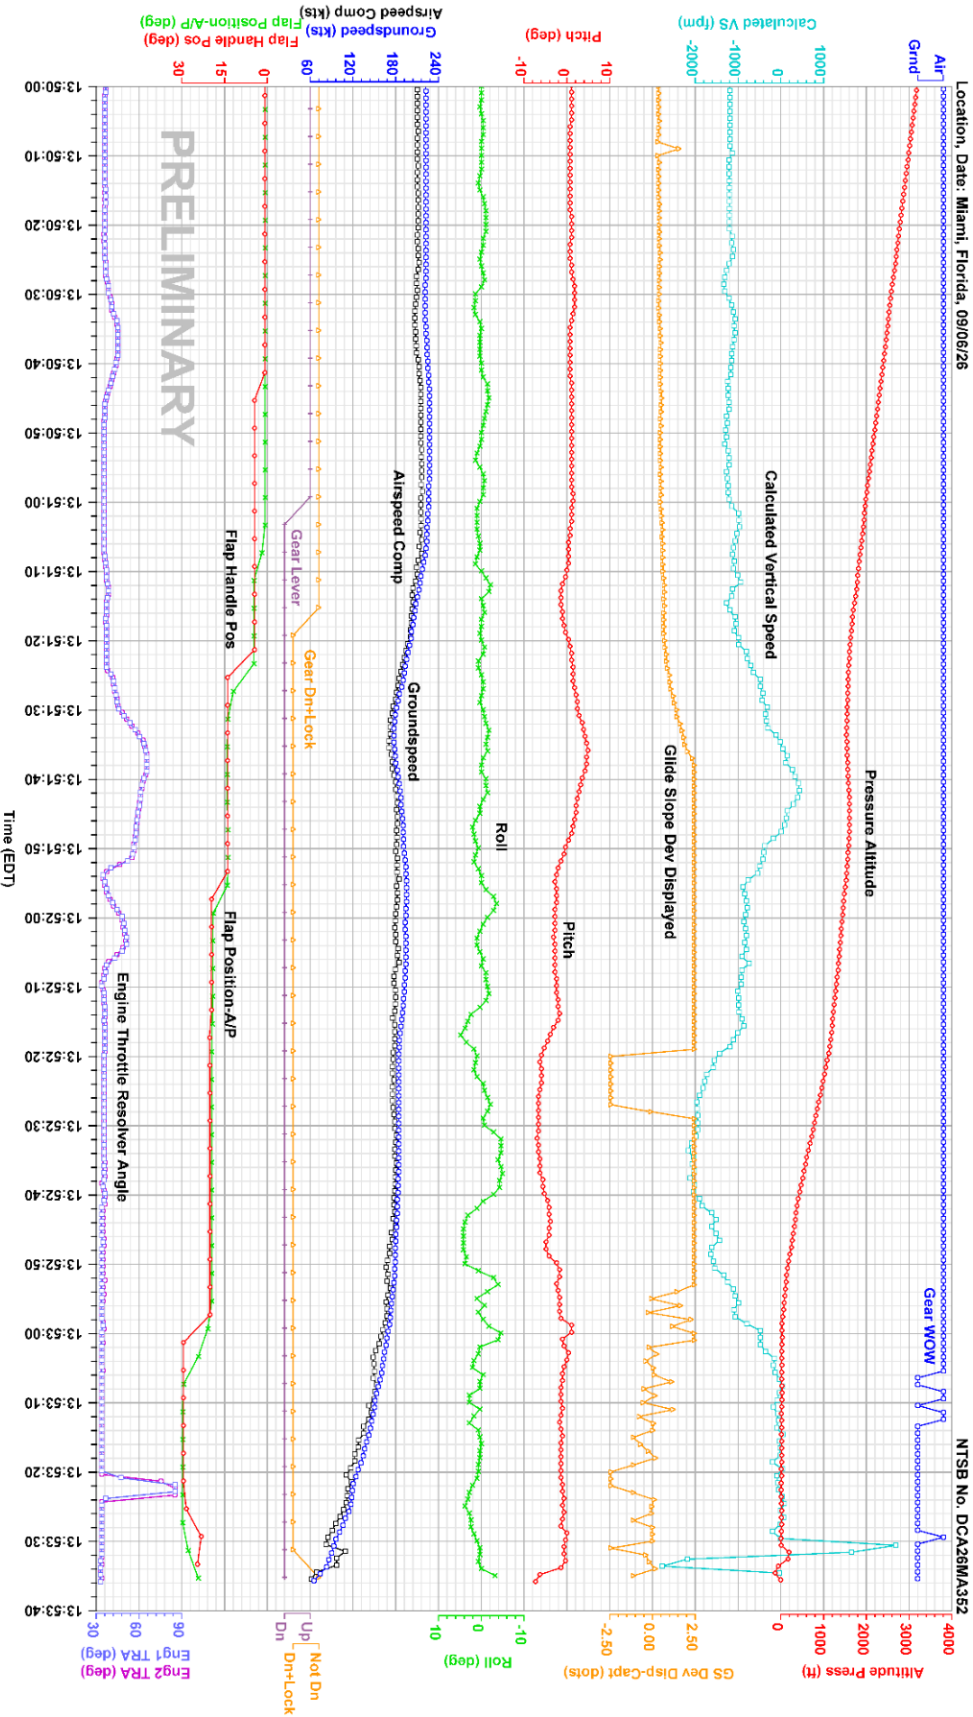
The FDR contained about 54 hours of data that spanned 16 flights, including the accident flight. The FDR recorded more than 400 parameters of flight data. Figure 4 shows a plot of the FDR data from 1350 EDT, when flight 7598 was about 9.8 nautical miles from the threshold of runway 30, until the end of recorded data. Figure 5 shows a plot of the FDR data from 1352:25, when flight 7598 was about 1.5 nautical miles from the threshold of runway 30, until the end of recorded data.

Left and right main landing gear tire contact marks on runway 30 were found about 3,750 ft and 3,820 ft, respectively, from the threshold of the approach end of runway 30. According to FDR data, the airplane's groundspeed was about 160 kts at the location of these initial tire contact marks, about 13 seconds after flight 7598 crossed the runway 30 threshold. The landing gear weight-on-wheels (WOW) parameter intermittently switched between "air" to "ground" for about 7 seconds. The WOW parameter switched to ground for the remainder of the recorded data when the airplane had about 2,730 ft of runway remaining.

The FDR data showed the speed brakes remained stowed and the thrust reversers did not deploy during the landing and subsequent landing rollout. Wheel brakes were manually applied at a groundspeed of 146 kts. The brake pedals for wheel braking were subsequently released about 8 seconds later at a groundspeed of 120 kts and the throttle resolver angle for both engines increased to go-around thrust values; the airplane had about 930 ft of runway remaining.

About 4 seconds later, the throttle resolver angles for both engines reduced to idle values at a groundspeed of 117 kts, when wheel brakes were reapplied; the airplane had about 415 ft of runway remaining. The airplane departed the runway at a groundspeed of 113 kts and subsequently impacted the localizer and MALSR at the northwest end of runway 30.

Figure 4. FDR data for the accident flight from 13:50:00 until the end of recorded data.

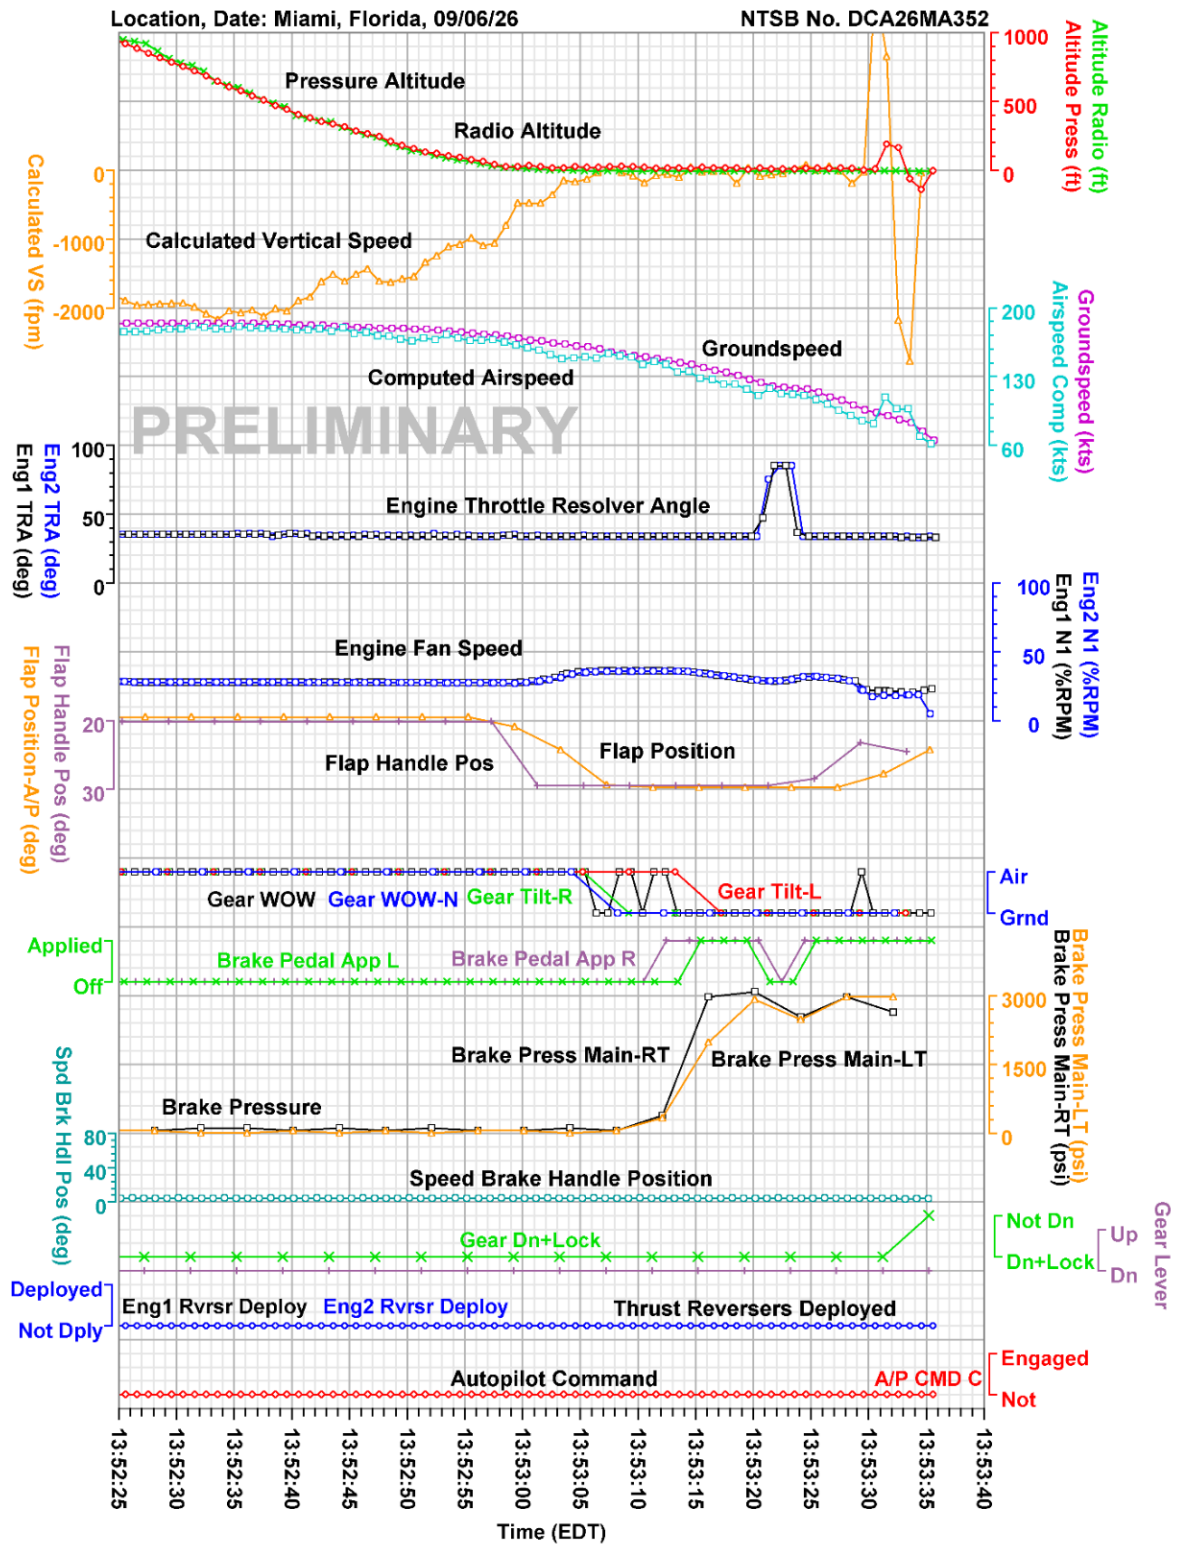
**Figure 5.** FDR data for the accident flight from 1352:25 until the end of recorded data.

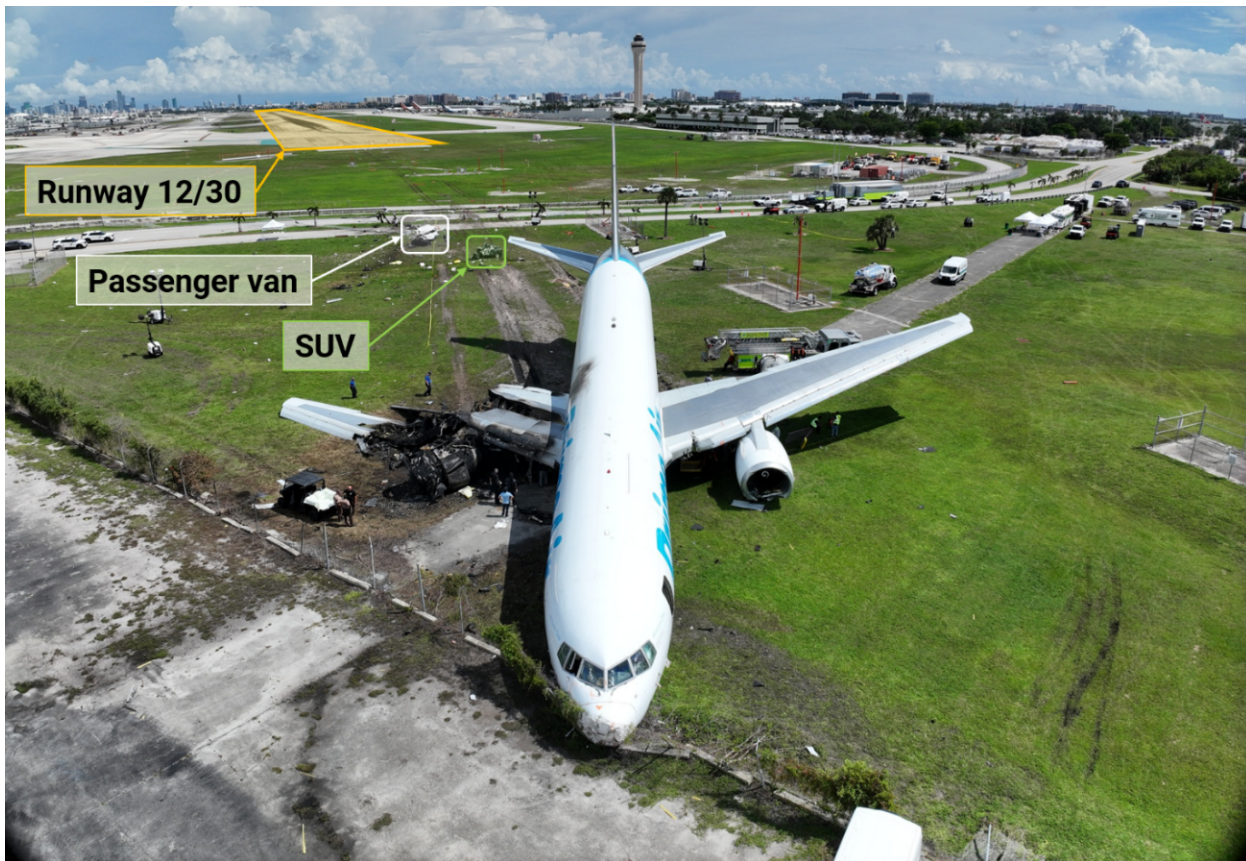
The accident airplane came to rest on an area of grass to the west of NW 67th Avenue and adjacent to a parking lot. Ground impressions consistent with the nose, right main, and left main landing gear were found along the path of the airplane departing from runway 12/30 to where the airplane came to rest (see figure 6). The nose landing gear was found displaced aft and was found underneath the belly of the airplane. The left and right main landing gear assemblies were found in an extended and locked landing configuration. Measurement of the brake wear pins on both the left and right main landing gear found all wear pins showed remaining service life for all eight wheels.

**Figure 6.** An aerial view of N1997A showing the relative location of the two impacted ground vehicles and ground scars leading up to the airplane's resting location.

Several orange paint transfer marks were found on the fuselage, wing leading edge, and horizontal stabilizer leading edge, consistent with the airplane impacting the localizer and MALSR at the northwest end of runway 30. The inboard end of the right wing remained attached to the fuselage and exhibited varying amounts of heat damage from the postcrash fire. Portions of the right wing were thermally deformed downward with its outboard end resting on the ground.

A large section of the upper wing skin had separated from the right wing and was found in the adjacent parking lot, about 158 ft to the northwest of the airplane. The right engine was thermally damaged, partially separated from the wing pylon structure, oriented outboard of its normally installed position, and was resting on the ground.

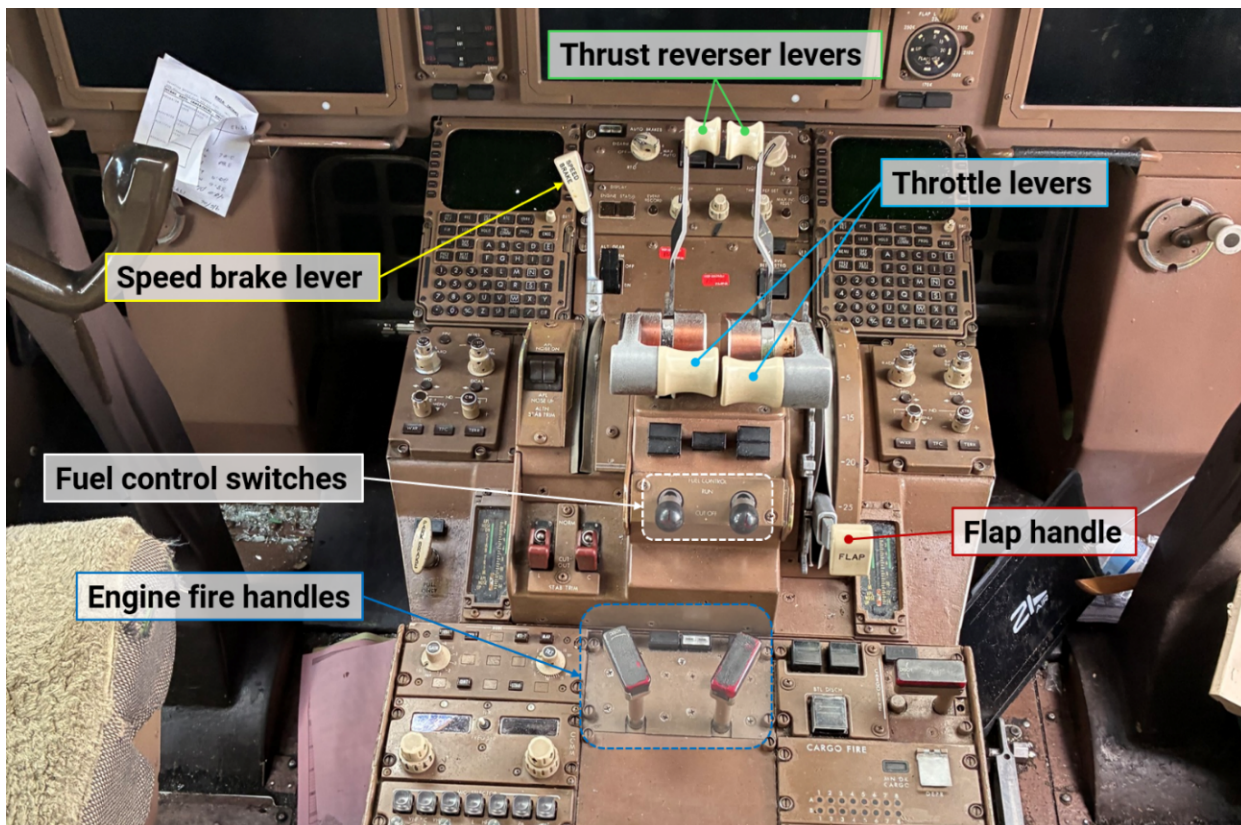
In the cockpit, the flap lever was found in the 25° detent (see figure 7). Measurement of the left- and right-wing slat tracks and flap support rods were consistent with a flaps 25° setting. The throttle levers were found in the idle position, and the fuel control switches were found in the cut-off position. Both engine fire handles were up and rotated and the auxiliary power unit (APU) fire handle was down. The thrust reverser levers were found in the first detent position. The speed brake lever was in the down (stowed) position.

**Figure 7.** The cockpit center aisle stand with the position of various controls observed at the accident site.
