National Transportation Safety Board
Investigative Update
ERA18FA120

On April 4, 2018, at 0953 eastern daylight time, a Piper PA-28R-201, N106ER, collided with terrain following the in-flight separation of its left wing shortly after takeoff from Daytona Beach International Airport (DAB), Daytona Beach, Florida. The airline transport pilot and private pilot were fatally injured, and the airplane was destroyed. The airplane was registered to and operated by Embry-Riddle Aeronautical University and operated under the provisions of Title 14 *Code of Federal Regulations* Part 91 as an instructional flight. Day visual meteorological conditions prevailed at the time of the accident, and no flight plan was filed for the local flight, which departed DAB at 0927.

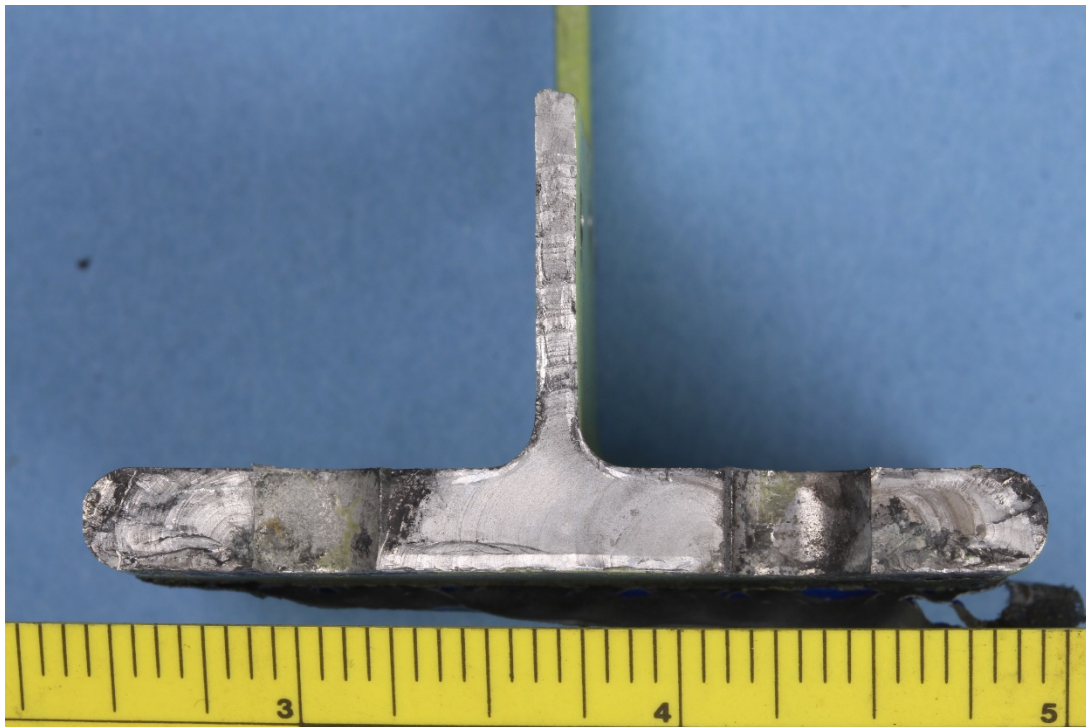
As discussed in the NTSB Preliminary Report for the investigation, the airplane's left wing separated from the fuselage near the wing root. Initial examination of the left wing main spar at the NTSB Materials Laboratory revealed that more than 80% of the lower spar cap and portions of the forward and aft spar web doublers exhibited fracture features consistent with metal fatigue (see figure 1). The fatigue features originated at or near the outboard forward wing spar attachment bolt hole (see figure 2). None of the surfaces exhibited visible evidence of corrosion or other preexisting damage. The right wing also exhibited fatigue cracks in the lower spar cap at the same hole location extending up to 0.047-inch deep. The remainder of the lower spar cap, spar web doublers, and upper spar cap displayed fracture features consistent with overstress.

Figure 1 – Left wing main spar lower cap fracture surface.

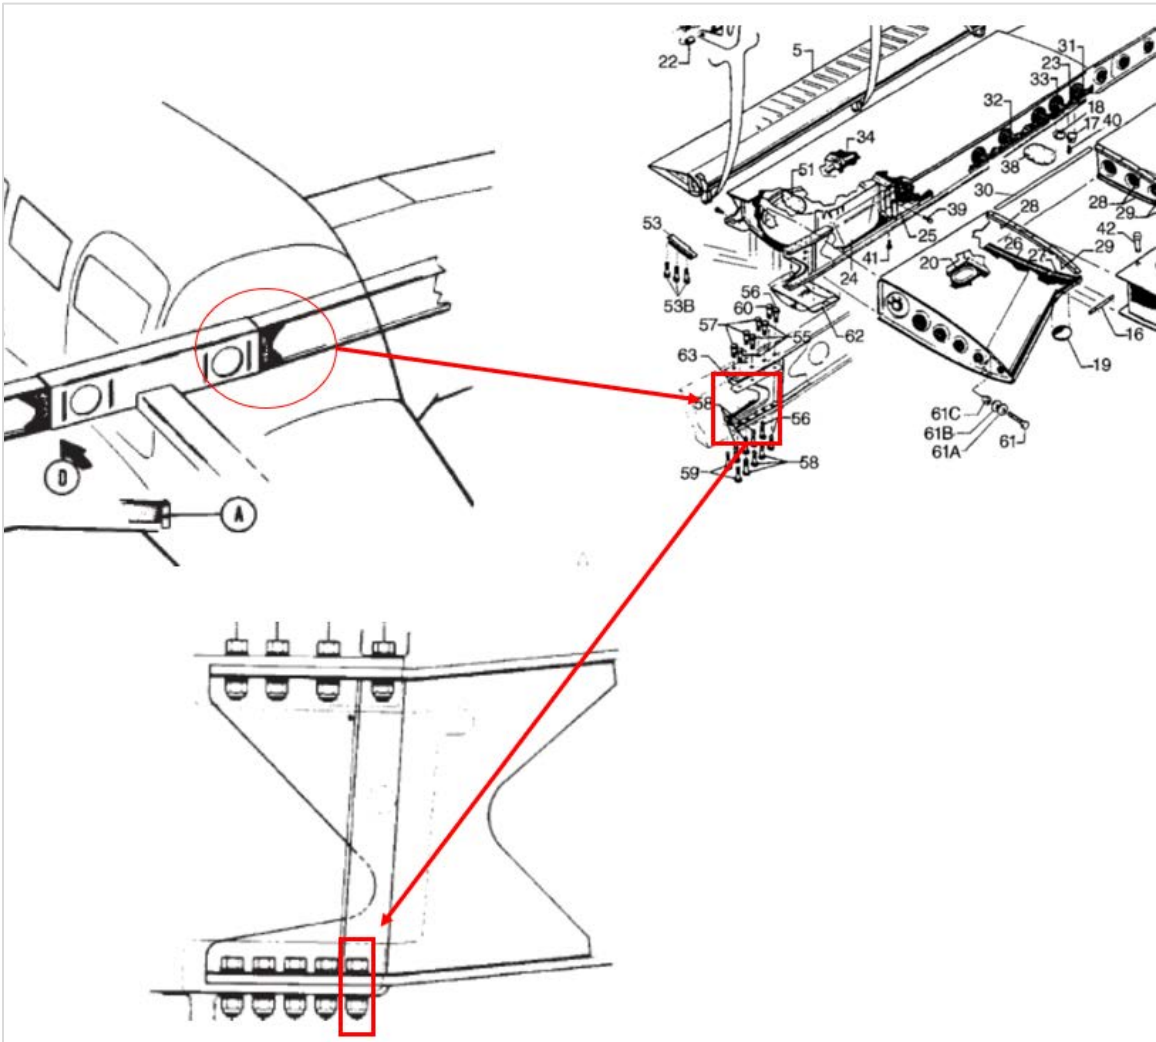
Figure 2 – Exploded view of left wing spar assembly and attachment bolt

On April 18-19, 2018, the Structures Group conducted an inspection of a second Piper PA-28R-201, serial number 2844135, which had accumulated about 7,661 total airframe hours and 32,228 cycles. The airplane’s wings were removed, and an eddy current inspection (ECI) was performed by representatives from Piper Aircraft. The inspection revealed a crack indication at the left lower outboard forward wing spar attachment bolt hole (the location previously illustrated in

figure 2). The crack measured about 0.040-inch long and 0.040-inch deep. The airplane's wings were subsequently reinstalled and examined using new inspection procedures developed by Piper Aircraft. A bolt-hole ECI probe was used to successfully confirm the location and size of the previously identified crack.
