# Aviation Investigation Preliminary Report

| <b>Location:</b> | Washington, DC | <b>Incident Number:</b> | OPS26LA063 |
| <b>Date &amp; Time:</b> | August 4, 2026, 14:34 Local | <b>Registration:</b> | MILITARY - VM1 (A1); N307LH (A2) |
| <b>Aircraft:</b> | Sikorsky VH3D (A1); YABORA INDUSTRIA AERONAUTICA S ERJ 170-200 LR (A2) | <b>Injuries:</b> | N/A (A1); N/A (A2) |

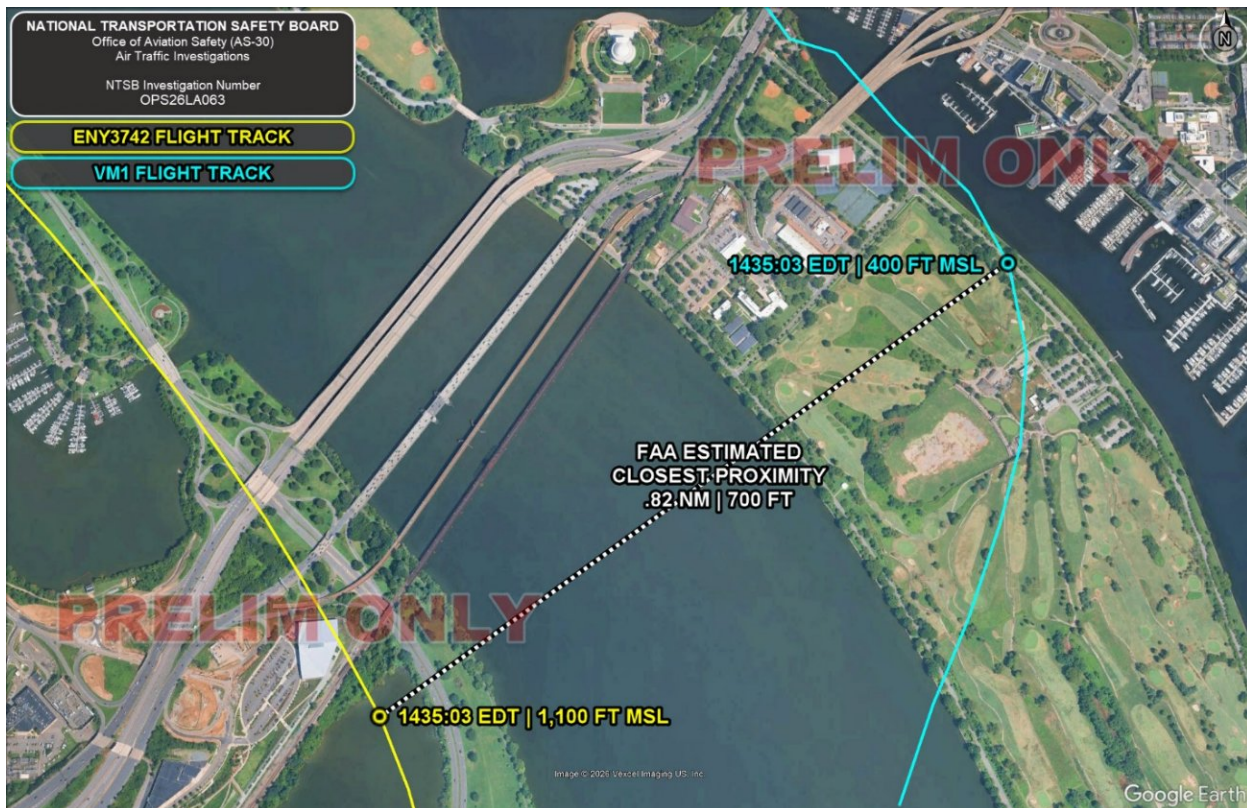
A preliminary FAA estimate of the closest proximity between VM1 and ENY3742 determined they were about .82 miles apart laterally and about 700 feet vertically, as shown in figure 2.

**Figure 2.** Radar flight tracks of both VM1 and ENY3742 overlaid onto satellite imagery with the FAA estimated closest proximity illustrated (.82 nautical miles (nm) lateral and 700 feet vertical).

The FAA reported the preliminary estimated closest proximity between VM1 and ENY3742 as about .82 nm laterally and 700 feet vertically. This would meet the required minimum radar separation as set forth in FAA Order JO 7110.65BB, Air Traffic Control, paragraph 7-9-4, which required 1.5 nm lateral or 500 feet vertical separation within Class B airspace, between a VFR aircraft and any aircraft weighing more than 19,000 pounds or any turbojet aircraft. The NTSB is still reviewing all sources of surveillance data to calculate and confirm closest proximity. Additionally, in accordance with the letter of agreement (LOA) between HMX-1 and Washington, DC area ATC facilities, aircraft operations with the President on board require flightcrews to contact DCA ATCT on 134.35 (HC frequency) 3 minutes prior to departure, and according to the LOA between DCA ATCT and PCT TRACON, DCA would stop all departures once the 3-minute call was received. In this incident, after attempting to contact DCA ATCT at least twice, they ultimately departed and were then able to reach DCA ATCT when the helicopter reached an altitude that provided adequate line-of sight communications. Having received no 3-minute call, the LC controller had cleared ENY3742 for takeoff and the airplane was becoming airborne simultaneously as VM1 established communications with the tower. The current altimeter setting and traffic advisory were provided to VM1, to which the crew immediately reported visual contact with the traffic.
