# Aviation Investigation Preliminary Report

<b>Location:</b>	Louisville, KY	<b>Accident Number:</b>	DCA26MA024
<b>Date &amp; Time:</b>	November 4, 2025, 17:14 Local	<b>Registration:</b>	N259UP
<b>Aircraft:</b>	McDonnell Douglas MD-11F	<b>Injuries:</b>	14 Fatal, 2 Serious, 21 Minor
<b>Flight Conducted Under:</b>	Part 121: Air carrier - Non-scheduled

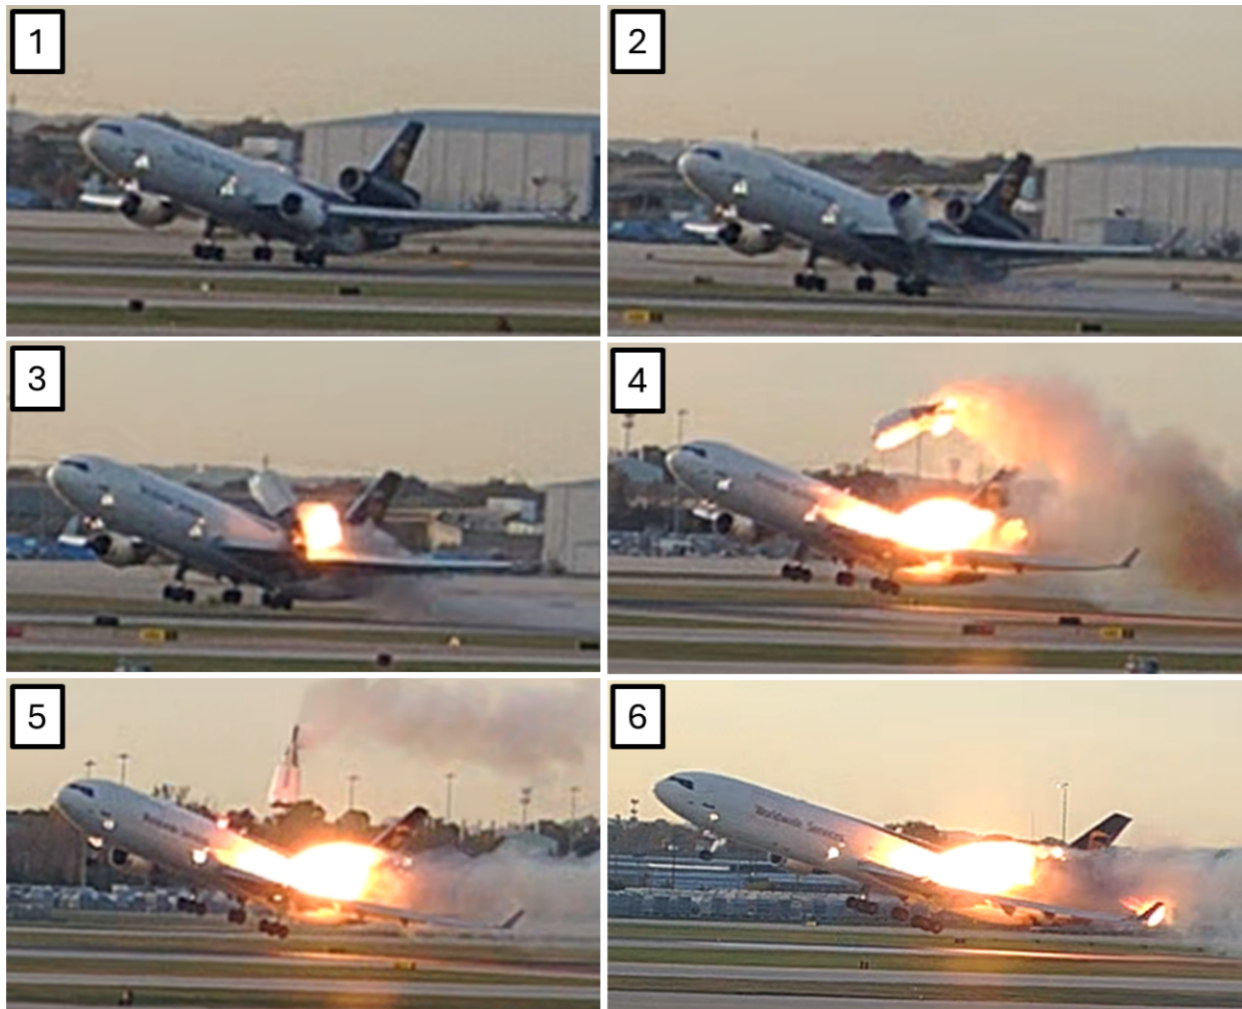
airplane rotated for takeoff. Airport surveillance video of the airplane showed the left (No. 1) engine and pylon separating from the wing shortly after airplane rotation, with a fire igniting on the left engine while it traversed above the fuselage and subsequently impacted the ground (see figure 1). A fire ignited near the area of the left pylon attachment to the wing, which continued until ground impact.

**Figure 1.** Still images from an airport surveillance video showing the left engine and left pylon separation from the left wing. (Source: UPS)

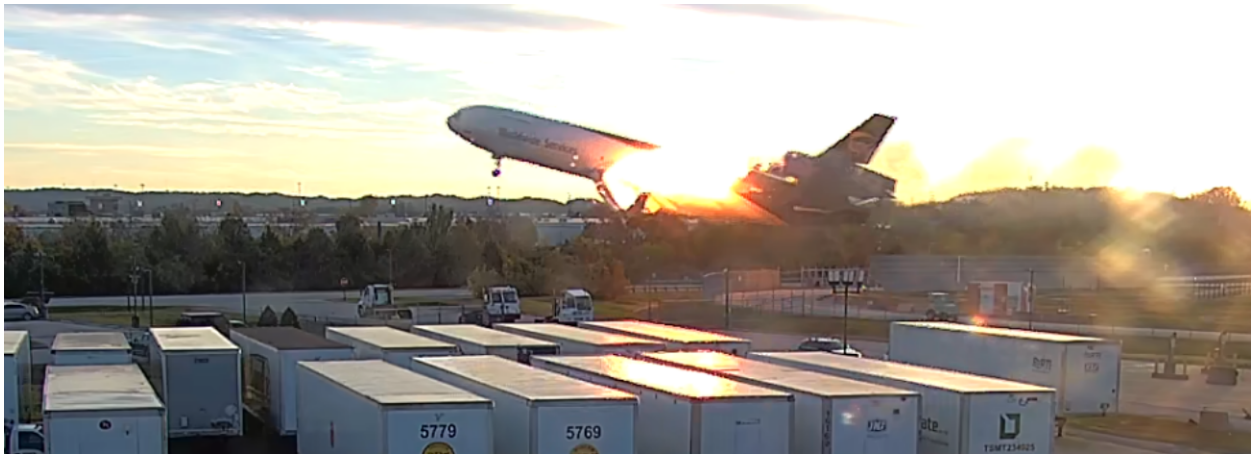
**Figure 2.** The fire in the area of the left pylon attachment to the wing continued as the airplane cleared the blast fence.

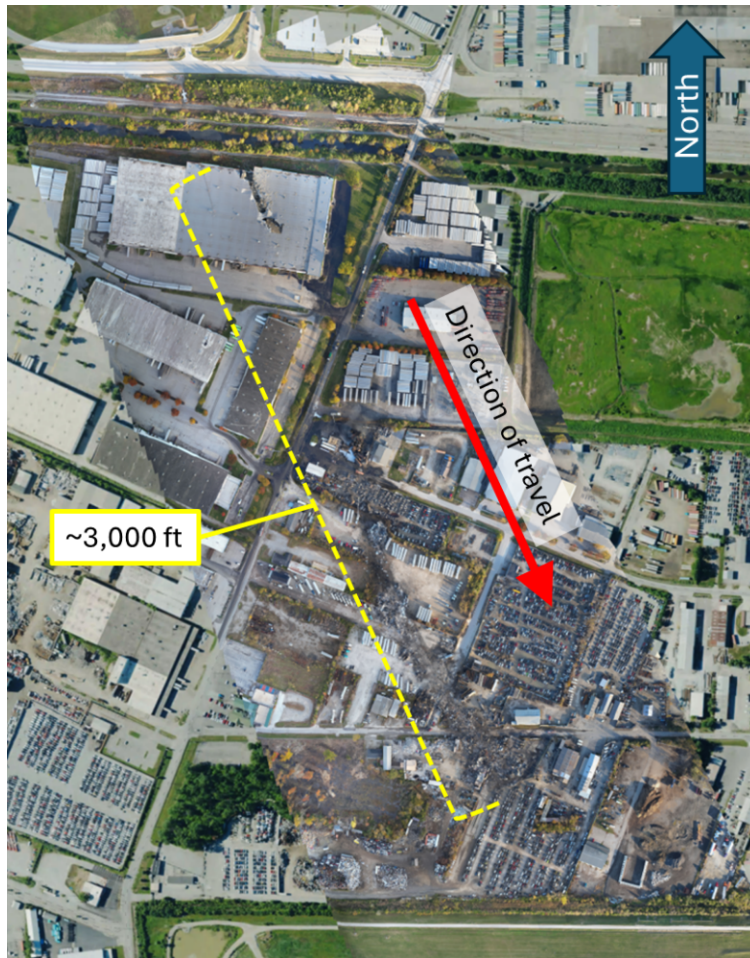
UPS warehouse to about 3,000 ft south-southeast of it (see figure 4). The accident site debris was centered about 38° 8' 49.85" north by 85° 44' 3.86" west.

**Figure 4.** Accident site composite view created from aerial imaging overlaid on a Google Earth image. The upper end of the yellow-dashed bracket is the initial impact between the airplane landing gear and the UPS building roof.

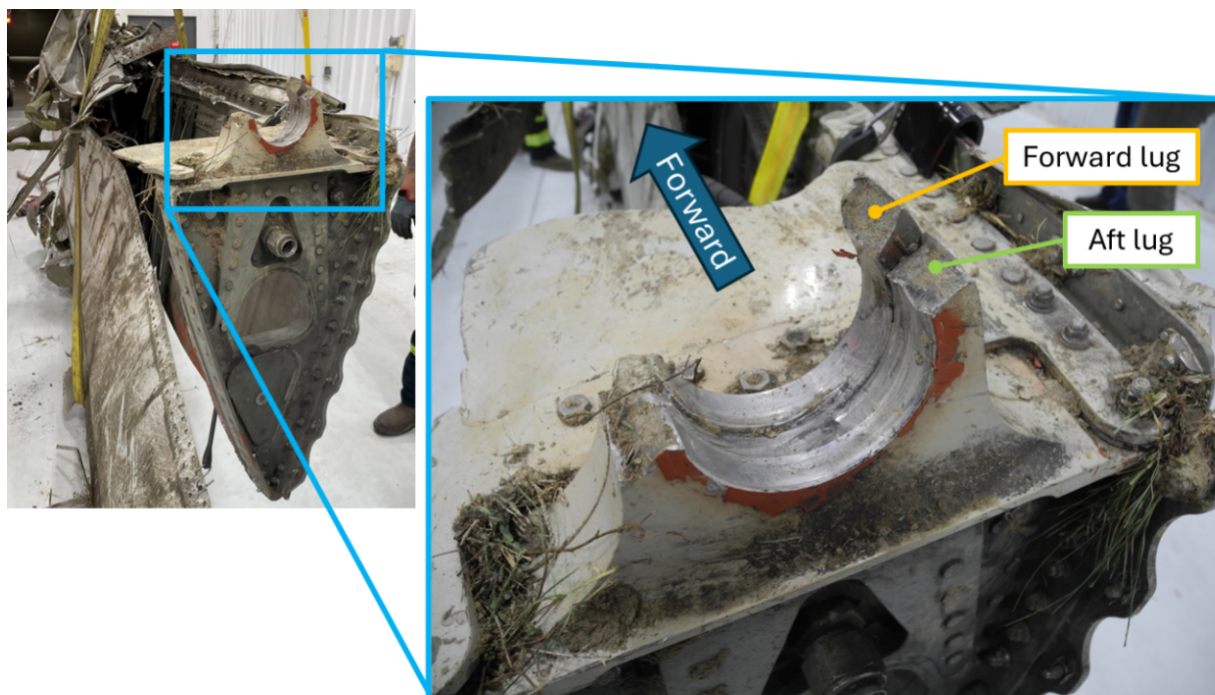
The left pylon aft mount's forward and aft lugs were both found fractured near their 2 o'clock (inboard fracture) and 9 o'clock (outboard fracture) positions when in the aft-looking-forward frame of reference (see figure 7). The fractured and separated upper portions of the forward and aft lugs were found adjacent to runway 17R. The left wing clevis, aft mount spherical bearing, and aft mount attachment hardware were found with a portion of the left wing at the accident site. The bolt, spherical bearing, and associated hardware remained attached to the wing clevis. The spherical bearing outer race had fractured circumferentially, exposing the ball element (see figure 8).

**Figure 7.** The separated left pylon after recovery (left image) and the left pylon aft mount's fractured forward and aft lugs (right/enlarged image).

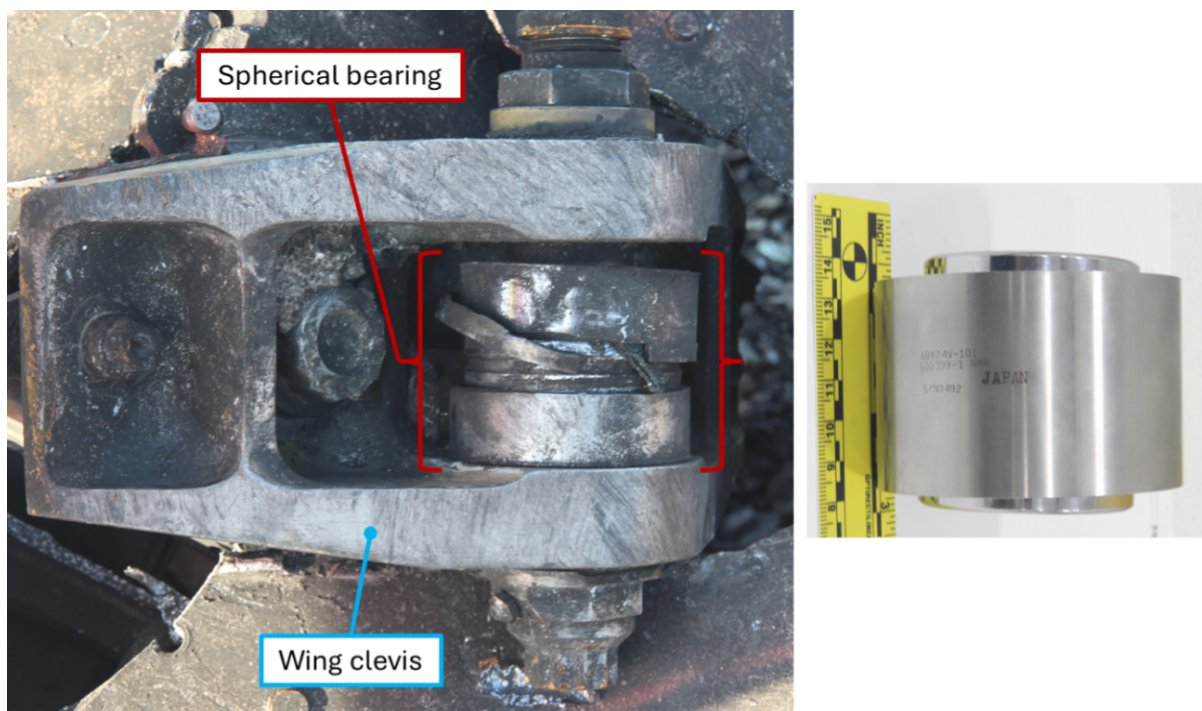
**Figure 8.** The left wing clevis, fractured spherical bearing (marked by the red brackets), and associated attachment hardware found at the accident site (left) and an exemplar spherical bearing (right).

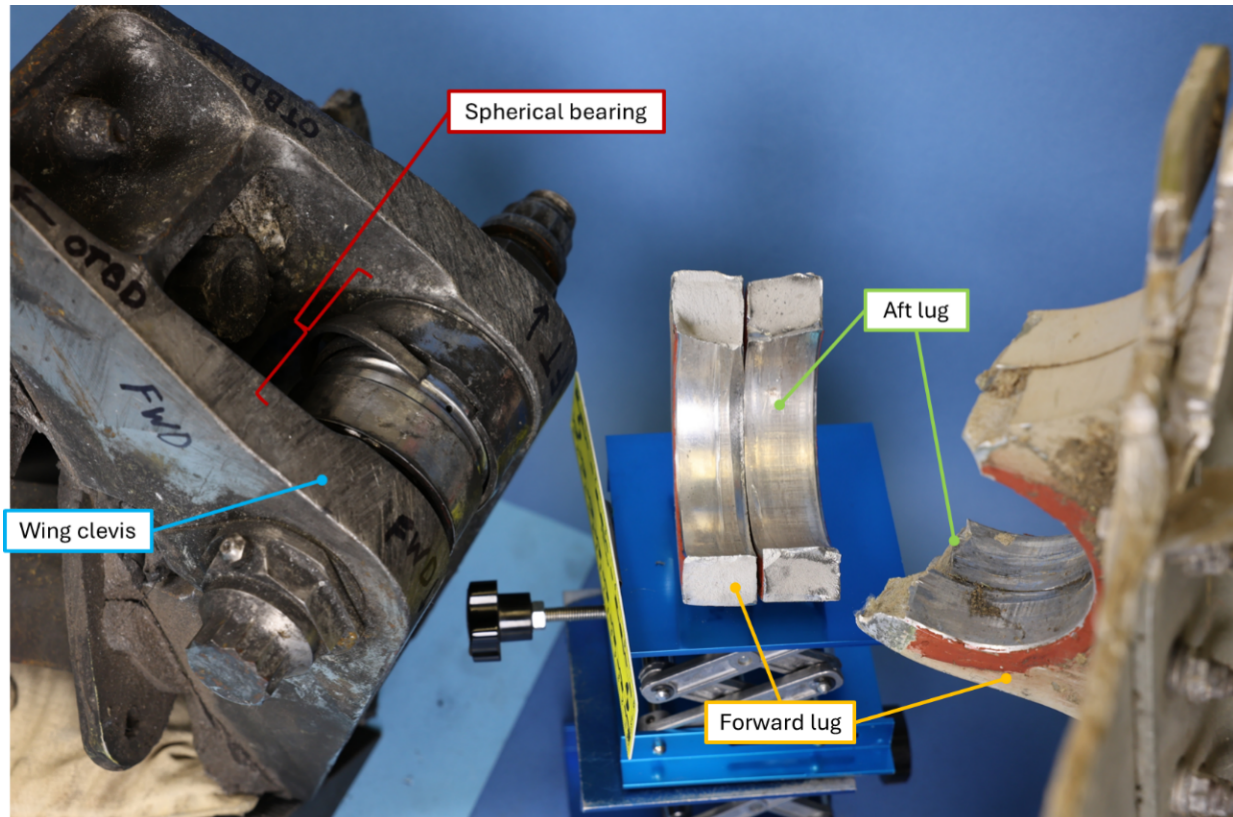
**Figure 9.** The left pylon aft mount, the fractured and separated forward and aft lugs, and the left wing clevis containing the attachment hardware and fractured spherical bearing.

After initial cleaning of the fracture surfaces, examination of the left pylon aft mount lug fractures found evidence of fatigue cracks in addition to areas of overstress failure. On the aft lug, on both the inboard and outboard fracture surfaces, a fatigue crack was observed where the aft lug bore met the aft lug forward face. For the forward lug's inboard fracture surface, fatigue cracks were observed along the lug bore. For the forward lug's outboard fracture surface, the fracture consisted entirely of overstress with no indications of fatigue cracking. The forward top flange of the aft mount assembly was examined for indications of deformation or pre-existing fractures, but no indications were found. The spherical bearing was removed from the wing clevis for further evaluation (see figure 10).

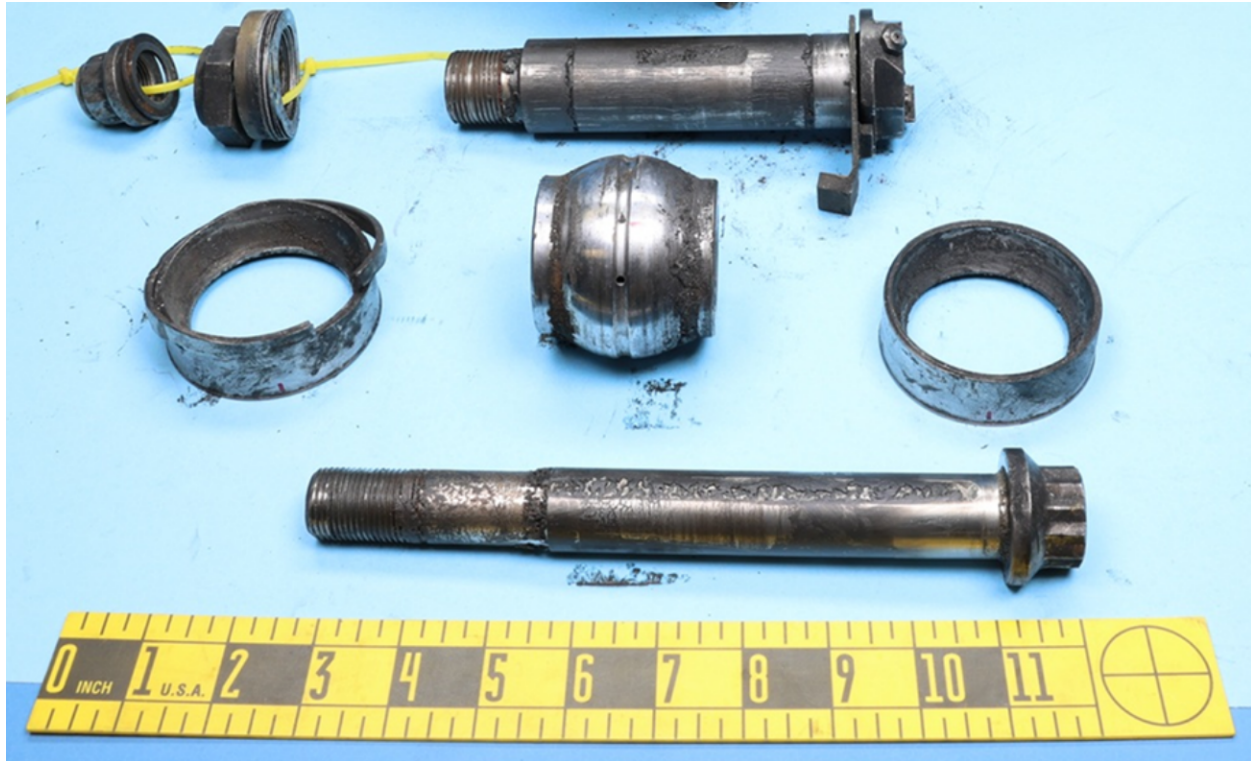
**Figure 10.** The spherical bearing and attachment hardware after removal from the left wing clevis.
