# Aviation Investigation Preliminary Report

| <b>Location:</b> | Cape Newenham, AK | <b>Accident Number:</b> | WPR26FA309 |
| <b>Date &amp; Time:</b> | August 20, 2026, 11:45 Local | <b>Registration:</b> | N128EZ |
| <b>Aircraft:</b> | Cessna 441 | <b>Injuries:</b> | 8 Fatal |

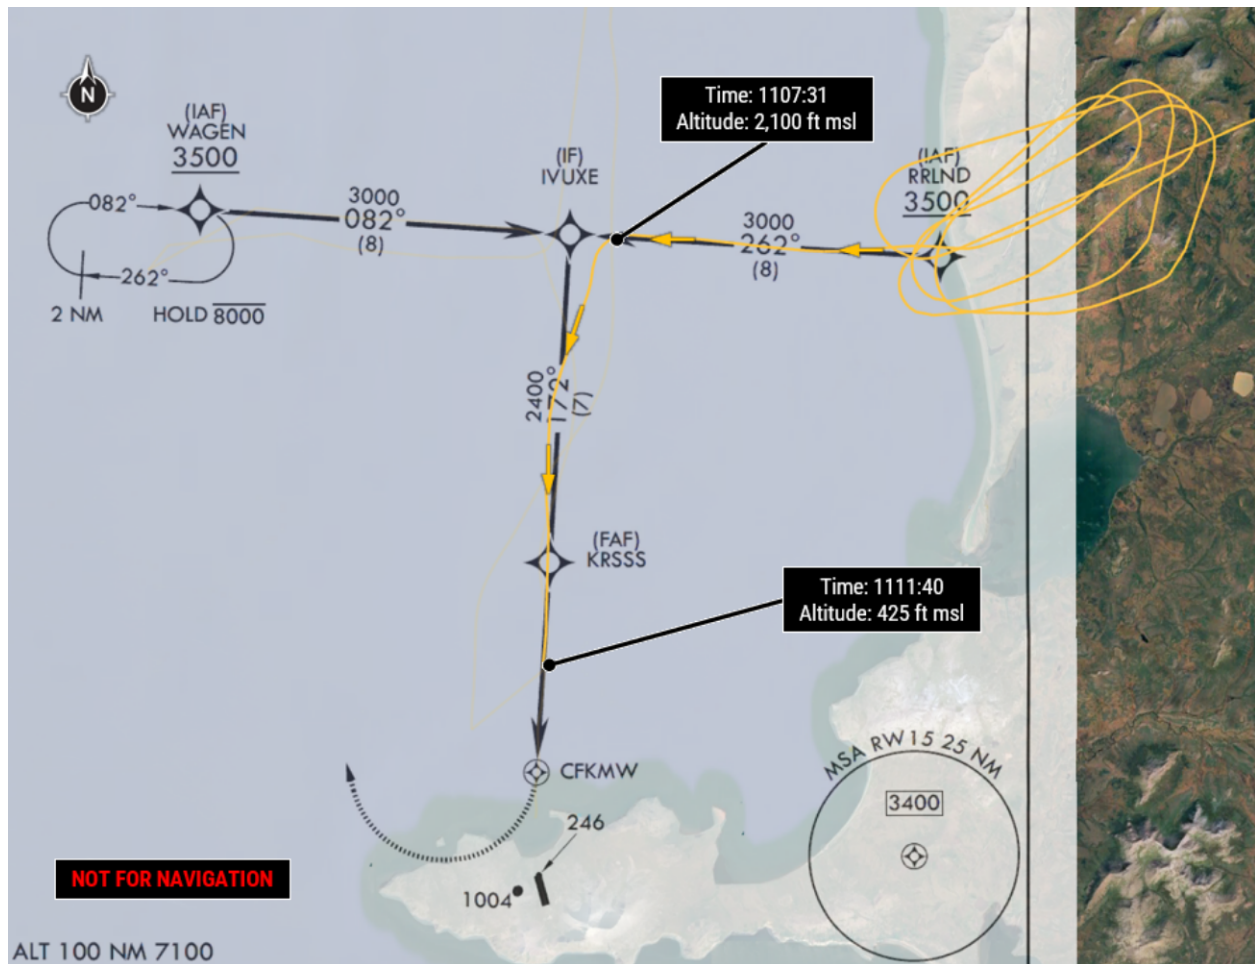
At 1104:31, while at an altitude of about 4,400 ft msl, the airplane turned westbound toward the Intermediate Fix (IF) IVUXE. At 1107:31, the airplane approached IVUXE at about 2,100 ft msl and initiated a left turn toward the Final Approach Fix (FAF) KRSSS. The last recorded altitude north of KRSSS was about 1,025 ft msl prior to ADS-B contact being lost at 1110:13. When ADS-B resumed at 1111:16, the airplane continued on the final approach, until contact was lost at 1111:40, the airplane was about 2.3 miles north of the Missed Approach Point (MAP) CFKMW at an altitude of about 425 ft msl. (See figure 1.)

Figure 1: Preliminary ADS-B flight track between 1040:28 and 1111:40, depicting the airplane's hold near RRLND, its turn to the south near IVUXE, and the last data point between KRSSS and CFKMW.

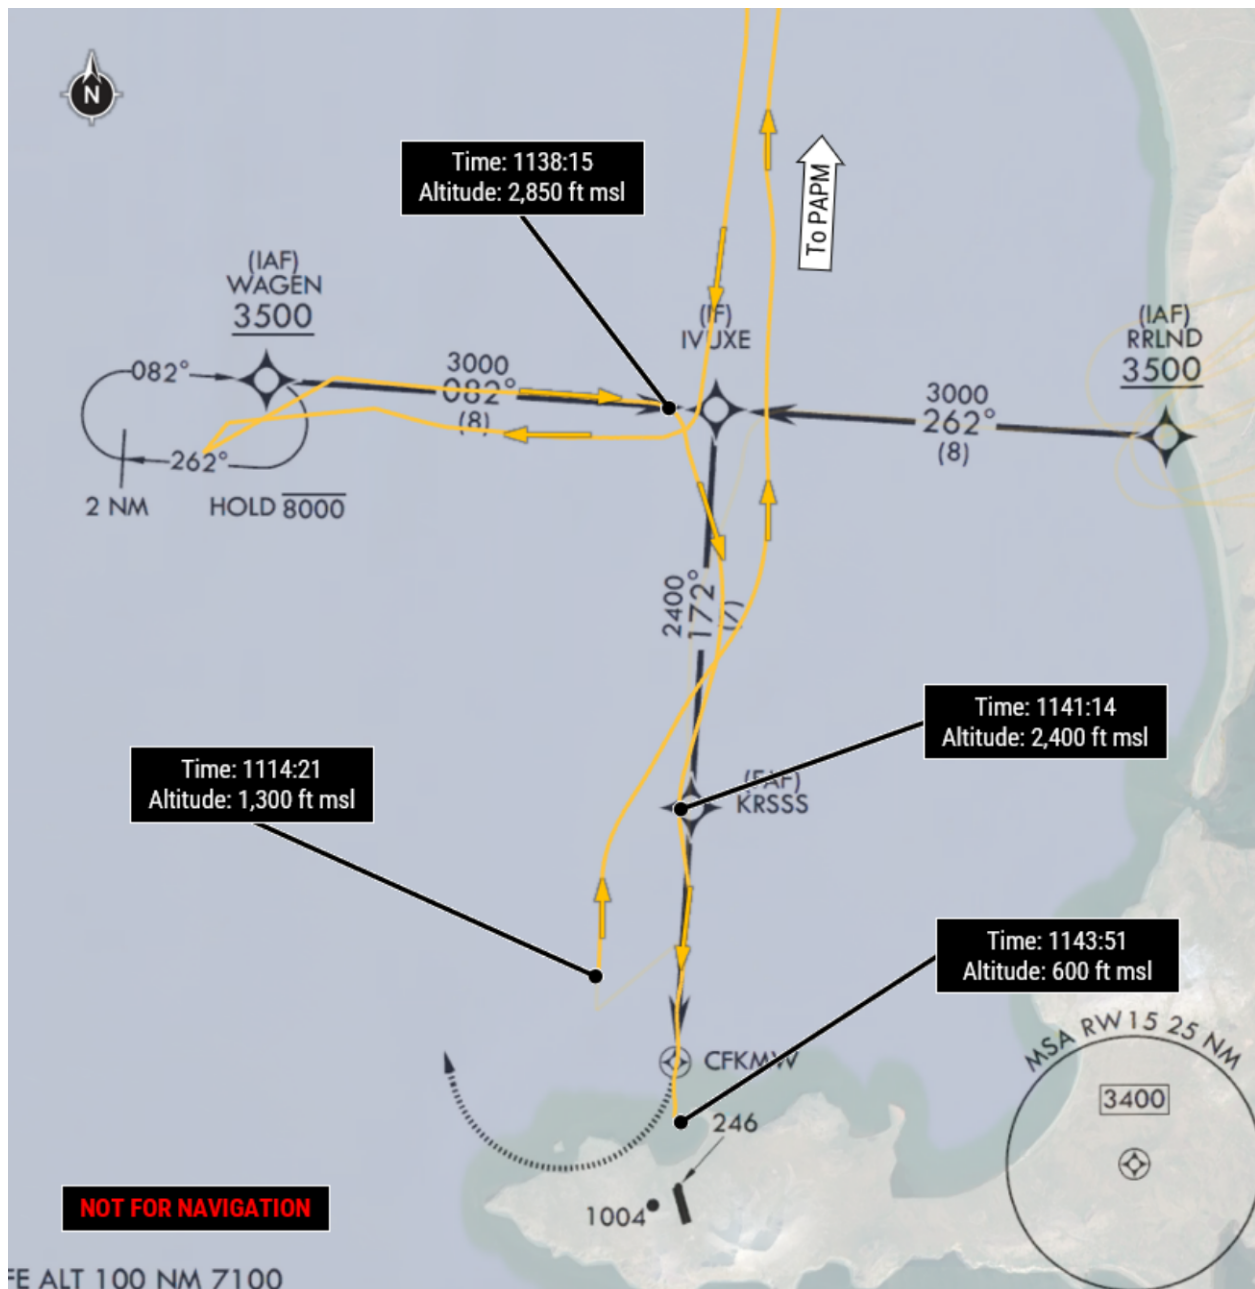
At 1138:15, the airplane was at an altitude of about 2,850 ft msl when it initiated a right turn near IVUXE. At 1141:14, the airplane crossed KRSSS at about 2,400 ft msl and continued southbound along the approach course. At 1143:18, the airplane crossed the MAP CFKMW at about 1,000 ft msl. The airplane continued beyond CFKMW, while it descended to about 600 ft msl, until ADS-B contact was lost at 1143:51. At that time, the airplane was about 1.3 miles north of the runway 15 threshold at PAEH. (See figure 2.)

Figure 2: Preliminary ADS-B flight track between 1144:21 and 1143:51, depicting the airplane flying northbound after executing a missed approach. The airplane subsequently initiated a second approach.
