PB90-910406
NTSB/AAR-90/06

AIRCRAFT ACCIDENT REPORT

**UNITED AIRLINES FLIGHT 232
McDONNELL DOUGLAS DC-10-10
SIOUX GATEWAY AIRPORT
SIOUX CITY, IOWA
JULY 19, 1989**

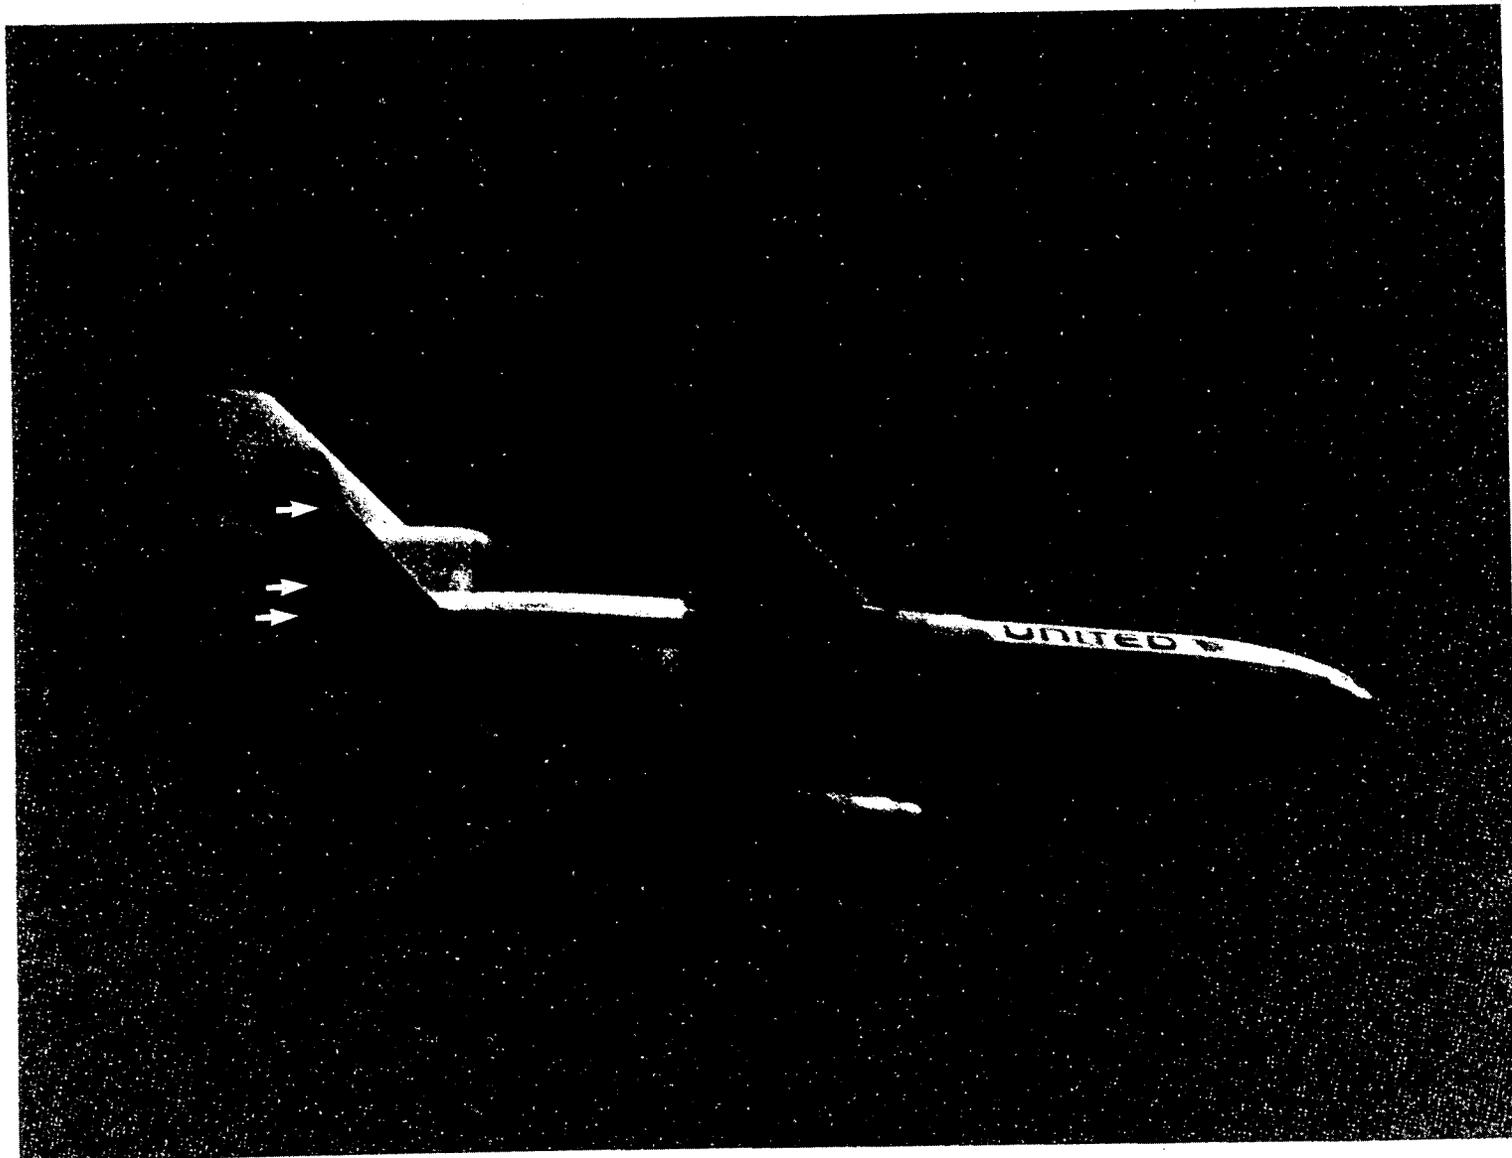
Photographs of the airplane were taken by observers on the ground during its final approach to Sioux Gateway Airport. They showed that the No. 2 engine fan cowling and the fuselage tail cone were missing. The remainder of the No. 2 engine appeared intact. Postcrash examination of the wreckage revealed that the No. 2 engine fan rotor components forward of the fan forward shaft, as well as part of the shaft, had separated from the engine in flight. (See figures 3 through 5).

Figure 3.--Photo (C. Zellmer) taken while flight 232 was approaching Sioux Gateway Airport. Arrows indicate damage to the right horizontal stabilizer. It is also evident that the No. 2 engine fan cowl door and the tail cone are missing.

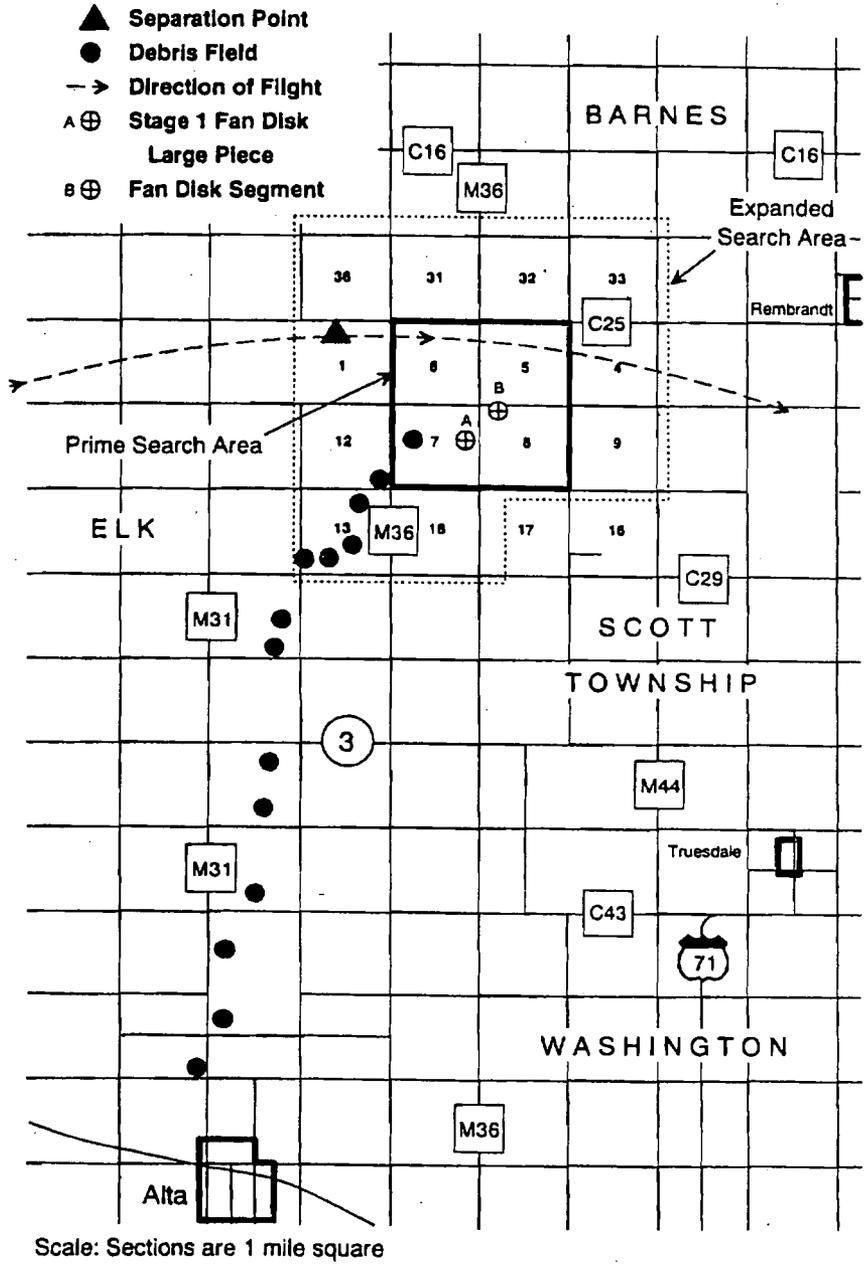
Also found near Alta soon after the accident were parts of the tail engine adapter assembly, consisting of adapter ring and bellmouth assemblies, an anti-ice pneumatic tube, a starter air tube, three cowl hold-open rods, two hydraulic system accumulators from the No. 2 engine-driven hydraulic pumps, fan blade fragments, two pieces of insulated metal braid-covered hydraulic hose clamped together, and a segment of aluminum material broken out of the large structural "banjo" forging from the airplane inlet duct structure.

About 3 months after the accident, parts of the No. 2 engine fan disk were found in farm fields near Alta. There were two sections that constituted nearly the entire disk, each with fan blade segments attached. These parts were initially taken to the GEAE facility in Evandale, Ohio, for examination under the direction of the Safety Board. The small segment was later transported to the NTSB Materials Laboratory in Washington for further evaluation. (See section 1.16, Tests and Research).

Figure 11.--Trajectory information/Alta debris field.

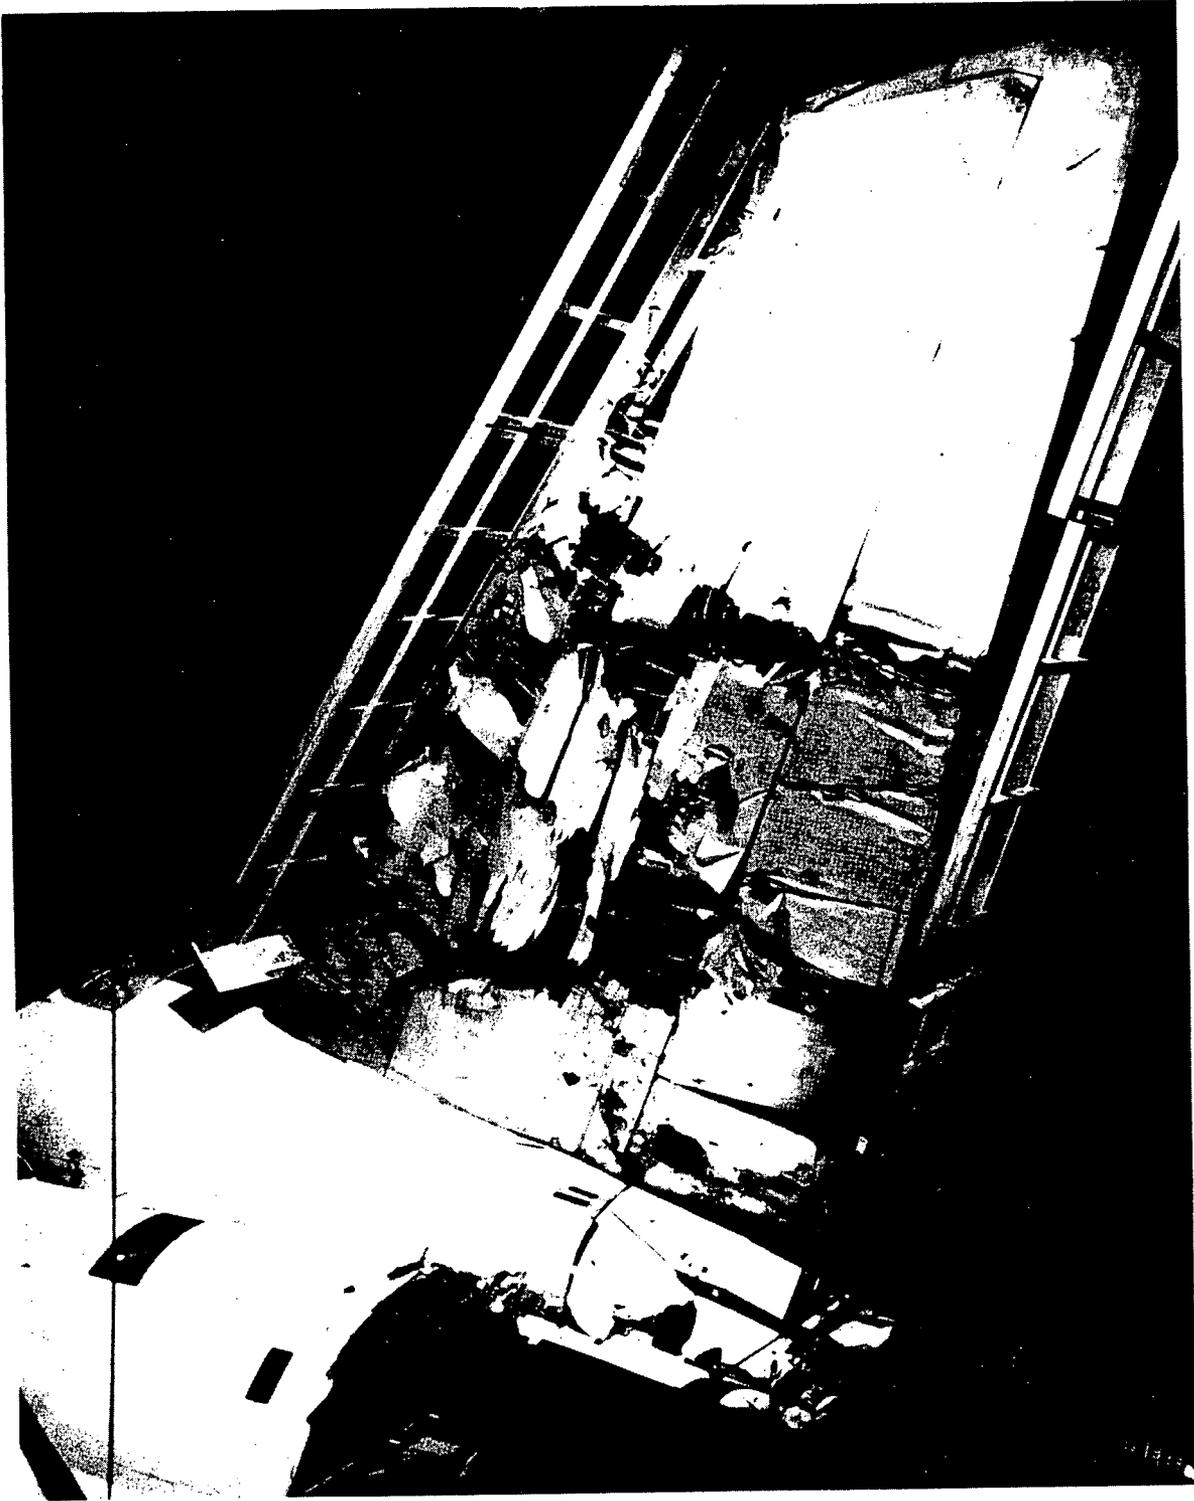
Examination of the empennage wreckage revealed that the No. 3 hydraulic system pressure line was severed in the inboard area of the right horizontal stabilizer. Holes penetrating the stabilizer skins were found in

Figure 13.--N1819U, view of top surface of right horizontal stabilizer.

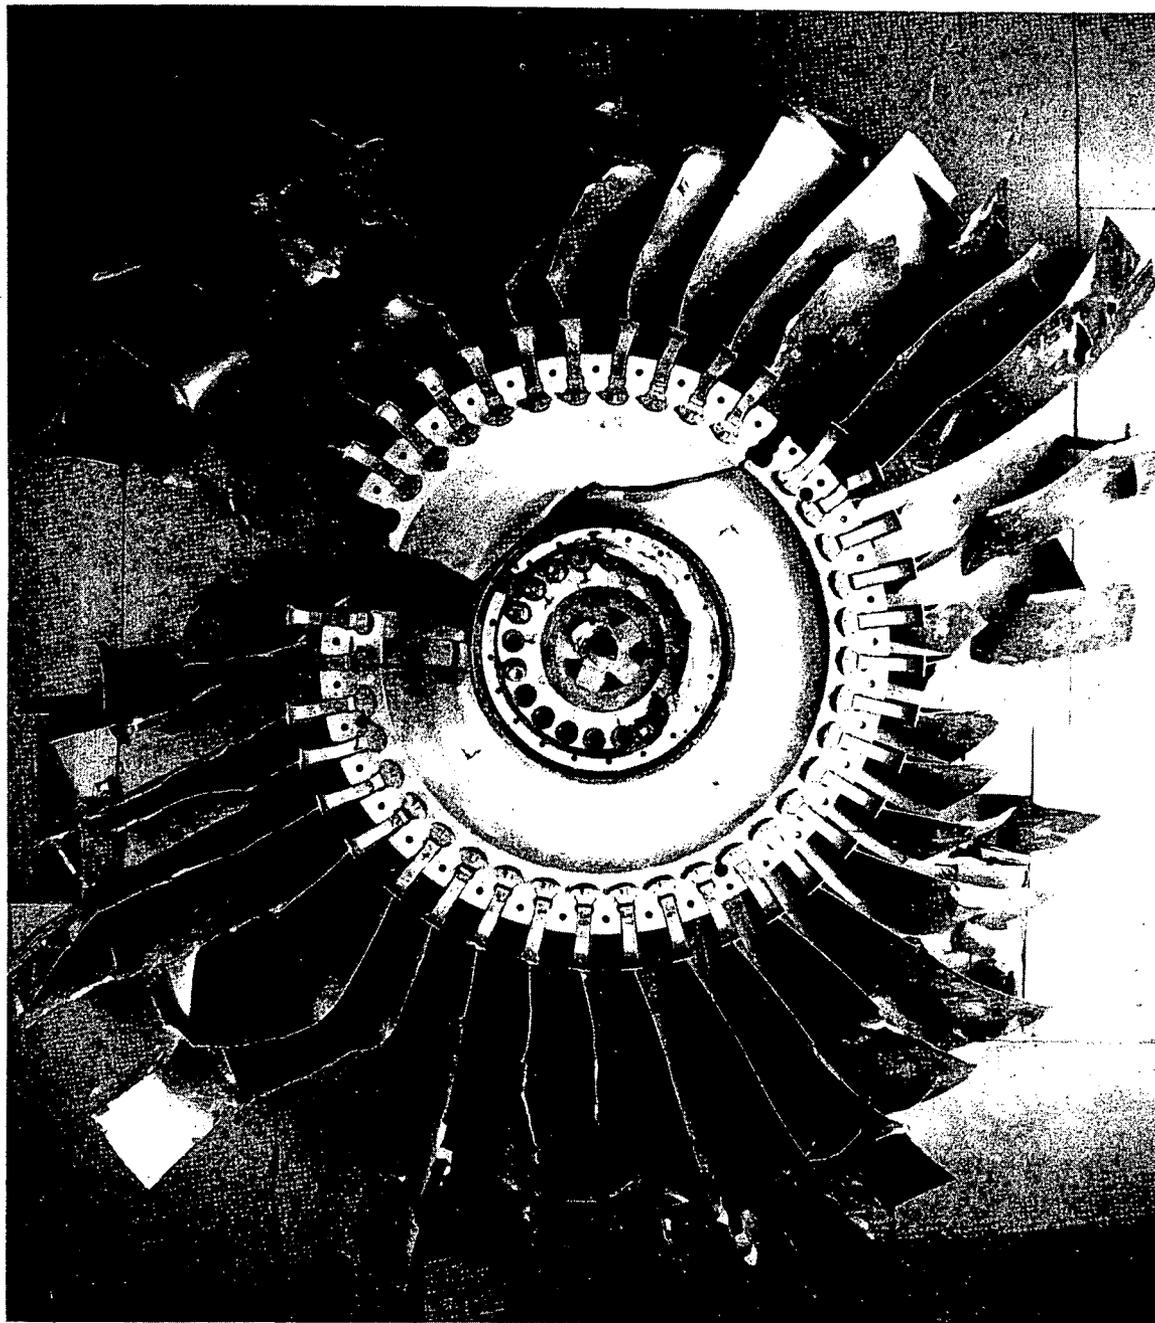
In mid October 1989, about 3 months after the accident, two pieces of the No. 2 engine stage 1 fan disk, with attached blade pieces, were found in corn fields near Alta, Iowa. The two pieces comprised the entire separated disk, with the exception of one dovetail post, which was not recovered. Figure 18 shows the reconstructed pieces of the disk after the larger disk piece had been cut during the metallurgical evaluations. The gap between the smaller and larger piece does not represent missing material but is a result of mechanical deformation that occurred during the disk separation. The disk contained two principal fracture areas, resulting in about one-third of the rim separating from the remainder of the disk. One of the fracture areas progressed largely circumferentially through the web and rim. The other was on a near-radial plane, progressing through the bore, web, disk arm, and rim. Features on the circumferential fracture were

Figure 18.--No. 2 engine stage 1 fan disk (reconstructed with blades).

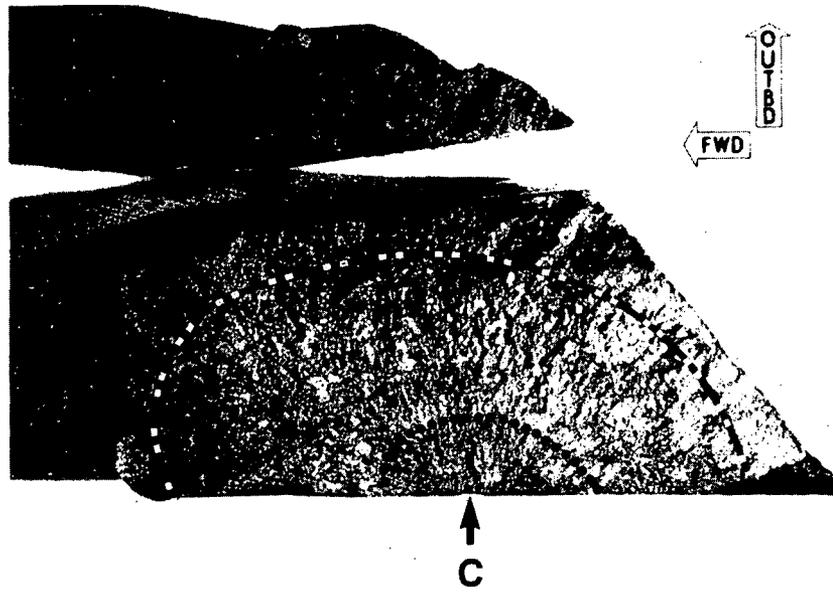
The mating fatigue regions on the pieces of the separated stage 1 fan disk were subjected to scanning electron microscope examinations. Some areas of fatigue striations were found just outboard of the stabilized-alpha

Figure 19A.--Fatigue crack fracture area cut from the bore of the smaller piece of the separated stage 1 fan disk. The fatigue crack extends from the cavity (arrow "C") to the dashed line position. The discolored portion of the fatigue crack is between the cavity and the dotted line. Magnification: 2.26X.

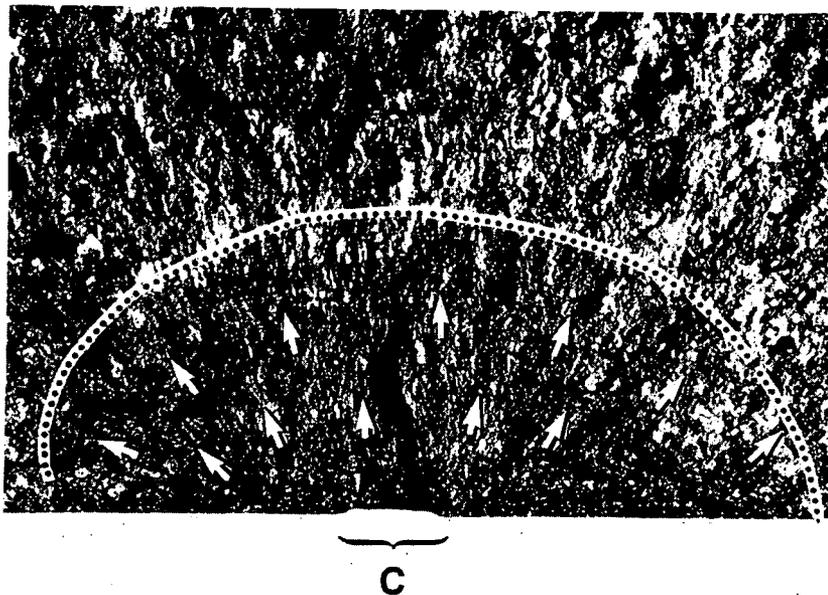
Figure 19B.--Closer view of the discolored area on the fatigue crack. The dotted line in this figure corresponds to the dotted line in figure 19A. Arrowheads on the fracture surface indicate cracking directions away from the cavity. Magnification: 8.6X.

portion of the inclusion at the fatigue origin. However, between the cavity bottom and a radial distance of 0.025 inch outboard of the bore surface, areas with brittle fracture features and a lack of fatigue striations were found intermixed among more ductile-appearing bands with fatigue striations. The zone with a mixture of brittle features and fatigue striation areas correlated with the enriched alpha microstructure surrounding the stabilized-alpha core of the inclusion.

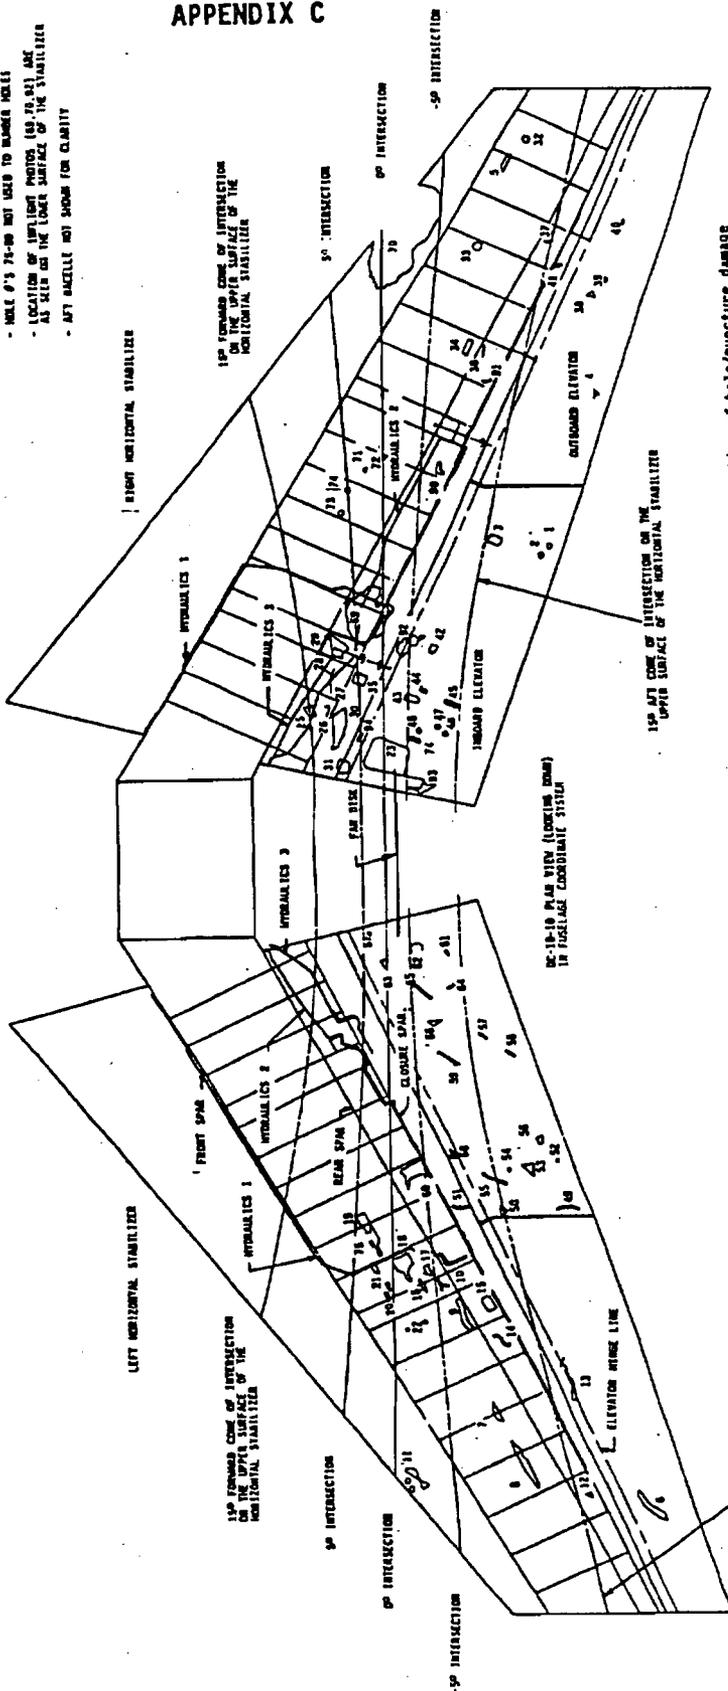
Four punctures on the vertical stabilizer were noted as probable fragment damage prior to ground impact. Documentation of hole/puncture damage to the horizontal stabilizers is contained in Appendix C. There were 79 punctures recorded from fragment damage and one large hole, about the same size as the large piece of recovered fan disk. The flight control surfaces were recovered in the aircraft wreckage and had varying degrees of damage that could have occurred before or after impact.

Figure 1. Documentation of hole/puncture damage to horizontal stabilizers.
