# NATIONAL TRANSPORTATION SAFETY BOARD

## AIRCRAFT ACCIDENT REPORT

IN-FLIGHT LOSS OF PROPELLER BLADE  
FORCED LANDING, AND COLLISION WITH TERRAIN  
ATLANTIC SOUTHEAST AIRLINES, INC., FLIGHT 529  
EMBRAER EMB-120RT, N256AS  
CARROLLTON, GEORGIA  
AUGUST 21, 1995

**Adopted: November 26, 1996  
Notation 6609B**

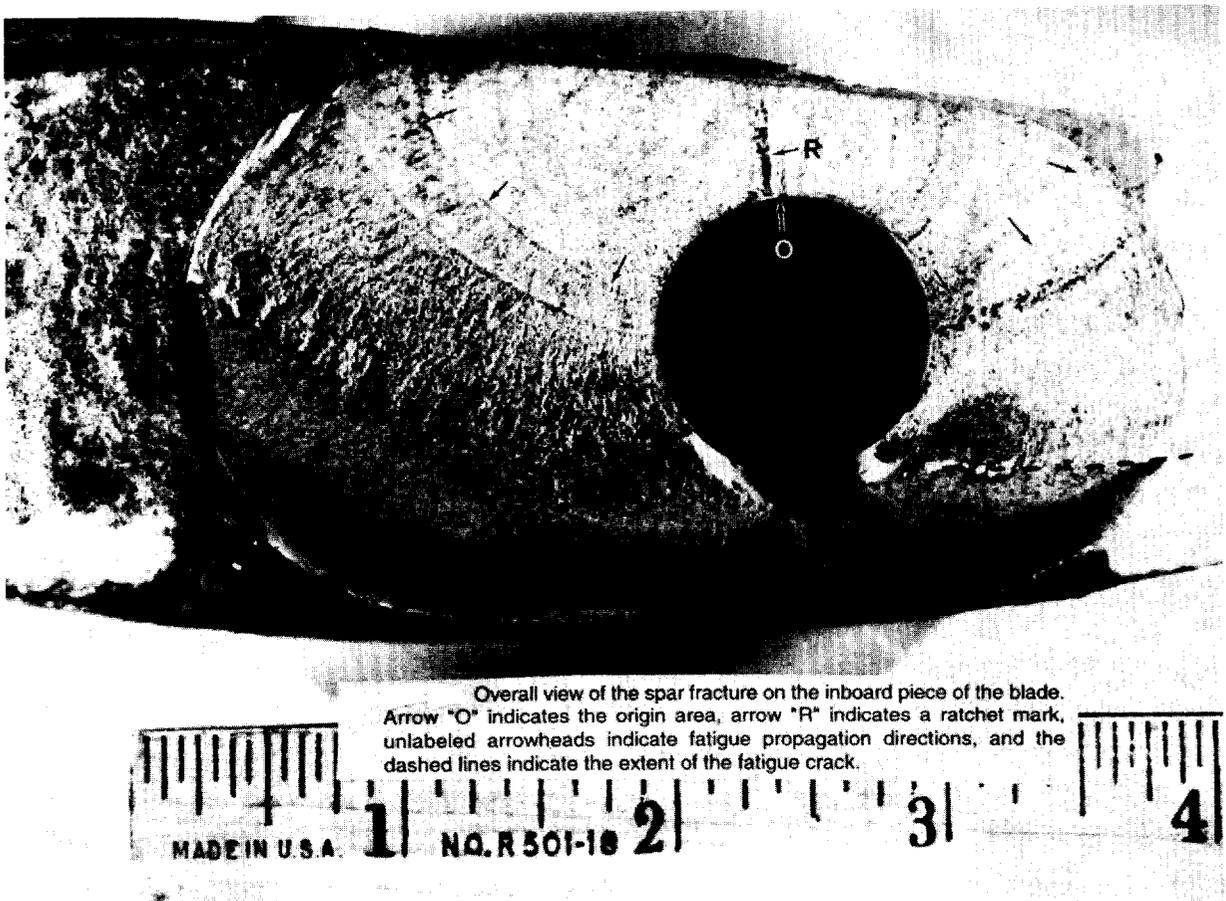
Figure 3.--Photo of the blade fracture surface.

The origin areas on both the inboard and outboard faces of the fracture were examined with a scanning electron microscope (SEM) before the faces of the fracture were cleaned. The fracture surface near the origin area on both faces of the fracture contained a layer of heavy oxide deposits that had a mud-cracked appearance. These deposits extended to a maximum depth of 0.049 inch from the taper bore surface. Their maximum circumferential width was 0.130 inch, based on the examination of the damaged outboard fracture face. X-ray energy dispersive spectroscopy (EDS) of the deposits of both faces generated similar spectra with a major peak for aluminum, a substantial peak for oxygen, and a minor peak for zinc.<sup>27</sup> EDS of the deposit area on the inboard fracture face also revealed the presence of chlorine.

After the fracture surface had been cleaned, additional SEM examination revealed that the fatigue cracking initiated from several corrosion pits in a line of pits in the taper bore that extended over a distance of about 0.070 inch. The maximum depth of the corrosion pitting at the fatigue origin area was measured as slightly less than 0.006 inch below the taper bore surface.

The taper bore surface, including the area adjacent to the fatigue initiation area, contained a series of nearly circumferential sanding marks. The marks extended over about 180 degrees of the circumference of the taper bore and to a maximum distance of about 1.5 inches inboard of the fracture surface. Outboard of the fracture, the sanding marks extended about 2 inches from the fracture surface.

The investigation revealed that sanding rework of the area had been accomplished using the blending repair procedures contained in PS960A.<sup>28</sup> The procedures required that the surface finish of the blended area should be restored to the original surface finish. Postaccident surface profilometer measurements conducted on the taper bore sanding marks indicated that the surface finish was much rougher than the manufactured surface not disturbed by the rework process.<sup>29</sup> Measurements also indicated that the nondisturbed surface met the manufacturing specifications.

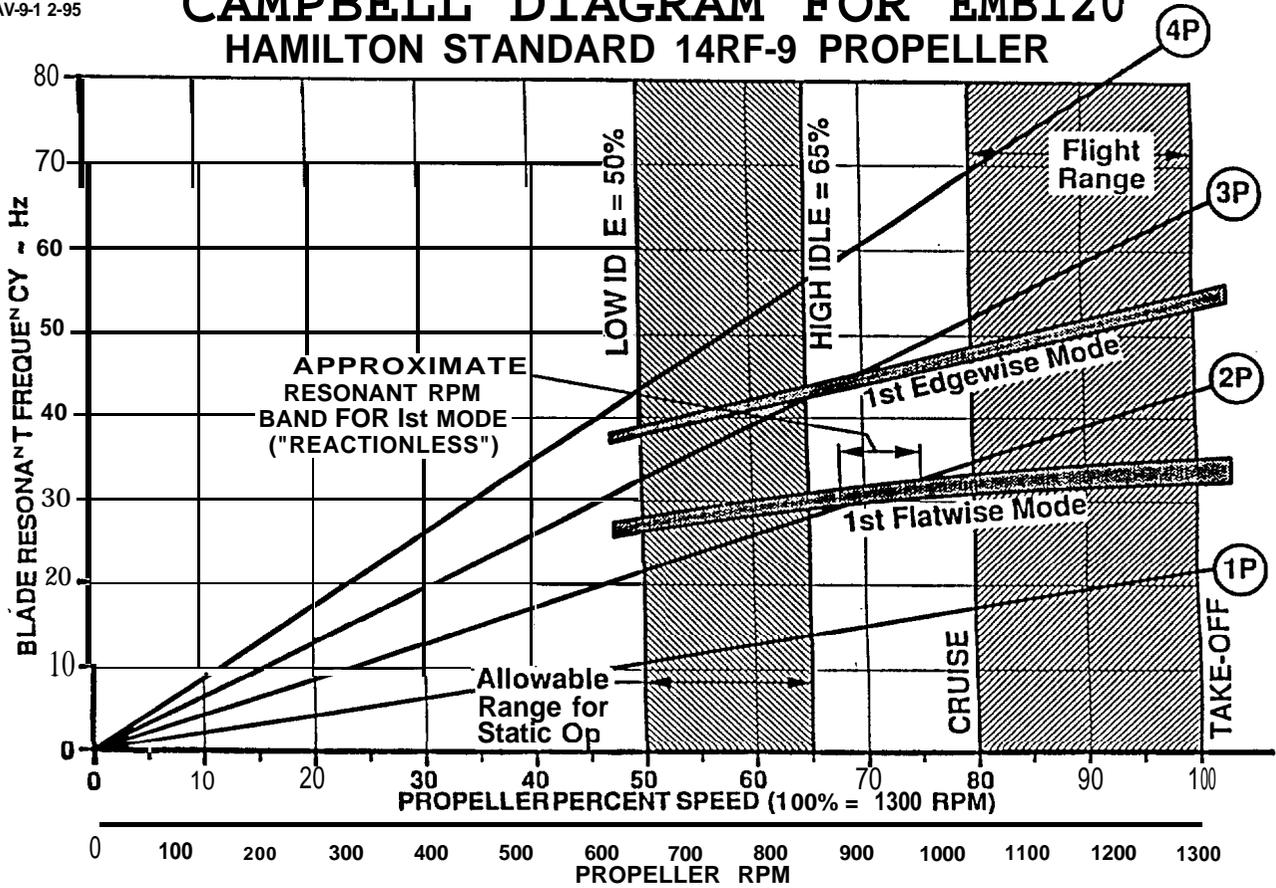
Figure 4.--Vibratory modes of the 14RF-9 propeller.

When the first flat-wise vibration frequency and the 2P excitation frequency coincide, a four-bladed propeller, such as the 14RF-9, vibrates in the reactionless<sup>49</sup> mode. The reactionless mode of vibration is characterized as when two blades of a four-bladed, rotating propeller, 180 degrees apart, reach a negative stress peak at the same time that the other two blades reach their positive stress peak. This type of propeller vibration is called reactionless because the bending loads of the four blades are canceled at the propeller hub which consequently transmits little or no vibratory loading to the propeller mounting structure.
