PB90-916301  
NTSB/RAR-90/01

## **RAILROAD ACCIDENT REPORT**

**REAR-END COLLISION OF TWO  
NEW YORK CITY TRANSIT AUTHORITY TRAINS  
103RD STREET STATION  
NEW YORK, NEW YORK  
MARCH 10, 1989**

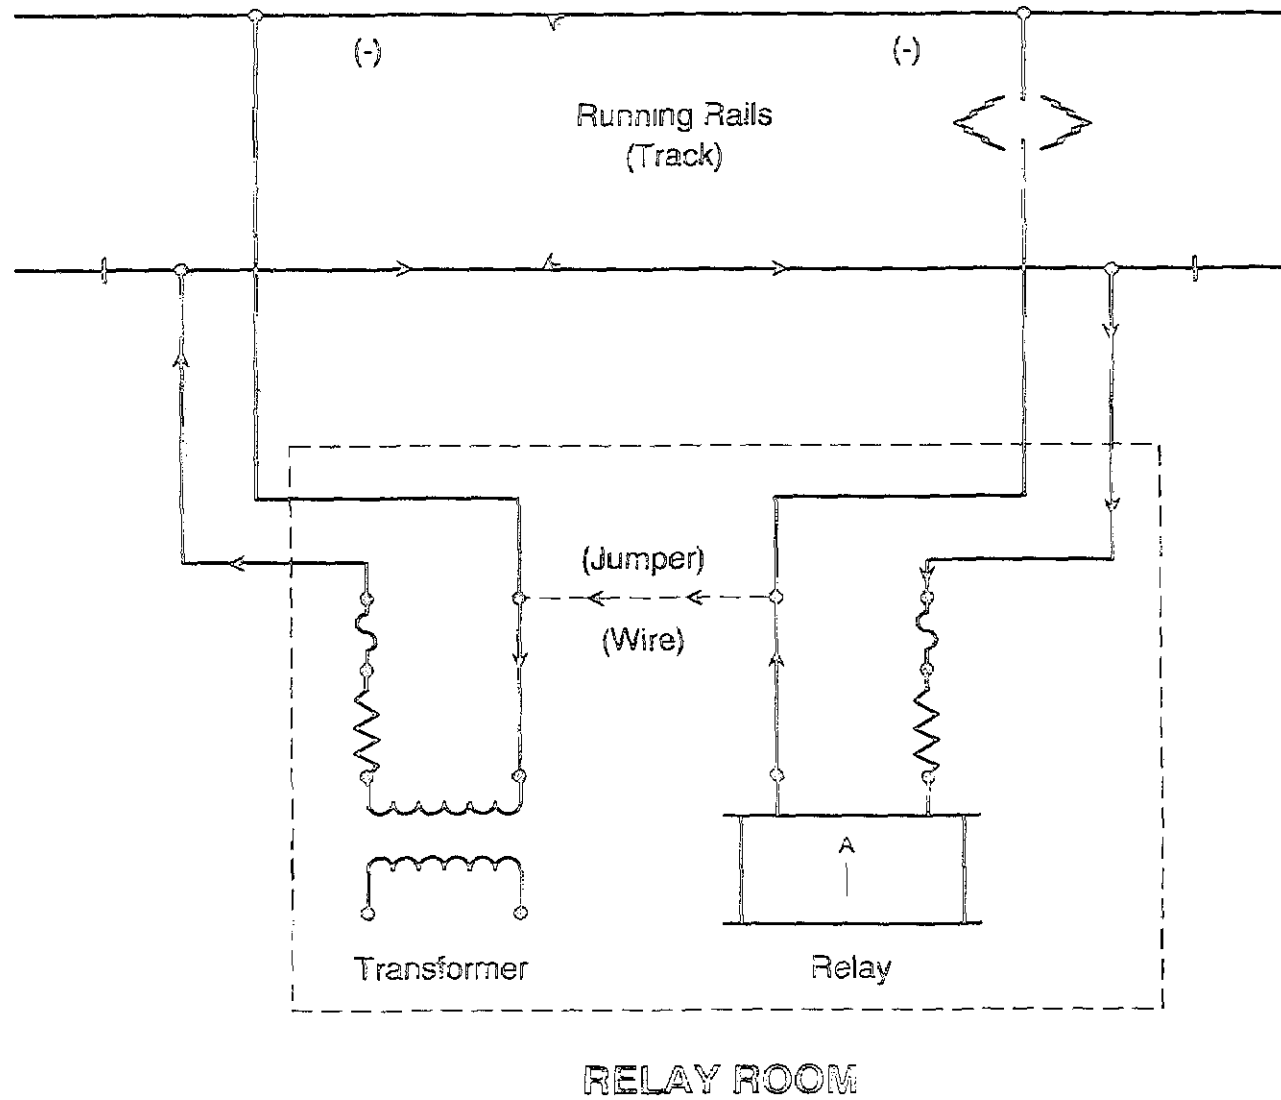
Figure 7 --Signal System Displays Clear With Jumper Wire Applied.

Inspection of the signal system at the 103rd street station following the accident revealed that a jumper wire had been installed between the transformer and the relay and tucked away (out of easy sight) in the circuit rack of the 204 circuit (the track circuit at which the train 3A was located at the time of the collision). With either of the negative relay or feed wires broken, current flow through the negative rail would be eliminated causing the relay to deenergize and the signal system to display a stop indication. However, with the jumper wire in place, current would still flow through the relay and the signal system would indicate clear when no train is

present (see Figure 7). Also, with the jumper wire in place, train wheels would still shunt the circuit removing the current to the relay, the relay would be deenergized and the signals would display a stop indication.
