National Transportation Safety Board

Aircraft Accident Investigative Update

On January 26, 2020, at 0945 Pacific standard time (PST), a Sikorsky S-76B helicopter, N72EX, collided with hilly terrain near the city of Calabasas, California. The pilot and eight passengers were fatally injured, and the helicopter was destroyed by impact forces and fire. The helicopter was operated by Island Express Helicopters Inc. under Title 14 Code of Federal Regulations (CFR) Part 135 as an on-demand passenger visual flight rules (VFR) flight from John Wayne-Orange County Airport, (KSNA), Santa Ana, California, to Camarillo Airport, (KCMA), Camarillo, California.

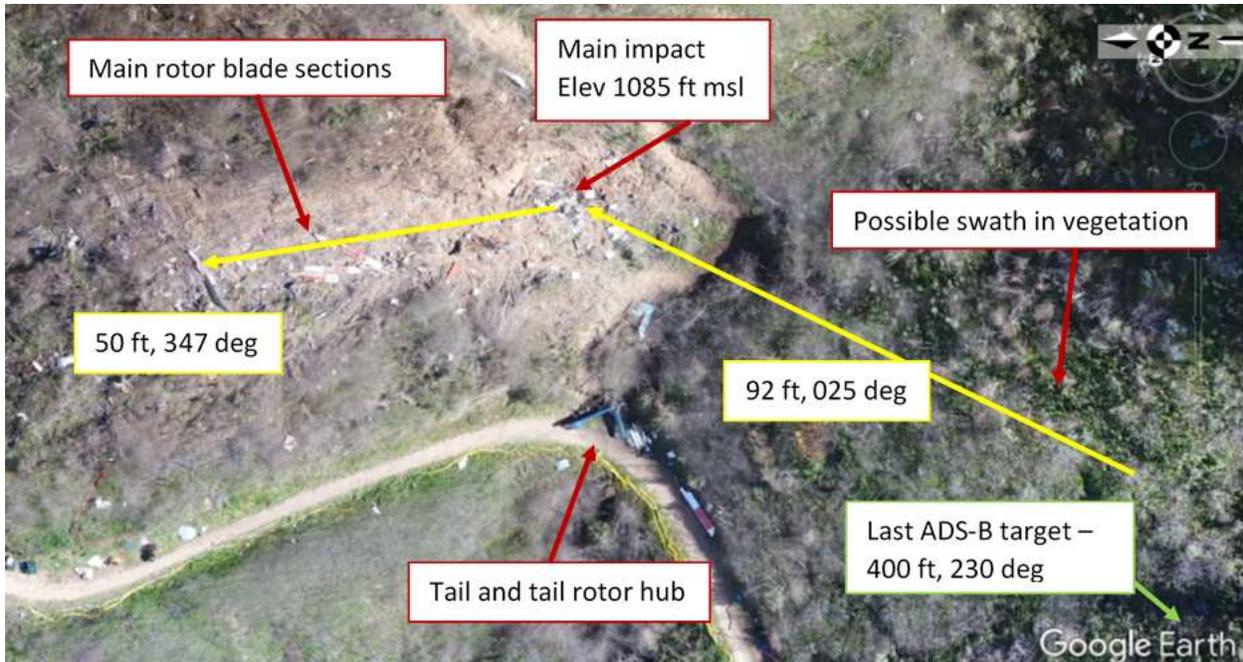
Figure 1a. Google Earth map of wreckage area – southern (directions reference true north)

All significant components of the helicopter were located within the wreckage area. Examination of the main and tail rotor assemblies found damage consistent with powered rotation at the time of impact. The initial point of impact consisted of highly fragmented cabin and cockpit debris. The vertical pylon and horizontal stabilizer were located about 40 feet below (downhill from) the

impact crater. A witness mark consistent with the length and width of a rotor blade and containing fragments of rotor blade skin and honeycomb was positioned perpendicular to the direction of the debris line and directly above the impact crater. One piece of 2-inch diameter tree branch was cut cleanly in 3 locations (similar to saw cuts) about 30 feet prior to the initial impact crater. Approximately 95% of the main rotor blades were recovered. All four blades exhibited similar damage consisting of midspan bending, pocket separation, blade tip separation, and leading-edge indentations and scuffing.

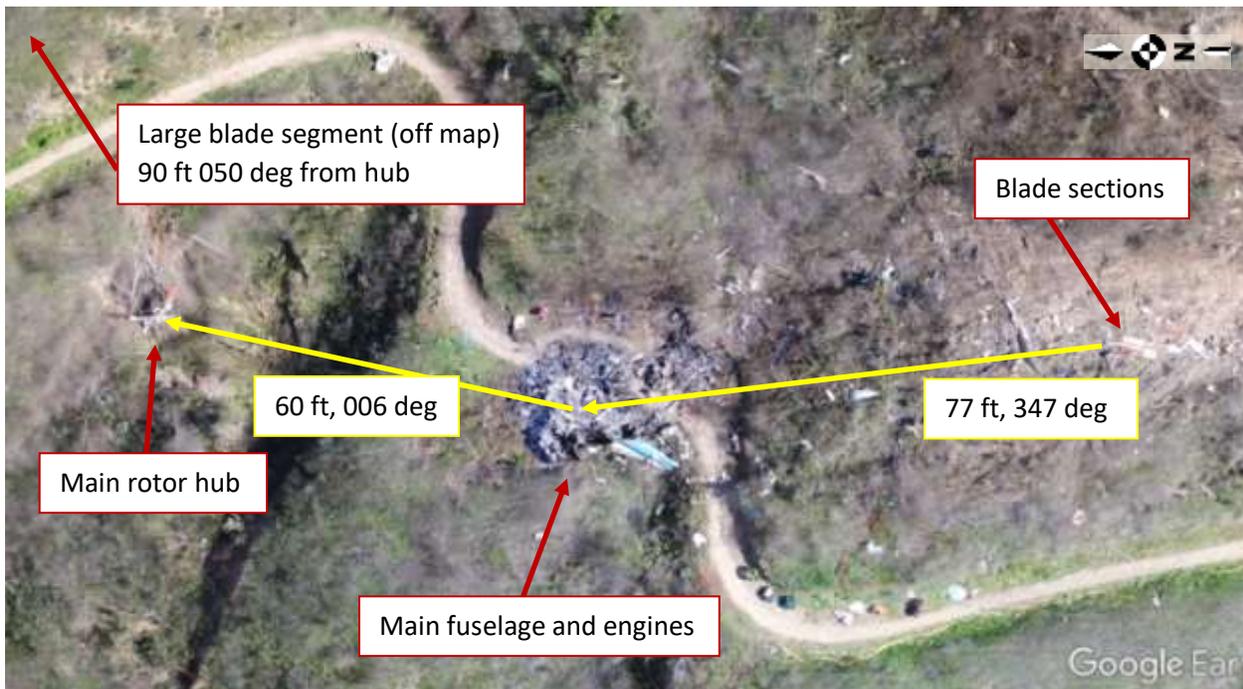
Figure 1b. Google Earth map of wreckage area – northern

The main wreckage was about 127 feet from the impact crater along a 347° true bearing (335° magnetic) and consisted of the empennage/tailboom, both engines, avionics boxes, and portions of the cockpit instrument panel. The entire fuselage/cabin and both engines were subjected to a postcrash fire. The cockpit was highly fragmented. The instrument panel was destroyed and most instruments were displaced from their panel mounts. Flight controls were fragmented and fire damaged.

The engines were found lying inverted near the empennage in the burned area. The accessory gearboxes and parts of the inlet cases of both engines were thermally destroyed. Viewable sections of the engines showed no evidence of an uncontained or catastrophic internal failure. The No. 2 engine first-stage compressor blades exhibited tip curl in the direction opposite of rotation, consistent with powered rotation at the time of impact. The engines were recovered for detailed disassembly examination.

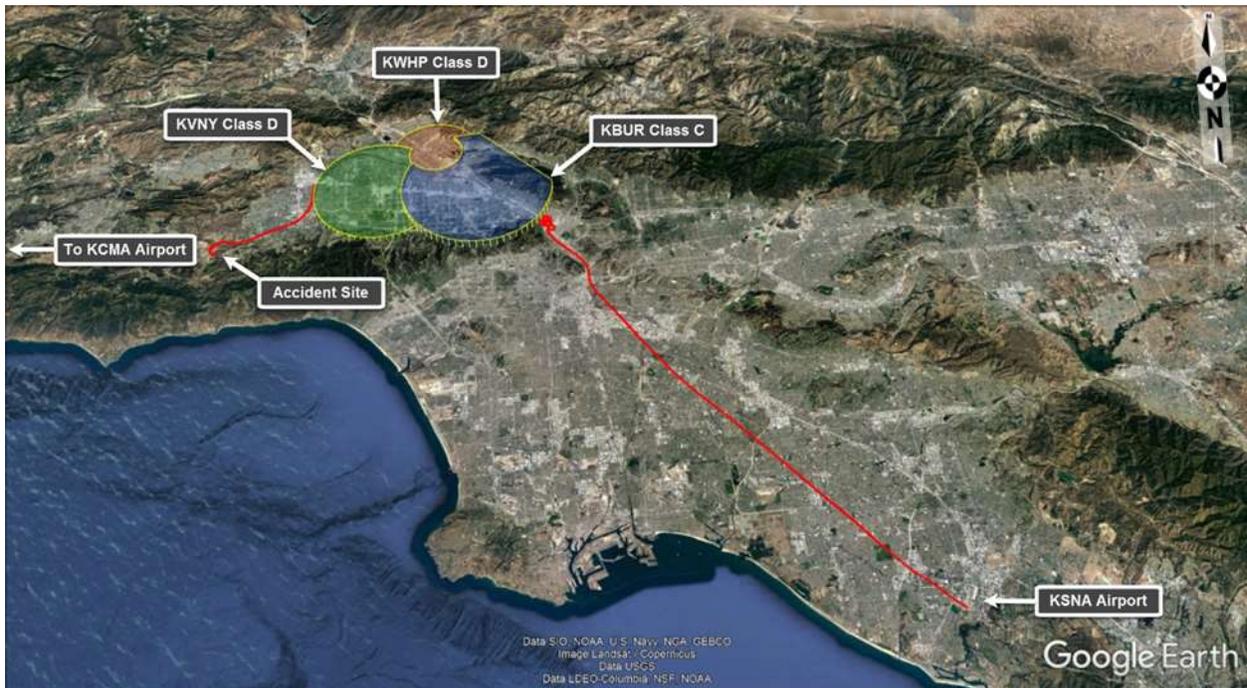
Radar/ADS-B data indicate the aircraft was climbing along a course aligned with Highway 101 just east of the Las Virgenes exit. Between Las Virgenes and Lost Hills Road, the aircraft reached 2,300 feet msl (approximately 1,500 feet above the highway, which lies below the surrounding terrain) and began a left turn. Eight seconds later, the aircraft began descending and the left turn continued. The descent rate increased to over 4,000 feet per minute (fpm), ground speed reached 160 knots. The last ADS-B target was received at 1,200 feet msl approximately 400 feet southwest of the accident site.

Figure 2a. Overall Radar/ADS-B track of N72EX

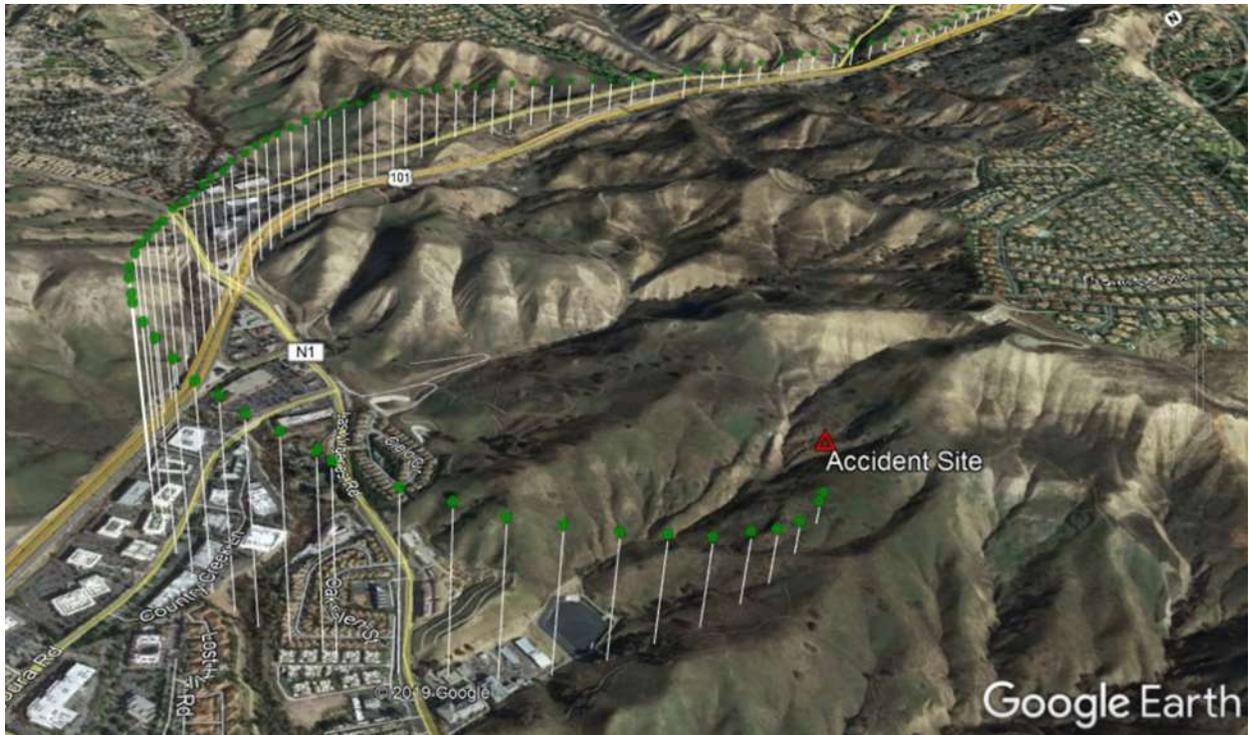
Figure 2b. Zoomed in depiction of ADS-B returns of last 1 minute of flight.

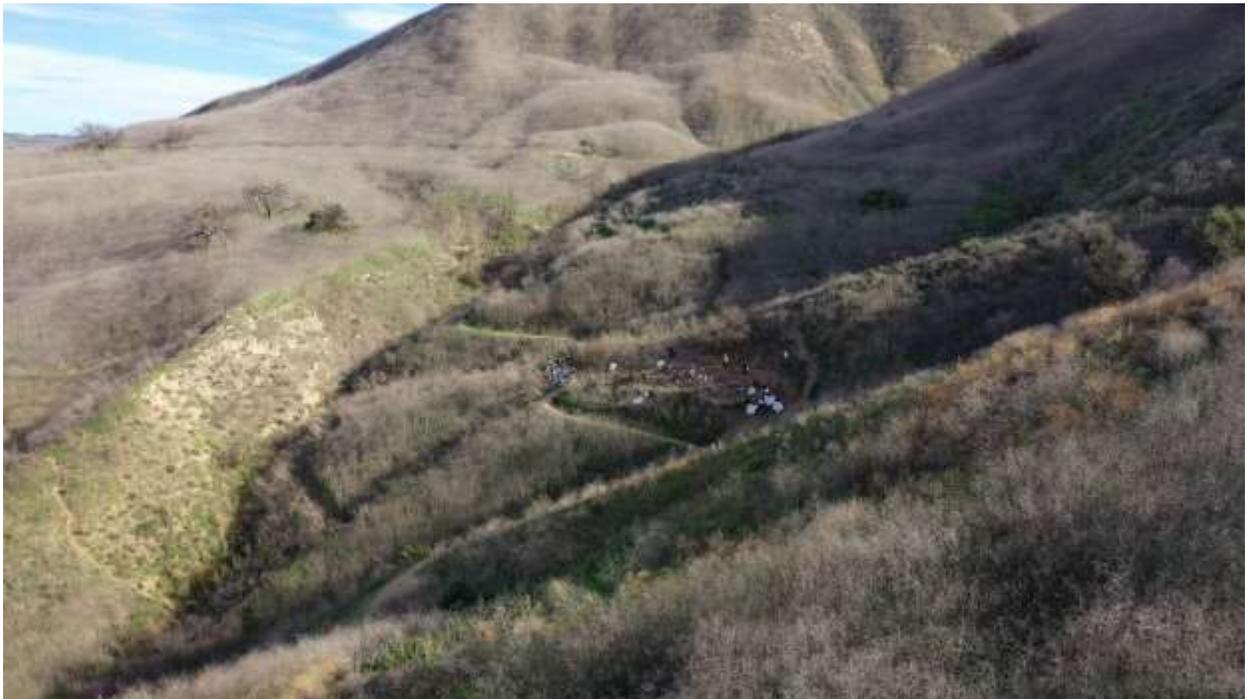
Figure 3. Still image from drone video duplicating the flightpath of N72EX at position/altitude of last ADS-B target

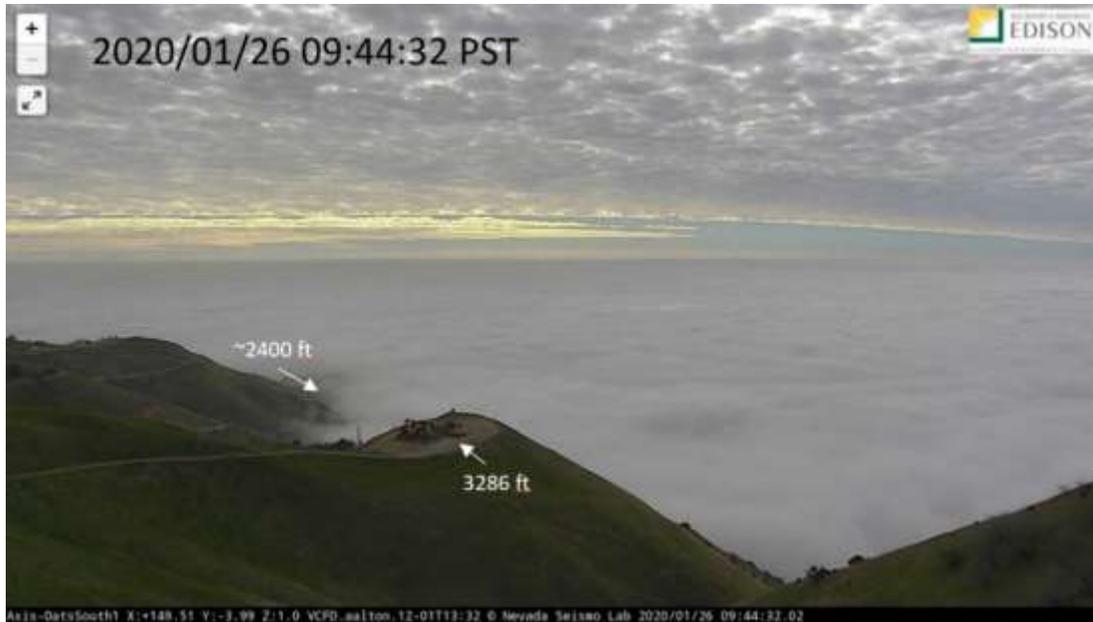
An ALERTWildfire camera image (figure 4) taken at 0944 PST looking southeast toward the city of Van Nuys, as publicized on the National Weather Service (NWS) Los Angeles Twitter account, depicted the top of the cloud layer to the east of the accident site. The NWS analyzed the top of the cloud layer to be about 2,400 feet above mean sea level near the terrain in the foreground of the image.

Figure 4. Camera image from 0944 PST

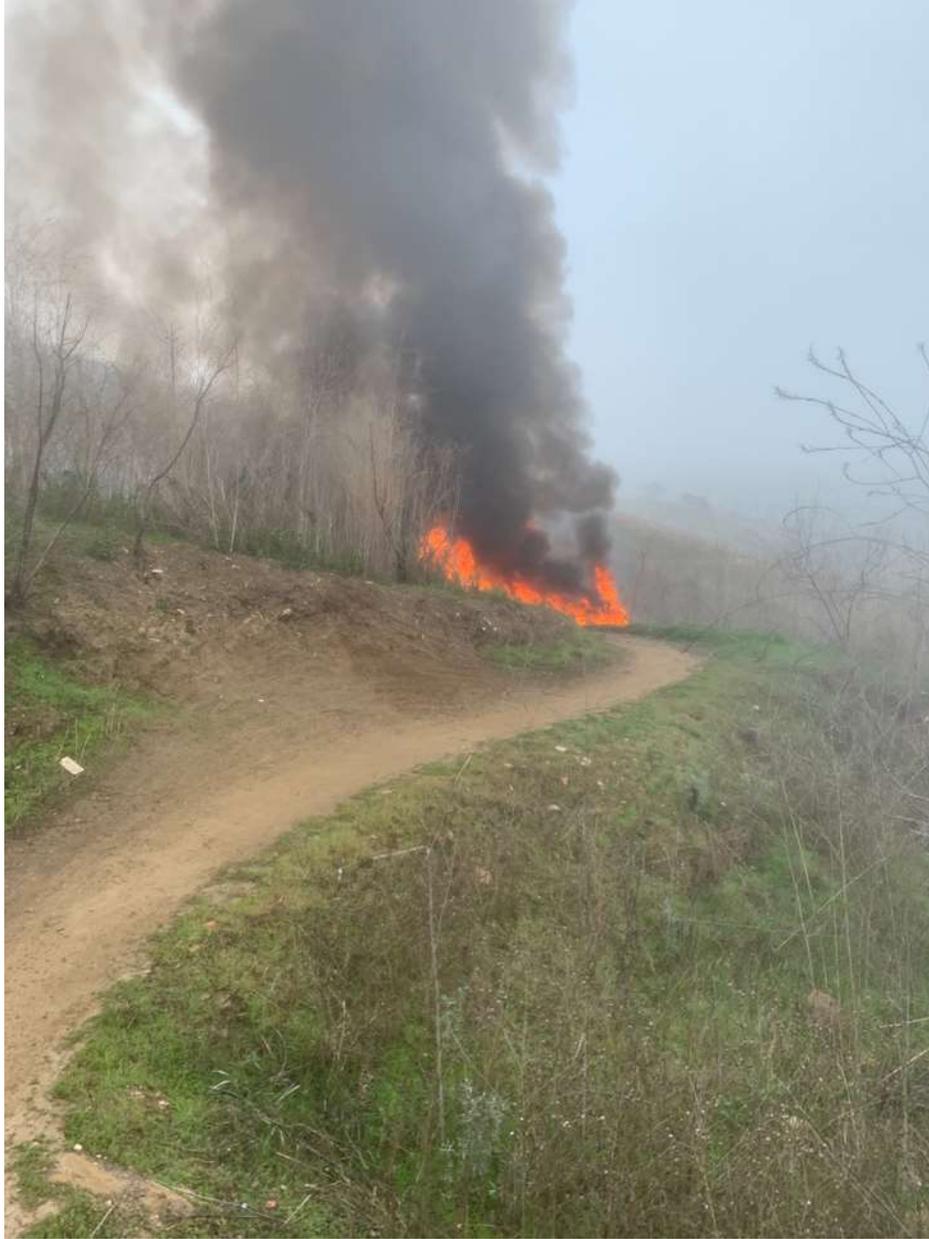
Videos and photos taken by the public in the area of the accident also depict fog and low clouds obscuring the hilltops. Figure 5a was taken by a witness on the mountain bike trail about 0950. The witness stated that the area was surrounded by mist. He said he began to hear the sound of a helicopter, which he described as appropriate for a helicopter flying while in a powered condition. He perceived the sound getting louder and saw a blue and white helicopter emerge from the clouds passing from left to right directly to his left. He judged it to be moving fast, travelling on a forward and descending trajectory. It started to roll to the left such that he caught a glimpse of its belly. He observed it for 1 to 2 seconds, before it impacted terrain about 50 feet below his position.

Figure 5a. Witness photo of accident site and weather conditions.

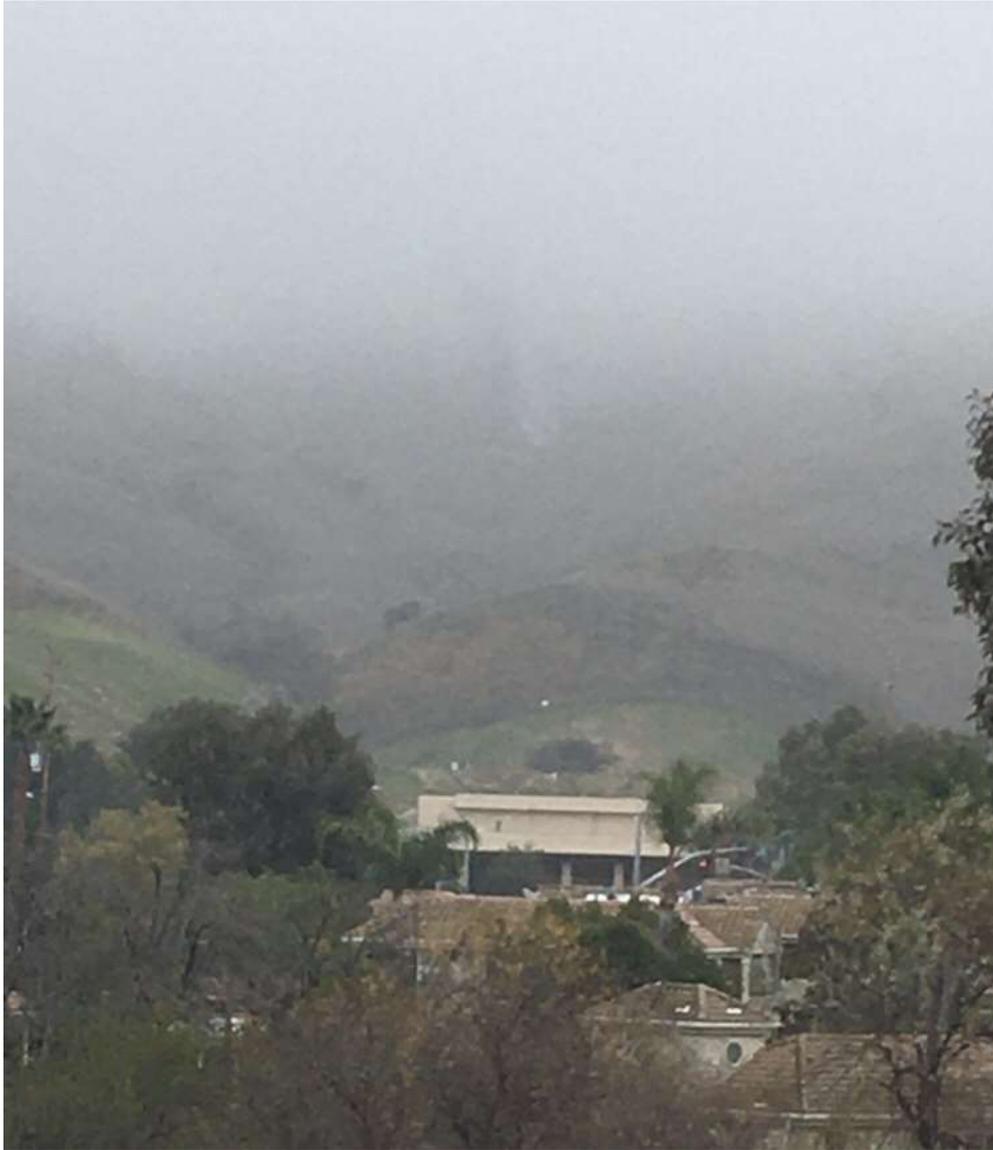
Figure 5b was taken by a nearby resident about 5 minutes after the accident from a location about 4,000 feet west of the site at an elevation of 750 feet msl.

Figure 5b. Resident photograph.

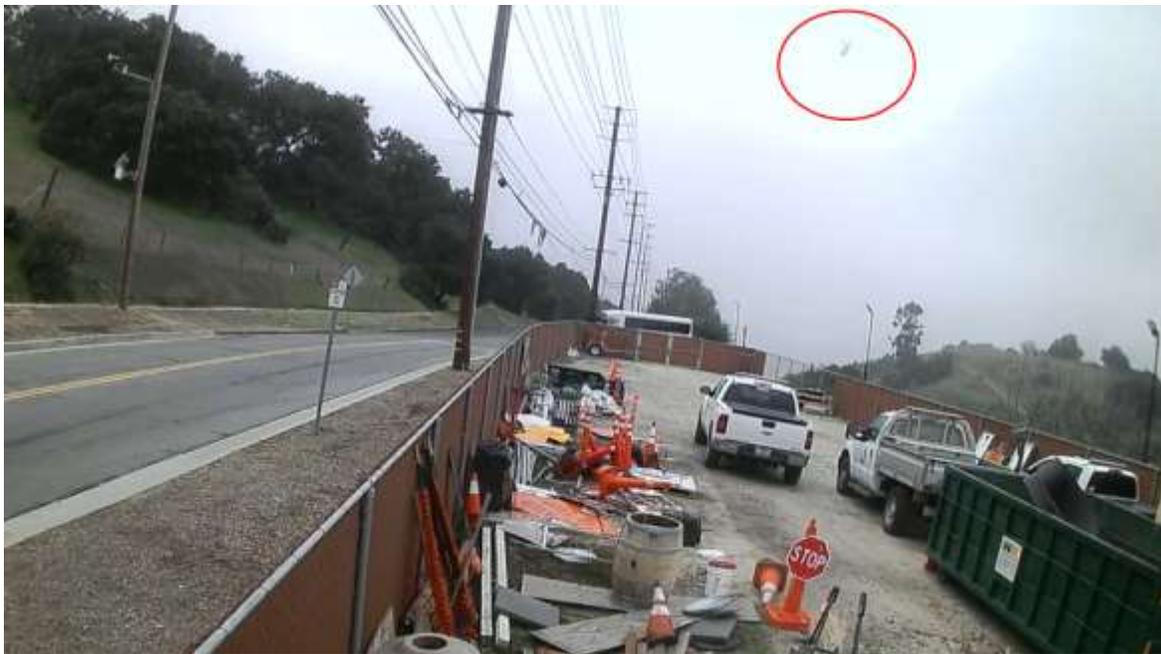
Figure 6 is a still frame from a security video obtained from a road maintenance yard adjacent to Moreau Road and Highway 101 depicting the helicopter proceeding westward along the highway and disappearing into the clouds.

Figure 6. Still frame from security video showing N72EX flying into clouds (circled in red)
