Fishing Vessel Safety Digest 2010

MARINE ACCIDENT INVESTIGATION BRANCH

This *Safety Digest* draws the attention of the marine community to some of the lessons arising from investigations into recent accidents.

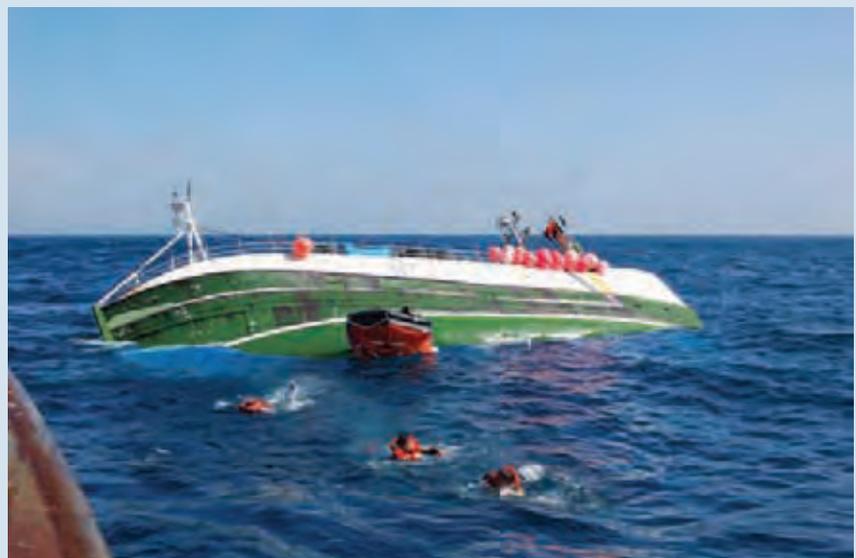
Figure 1

Without the vessel being available to inspect, the cause of the flooding is a matter of speculation. However, the rate of flooding calculations suggested that a 60mm diameter hole or comparable split would have caused the conditions which led to the foundering. The skipper was unable to see the source of water ingress, which suggested that it was under the engine room floor plates, below the water level. It is noteworthy that the main engine sea water cooling system used 60mm diameter pipes.

- 1 Investigate bilge level alarms on every occasion. It is all too easy to become complacent and switch on the bilge pump without identifying the cause of the alarm.
- 2 Use suitable components when penetrating watertight bulkheads so as to maintain, so far as is practicable, the watertight integrity.
- 3 Consider fitting extended spindles to sea valves that are not already required by regulation to be fitted, and regularly check the condition of related pipework.
- 4 Ensure that all bilge pumps, including hand-operated emergency pumps, are maintained ready for immediate use.
- 5 Conduct regular emergency drills.
- 6 Consult MGN 165 (F) – Fishing Vessels: The Risk of Flooding. This publication, which is available on the MCA’s website, provides comprehensive advice on flooding prevention measures, and makes essential reading.

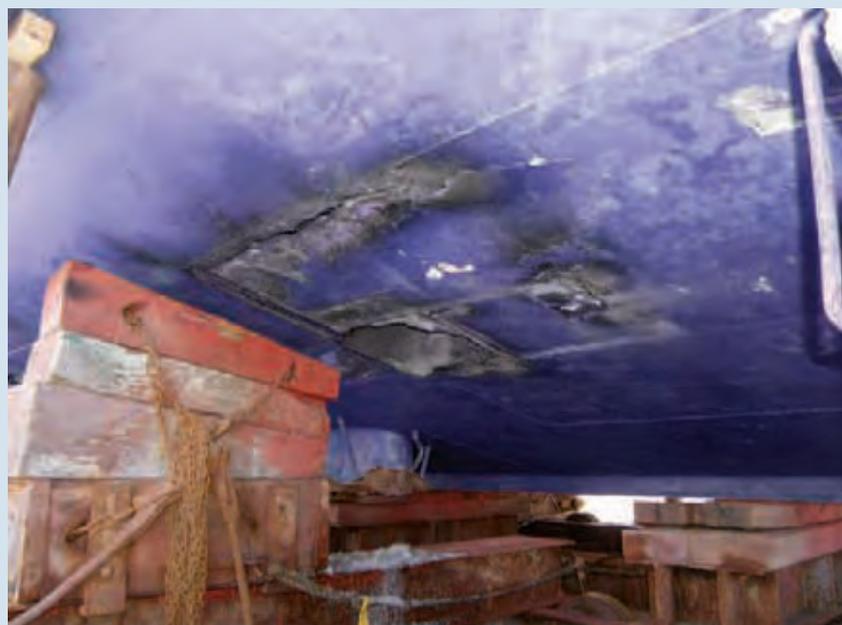
Port control contacted the vessel when it was no longer held on radar, and the skipper advised them that he had grounded. The crew checked for water ingress; none was found. The skipper decided to wait for a rise in tide before attempting to refloat, and 12 minutes later the vessel was afloat. The skipper and mate carefully made their way back into the harbour, this time making use of the chart plotter. On their arrival, the coastguard noticed a considerable amount of pollution in the vicinity of the propeller, and the decision was taken to remove the vessel to a nearby slipway.

Some of the damage caused by the grounding

2 There was no heading readout available because of the defective satellite compass. This was the main factor behind the disorientation suffered by the skipper. The absence of essential navigational equipment, in this case a heading display, changes the risks involved in sailing. A further assessment of the risks should be made and, if necessary, sailing deferred until the equipment is repaired.

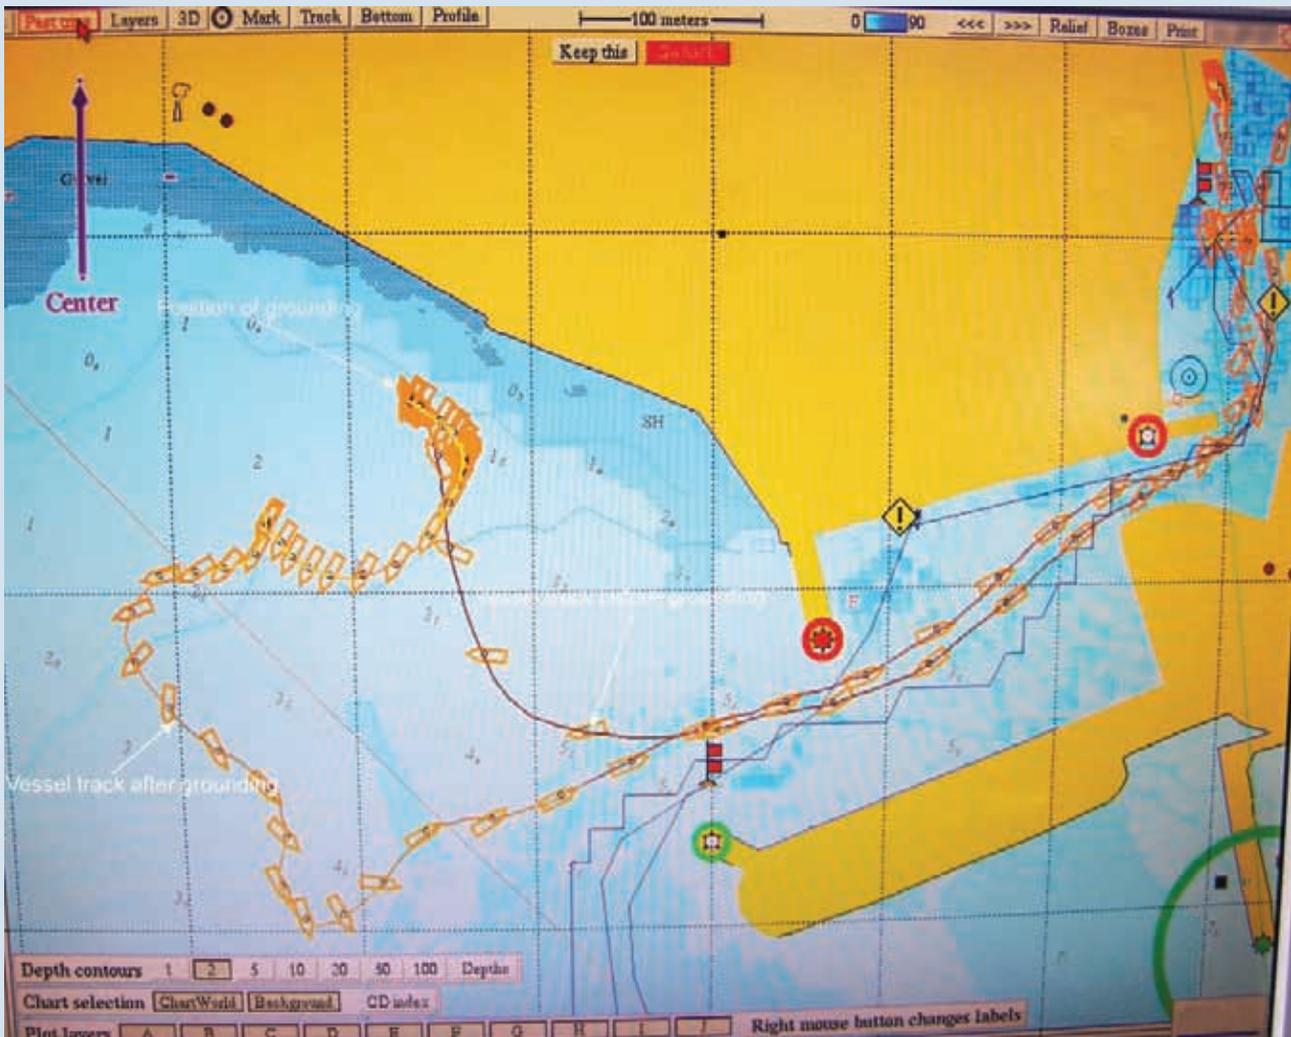
Vessel's track – recorded from electronic chart plotter

3 A probable reason for the rudder being applied hard to starboard was the location of the tiller next to the skipper. With his attention focused on looking for visual navigation marks, he had failed to realise that he had nudged the tiller over to starboard. Given the prevailing conditions, it would have been better to have a dedicated helmsman on the wheel, which would have allowed the skipper and mate to concentrate on navigating and looking out.

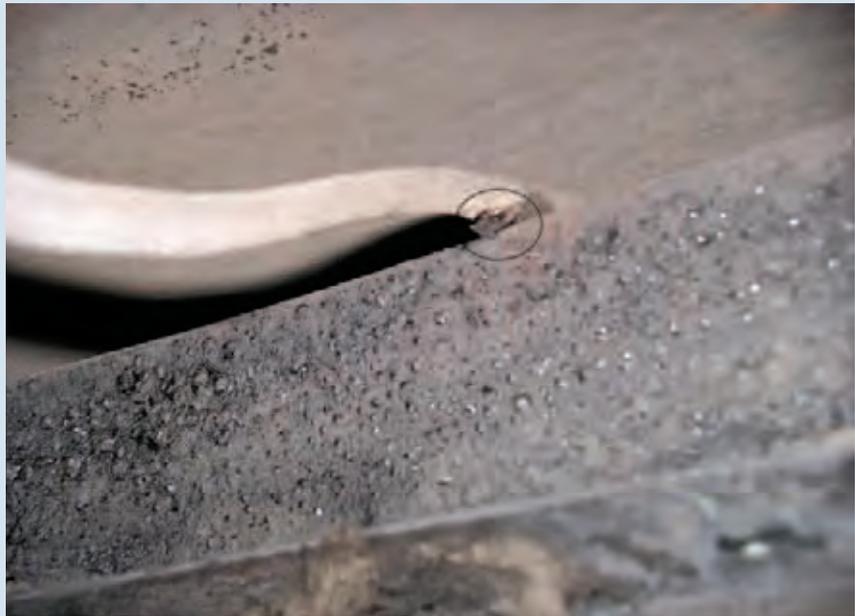
The fire was caused either by a short circuit where the electrical cables were draped over the non-continuous bulkheads, or by an overheating electrical device belonging to one of the crew. It caused widespread damage throughout the accommodation area, alleyways, galley and mess room. The 220 volt electrical distribution panel outside the engine room access was totally destroyed (Figures 3, 4 and 5).

Figure 1: Cable chafing

- 3** Make sure that fire detection systems are always fully functional. Test them regularly – especially before sailing – and repair any defects without delay.

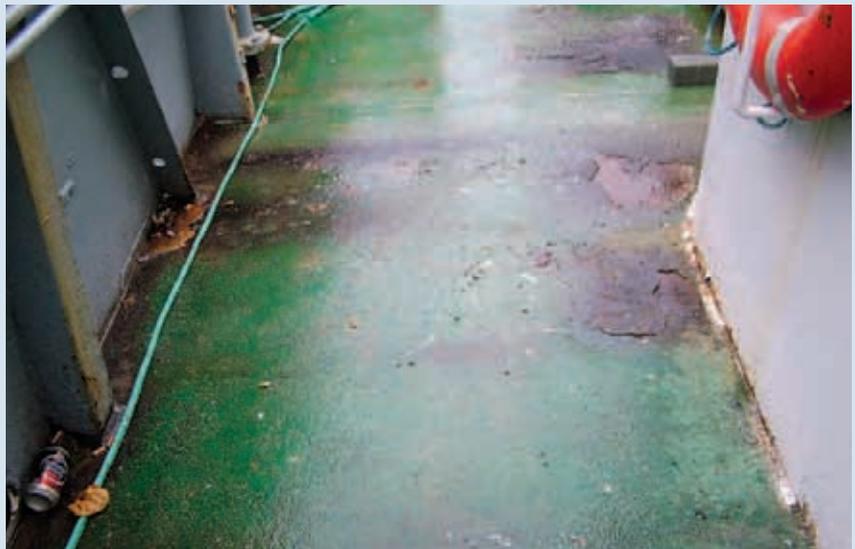
Figure 2: Blistering of the paint on the main deck

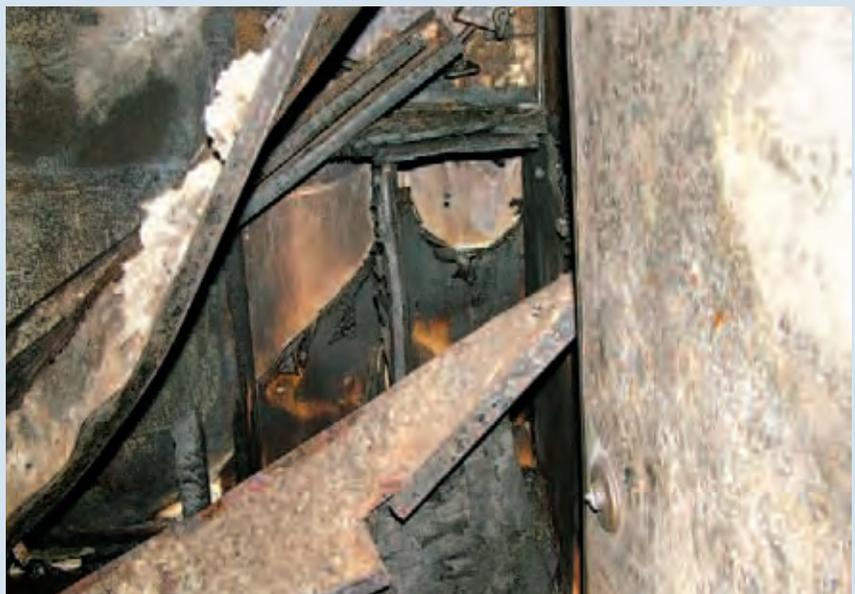
Figure 3: Cabin damage

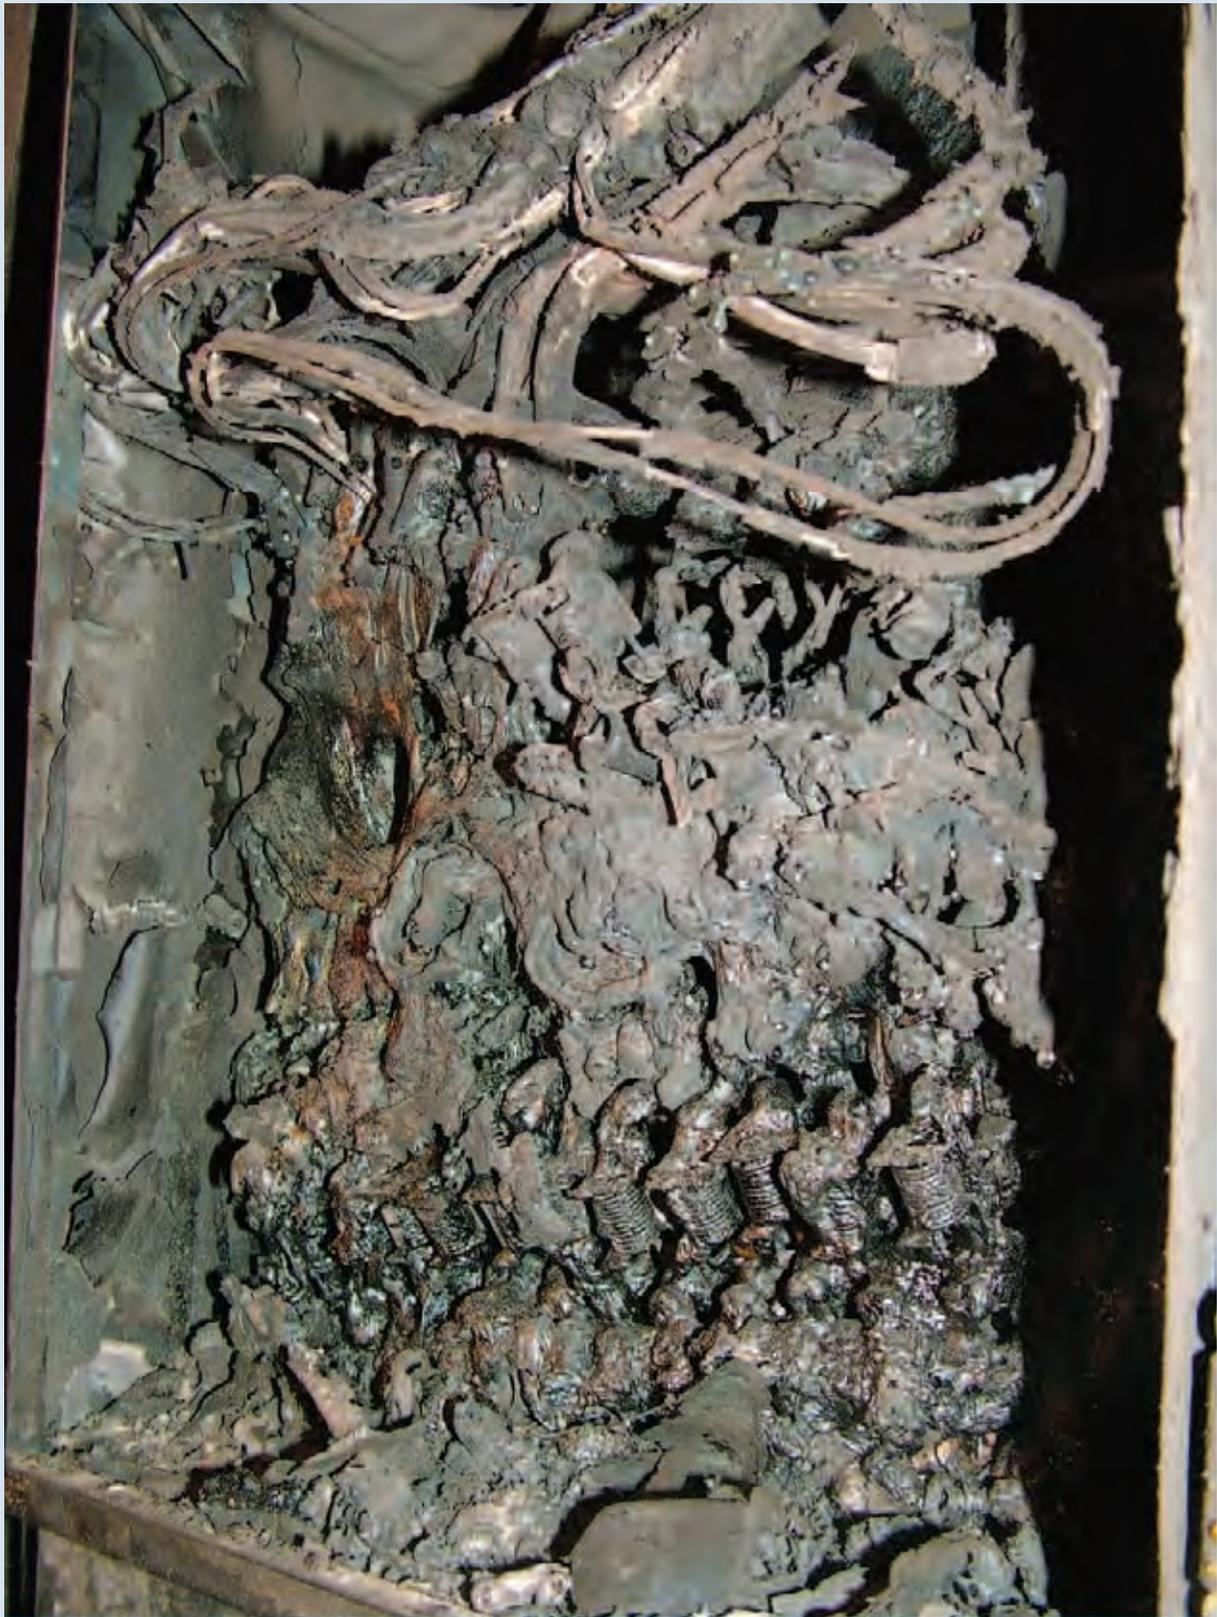
Figure 5: Damage to the 220v distribution panel

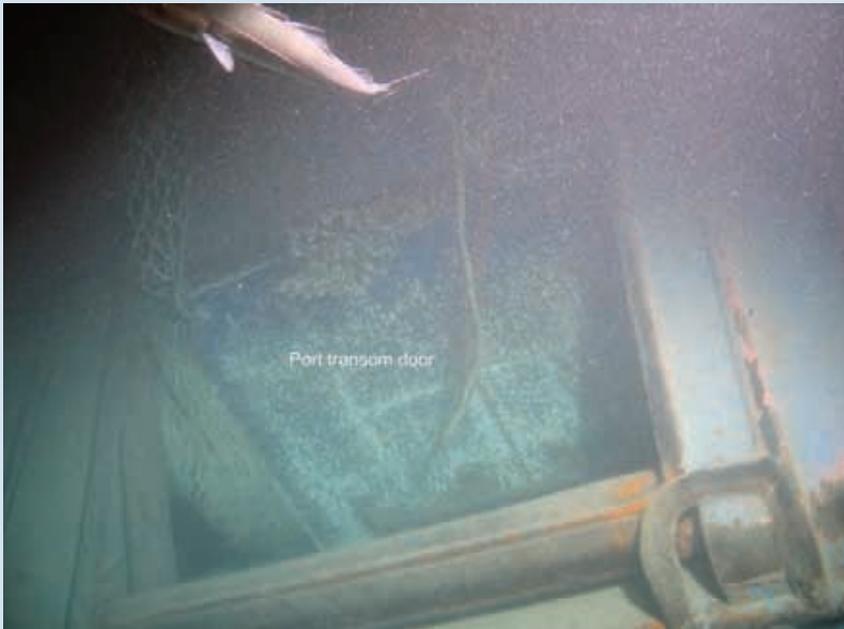
A port list quickly developed, and this worsened as water continued to pour in. The crew's attempts to close the door using the hydraulic ram were thwarted when the ram became damaged by a green sea, and the door could no longer be closed.

Figure 1: Port transom door open on wreck

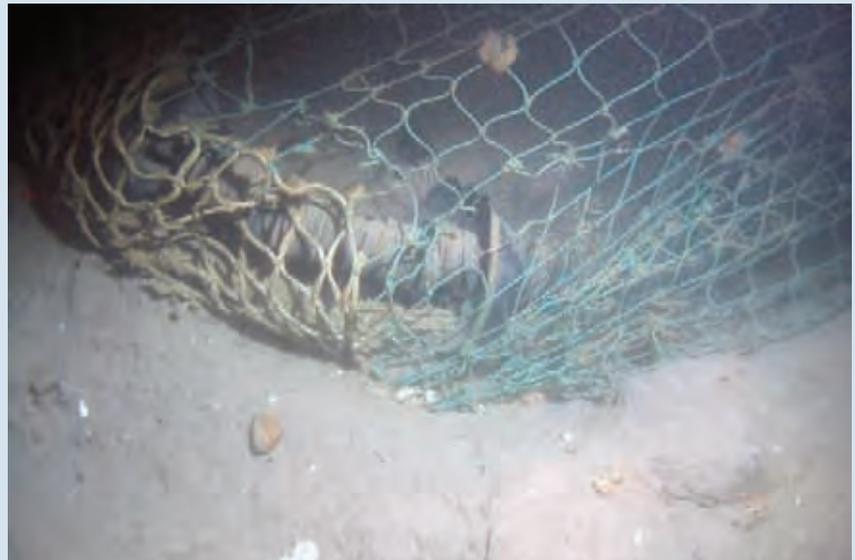
Figure 2: Trawl gear embedded into mounds of boulder clay

7 Although the trawl warps were cut, this required the crew to fetch and operate a grinder. It would have been better to have had a quick and reliable means of releasing the brakes available, preferably integrated into the winch system or, failing that, a simple manual method. Such considerations should be included in the vessel's risk assessment, and a practical method of releasing the gear made known to all crew members.

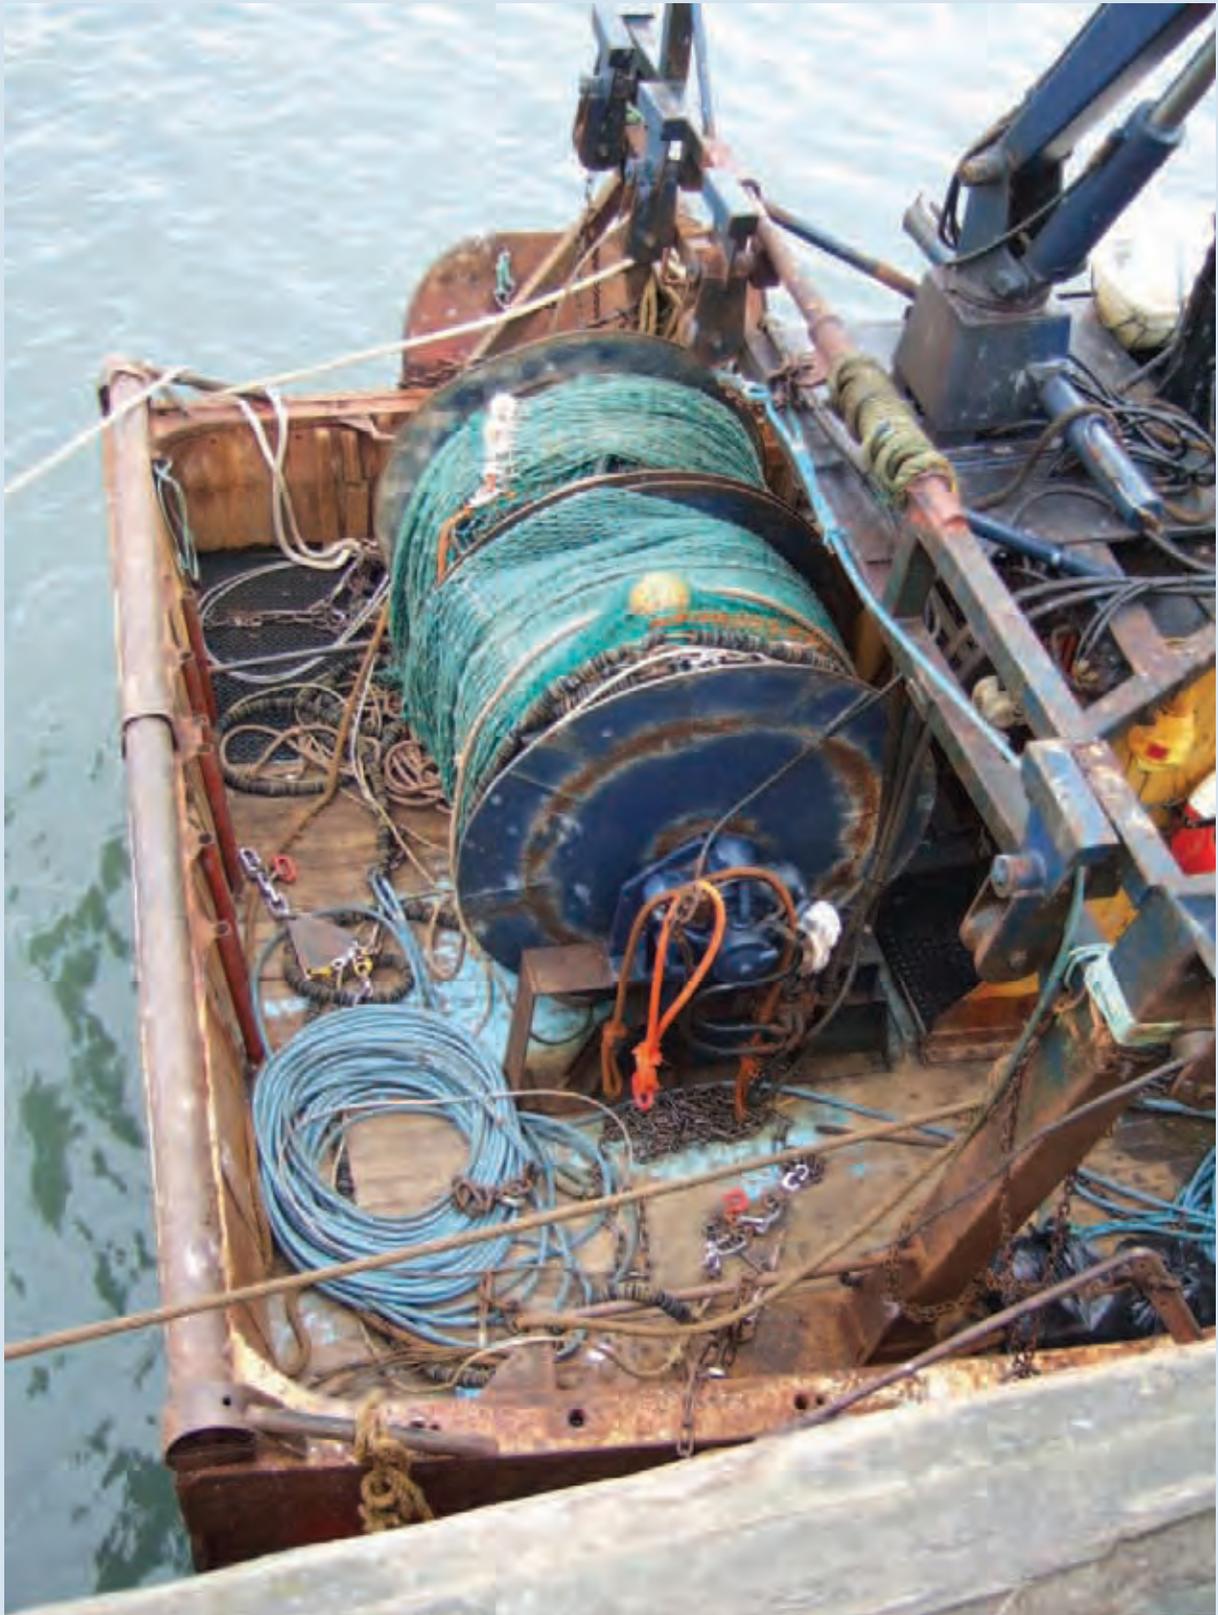
As the weight came on the wire, both stoppers parted and the crewman in the bight of wire was lifted off his feet and thrown overboard. He was not wearing a lifejacket or buoyancy aid.

Figure 1: Vessel's net drum and aft working area

4 No one on deck was wearing a lifejacket or buoyancy aid. The wearing of lifejackets or buoyancy aids will make the difference between life and death for many man overboard casualties; it is very strongly recommended that crew working on the deck of a fishing vessel routinely wear them.

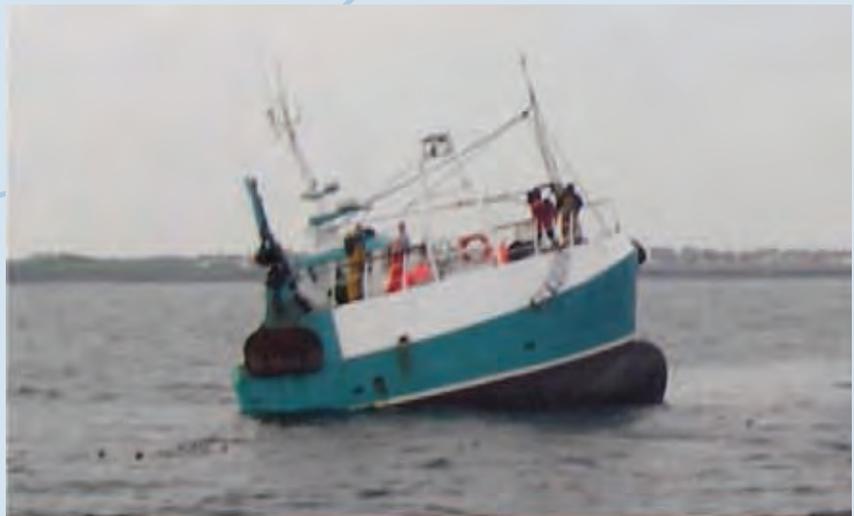
prawns. The autopilot was on, and the boat steamed across the fairway to the port – one used by high speed ferries – to strike a well marked isolated rock, about half a mile off its home port. They were lucky; nobody was injured, and the boat lodged itself in place on the rock. The RNLI lifeboat was with them in minutes. However, the boat was seriously damaged, and repairs meant that she was out of service for weeks – so much for keeping fishing, and that bumper haul of prawns!

The vessel aground 0.5 mile from port

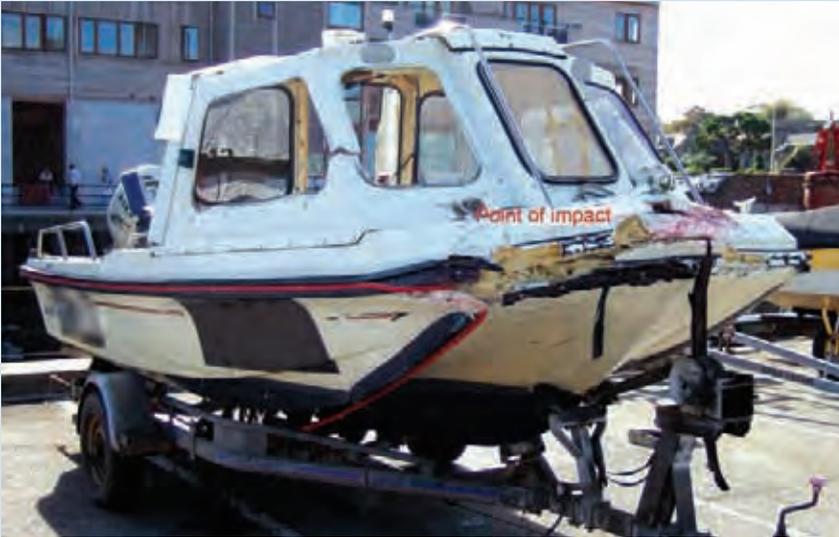
Figure 3: Damage to bow of the dory

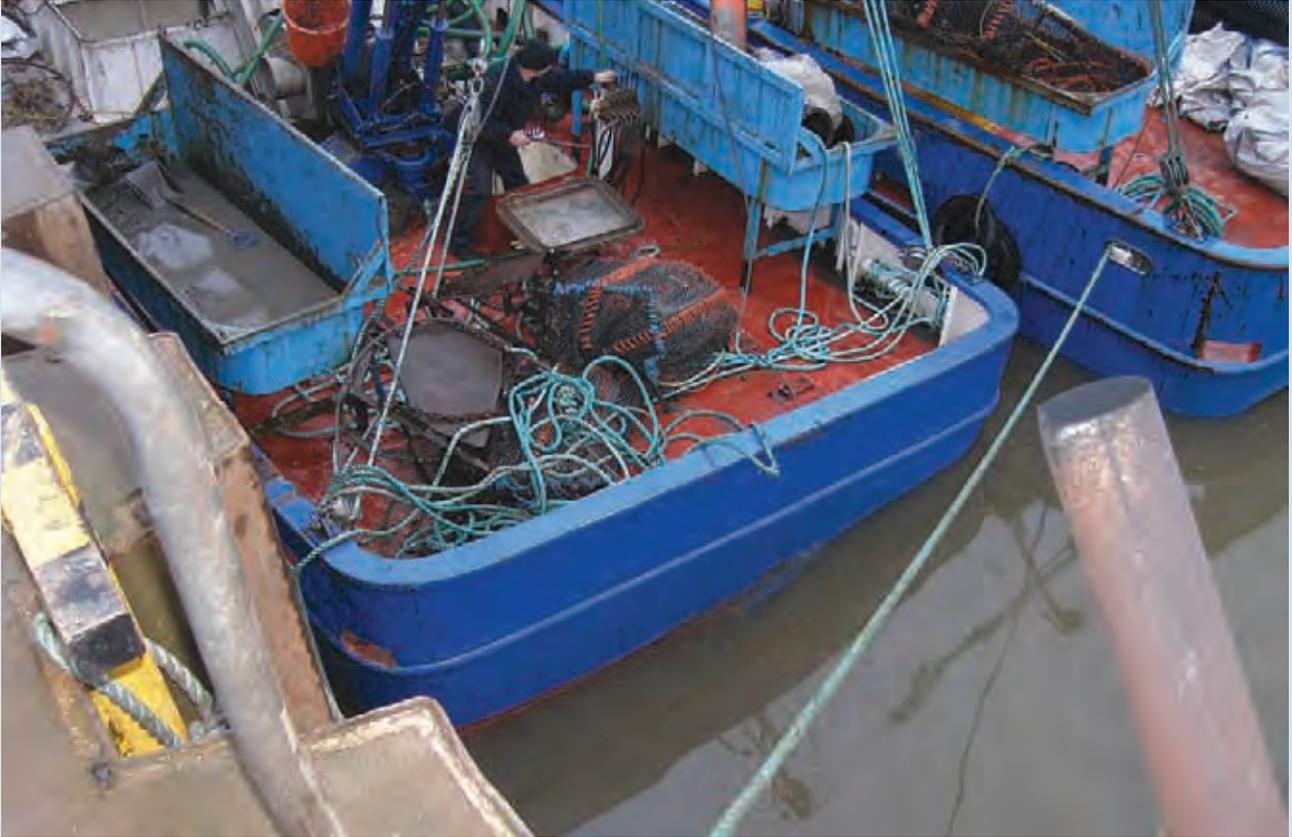
Figure 2: View of stern showing limited freeboard

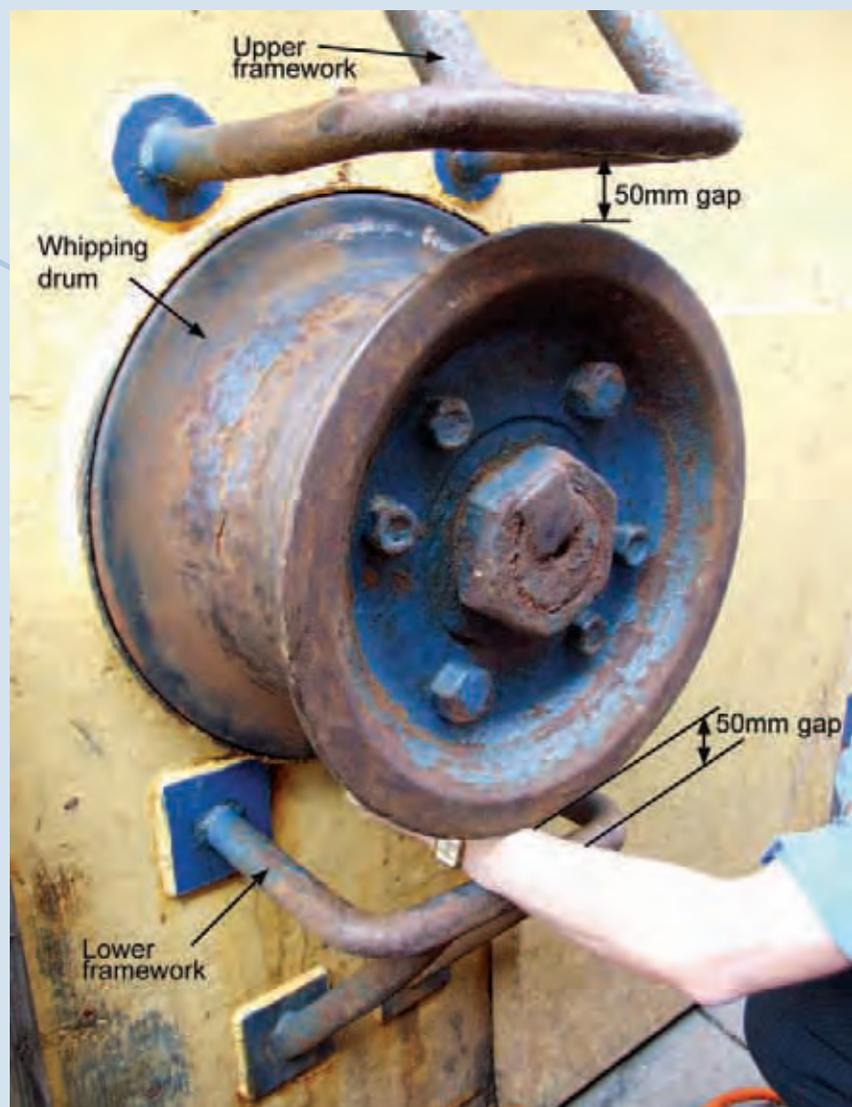
Figure 1: Port whipping drum with demonstration of an arm in the gap between winch head and lower framework

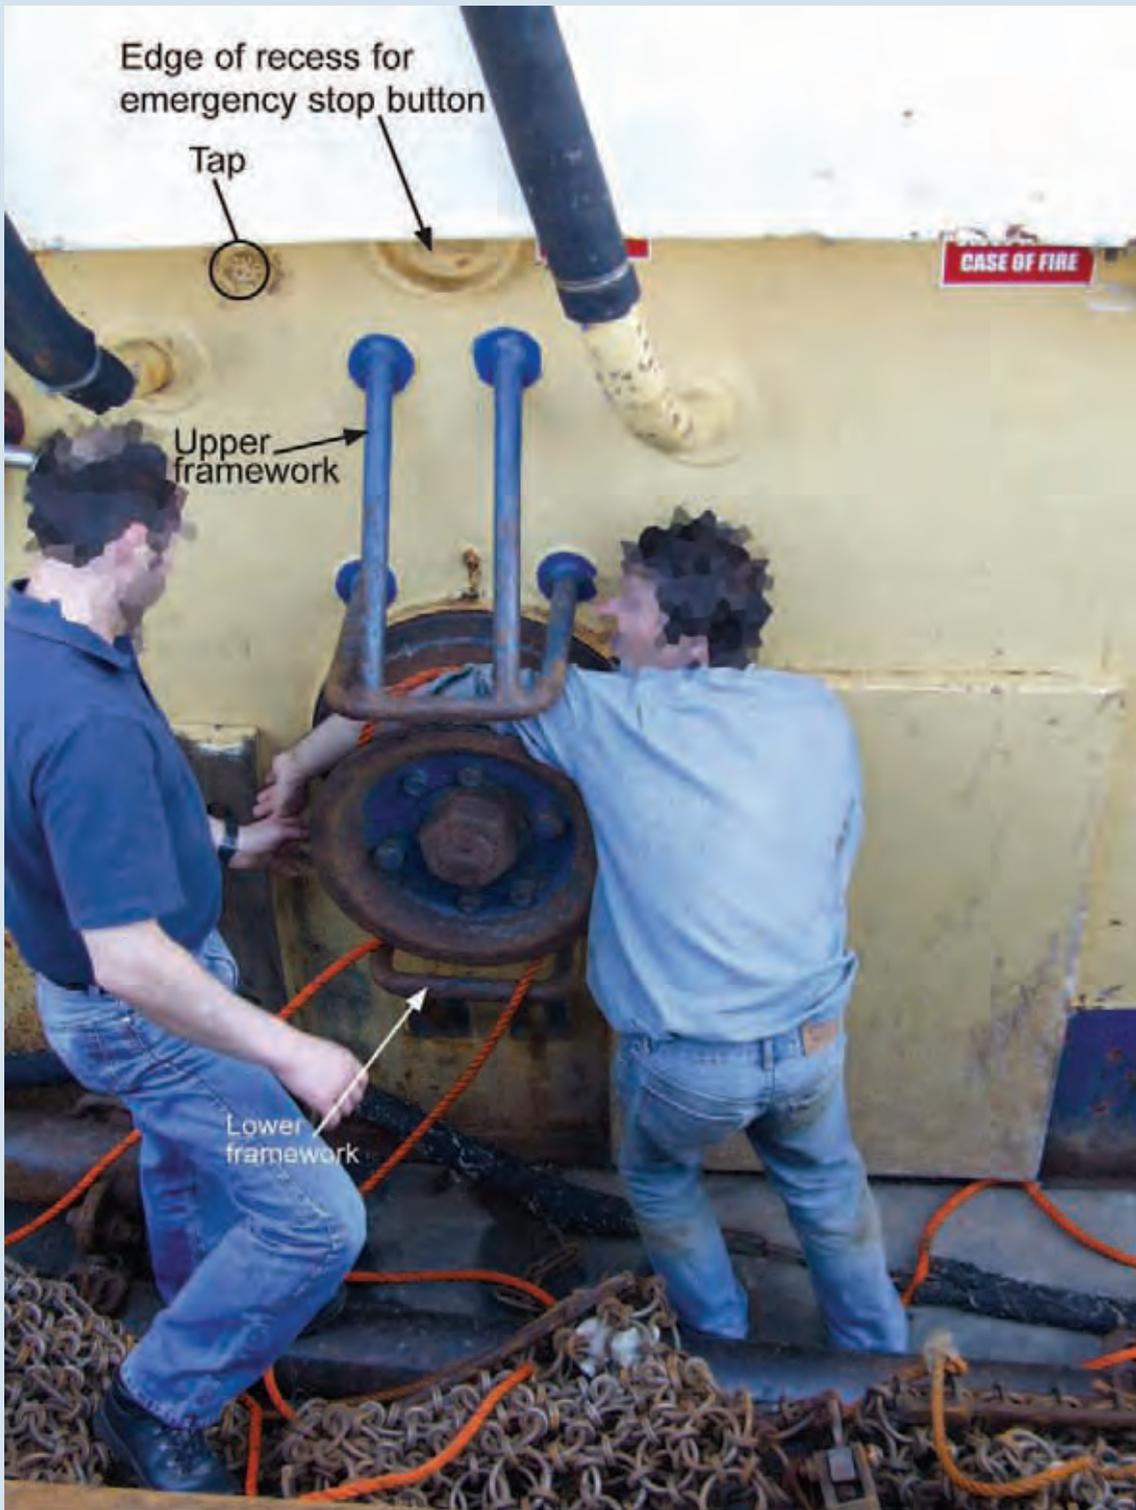
Figure 2: Demonstration of “as-found” position of deckhand, trapped in whipping drum

As he approached the winch, he slipped on the recovered dredging gear lying on the deck and, as he fell, his left hand became caught in the rope between the winch head and the lower framework. He was subsequently dragged twice round the whipping drum and framework, effectively performing two backwards somersaults, and on both occasions was unable to reach the stop
