MAIB TRILOGY REPORT

Korenbloem

Osprey III

Optik

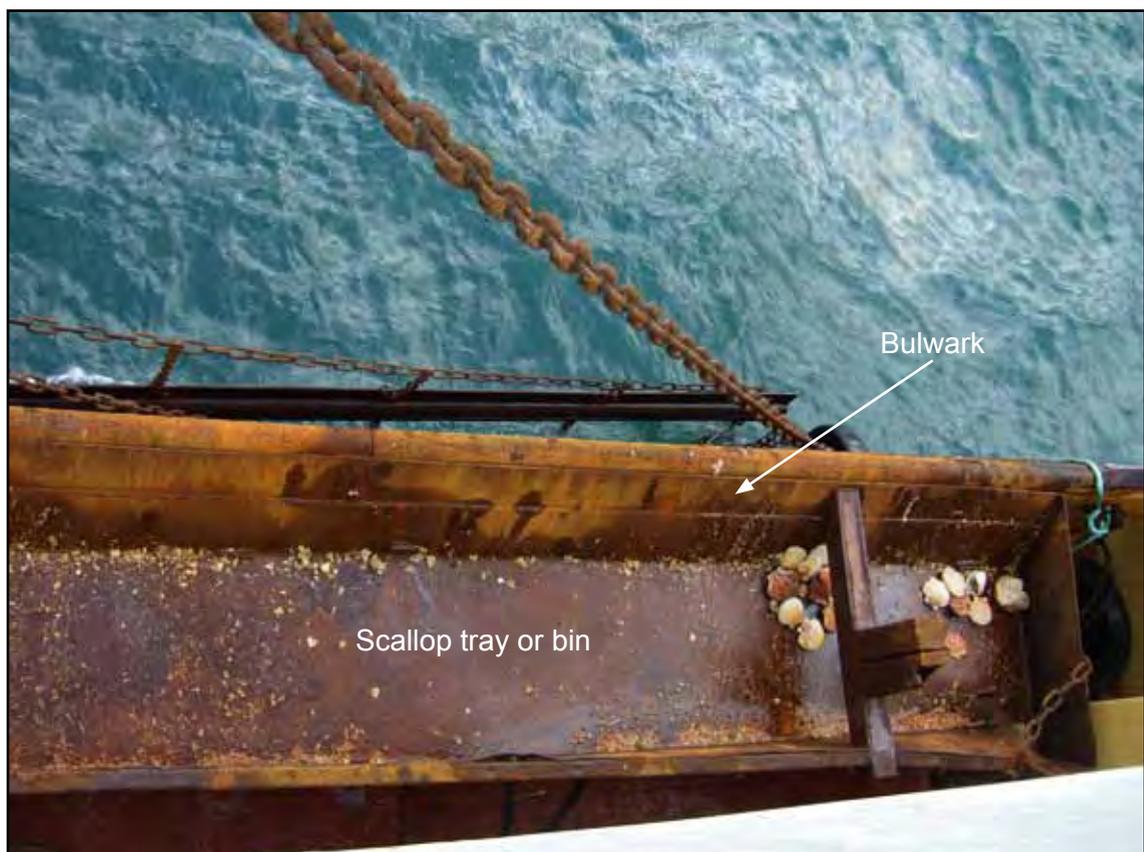
Figure 1

Korenbloem is a beam trawler with the ability to carry out either white fishing or scallop dredging depending on the fishing gear fitted. At the time of the accident she was working as a scallop dredger, operating 12 dredge bags on either side. At the end of each haul the dredge bags, which were suspended between the towing beams and tipping bars, were emptied into long trays (bins) adjacent to the bulwarks by lifting the tipping bar using the gilson winch. During hauling and shooting the gear, deckhands had to climb on top of the bins to attach or detach the gilson clips. The top edges of the bins were nearly at the same height as the bulwarks (**Figure 1**).

Scallop trays or bins adjacent to the bulwark

Korenbloem was surveyed twice in 4 years, and inspected once annually. However, the potential hazard posed by fitting the scallop bins flush with the bulwark was not identified during these surveys.

In practice, the bins extended the bulwark inboard and, as such, did not pose a hazard until anyone climbed on top of them to operate the gilson clips. As the bins are removed during the surveys, it is understandable that the danger of falling into the sea from the bins was not readily apparent to the attending

In order to appreciate the implications of fitting additional equipment, such as bins, it is necessary for the surveyor to see them in place. Therefore, it would be prudent for surveyors to insist on seeing the vessel in the 'ready to sail' condition during surveys and inspections.

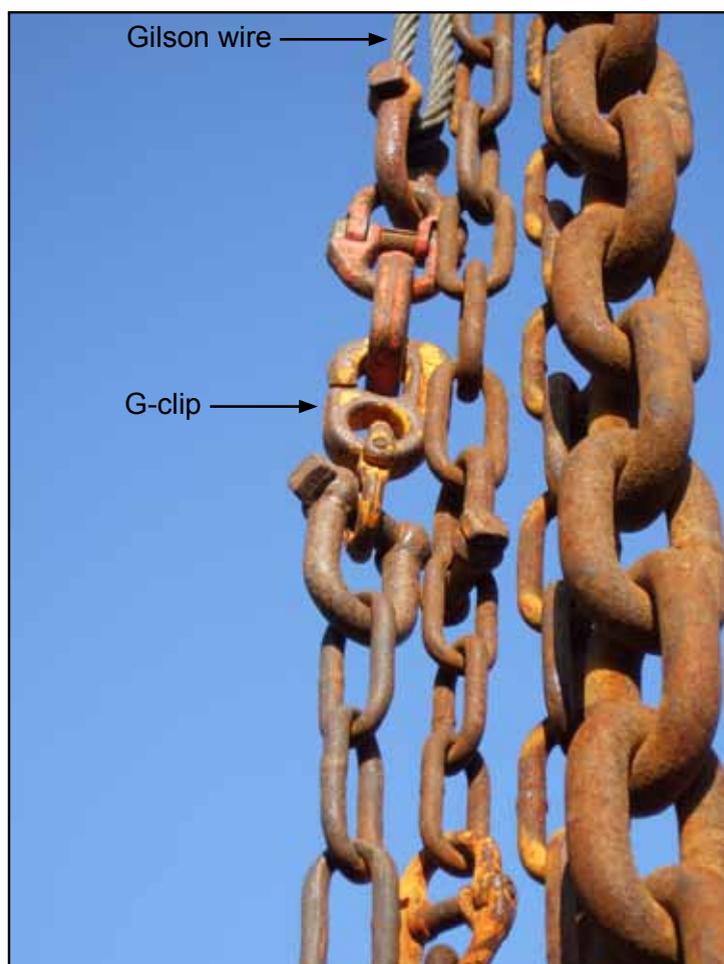
Figure 4

Gilson wire with G-clips

The risks associated with standing on a catch of scallops, without any guardrails or restraints, to unhook the Gilson G-clips were obvious and those risks were multiplied by the vessel's movement in rough weather. The acceptance of such working practices as routine demonstrates an unacceptably high tolerance of risk. In this instance the risk became reality, and a man lost his life. There is no need for such unsafe working practices to go unchallenged; skippers and crews, supported by the owners, must start taking more responsibility for their own safety if the fishing industry is to reduce its high fatality rate.

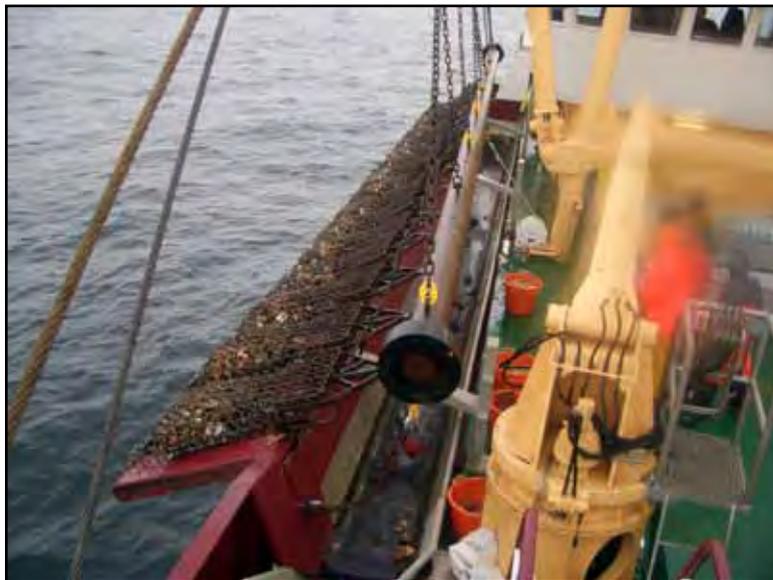
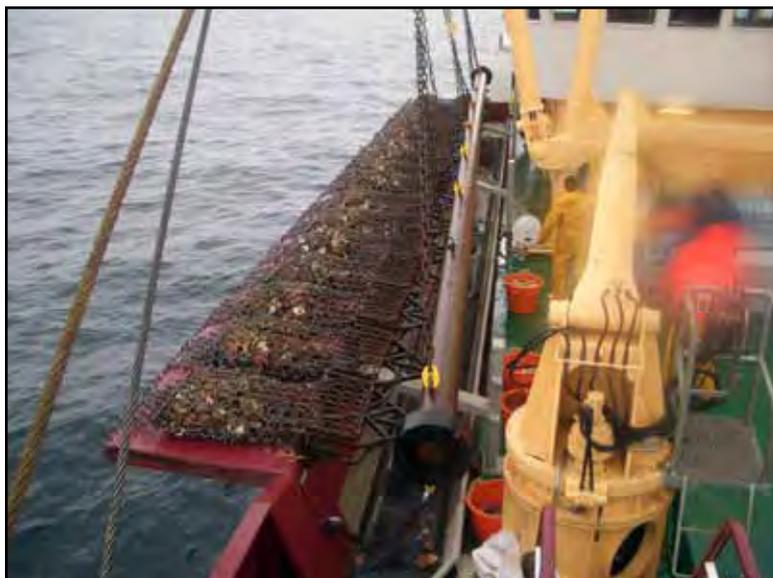
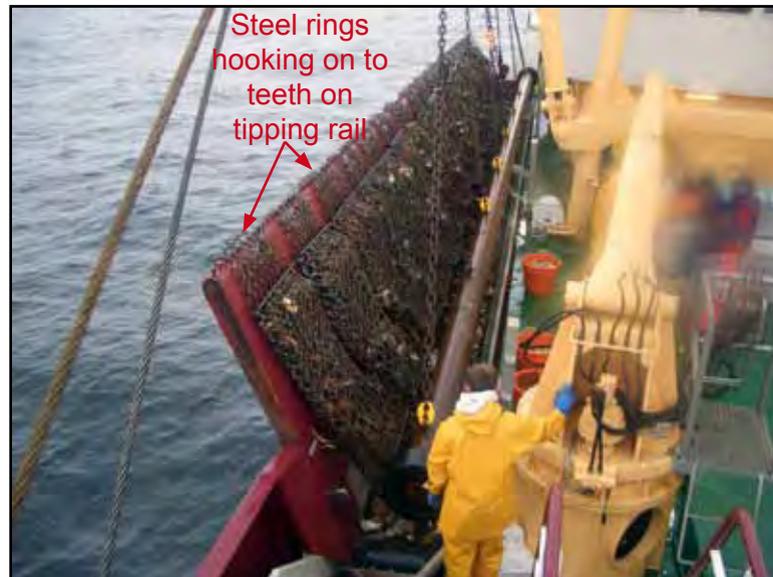
The tipping rail system is a recent innovation implemented in several of the larger Scottish scallop dredgers, which eliminates the need for a tipping bar and gilson to invert the dredge bags. The tipping rail is, effectively, a second movable bulwark which rotates to lift the dredge bags. Steel rings attached to skirts at the bottom of the dredge bags hook on to teeth protruding from the tipping rail as it is raised, inverting the bags over the bins. The tipping rail is hydraulically rotated and is controlled from the bridge so the crew can remain clear of the moving equipment (**Figures 8a, 8b, 8c**). Some fishing vessel owners have tried other means of tipping the dredges, but none of them have achieved the same level of safety as the tipping rail system.

Tipping rail mechanism

The tipping rail system is a recent innovation, and it is possible that as the industry gains experience of its use it will find new hazards which have not yet been identified. However, at present the tipping rail system appears to significantly improve crew safety compared with existing systems.

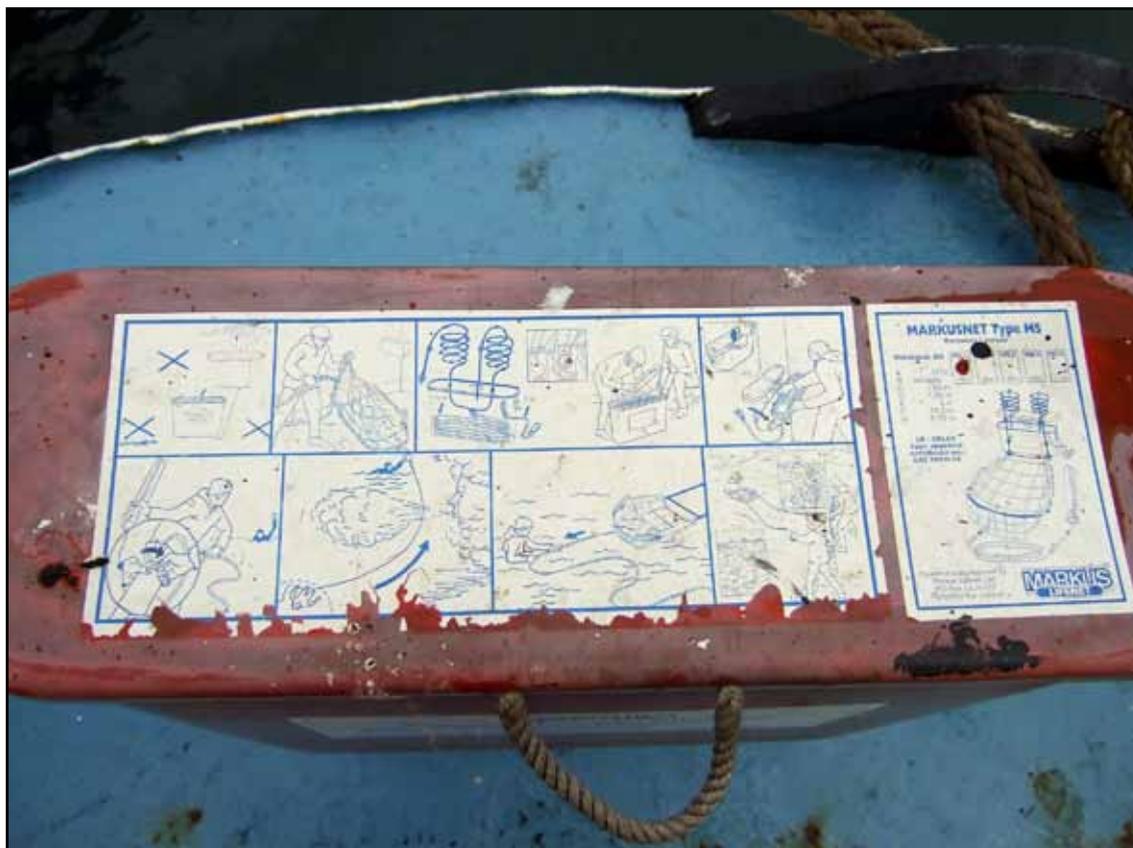
Figure 9

The MOB recovery system on *Korenbloem* was a Markus Net. The crew was unfamiliar with it and did not know how to use it. The model on board was a 'Markus MS2' which had a 14m attachment line, a 20m lifting line on the inner end, and a 25m throw line with a chest-loop (**Figure 9**). The net weighed 4kg and was enclosed in a portable storage container. The MOB could be lifted manually, or hoisted with a crane or winch in a standing, sitting or horizontal position. To rescue an unconscious person from the water, another person attached to a life-line had to enter the water and physically drag the casualty into the net.

Markus net

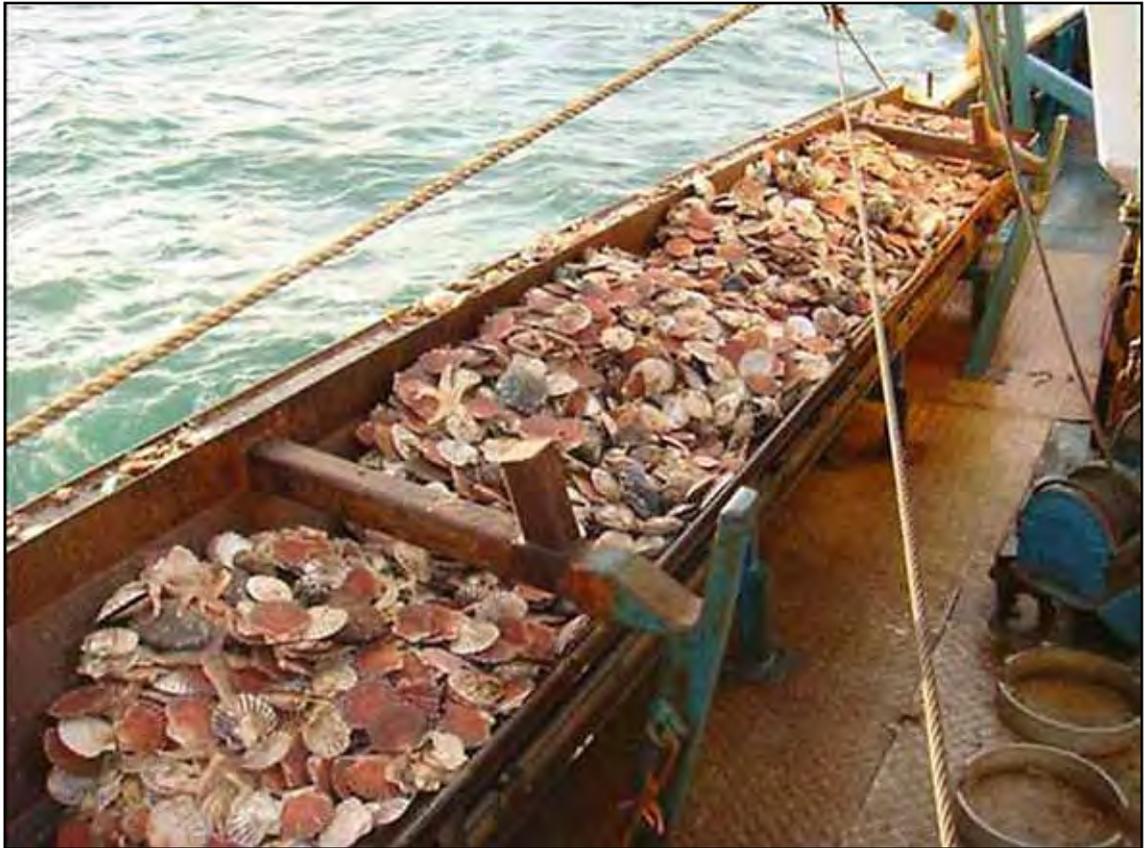
James Grindy was last seen, by the skipper, standing on the catch in the port bin waiting for the second crewman to join him so that he could unhook the gilson wire from the tipping bar chains. As there was no eye witness, it is not possible to establish the exact sequence of events immediately before and during the accident. It is unlikely that James was knocked into the water by the towing beam because it had already been lowered over the side ready for him to unhook the gilson clip. However, as the vessel's engine was stopped, the towing beams and tipping bars would have been swinging about considerably due to the roll of the vessel in a beam sea. The instinctive reaction of the skipper on seeing James in the water was to top the derrick out, indicating the beam was still quite close to the vessel's side when James fell in. Therefore, there is a very strong likelihood that either James fell between the vessel's side and the towing beam, or he ended up in that position while attempting to rescue himself. In any case the blunt object, which struck him, causing the *unsurvivable* injuries, was most probably the towing beam either crashing onto him or crushing him momentarily against the ship's side.

Heavy rain, possibly refracting the deck lights; severe rolling of the stopped vessel in a beam sea without the damping effect of the gear in the water; strong winds; having to stand on the wet and slippery catch (**Figure 12**); and obstructive metal partitions in the bin concealed by the catch, all contributed to making the activity of standing or moving on the bin an extremely dangerous one. In addition, it is possible that under the poor weather conditions, the skipper made an error of judgment and topped the gear out further than normal as he had no means of calibrating its position, except visually. In any case, the tipping bar suspended from the 'monkey face' and a slack gilson wire, would have swung like a pendulum as the vessel rolled. James, in reaching out to unhook the gilson clips, either could have over-extended himself and lost his balance, or more simply lost his footing, causing him to fall overboard.

Scallop tray or bin with catch (not from *Korenbloem*)

The most effective method of achieving a safe working environment is by the elimination of hazards. In the case of scallop dredging, this is not entirely achievable, and therefore the next best strategy would be to physically separate the crew members from the fishing gear during the most hazardous parts of the operation: shooting the gear and hauling in the catch. The tipping rail and conveyor system achieves this objective. On vessels where sorting bins are still in use, it is vital to ensure that the mandatory height of 1m provided by the bulwark is maintained at all times, and fishermen should not be required to climb up on the bins if there are then no further barriers between the bins and the open sea. If there is no alternative to working on the unprotected bins, a safety harness or similar safety device should be worn.

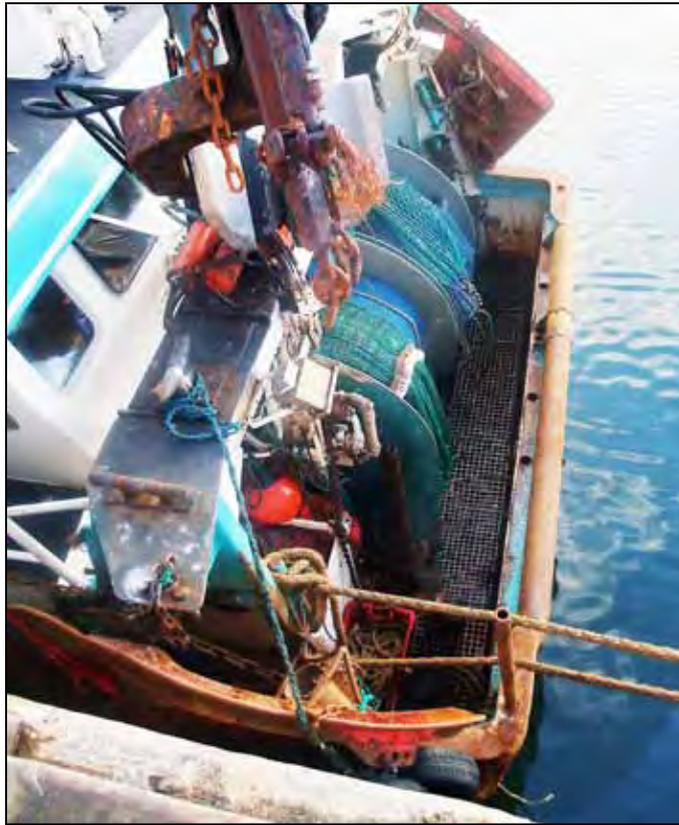
Figure 13

Photograph of the aft deck

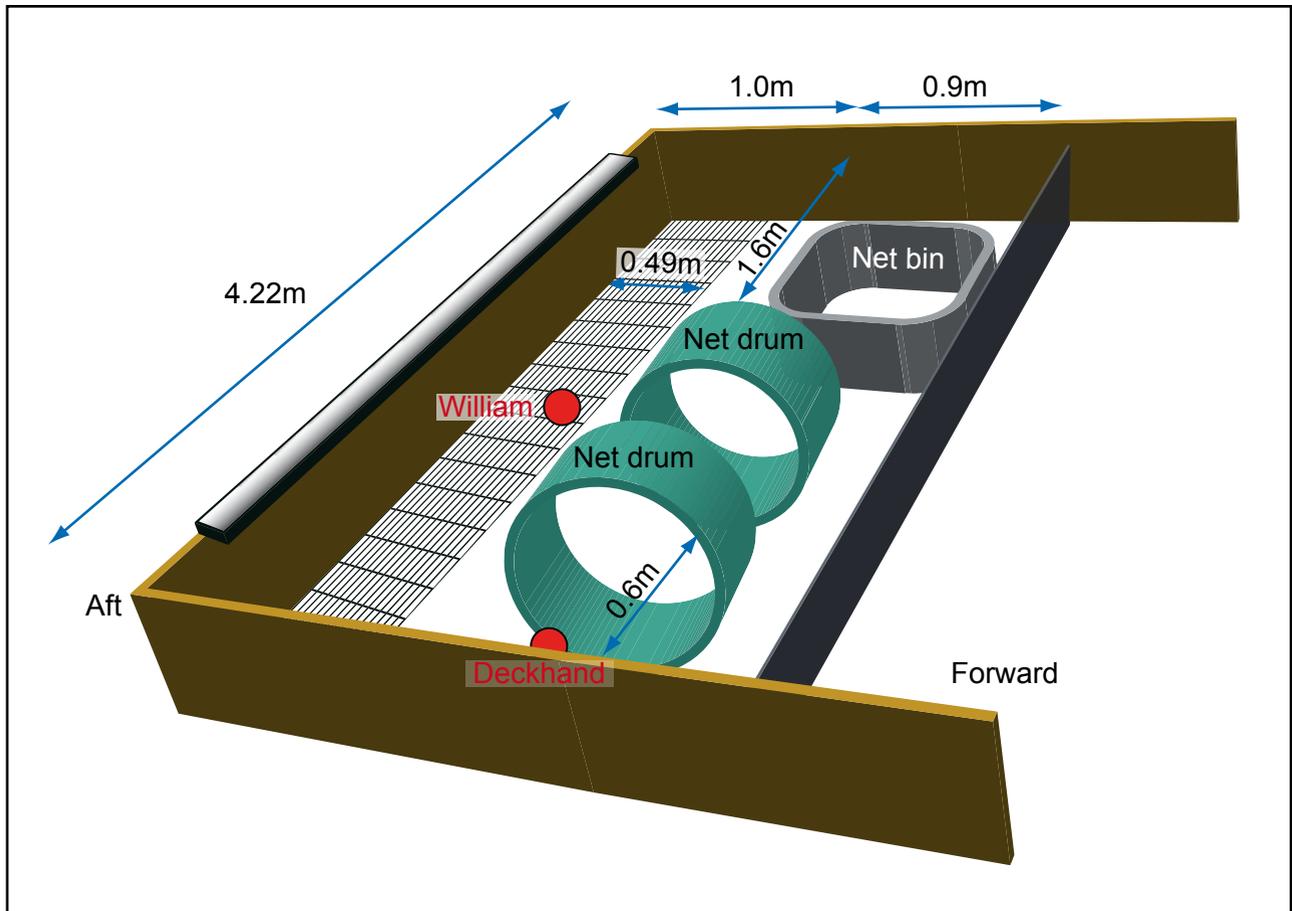
Figure 14

Diagram showing the position of deckhands

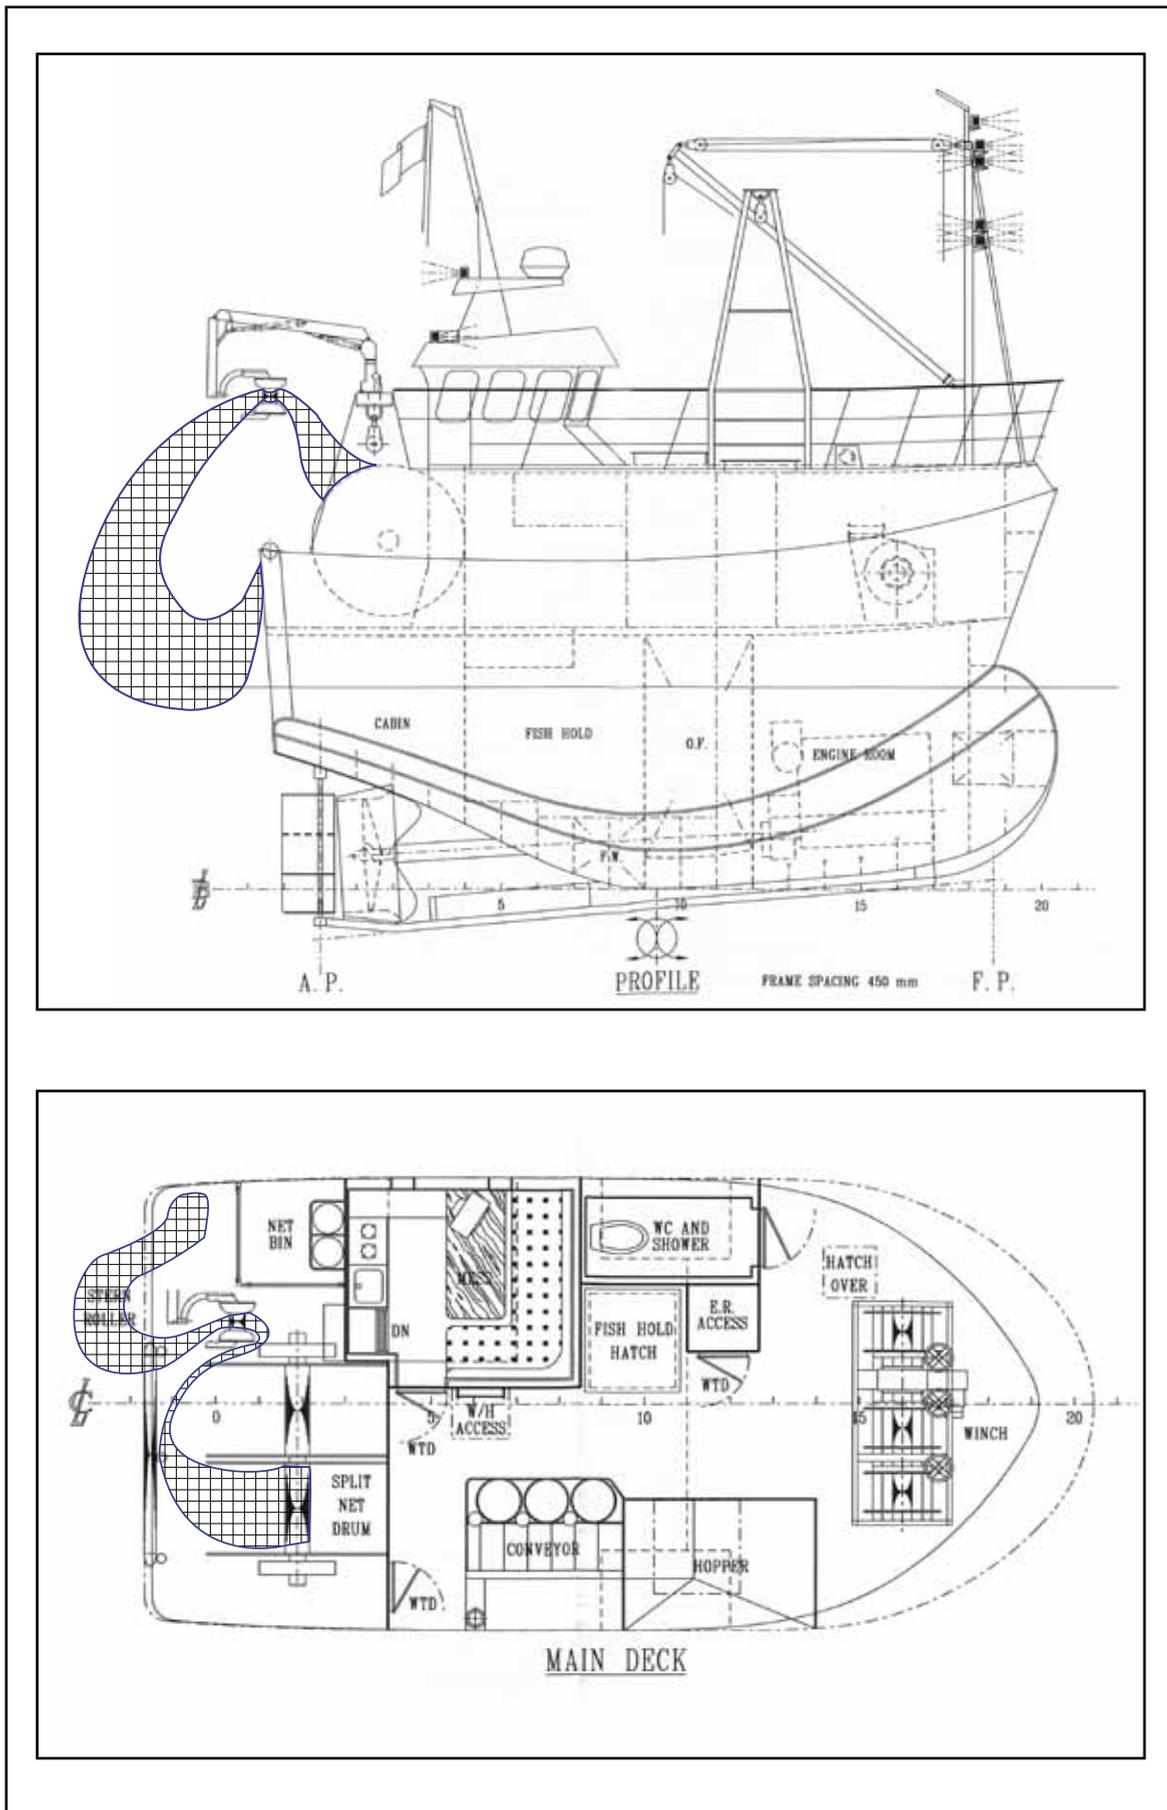
The skipper immediately pressed the manoverboard (MOB) button on the chart plotter. He also deselected the propulsion unit, which allowed him to haul in the net onto the drum at full power. As the net was hauled onto the drum, which took less than 1 minute, the other deckhand saw one of William's boots caught between the dog rope and the net.

Diagram showing arrangements when net entered the water

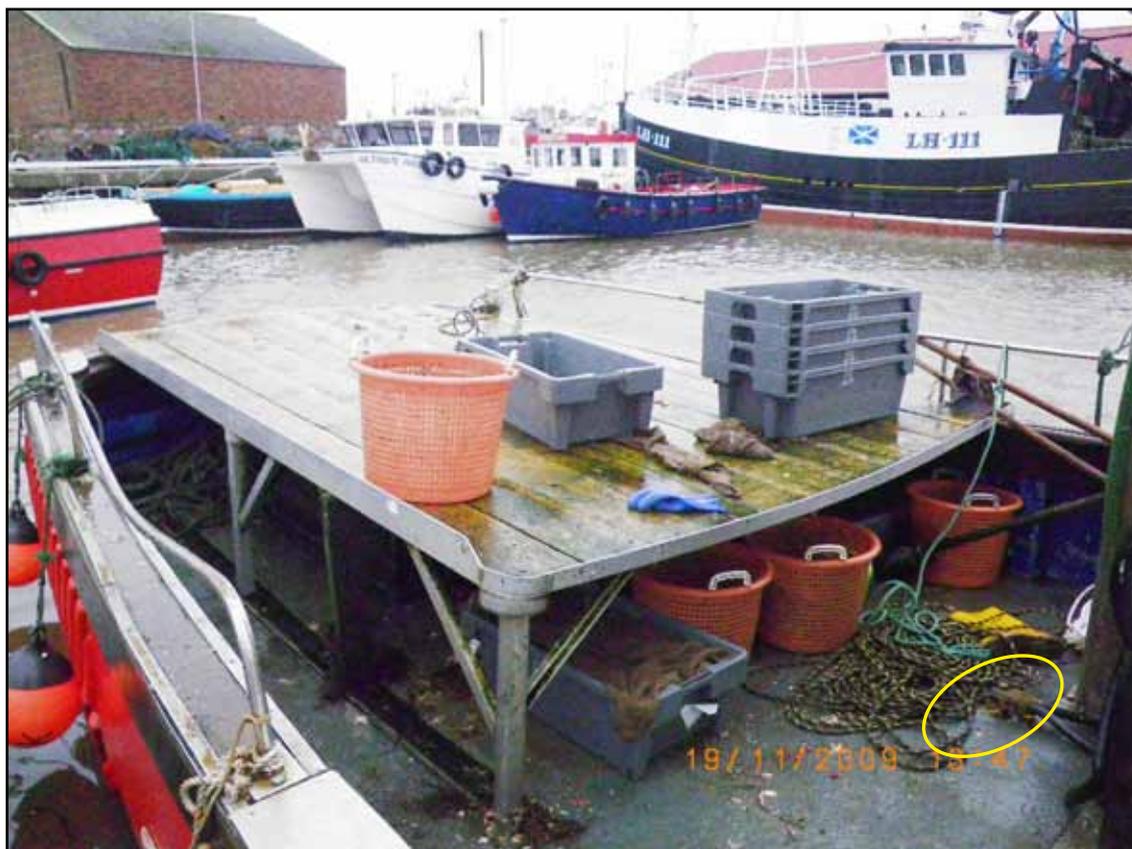
Optik's deck (after the accident) showing the approximate position of the crewman before he was dragged overboard by the rope shown

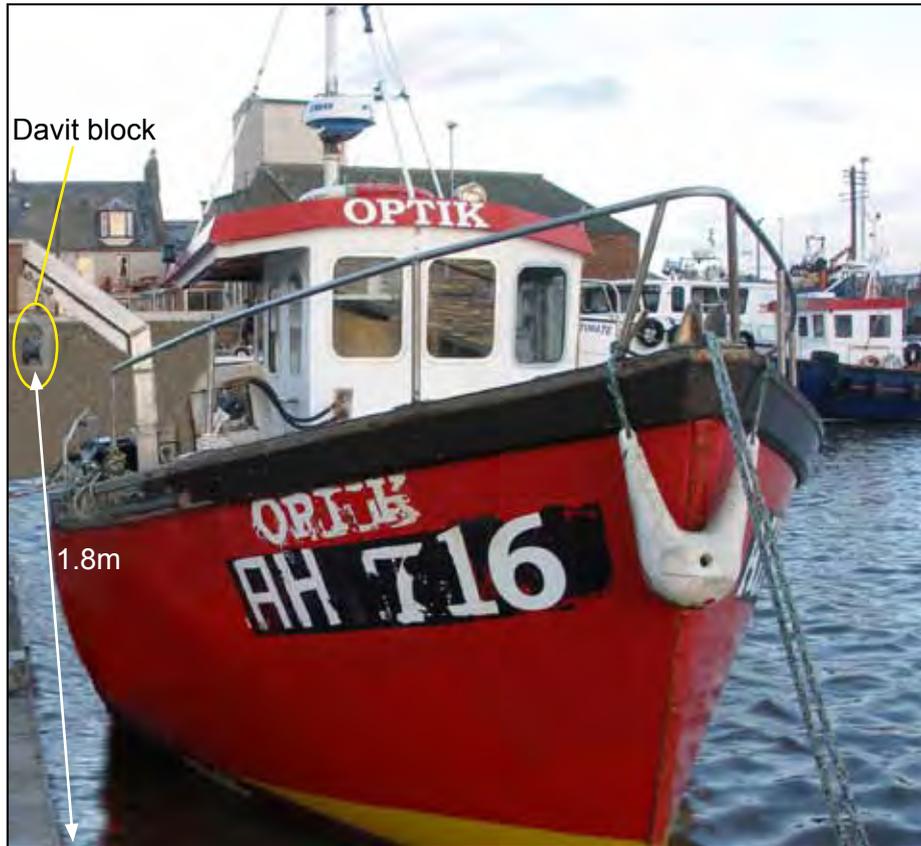
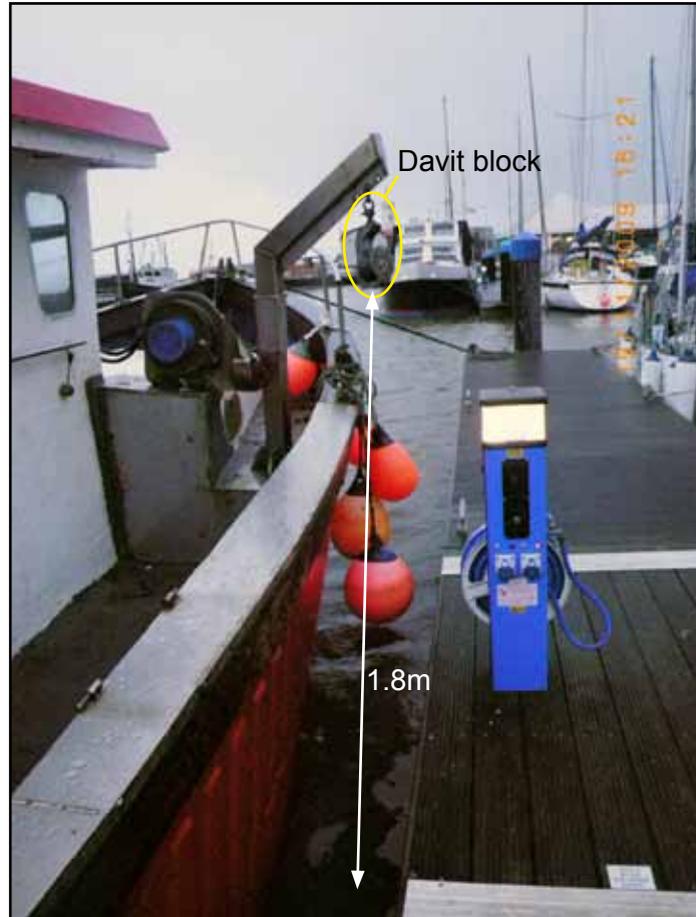
Figure 20a

Optik's skipper continued to haul the rope until the casualty's ankle was touching the davit block (**Figures 20a & 20b**) and he was suspended, head down, towards the sea. There were no signs of life in him at this time. The skipper cut the rope free from around the casualty's torso and attempted to pull him back on board. Despite several attempts, the skipper was unable to get sufficient grip to haul the casualty up and over the bulwarks and slack the retaining rope from the hauler at the same time. Realising he could not recover the casualty alone, he ran into the wheelhouse to use the VHF to call the nearby fishing vessel *Orianne* for help.

Davit block used to recover the casualty

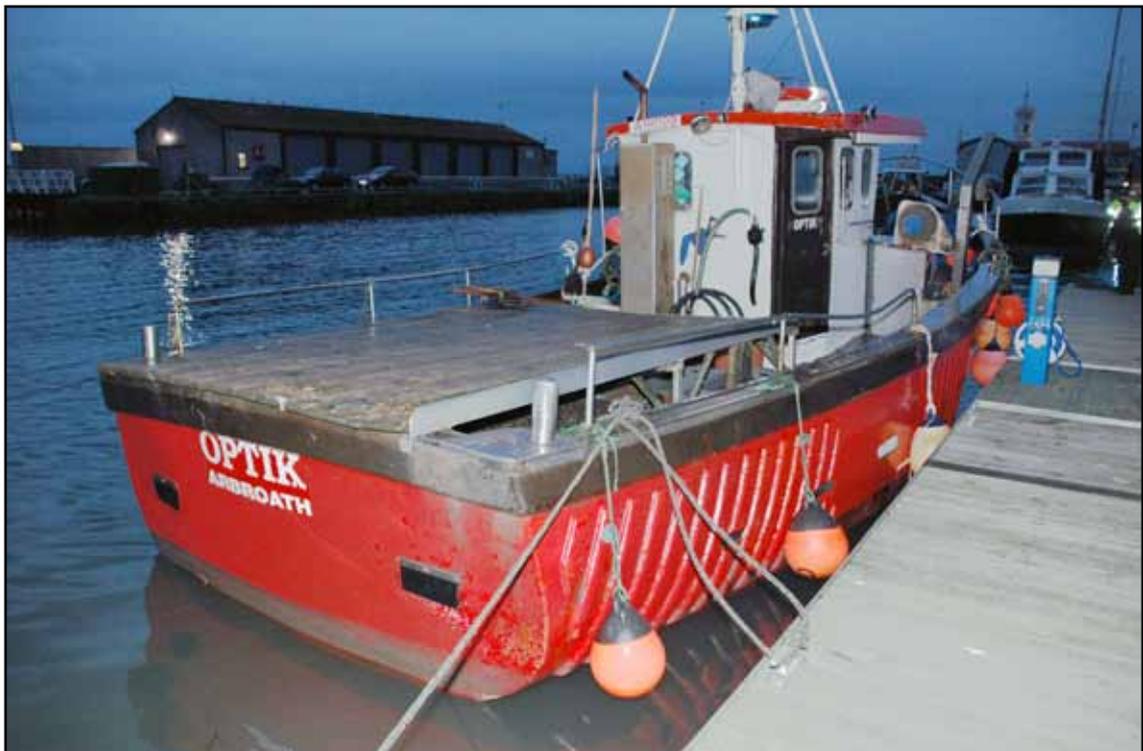
Figure 21

When *Optik* was purchased, the current owner fitted a shooting table, or platform, on the working deck aft to facilitate “self shooting” of creels (**Figure 21**). This was a common practice on many Arbroath creel vessels at the time. The shooting table measured 3.65m long x 2.44m at its widest point and tapered slightly towards the stern. This allowed approximately 24 creels to be stowed flat on the table with a walkway down its starboard side and free deck space of 1.07m between the front of the table and aft wheelhouse bulkhead. Installation of this shooting table blocked off the dedicated engine space access hatch from the main deck, requiring an alternative access to be opened up in the watertight bulkhead between the forecastle and engine space.

Shooting table on aft deck of *Optik*

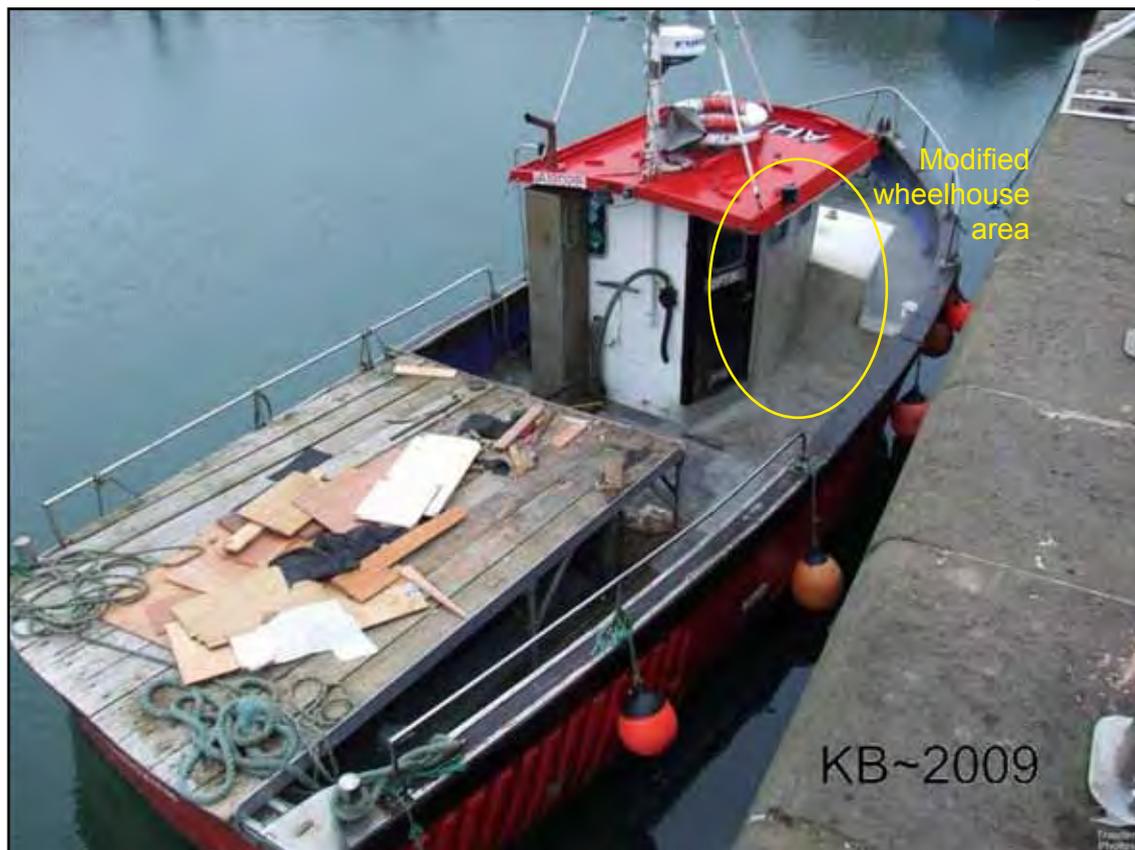
Figure 22a

In June 2009 the skipper further modified the vessel by removing part of the wheelhouse from *Optik's* starboard side (**Figures 22a and 22b**). The modification provided more clear deck space and therefore improved safety in the area of the hauling position. A new sleeved box section hauling davit was also installed at this time, enabling the davit arm to be lifted and rotated through 90°, and prevent it from becoming fouled when *Optik* was moored alongside other fishing vessels. The snatch block on the outboard end of the davit was 1.8m above the waterline (**Figures 20a and b**).

Optik undergoing modifications to starboard side of wheelhouse to enlarge deck space

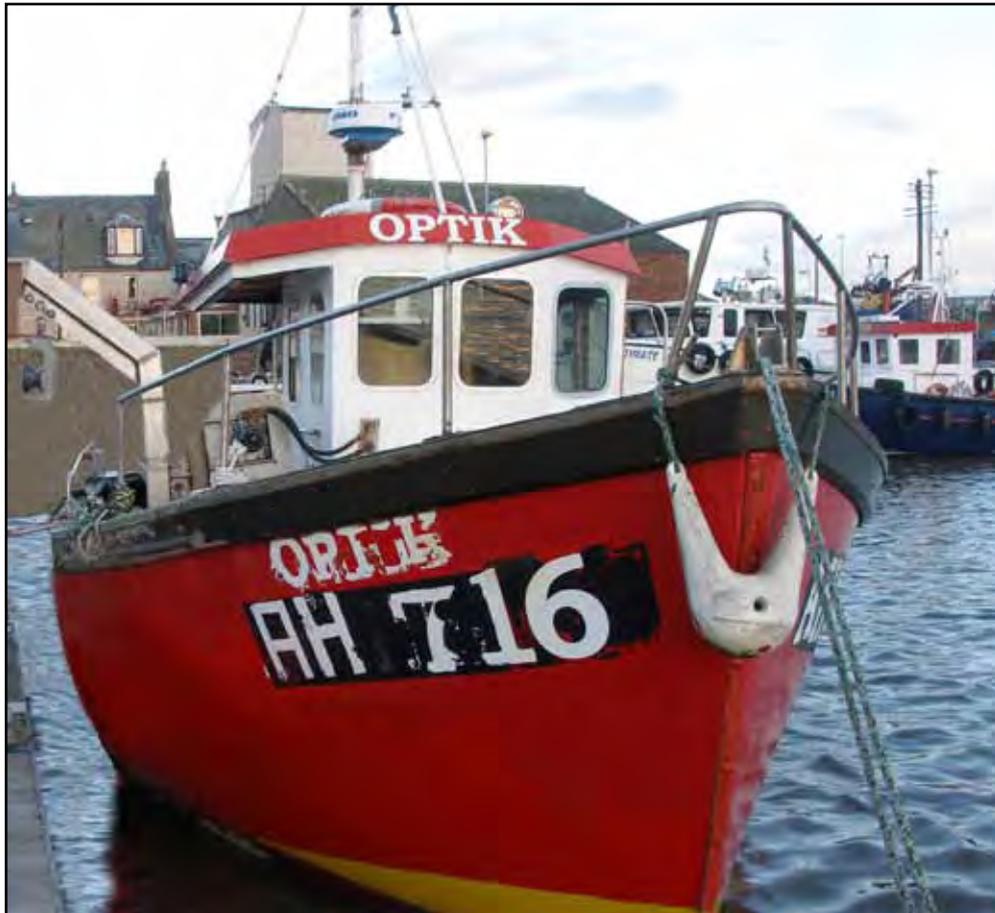
Optik showing completed modifications to wheelhouse and davit arm
