National
Transportation
Safety Board

Enbridge Hazardous Liquid
Pipeline Rupture and Release
Marshall, Michigan
July 25, 2010

Fracture Mechanism of the Pipeline Rupture

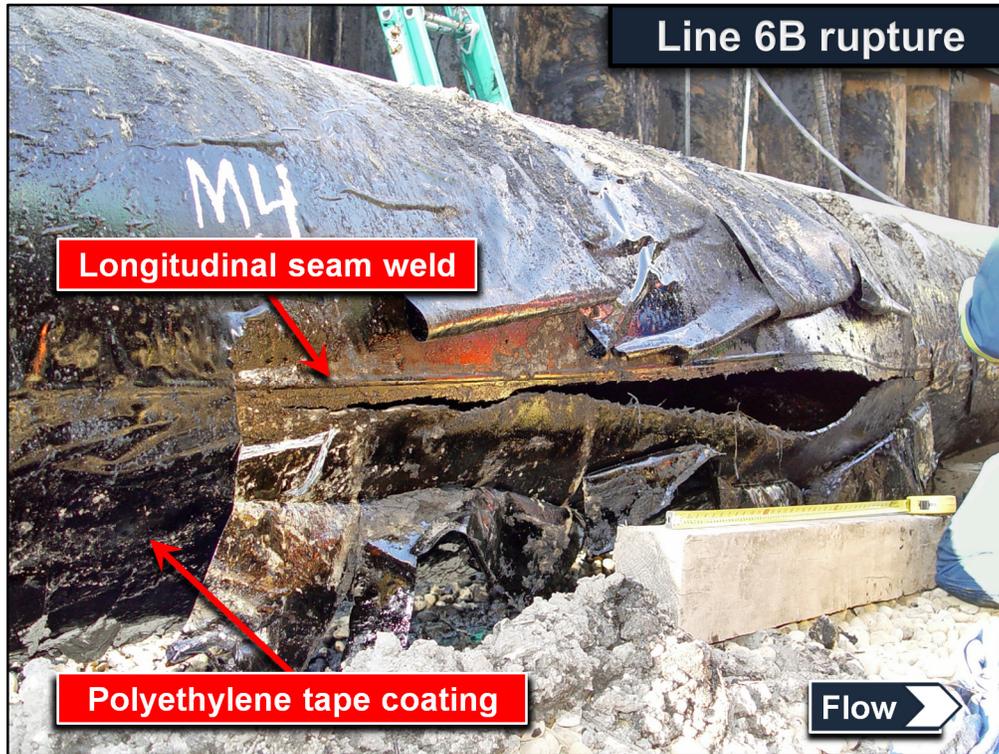
The rupture, shown here, occurred below the longitudinal seam weld and measured over 6.5 feet long and over 5 inches wide at its widest point.

The rupture was made up of numerous small cracks in areas of corrosion that grew larger and joined together over time under a disbonded tape coating. Enbridge had inspected Line 6B for corrosion in 2004 and for cracks in 2005. The group of small cracks that ultimately grew to failure had been detected but misidentified as a single 51.6-inch-long crack following the 2005 pipeline inspection. The crack was analyzed under the Enbridge integrity management program, which determined that no remediation or repair was necessary. [\[Click\]](#)

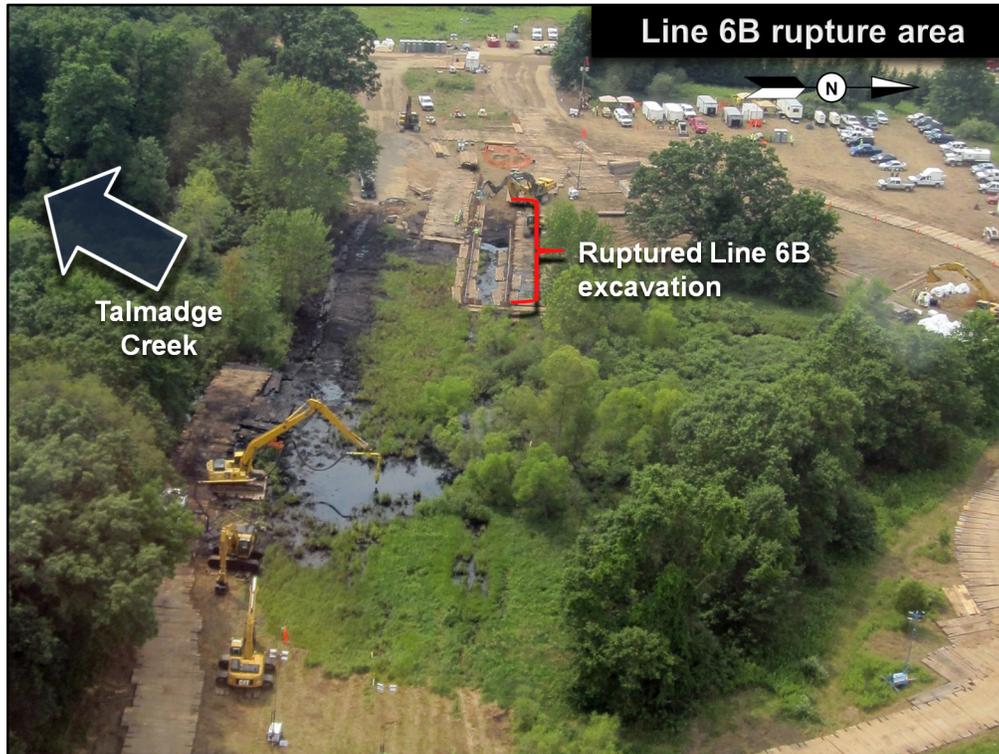
Shown here is an area adjacent to the ruptured segment, about a week after the release. The segment is being excavated for removal near the top of the photo. Talmadge Creek is located through the trees to the left of the pool of oil.

The rupture and delayed recognition resulted in a total Enbridge reported release of over 843,000 gallons of crude oil. This would produce enough gasoline for one person to drive around the world about 500 times. [\[Click\]](#)

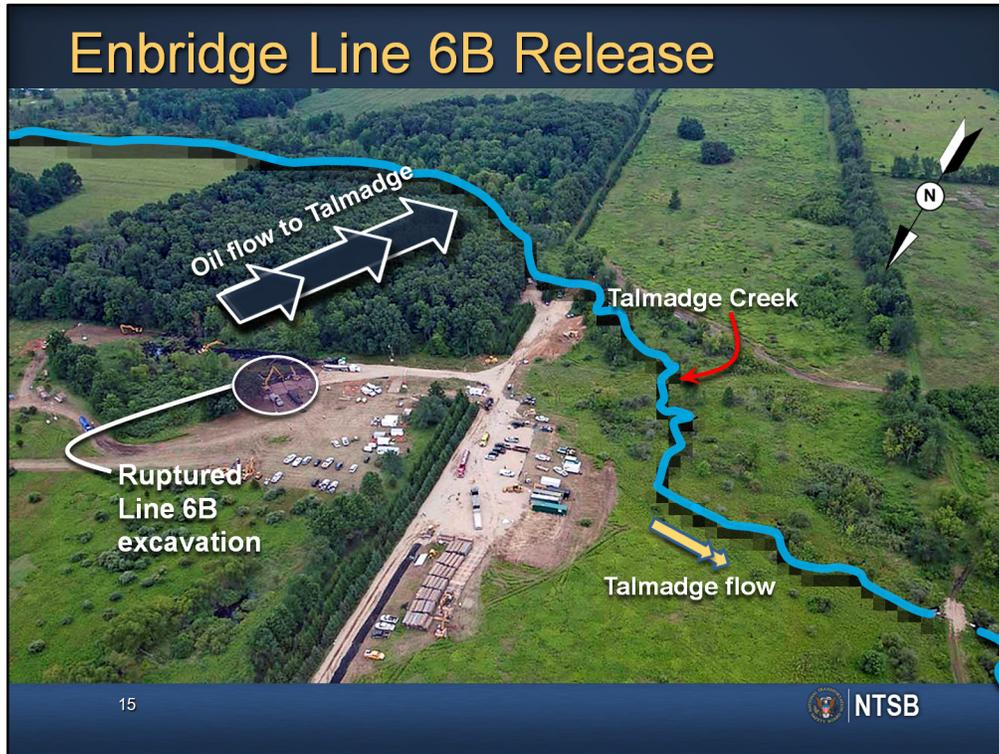
This photo provides another vantage point of the rupture site and nearby Talmadge Creek. During the almost 17.5 hours preceding discovery of the rupture, oil followed the terrain south from the rupture site and into Talmadge Creek. Once in the creek, the oil was eventually carried into the Kalamazoo River, about 2 miles west. Both waterways were flowing fast due to the recent heavy rains. [\[Click\]](#)

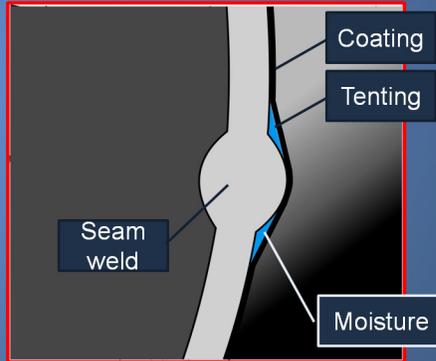
Degraded Coating

- Coating showed evidence of tenting and wrinkling
- Moisture penetrated gaps between the coating and the pipe surface

However, the corrosion protection system on the ruptured segment of the pipe failed to protect the external pipe surface from corrosion. Plastic tape coating has a known susceptibility to tenting and wrinkling. In this slide, we will zoom in on a cross-section of the double submerged arc weld seam to show gaps associated with tenting. [\[CLICK\]](#) Tenting forms at the edges of the longitudinal seam weld due to the height of the external weld bead as shown in this close-up view of the weld cross-section. Moisture then penetrates the gap between the pipe surface and the coating, leading to corrosion of the pipe surface. Soil loads can increase the size of the tenting gaps and can cause the coating to wrinkle, particularly at the sides of the pipe. Tenting and wrinkles on the ruptured pipe segment produced gaps between the coating and the pipe surface that allowed moisture to reach the pipe wall, resulting in corrosion at the outer surface. [\[CLICK\]](#)

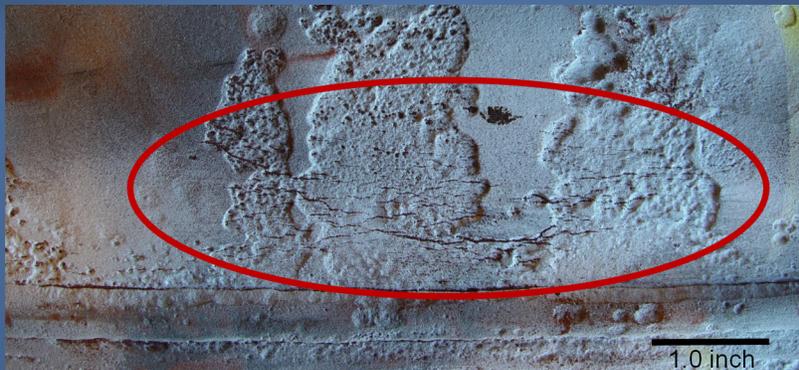
Cracks Initiated in Corroded Areas

Pipe surface showing corrosion and cracks

Many areas of corrosion and clusters of cracks were observed on the outer surface of the ruptured pipe near the longitudinal seam. The image in this slide shows typical corrosion and crack clusters on the external surface of the pipe adjacent to the seam weld. These features indicated the surfaces had been exposed to moisture that led to corrosion and cracking. [\[CLICK\]](#)

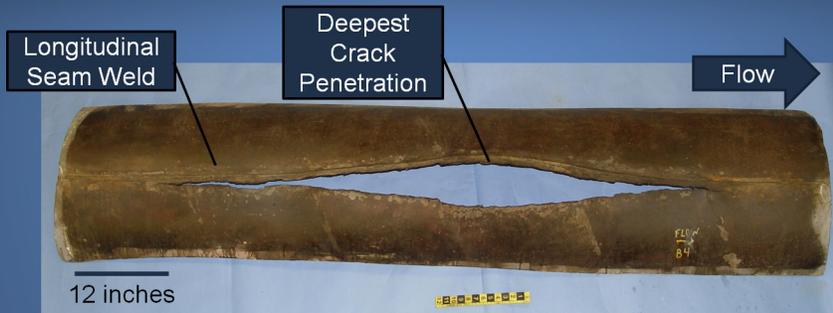
Pipe Rupture

Rupture near longitudinal seam weld

A piece of the pipe wall containing the rupture is shown in this slide after the tape coating was removed and the surfaces were cleaned. The rupture was located near the longitudinal seam weld on the side of the pipe, which is an area susceptible to tape coating wrinkling and tenting. The fracture consisted of many smaller cracks that grew and linked together to form the rupture. The area of deepest crack penetration was located near the widest opening in the rupture. [\[CLICK\]](#)

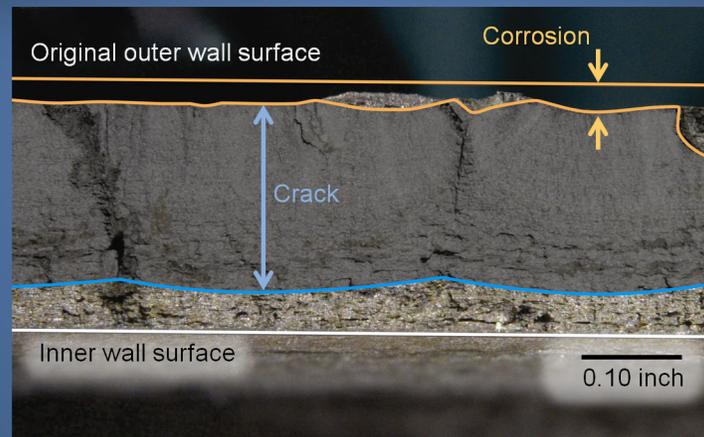
Corrosion-Fatigue Cracks

This slide shows the fracture surface at the area of deepest crack penetration. Cracks initiated from corrosion pits, at first growing due to near-neutral-pH stress corrosion cracking. As the cracks grew deeper, they continued to grow due to corrosion fatigue. Near-neutral-pH stress corrosion cracking and corrosion fatigue are two forms of environmentally assisted cracking where crack growth can be accelerated due to the synergistic effect of loading combined with a corrosive environment. The corrosion and cracks in the ruptured segment extended through 84 percent of the wall thickness before the pipe ruptured under normal operating pressure during the scheduled Line 6B shutdown. [\[CLICK\]](#)

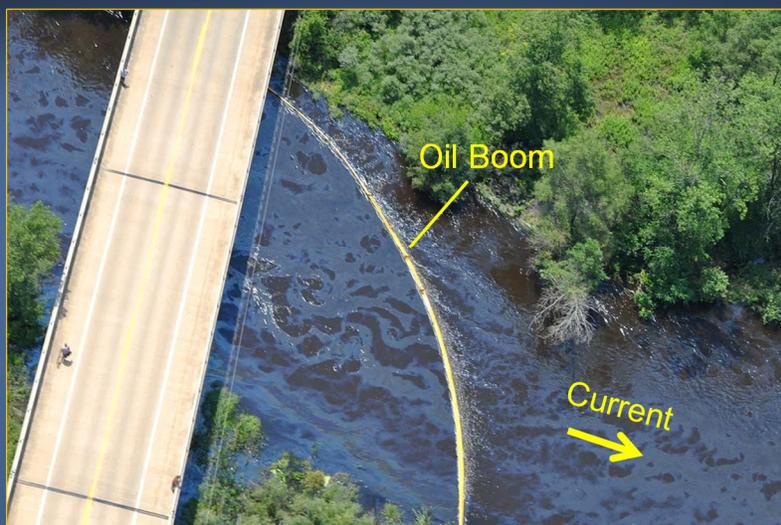
Lack of Source Control

This aerial view taken on the second day of the spill response shows the Interstate 94 bridge over the Kalamazoo River about 8.9 miles downriver of the pipeline rupture site. While a considerable amount of Enbridge's initial effort was expended here on the first day, the deployed oil booms had little effect containing oil when it finally arrived in the strong current.

A crew of 4 Enbridge maintenance employees provided the initial response on Talmadge Creek, but booms they installed far below the pipeline release site were not effective for the environmental conditions and did not prevent much of the oil from escaping into the Kalamazoo River. The opportunity to mitigate the spread of the oil spill was lost before follow-on resources arrived.

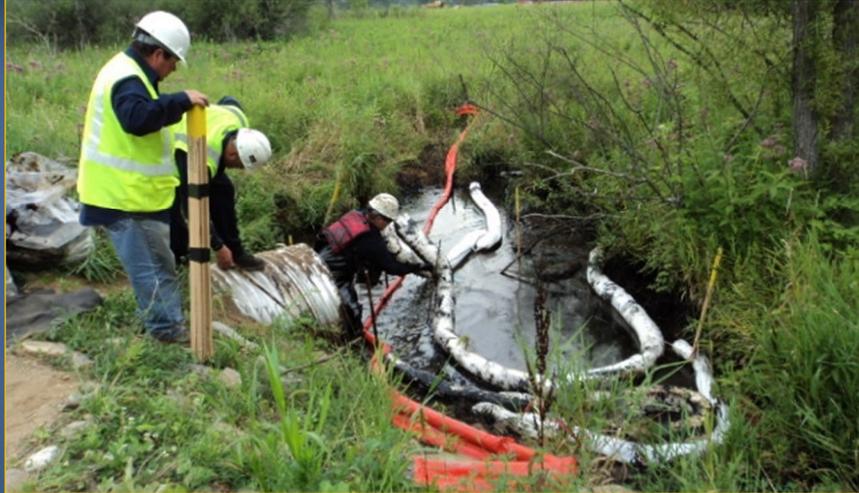
Oil Containment Techniques

This photograph shows oil containment actions attempted later at the culvert on Talmadge Creek at Division Drive with crews installing a combination of white sorbent boom and orange skirted oil boom. This would have been a prime location for initial response action to contain the release within 1/4 mile from the ruptured pipeline.

On the day the spill was discovered, first responders noted that the majority of the released oil was upstream of this location, yet they focused most of their attention on placing containment measures much farther downstream.

Industry and Federal guidance suggests that the skirted oil booms Enbridge had available were not suitable for small and fast flowing streams, and the sorbent booms were an ineffective method of containing oil except for small oil spills in stagnant waters. **[CLICK]**
