**NTSB** *TRAINING CENTER*

## **Practical Exercise**

**Cessna 210N  
In-Flight Fire**

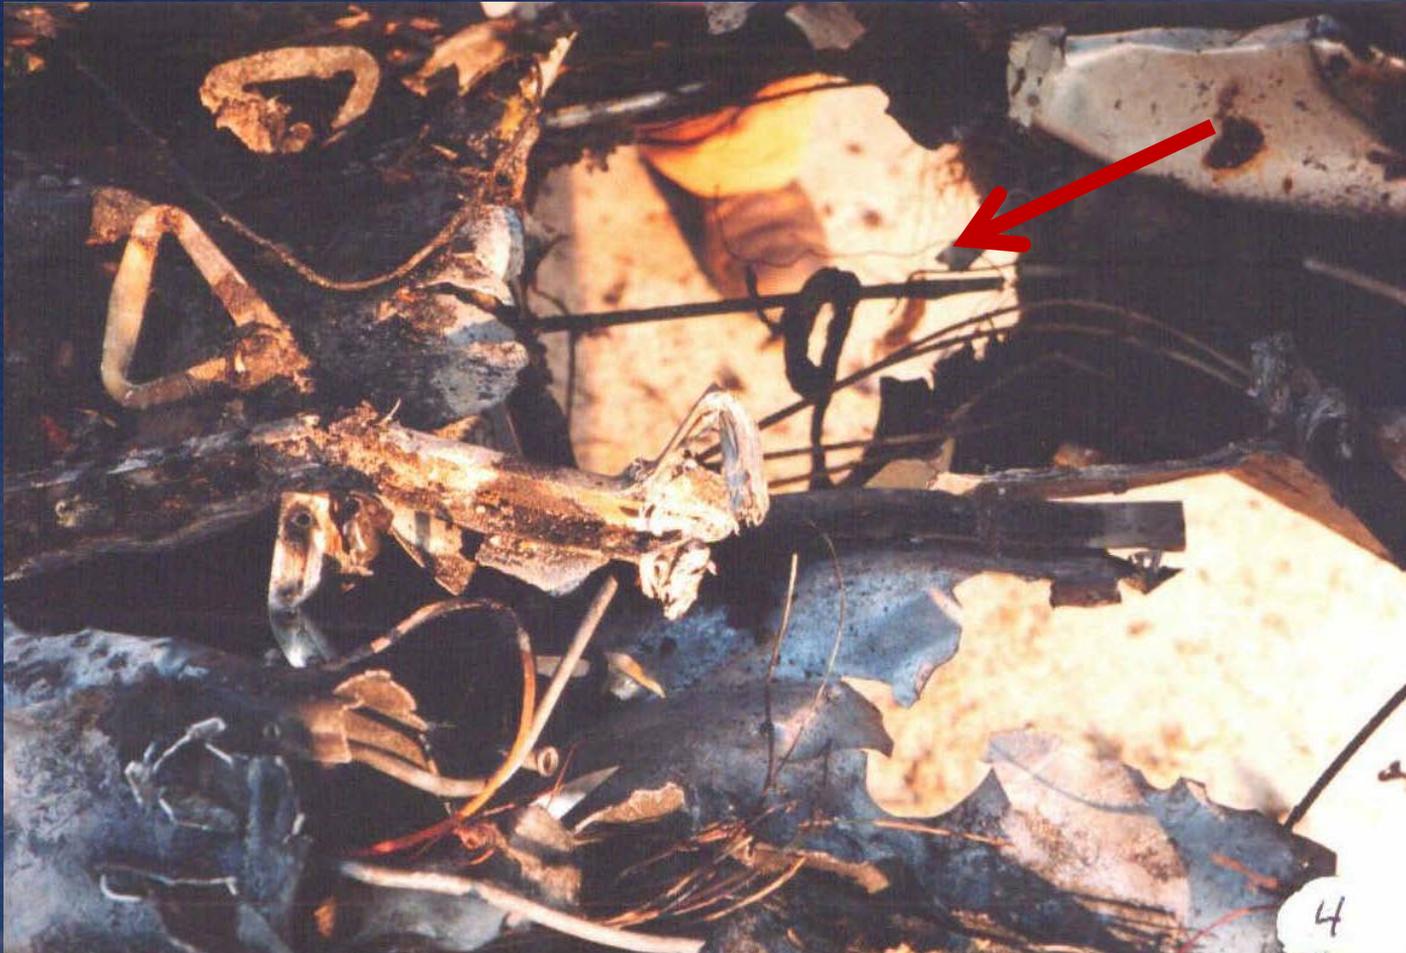
# Fire Damage

- Most severe fire damage = underside of cockpit area
- Aluminum hydraulic lines ran under pilot's seat
- Several pieces of the hydraulic lines were missing

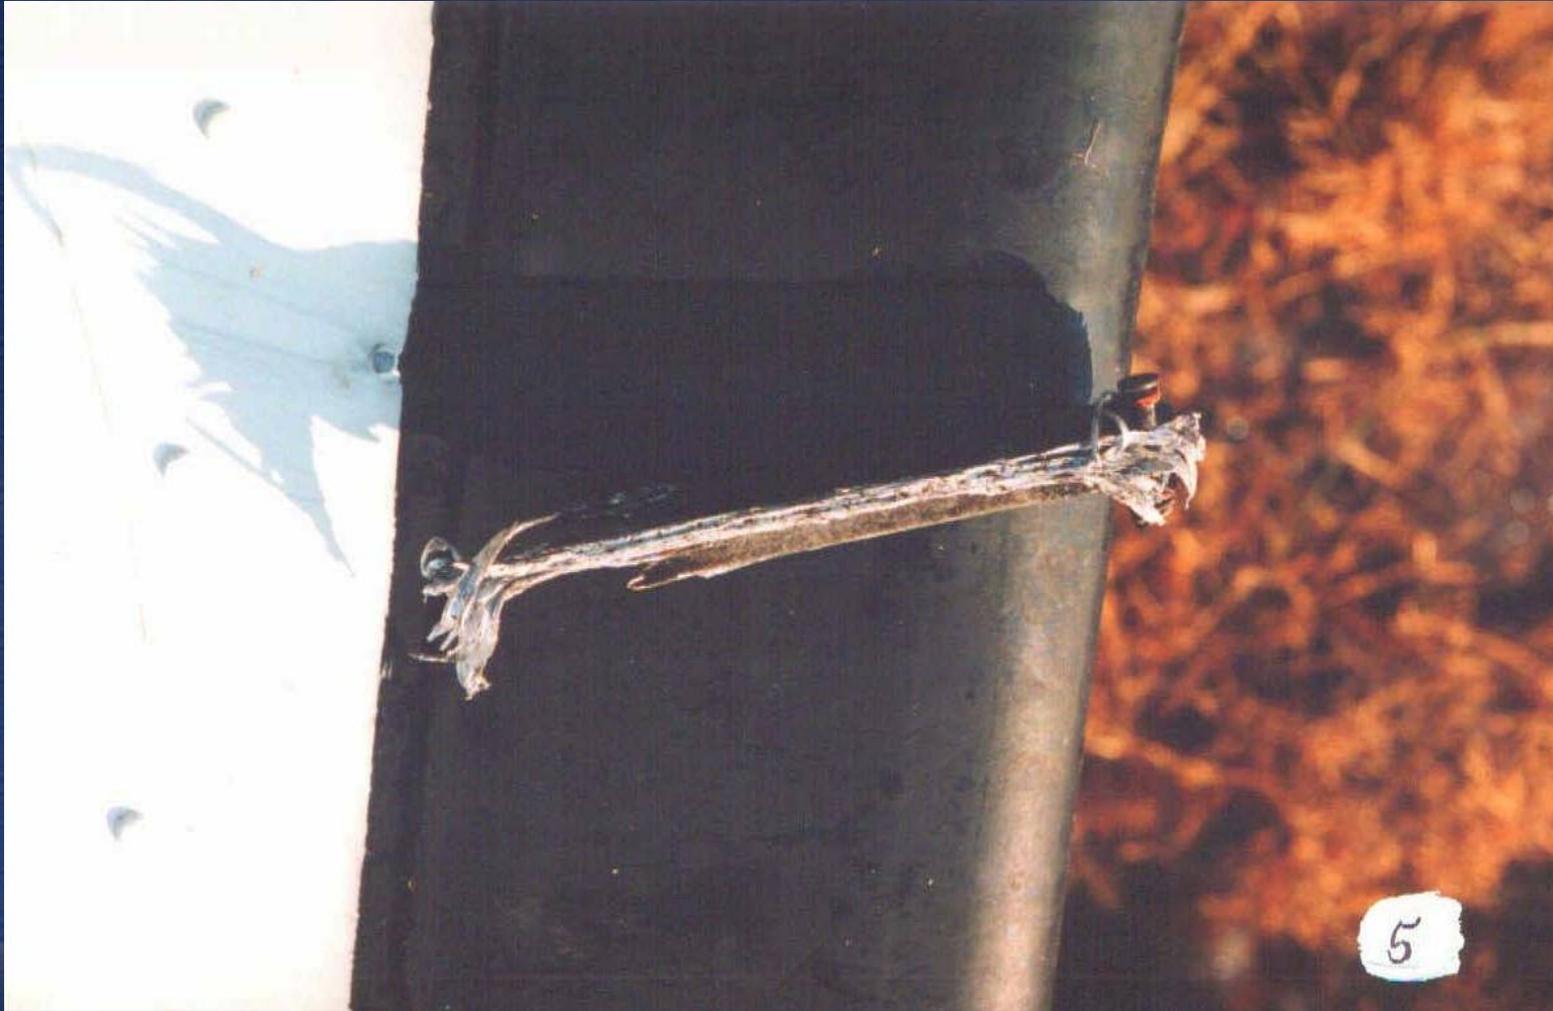
# Pilot's Seat Track

- Remains of wire bundle found in area of fire damage
- Seat track section displayed “broomstraw” features

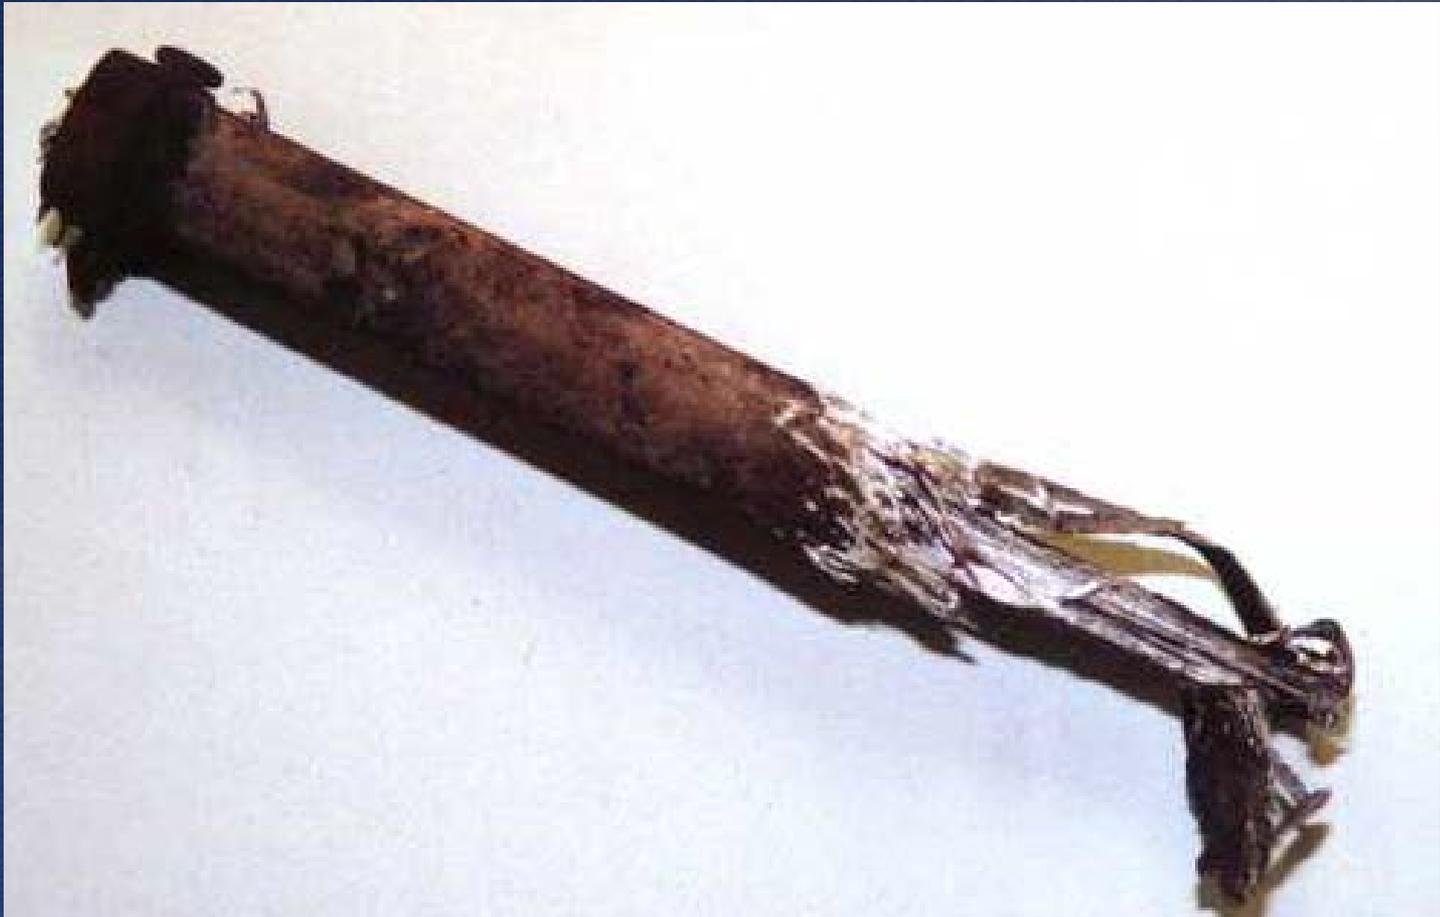
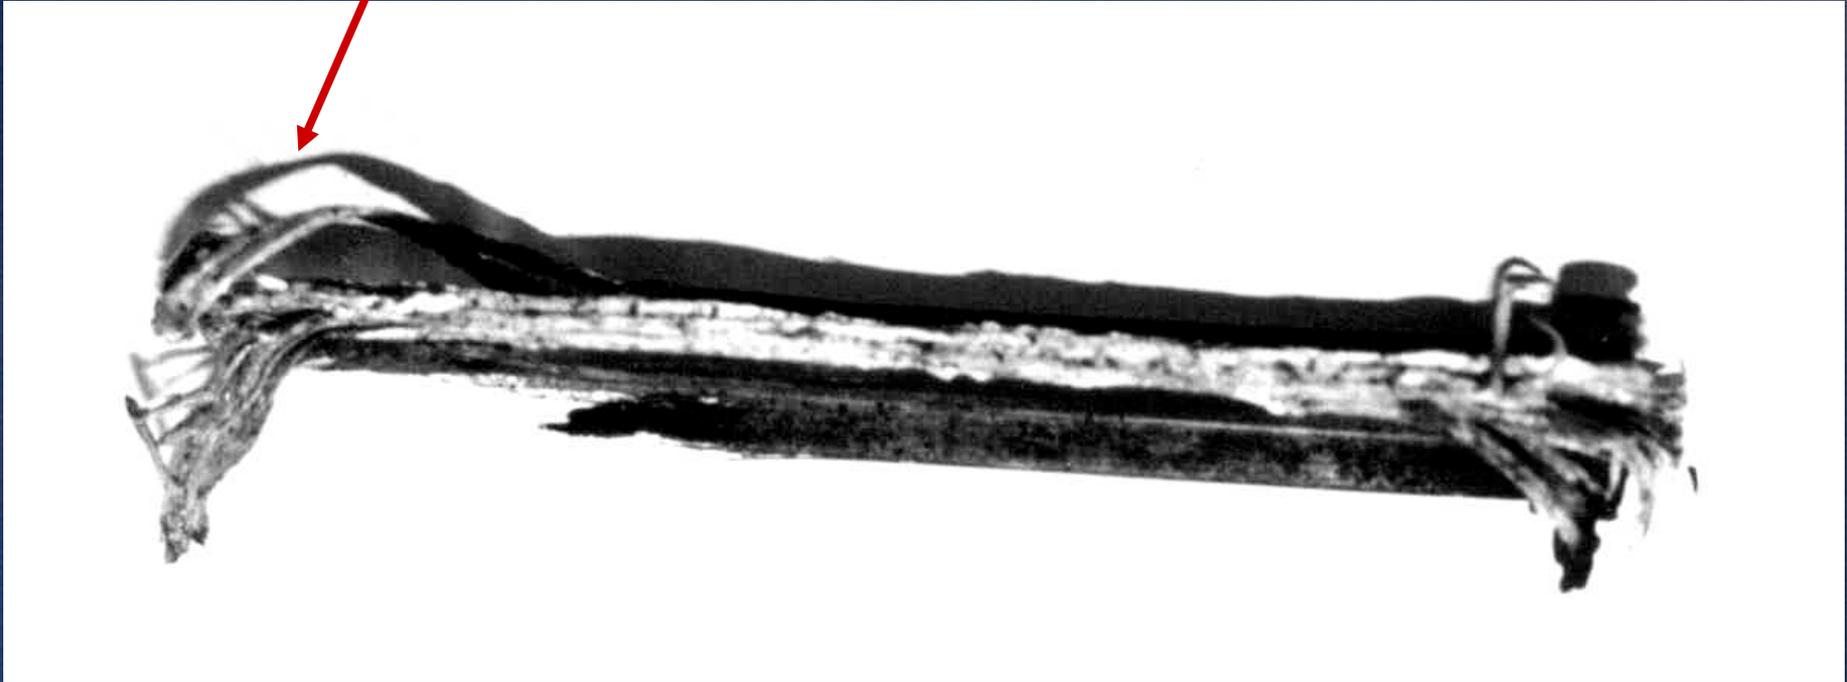
*The failure of the flex hydraulic line and the chaffing of an electrical line under the pilot seat that resulted in an inflight fire...*

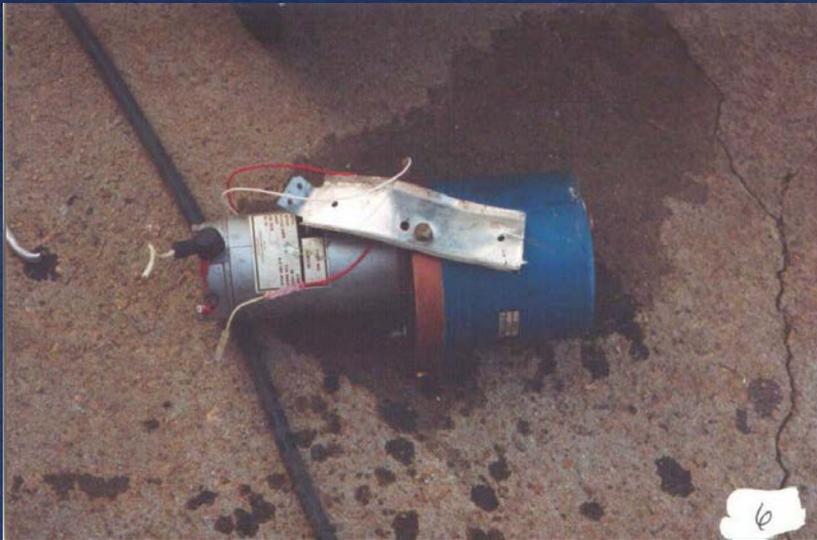
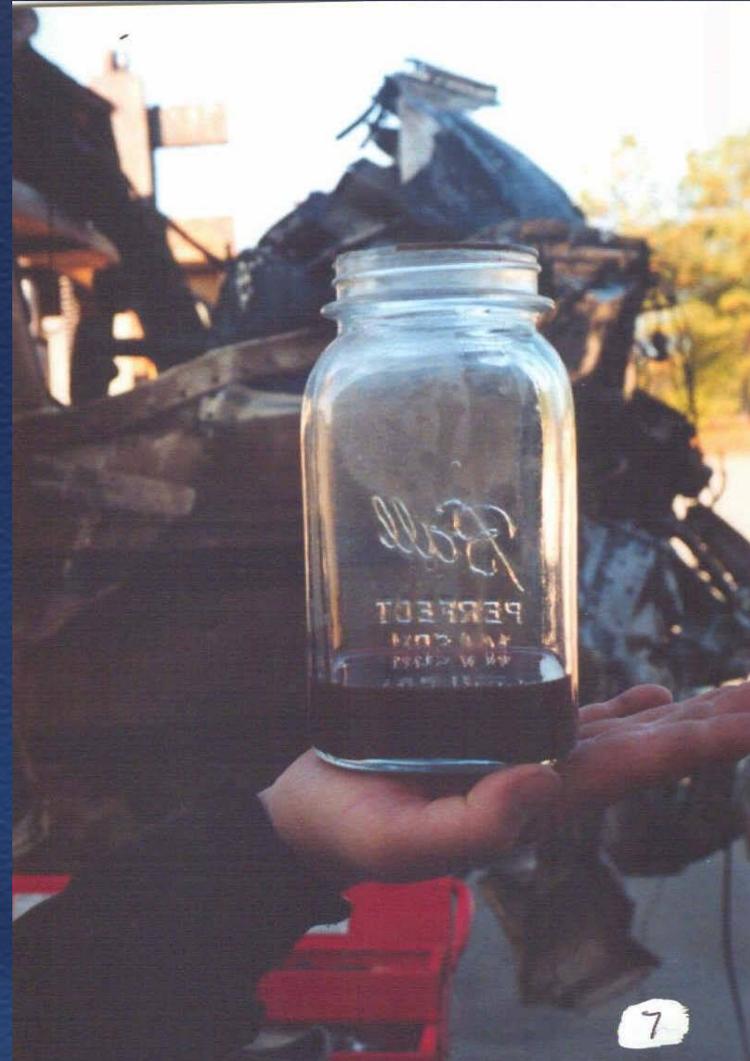
# Hydraulic System

- A few ounces of fluid were recovered from the pump and reservoir assembly
- No mechanical anomalies with pump
- Hydraulic fluid = Flash point of 82 degrees C (180 degrees F)
