National Transportation Safety Board

Crash During Nonprecision Instrument Approach

Execuflyght Hawker 700A
Akron, Ohio
November 10, 2015

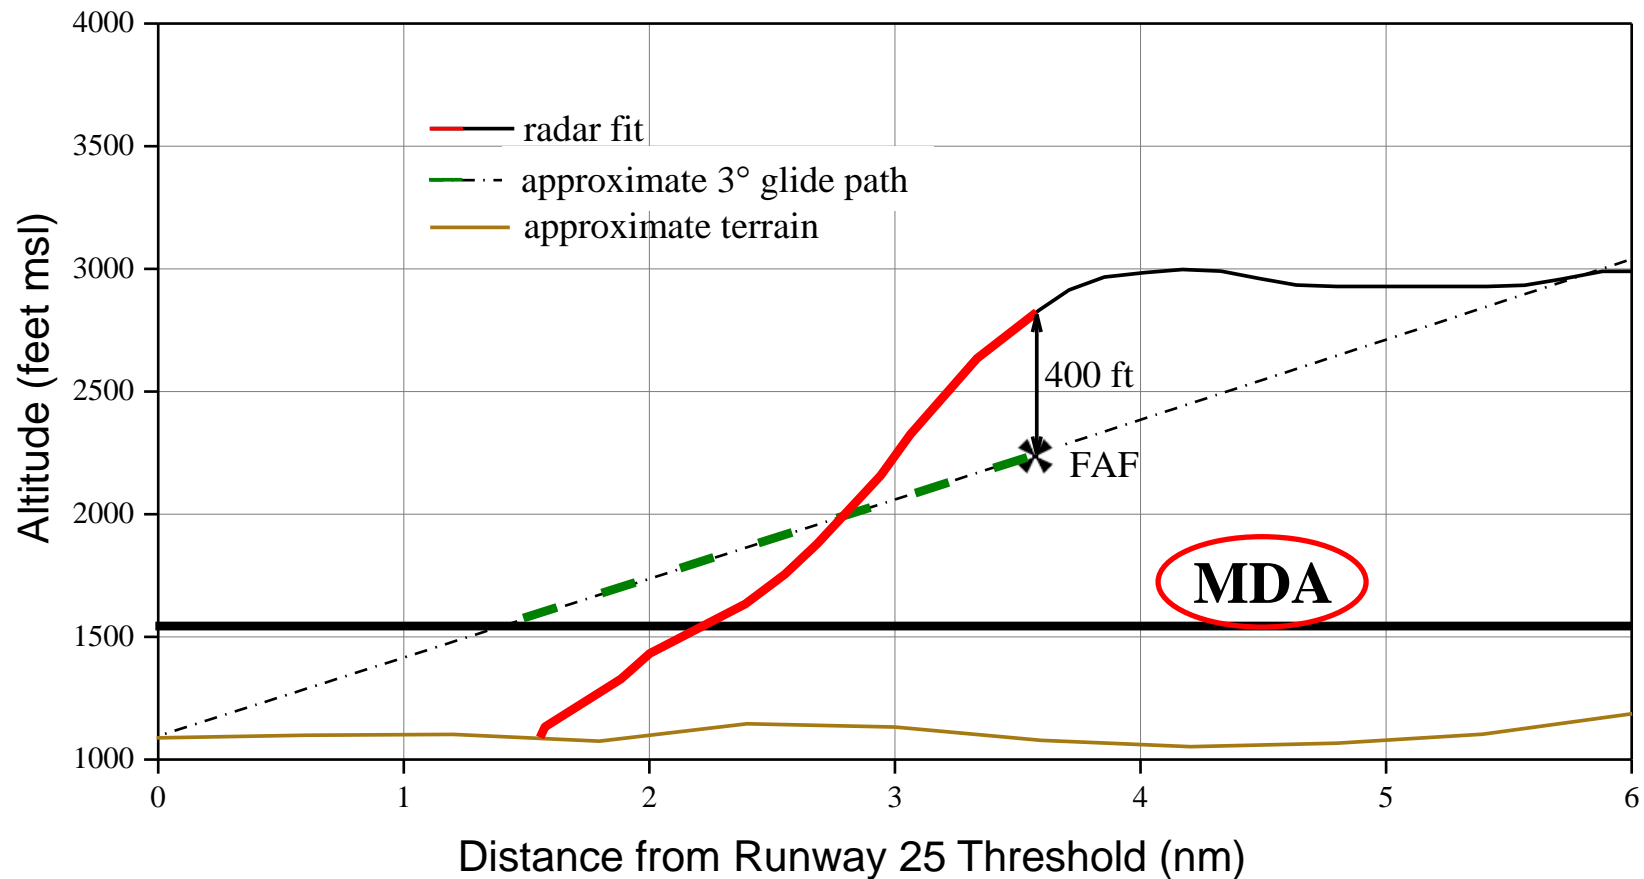
Profile View of Approach

- First officer slowed airplane and placed it in danger of a stall
- Captain failed to take control
- First officer improperly configured airplane by selecting flaps 45°
- Landing checklist never completed

- Speed decayed below approach speed
- Captain did not call out “minimums”
- Airplane descended below minimum descent altitude without runway in sight
- First officer attempted to arrest descent, airplane entered an aerodynamic stall

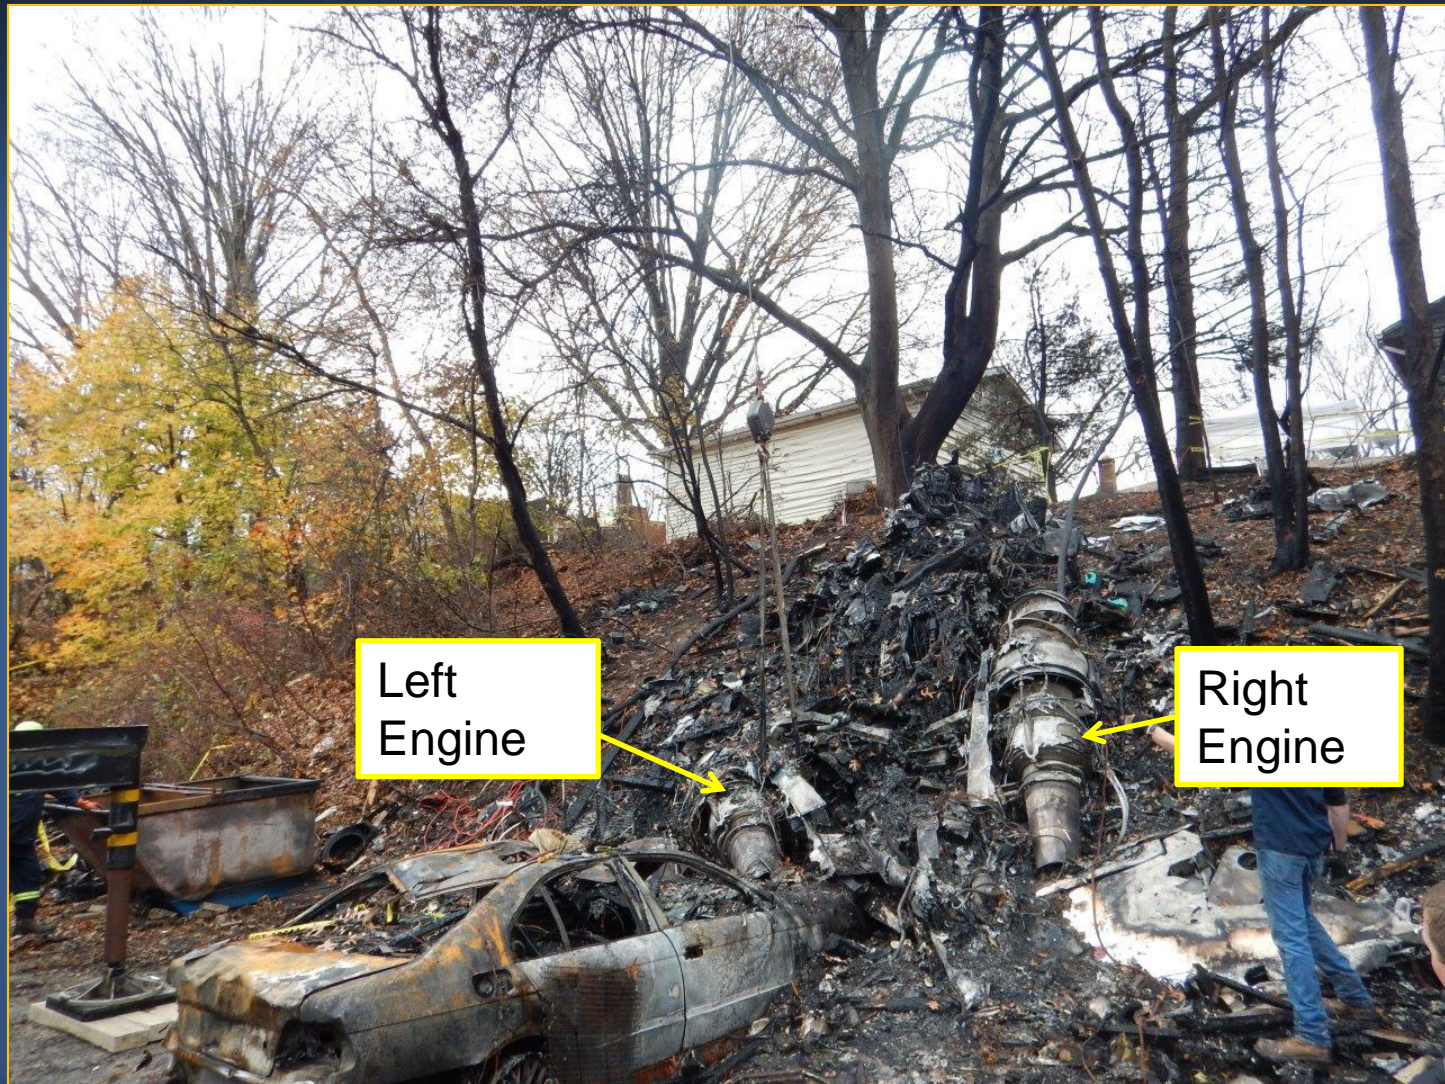
View of Fuselage and Engines

- No preimpact structural, engine, or system failures
- Pilots were properly certificated
- Pilots not affected by toxins, alcohol or other drugs, or medical conditions
