National Transportation Safety Board

Highway-Railroad Grade Crossing Collision
Commerce Street, Valhalla, New York
February 3, 2015
DCA15MR006

Michael Hiller, IIC

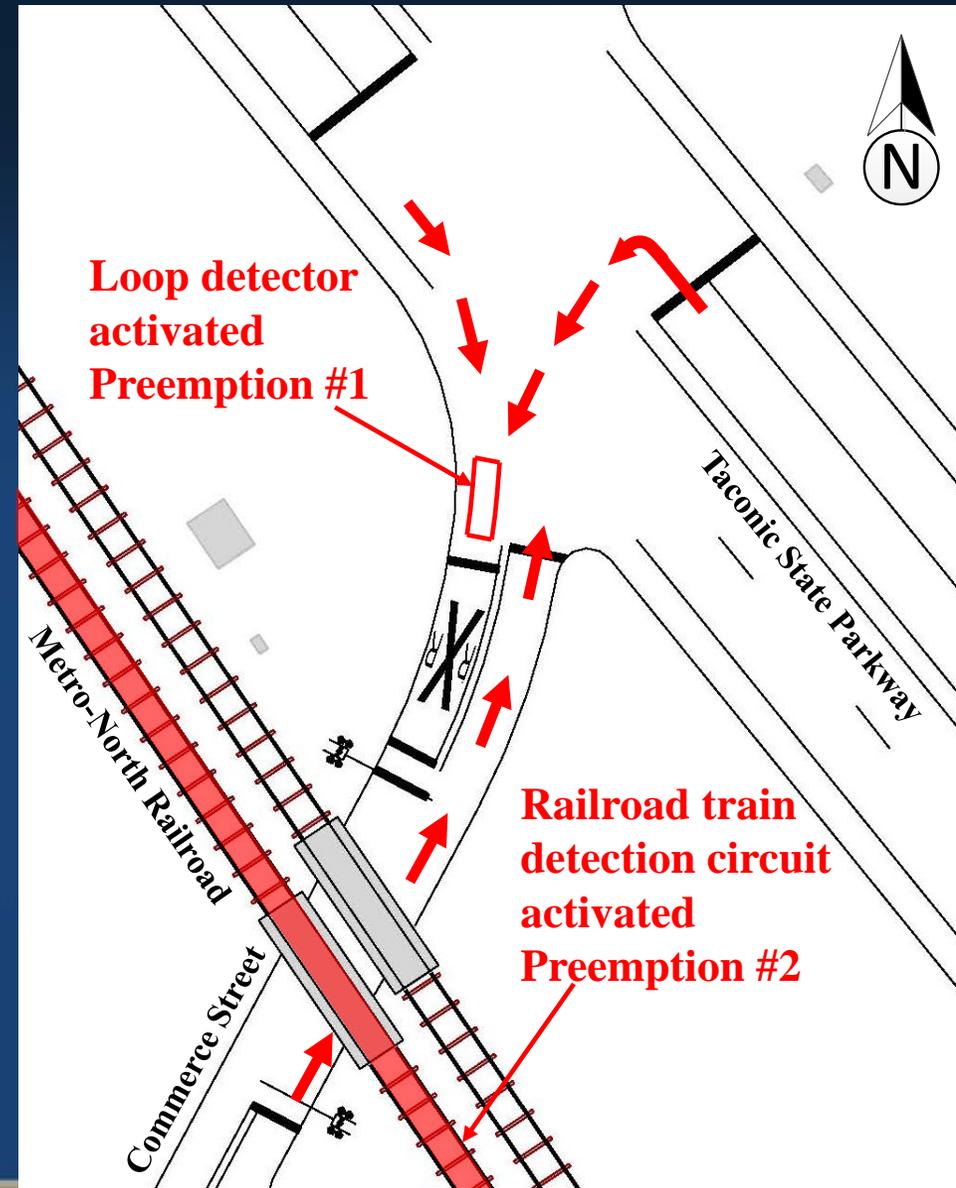
- Traffic signal contained two preemptions
- Preemption #1 – activated by loop detector in the pavement of the southwest approach to the grade crossing
- Preemption #2 – activated by railroad train detection circuit

- Post-accident examinations revealed
 - Preemption #1 did not comply with MUTCD
 - Changed clearance time to 29 seconds
 - Based on guidance in the Railroad Highway Grade Crossing Handbook

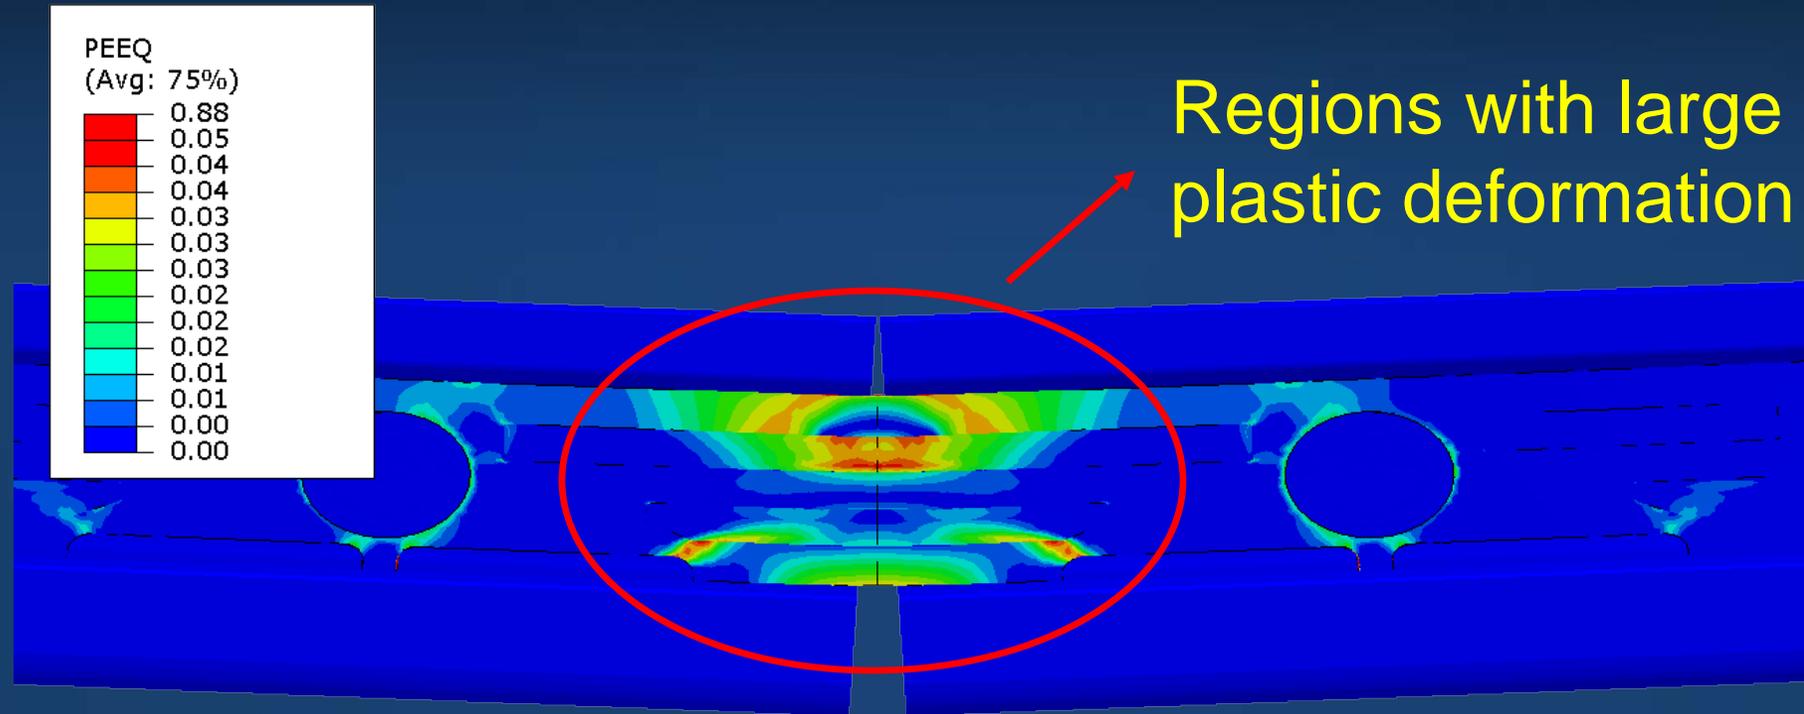
Simulation Results: Up and Down Bending

- The third rail assembly structure was not constructed to fail in a controlled manner or break away under undesirable overloaded conditions
 - The third rail assembly would have undergone large deformation before failing
 - Both the splice bars and the bolts could fail under these overloaded conditions
