National Transportation Safety Board

Sinking of Cargo Vessel *El Faro*Atlantic Ocean, Northeast of Acklins and Crooked Island, Bahamas
October 1, 2015

Engineering Factors

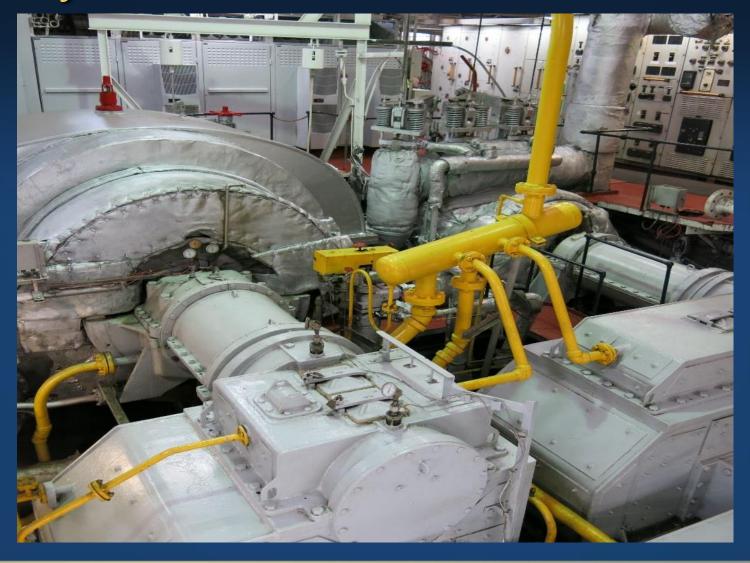
Lube Oil System

0440/0513 – Chief Engineer reported oil levels affected by list

After 0600 – Vessel began losing speed

0616 – Bridge notified of loss of propulsion

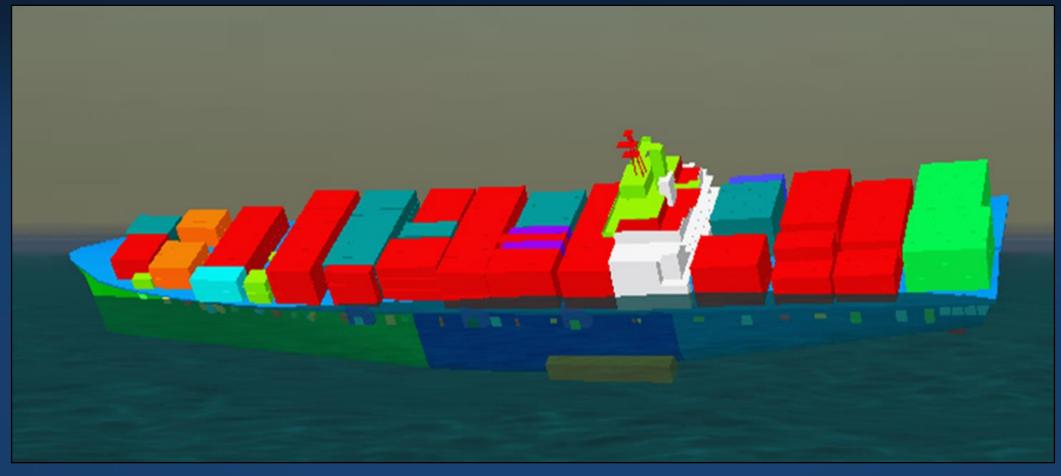
Design Standards

Extreme list to port

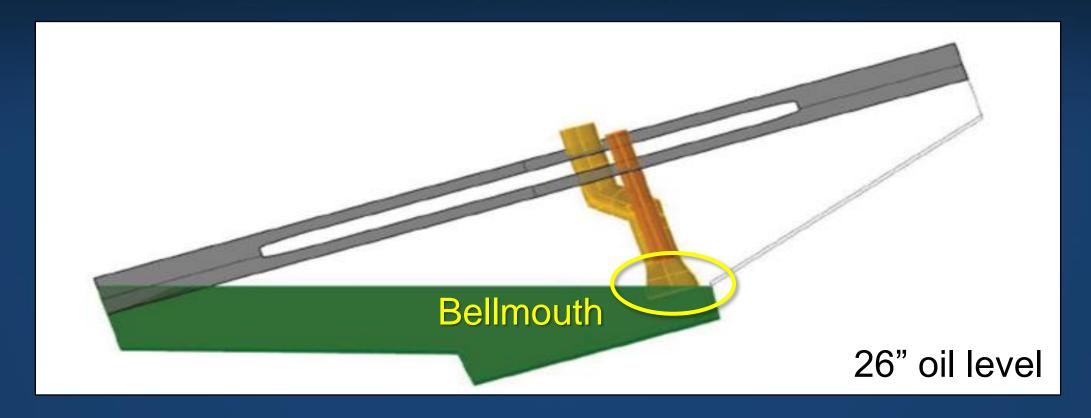
Design Standards

18° list to port – looking forward

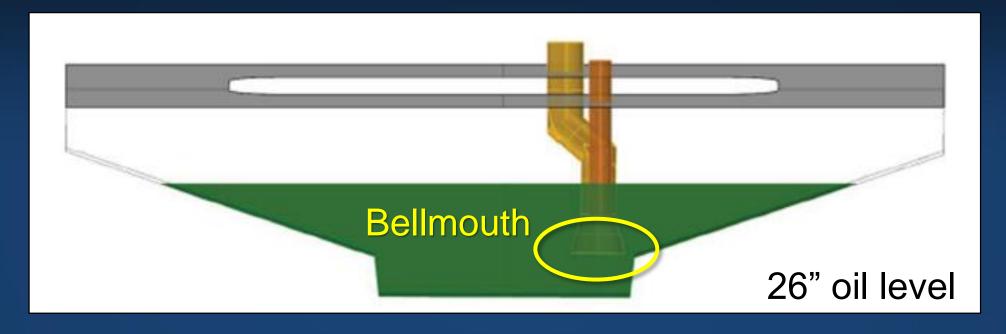
Oil Level in Sump

25" = 1,255 gallons

26" = 1,346 gallons

27" = 1,436 gallons
