# National Transportation Safety Board

## Flooding of Cargo Holds

Eric Stolzenberg

Naval Architecture Group Chairman

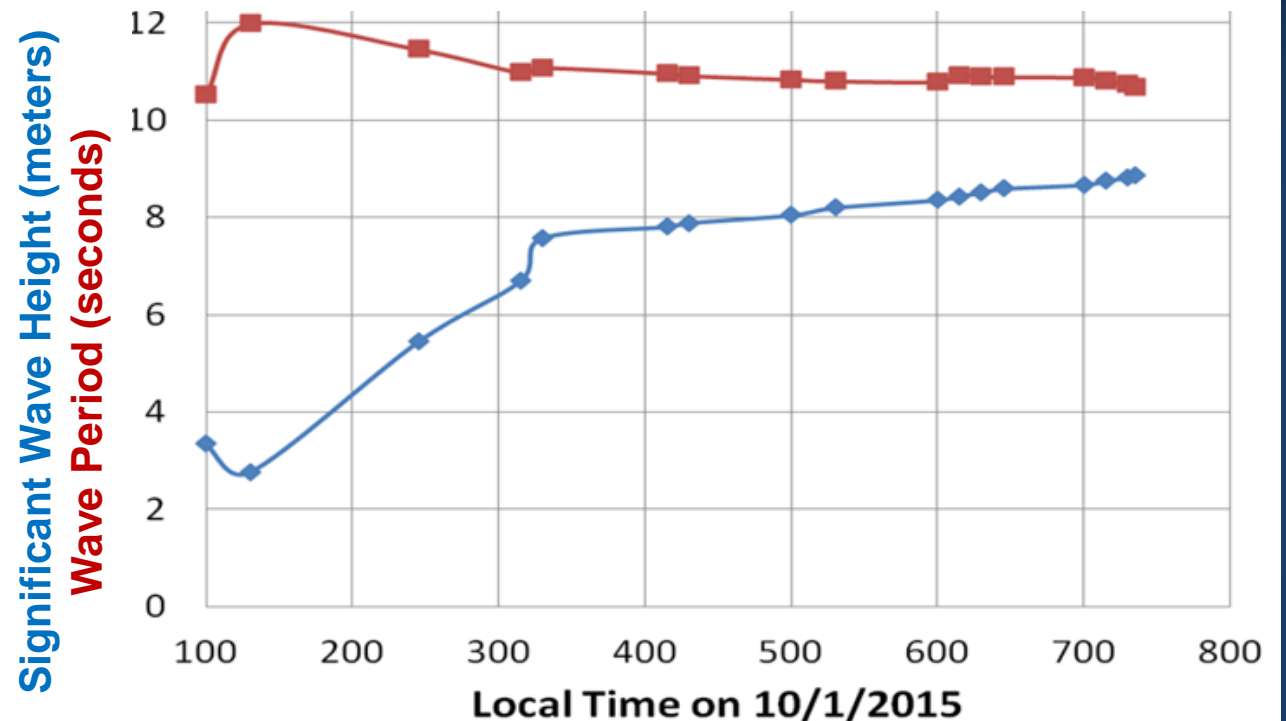
**Analysis of Post-Storm (Hindcast Data) Sea/Weather Models  
Along *El Faro's* Track**

- Seas increase rapidly after 0130
- Over 7 meters (23 feet) by 0300
- Build to 9 meters (30 feet)
- Wave period of 11 seconds

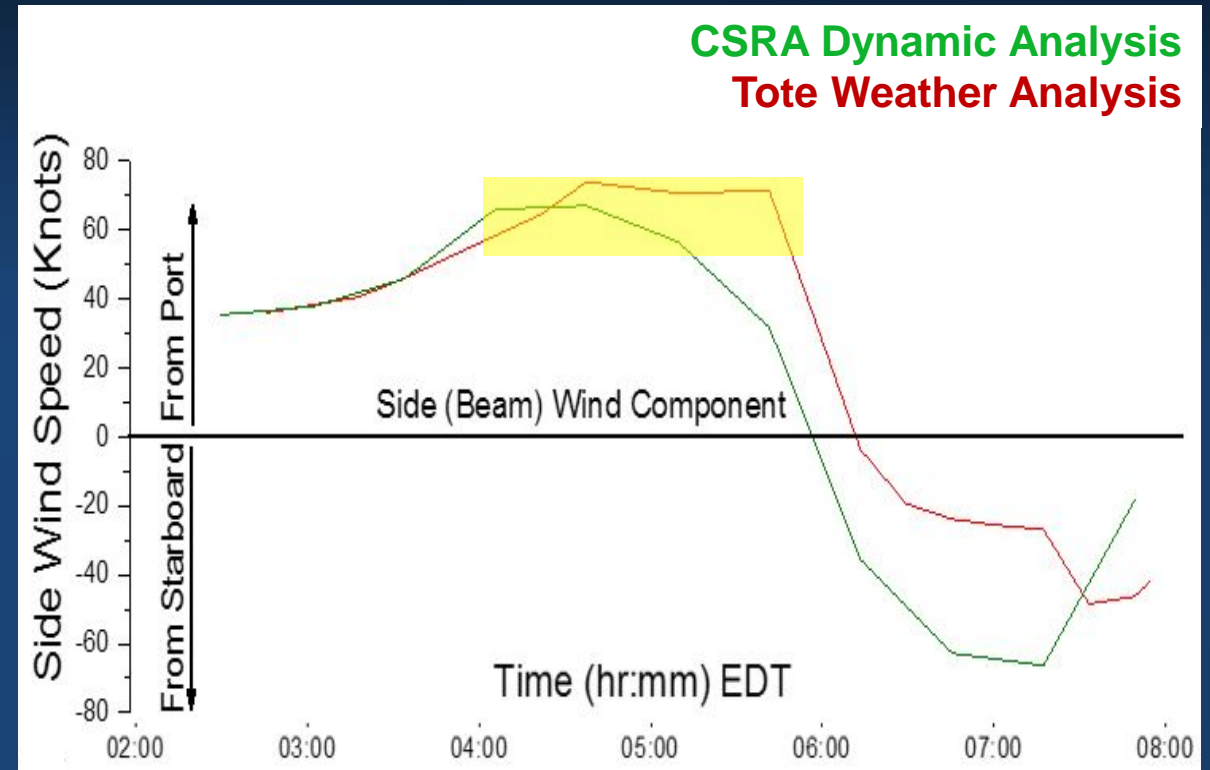
- Increasing winds after 0200 on vessel's port beam
- Wind near 70 knots by 0400
- Effect: increasing and sustained heel (windheel) to starboard
- Hydrostatic analysis shows heel from 5° to 8° for winds 60 to 80 knots on beam

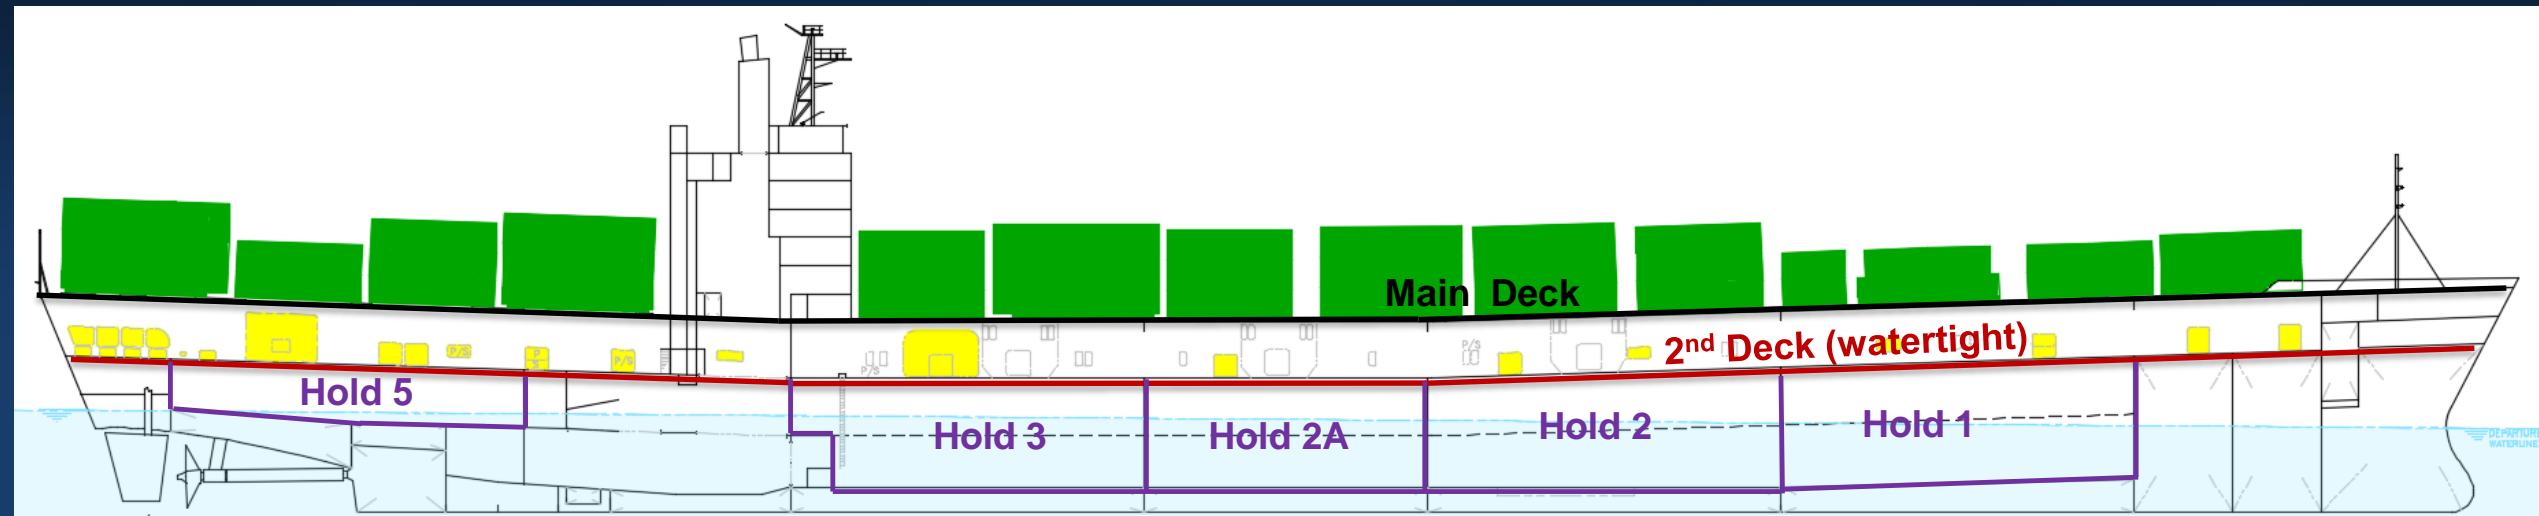
- Boarding seas (green water) was known to enter onto 2<sup>nd</sup> deck in past
- Partially enclosed 2<sup>nd</sup> deck was watertight

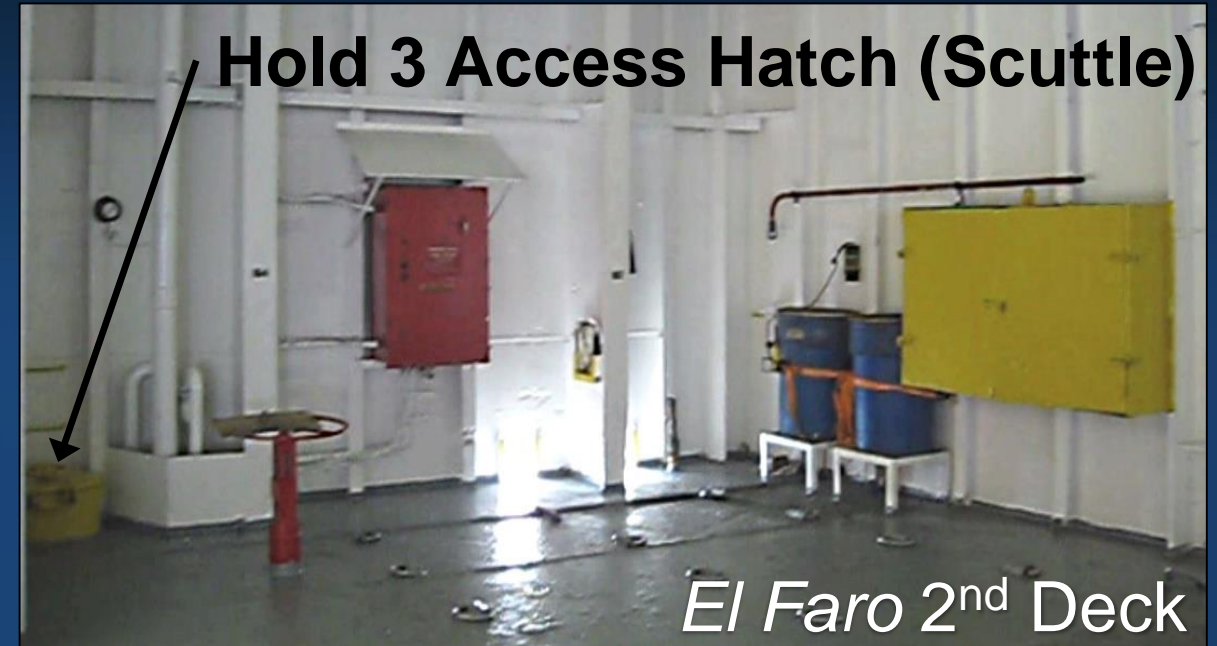
- Hold 3 was flooding at 0543 per VDR
- Small watertight deck hatch (scuttle) to cargo hold 3 on second deck was open
- Open scuttle allowed downflooding through ship's watertight envelope

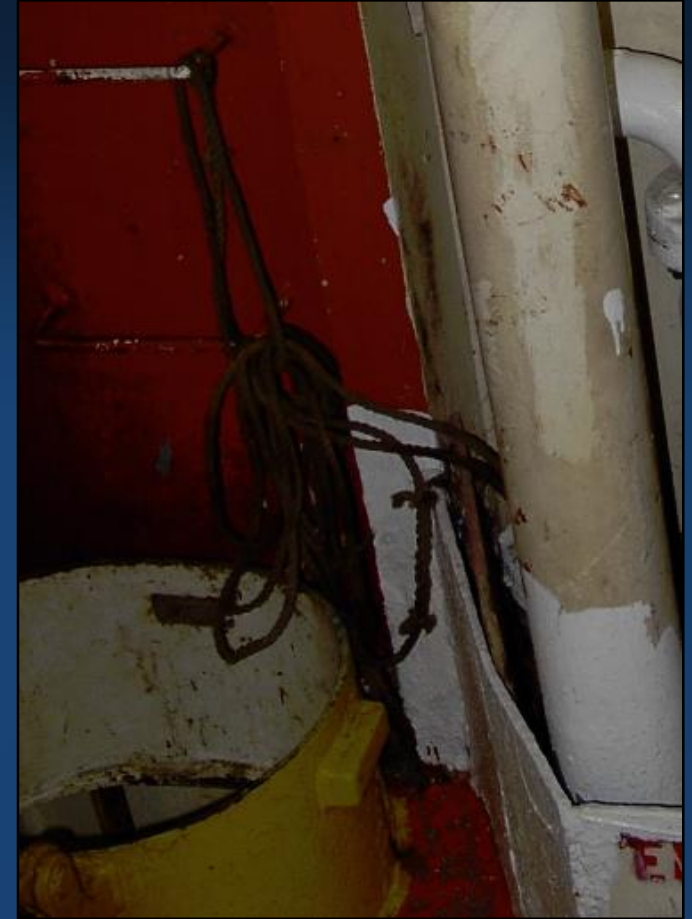
*El Faro Scuttle*

- Crew did not know when or how scuttle to hold 3 opened
- If bridge had open/close indicator, crew would have known scuttle was open

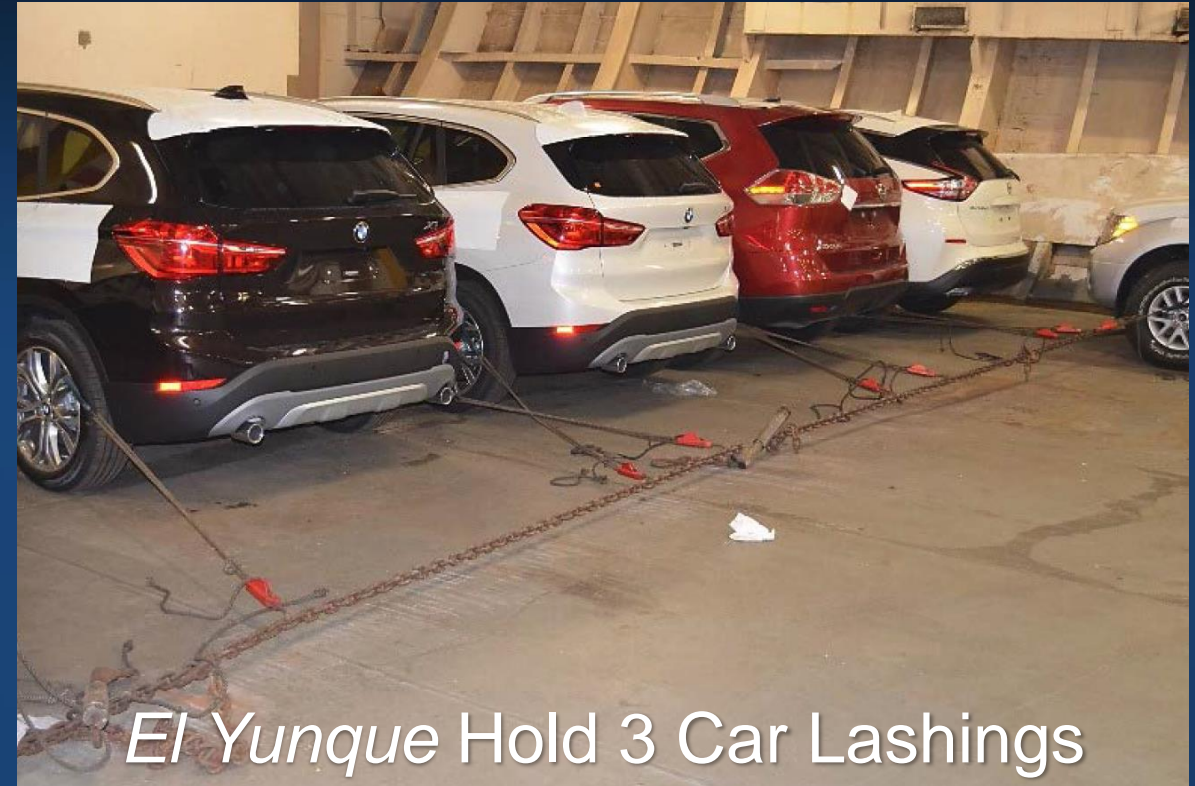
- Automobile lashings did not conform to cargo-securing manual
- Cars were more likely to shift during heavy weather

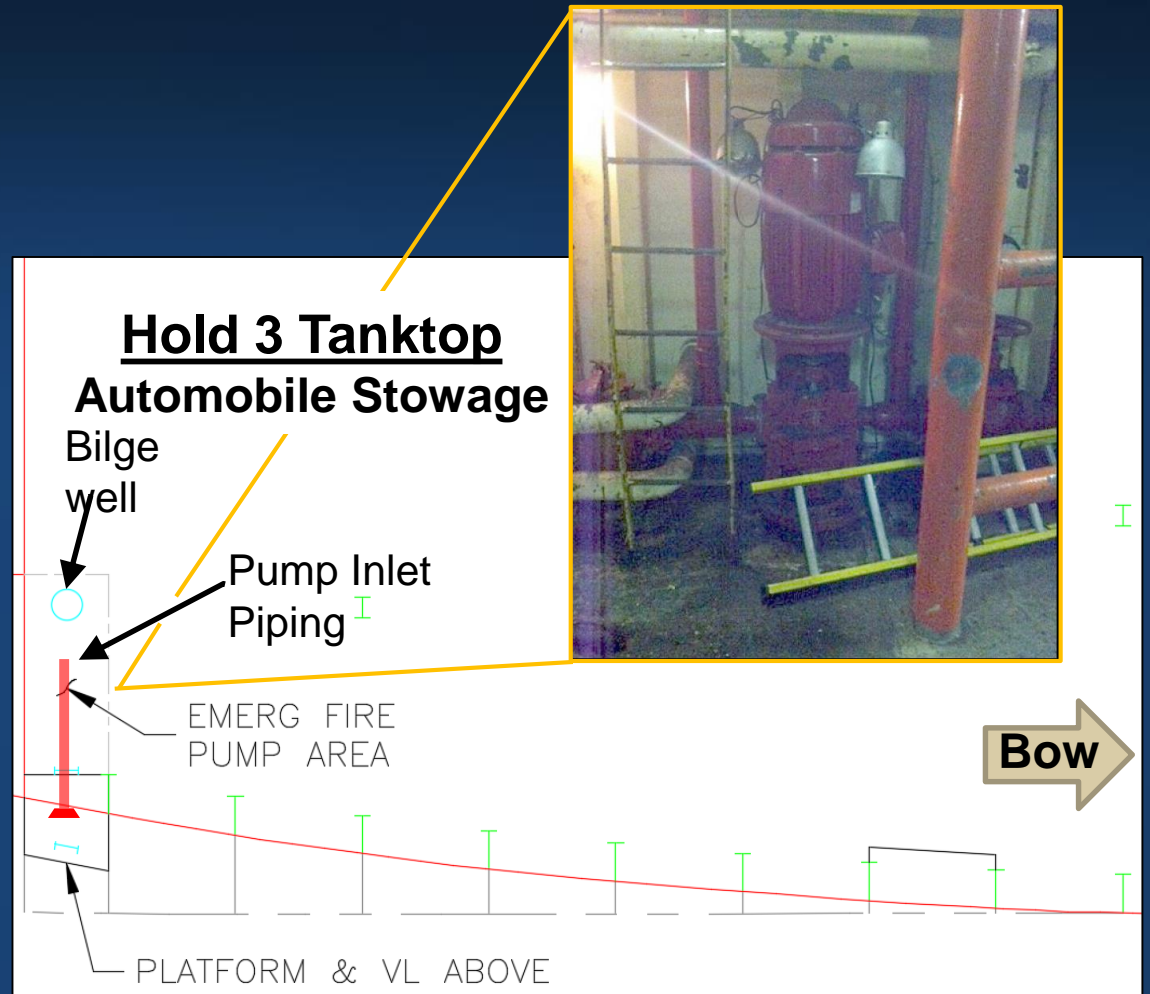
- Cars loose in hold 3 at 0544
- Bilge pumps already running
- Scuttle secured about 0600, but hold 3 still flooding
- Piping to fire pump possible source of flooding
- Loose cars could have struck piping to fire pump

- Damaged piping potentially flooded hold 10% to 20% by 0716
- MSC hydrostatic analysis
  - Beam-to 80-knot wind after loss of propulsion
  - Hold 3 flooded 10% to 30%
  - Rolling about sustained windheel
  - Vessel susceptible to capsizing
- Damage to seawater piping in hold 3 most likely led to flooding in the hold, which significantly compromised vessel's stability

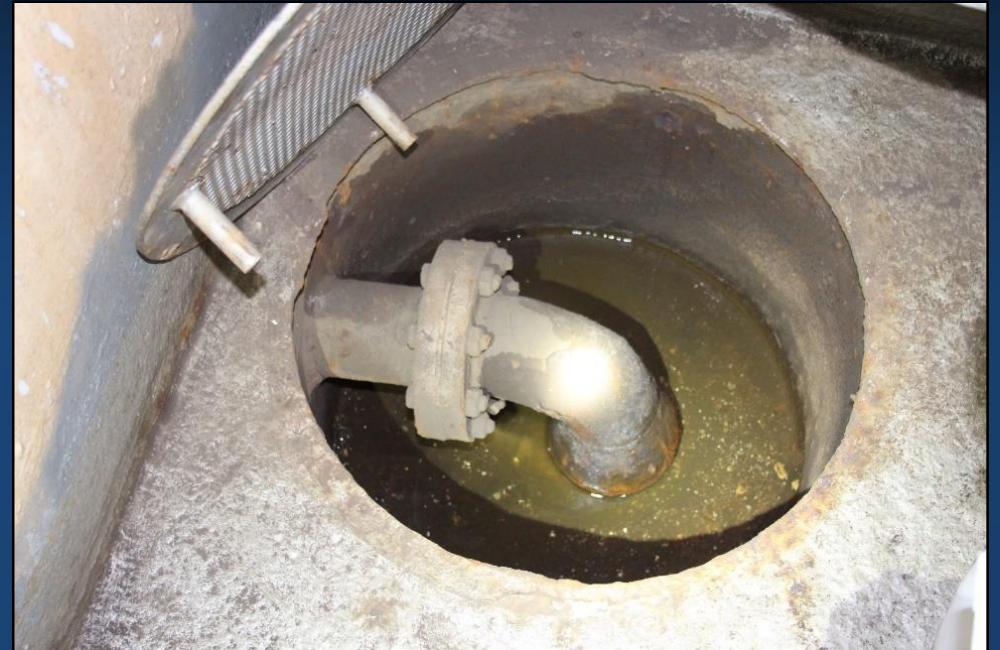
*El Yunque Bilge Well, Hold 3*

- Two bilge wells per cargo hold (port and starboard)
- Bilge system operated continuously from at least 0544
- Flooding in hold 3 exceeded design capacity of bilge pumps
- Water level continued to rise despite pumping

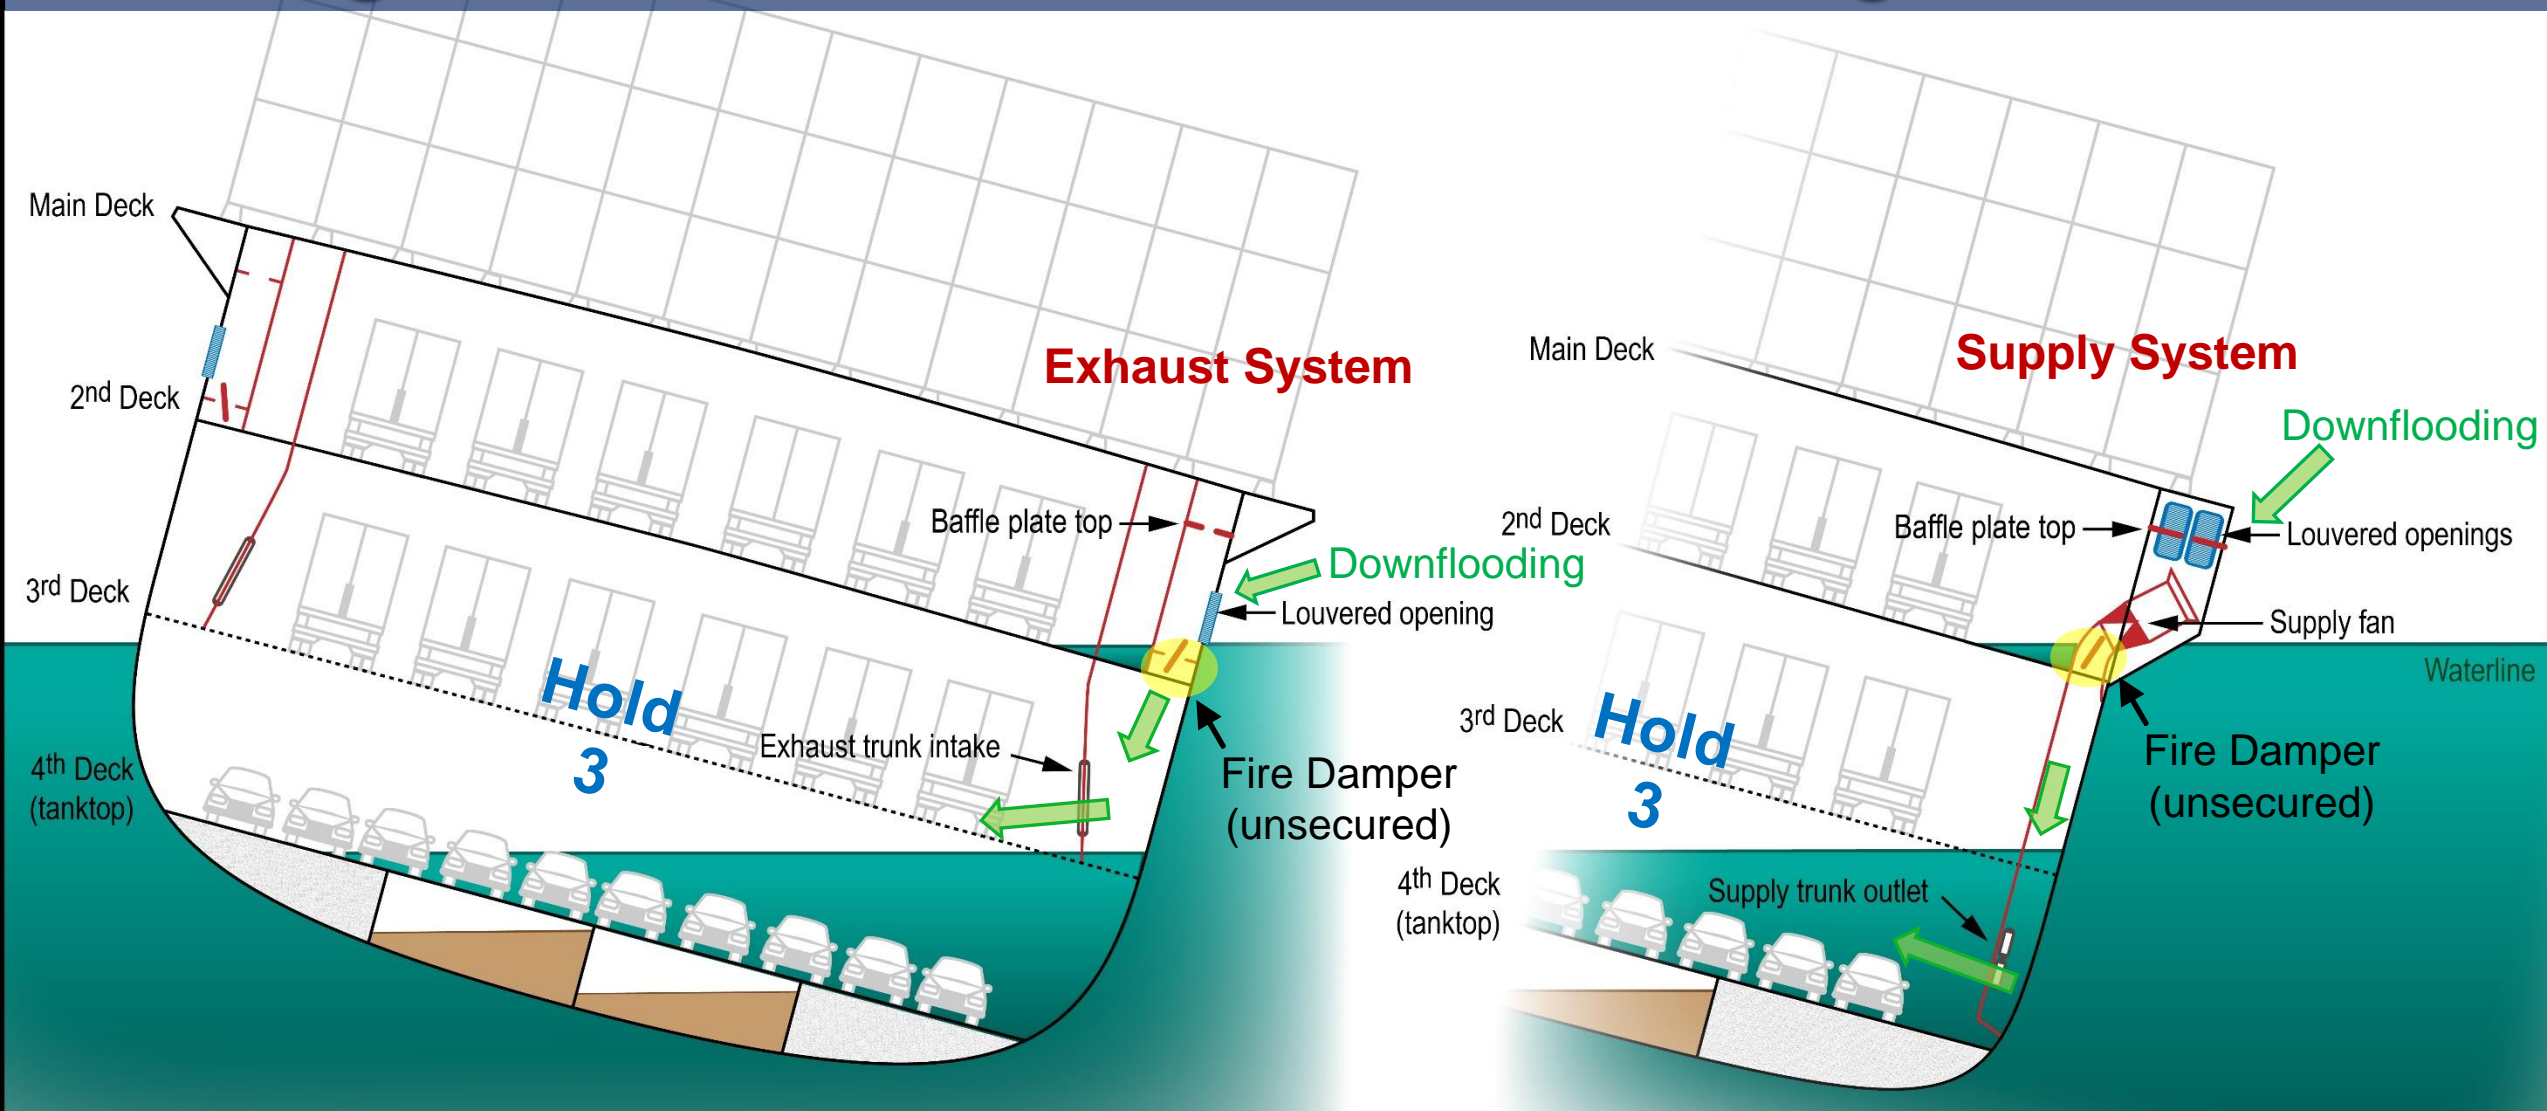
- Ventilation closures most likely remained open throughout sinking
- COI required ventilation of holds at sea
- Intact and damage stability standards consider ventilation openings to be closed
- Vessels should not have conflicting requirements
