Survival Factors

R. Jon Furukawa
Survival Factors Group Chairman

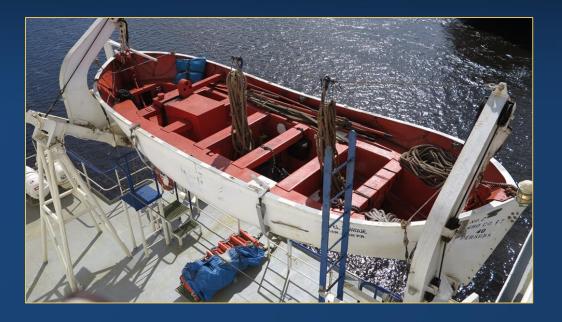
Survival Craft – Open Lifeboats

- 1980s: recognized as inadequate
- Does not protect crew from elements
- Not allowed on new vessels since 1986
- Allowed to remain if maintained
