National Transportation Safety Board

Uncontained Engine Failure and Subsequent Fire
American Airlines Flight 383
Chicago, Illinois
October 28, 2016

Investigator-in-Charge
presentation

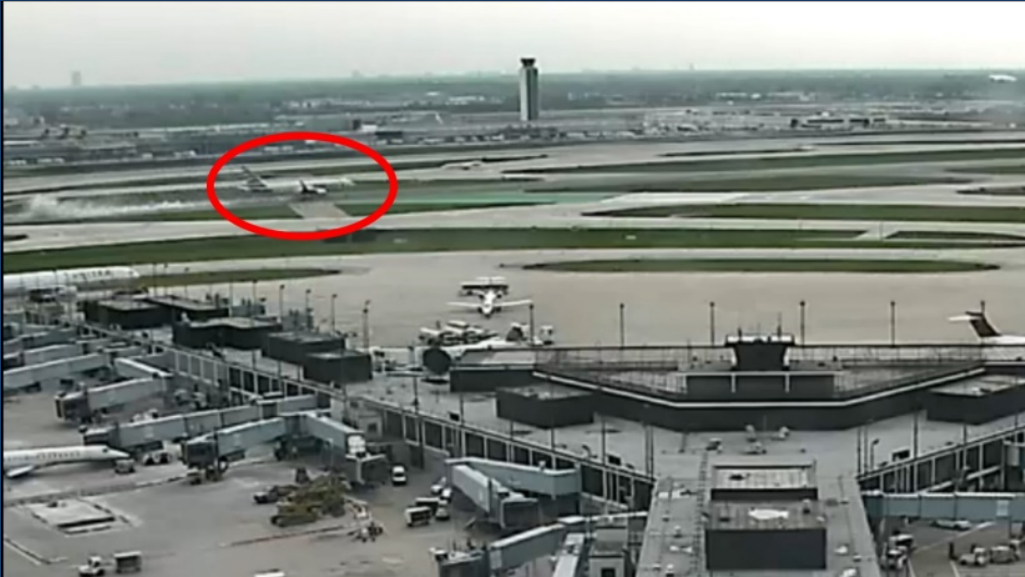
Rejected takeoff

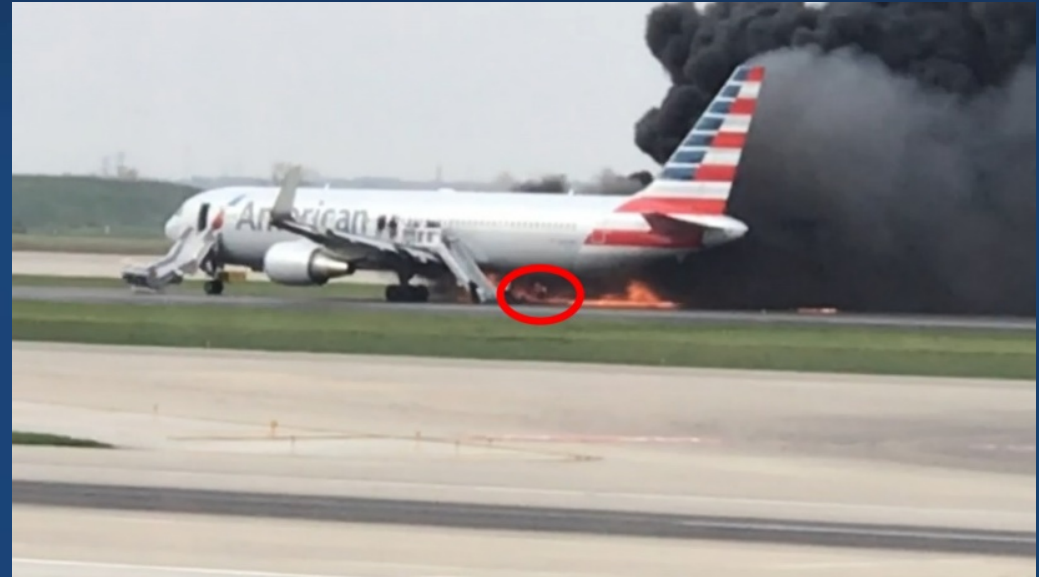
Evacuation

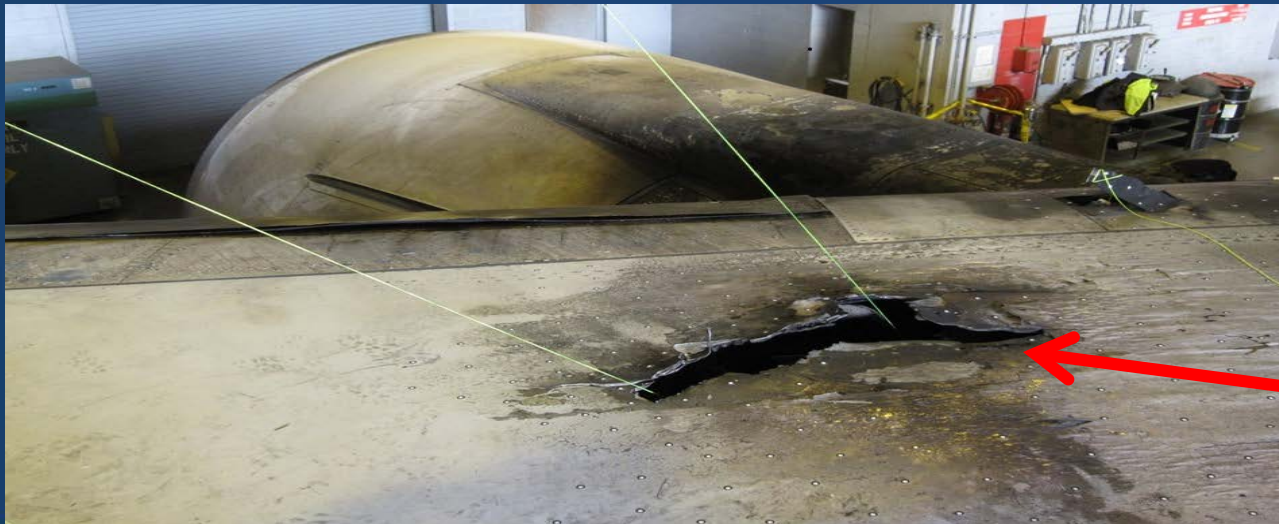
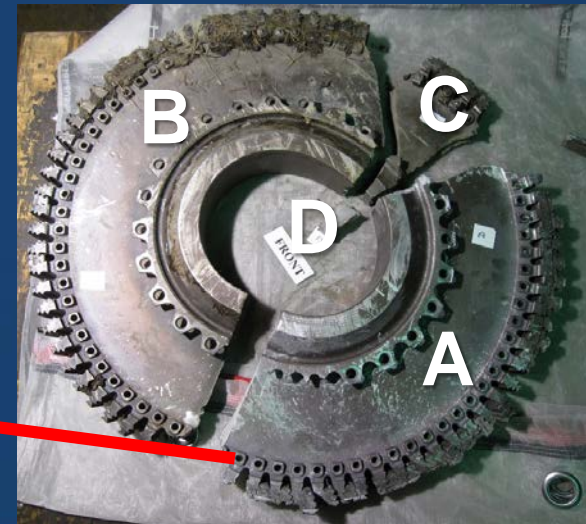
Uncontained Engine Failure

- High-pressure turbine (HPT) stage 2 disk rupture
- HPT stage 2 disk nickel-based alloy
