National Transportation Safety Board

Uncontained Engine Failure and Subsequent Fire
American Airlines Flight 383
Chicago, Illinois
October 28, 2016

Powerplants and Metallurgy
presentation

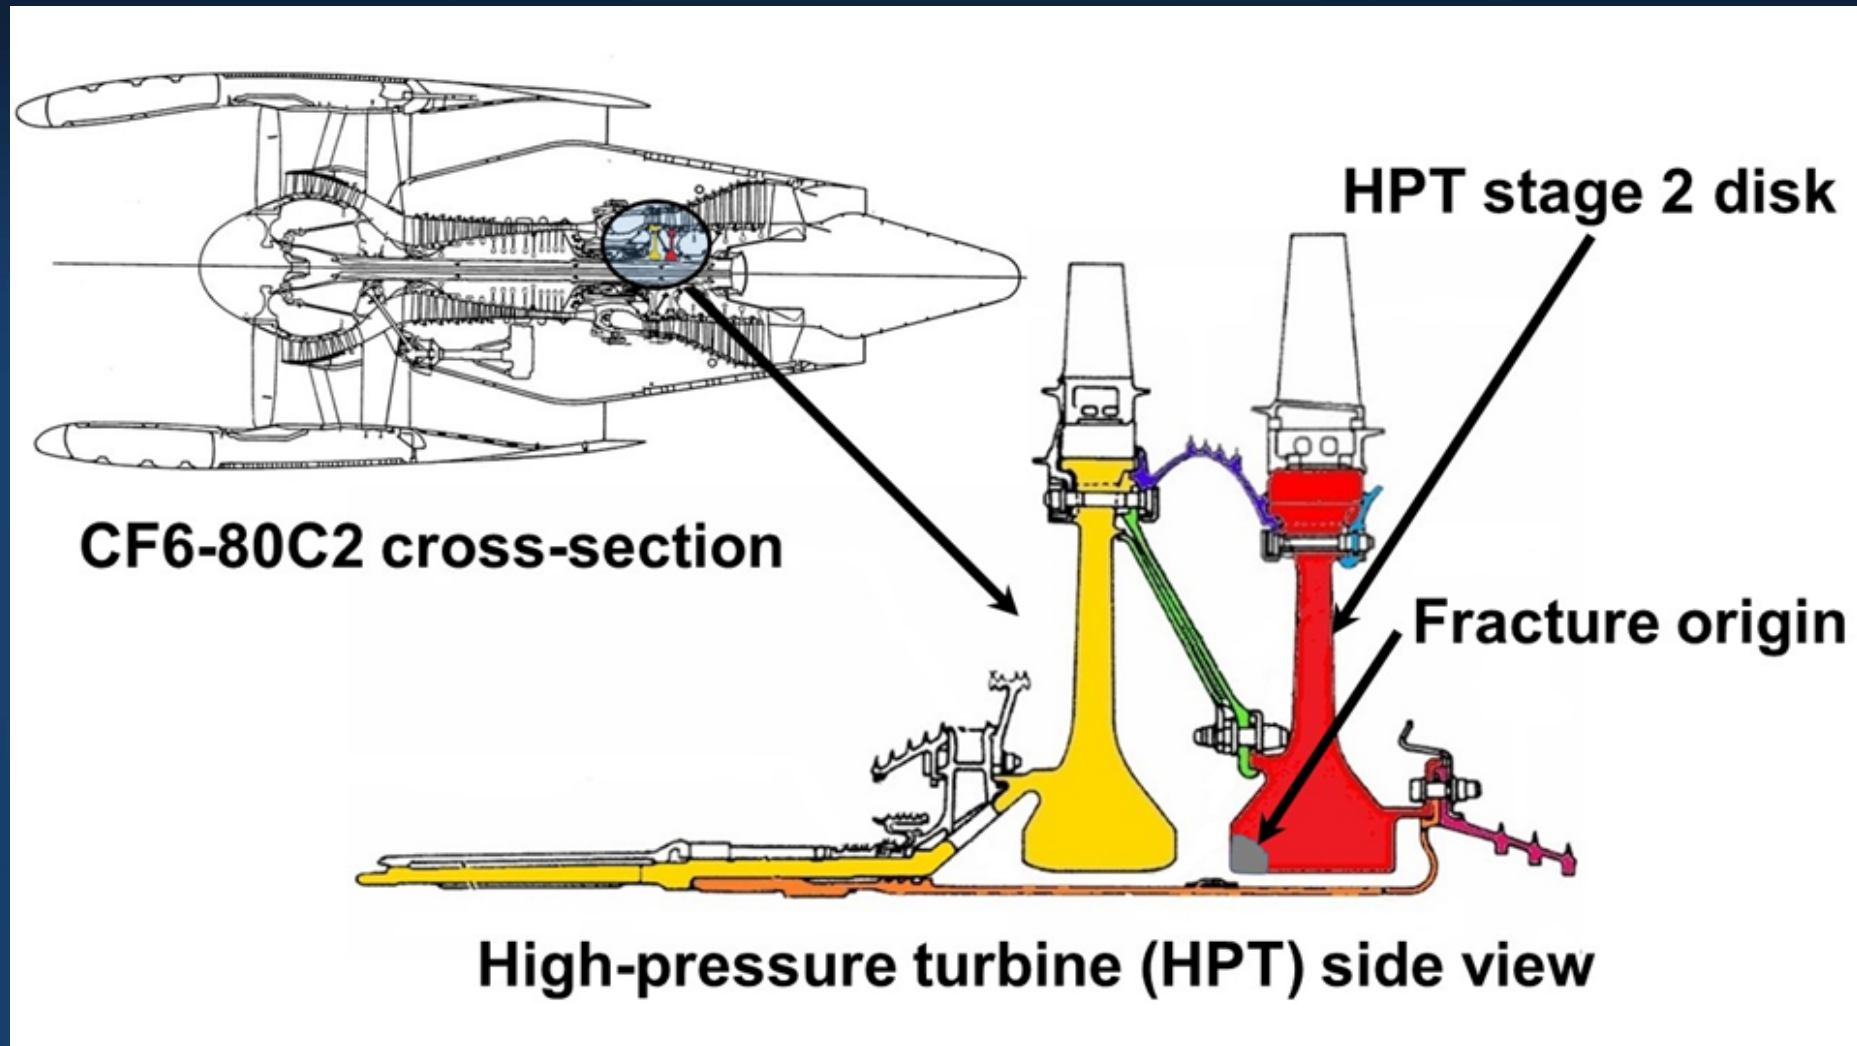
Accident Engine Model

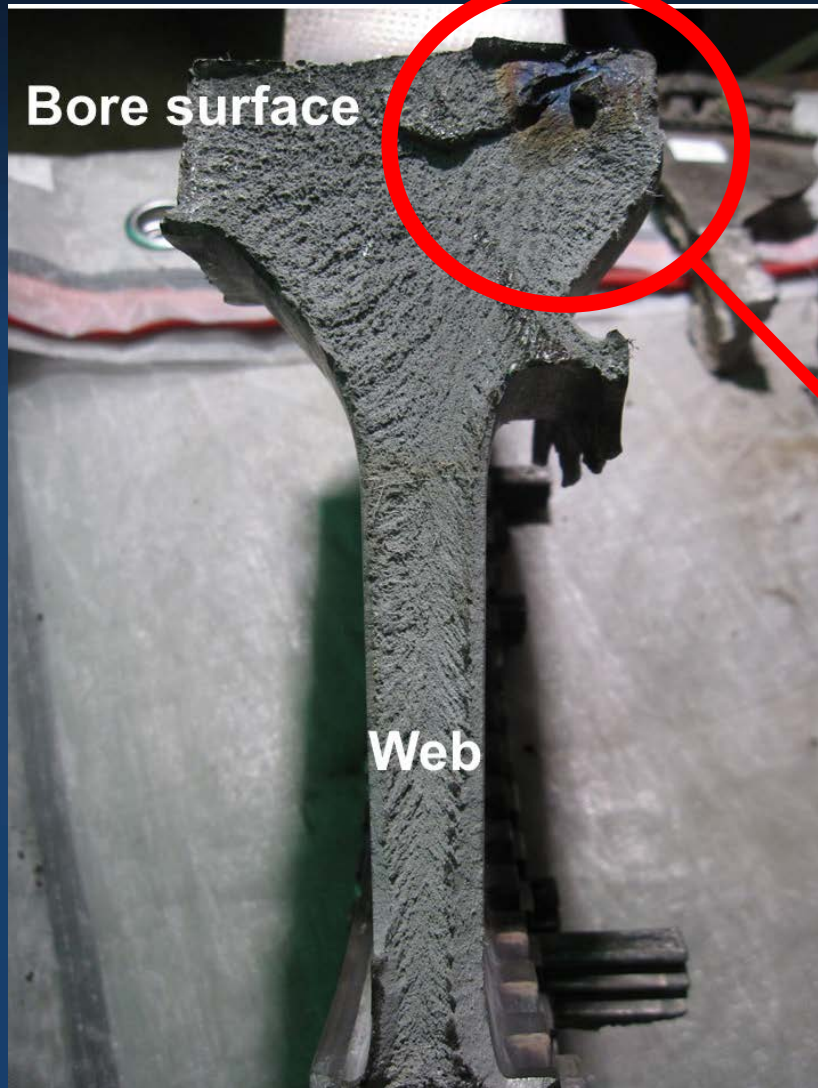
HPT Stage 2 Fracture

- Internal defect found near bore
- NTSB Materials Laboratory performed examination

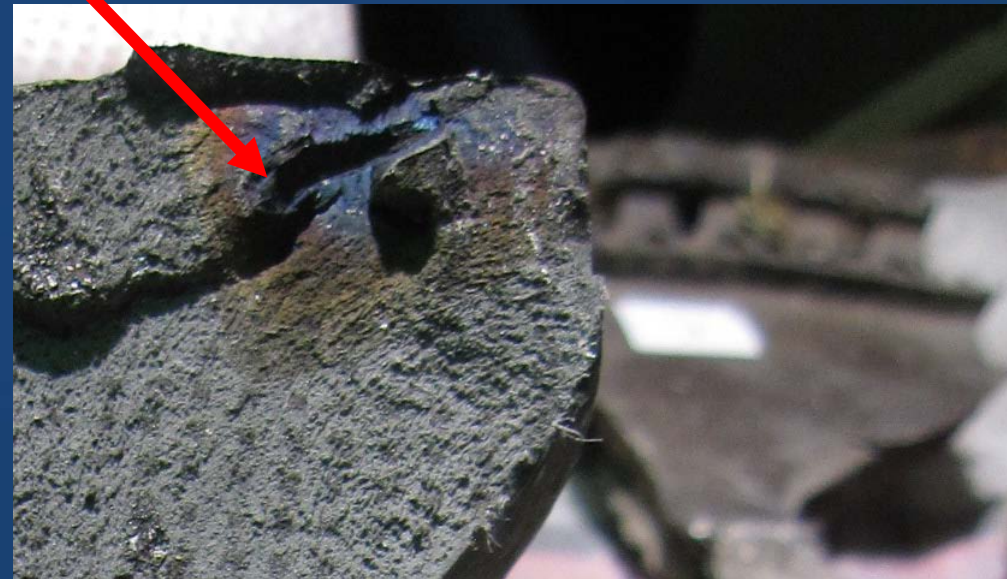
Initiation at Internal Anomaly by Low-Cycle Fatigue

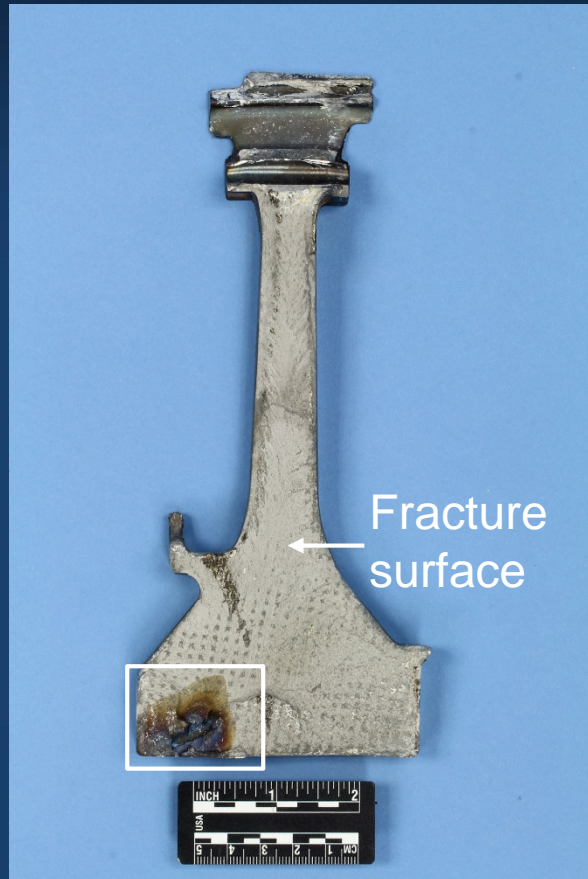
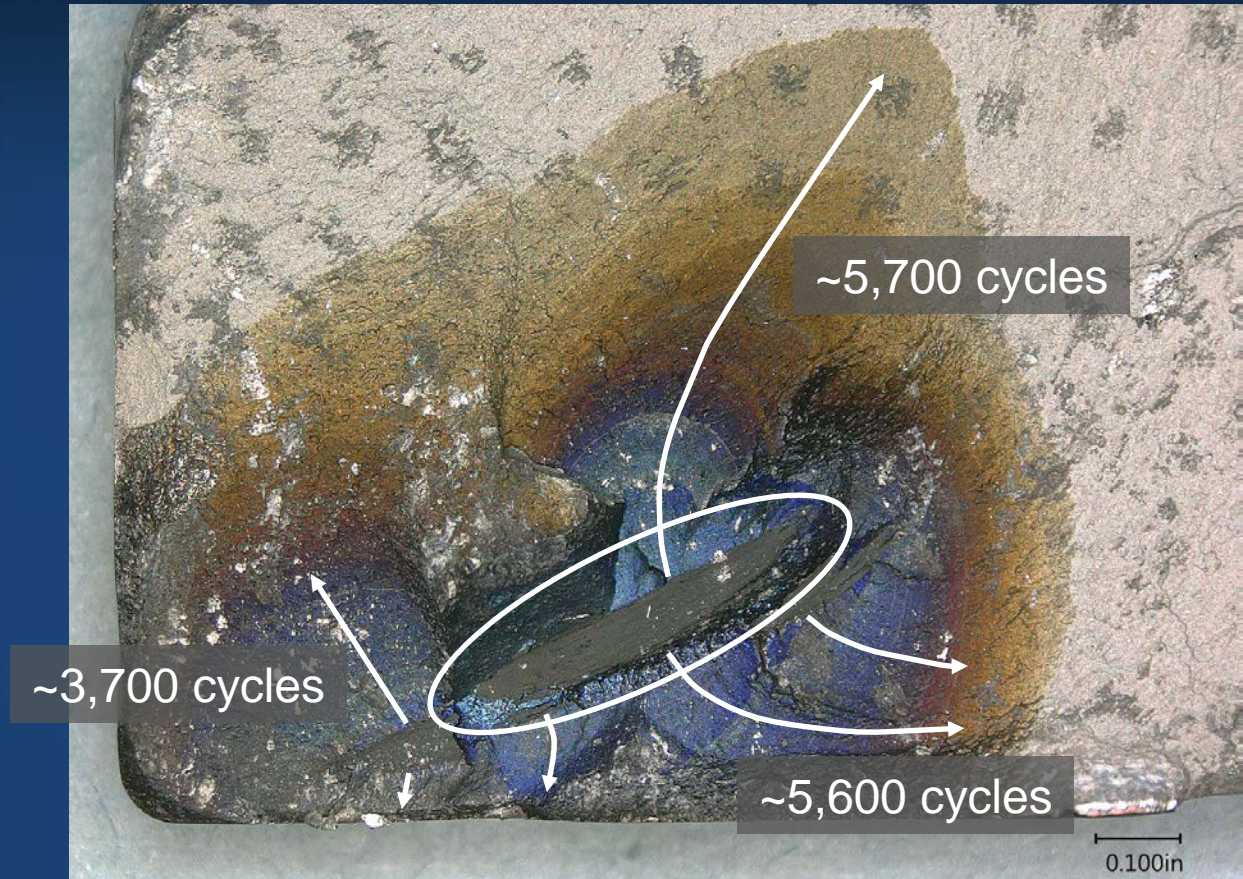
Metallurgical Characterization of Anomaly

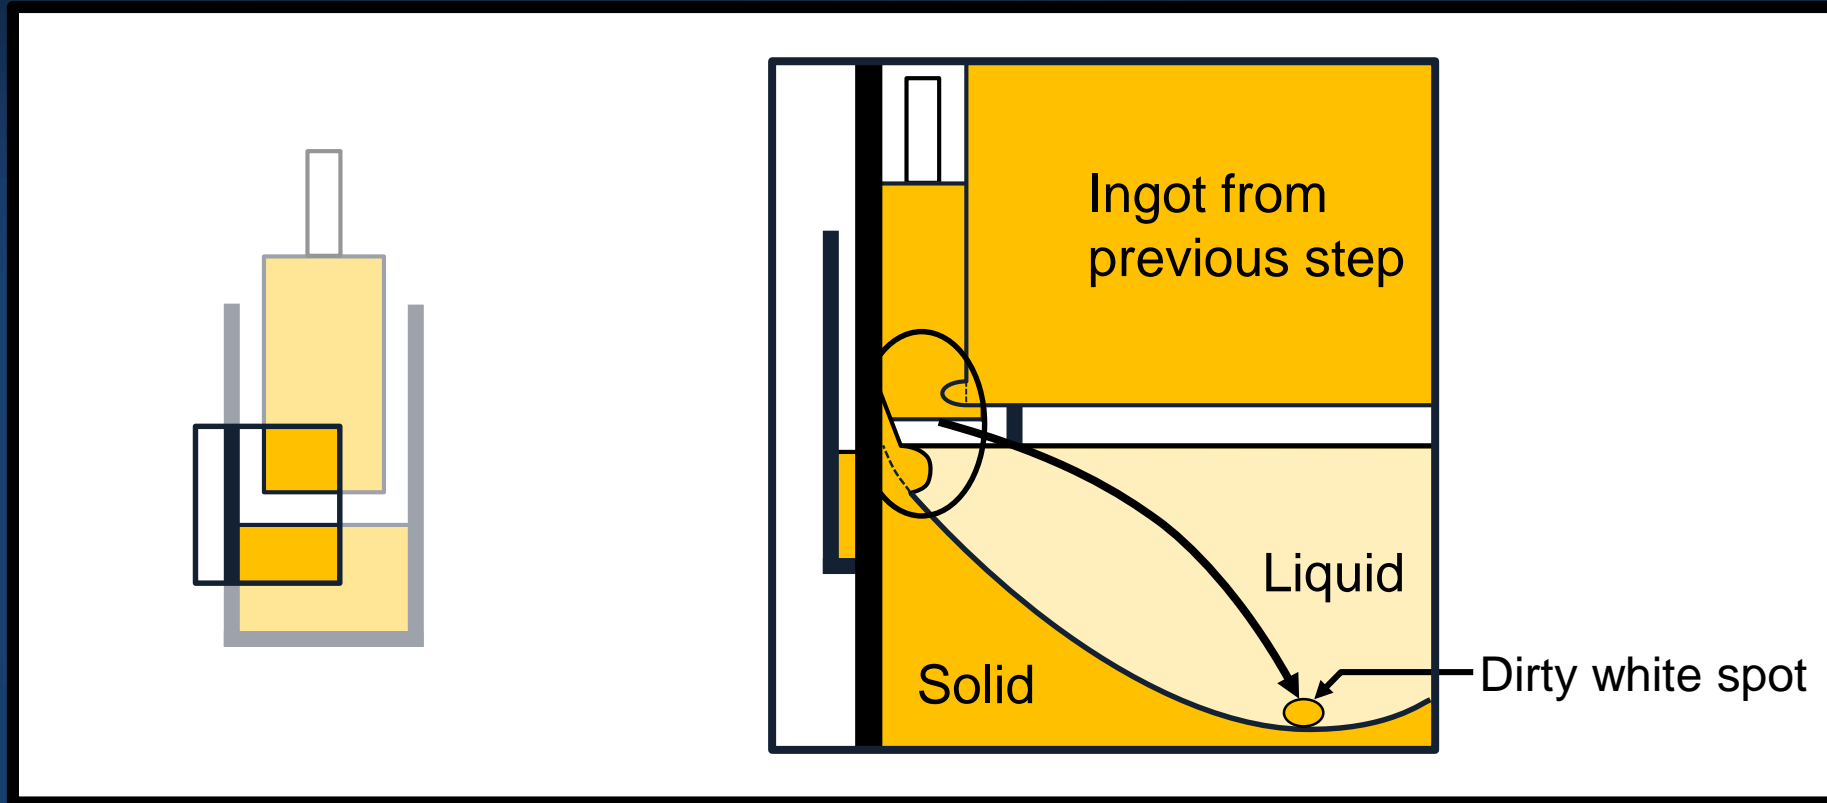
Formation of Dirty White Spot

- No discrepancies found in production records
- Dirty white spots known to reduce low-cycle fatigue life
- Typically detected by ultrasonic inspection

- All aviation parts made from same material as failed disk removed from service; no defects reported
- Service bulletins (SB) calling for ultrasonic inspections of all CF6-80A/C2 HPT stage 1 and 2 disks produced before 2000
- Notice of proposed rulemaking to mandate inspections in SBs

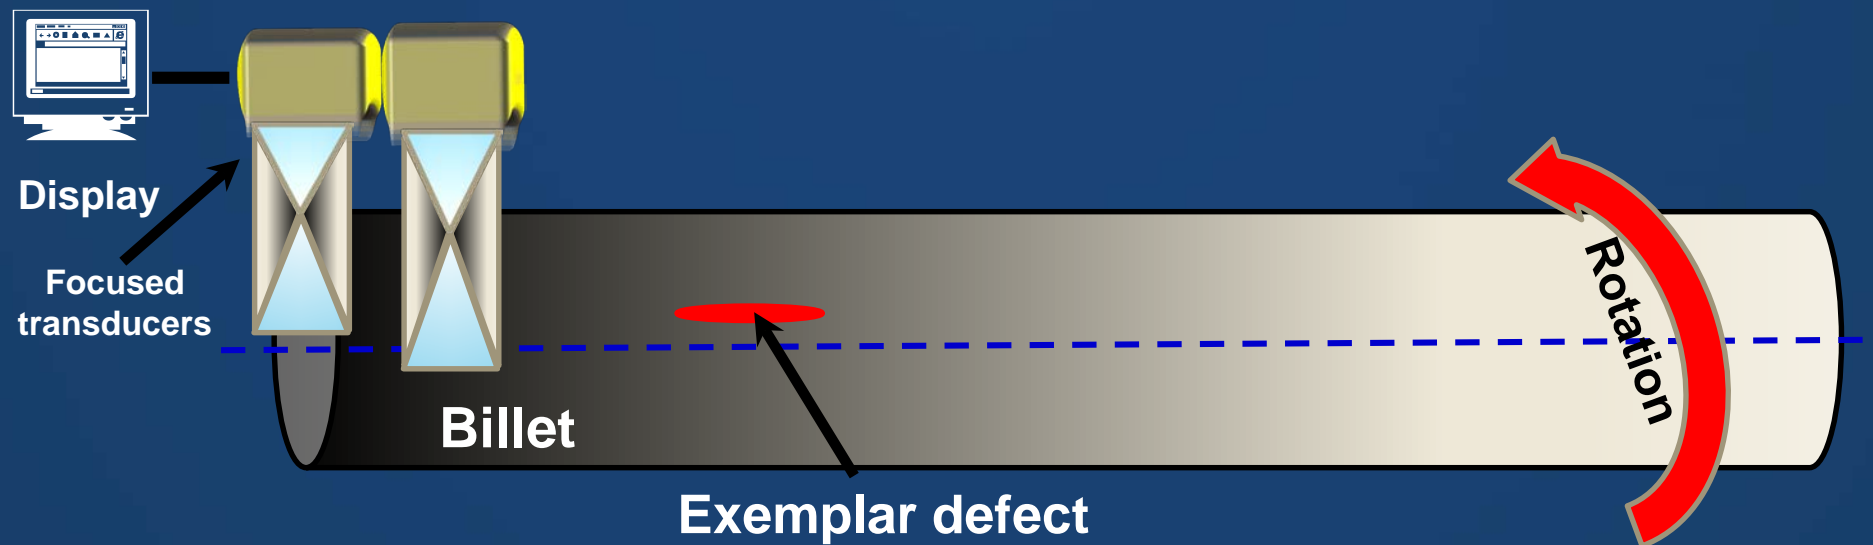
- Event disk subjected to four inspections - two production and two in-service
- Production inspections - immersion ultrasonic inspections
 - Excellent for subsurface detection
 - Billet inspected by ATI Specialty Materials; no defects reported

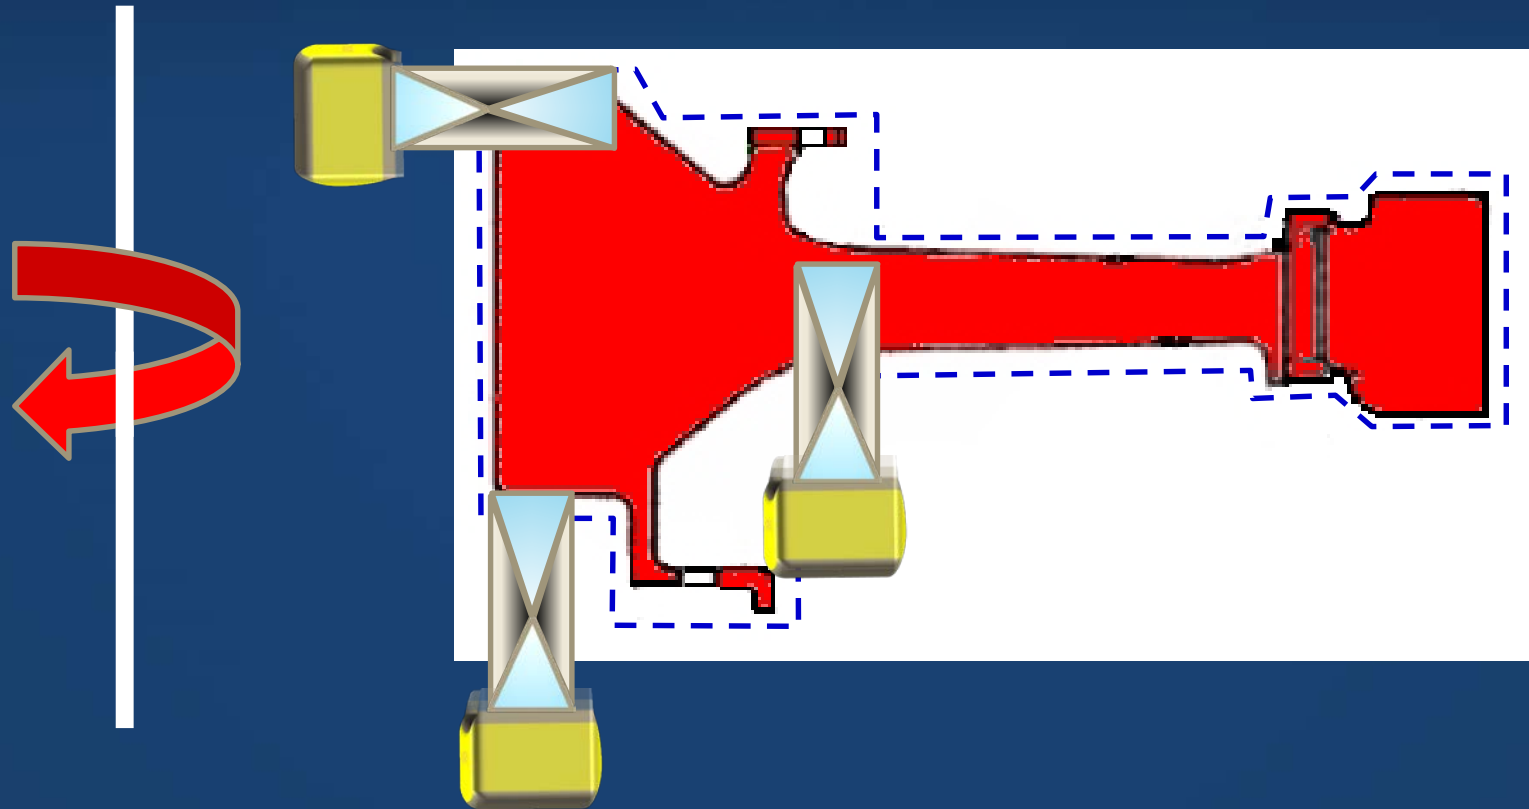
Centerline of bore

- “Sonic shape” inspected by MTU using combination of scanning techniques; no defects reported

- American Airlines (AA) performed fluorescent penetrant and eddy current nondestructive inspections
 - No defects in bore reported
 - Inspections are surface based; defect was subsurface
 - Internal cracks had not reached surface when AA inspected disk
 - Cracks should have been detectable with subsurface inspection techniques
