Clinton O. Johnson
Chief
Alaska Regional Office

Controlled
Flight
Into
Terrain

Cessna 182P Juneau, Alaska

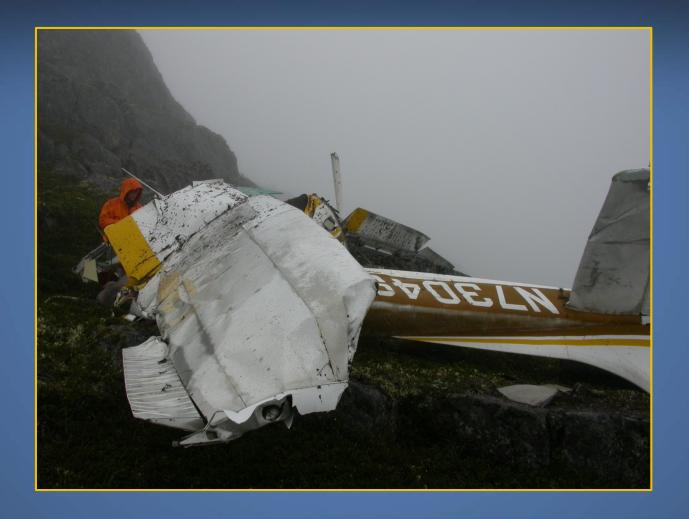
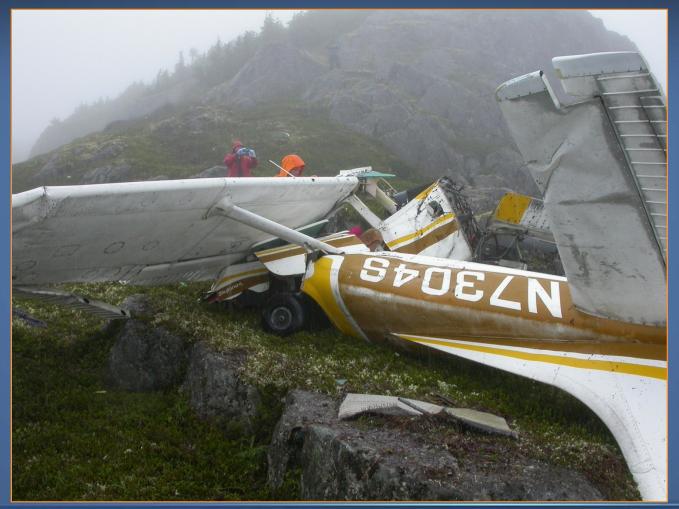
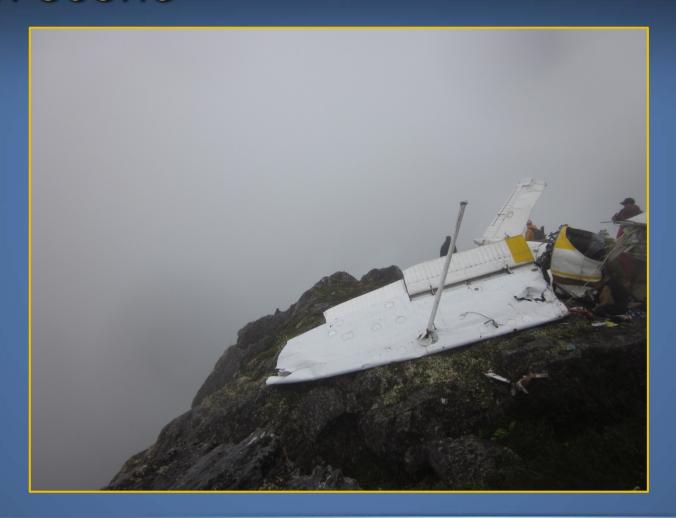
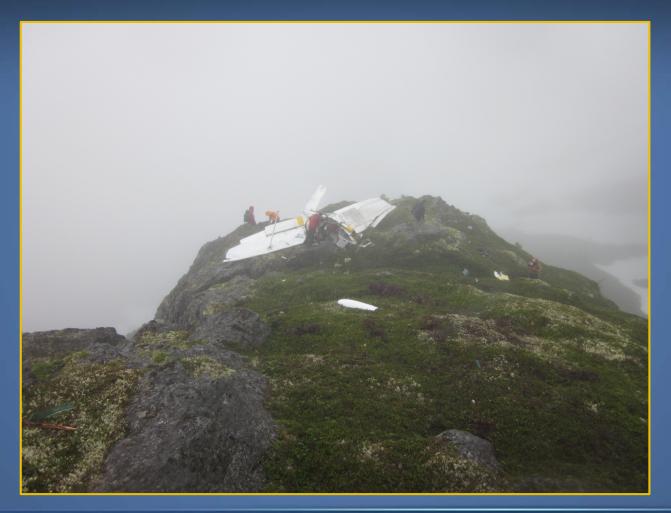
Wreckage located

- 3,100 foot level
- Mountainous terrain
- Fragmented wreckage
- 2 occupants, deceased

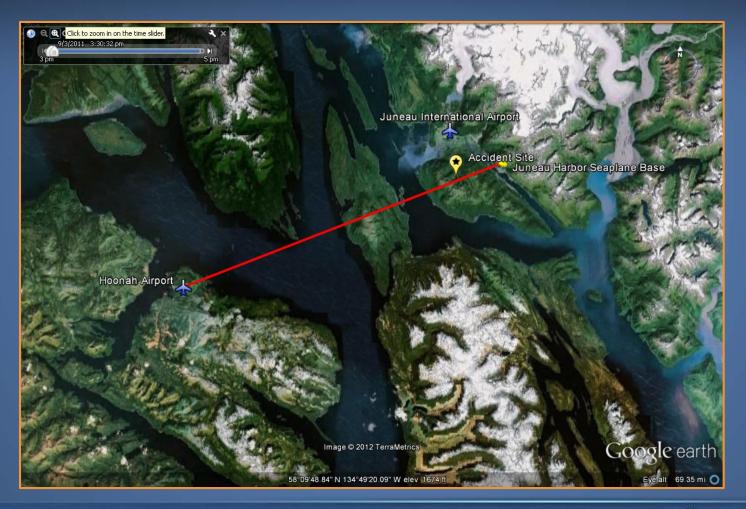
Actual flight path

The pilot's continued visual flight into instrument meteorological conditions, which resulted in an in-flight collision with mountainous terrain. Contributing to the accident was the pilot's self-induced pressure to reach his destination.

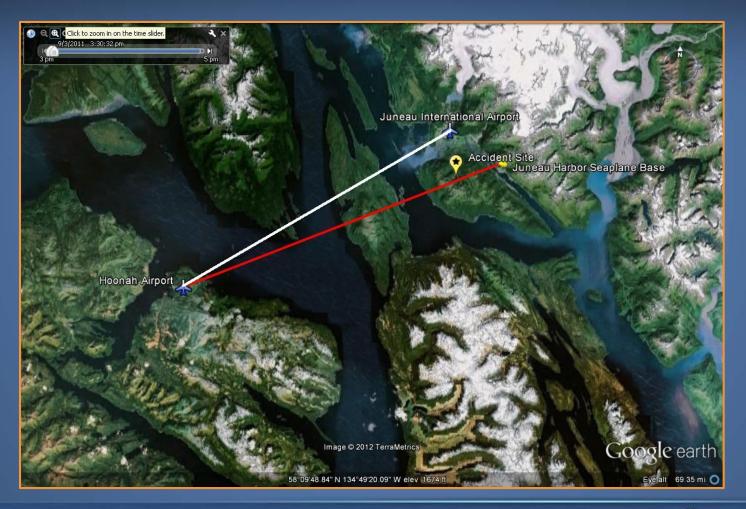
Intended flight path

- Late departure
- Missed flight
- Wife's job
- Poor weather along route
- Unfamiliar with area
- Wrong destination airport (W/P)
