National Transportation Safety Board

Hageland Aviation
Cessna 208B Grand Caravan
October 2, 2016
Togiak, Alaska

Shaun Williams
Investigator-in-Charge

History of Flight

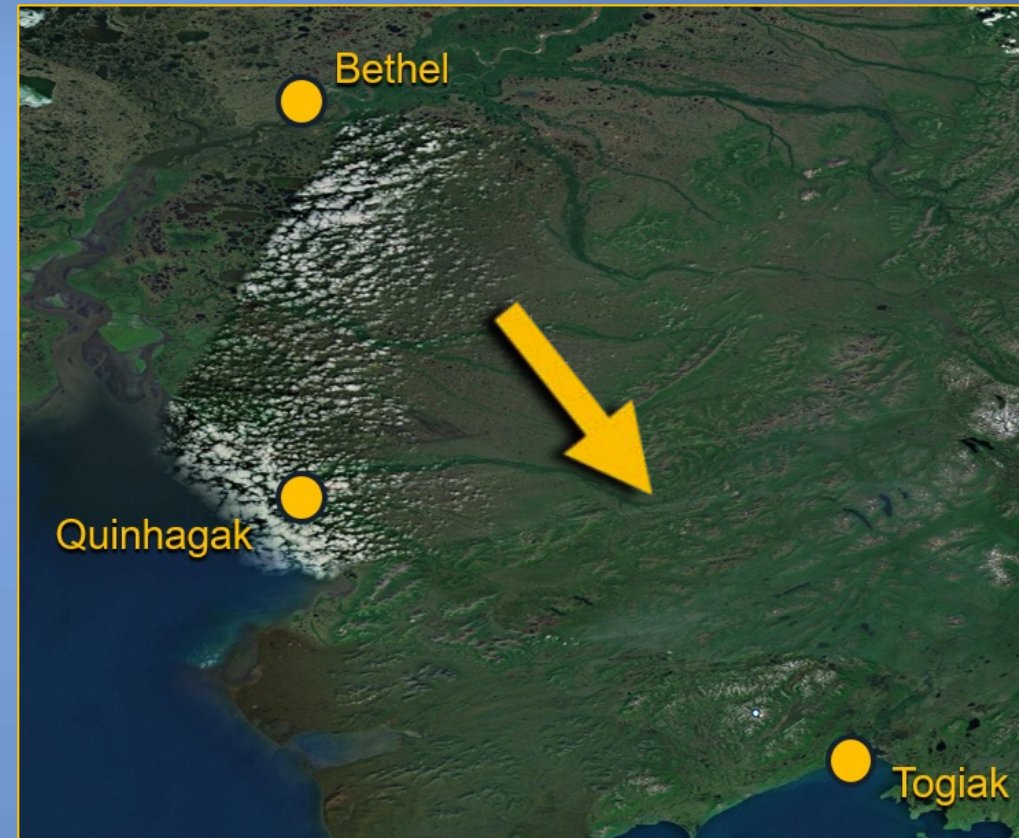
Second Leg: Togiak to Quinhagak

- Departed at 1044
- Arrived at 1125
- Altitude about 4,500 ft msl

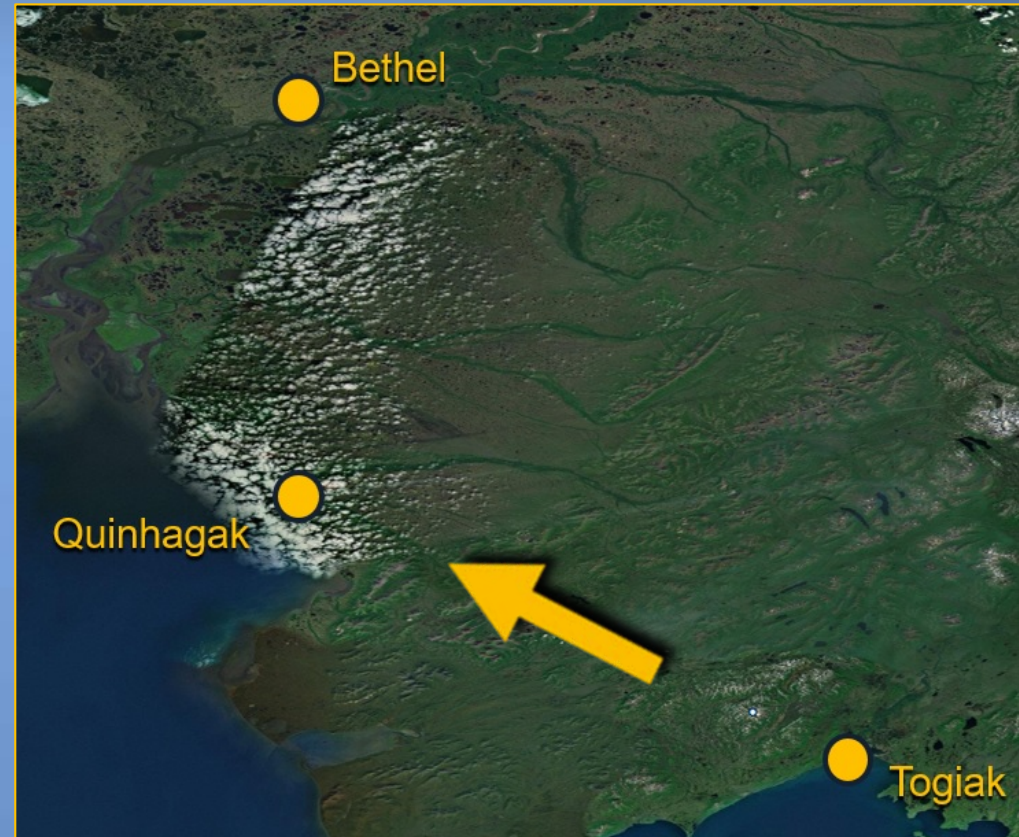
Third leg: Quinhagak to Togiak

- Departed at 1133
- Altitude about 1,000 ft msl (500-700 ft agl)
- During final 4 minutes climbed to 2,300 ft msl before colliding with mountain ridge
