National Transportation Safety Board

Fire and abandonment of Ro/Ro Passenger Vessel
Caribbean Fantasy
Two Miles Northwest of San Juan Harbor
San Juan, Puerto Rico
August 17, 2016

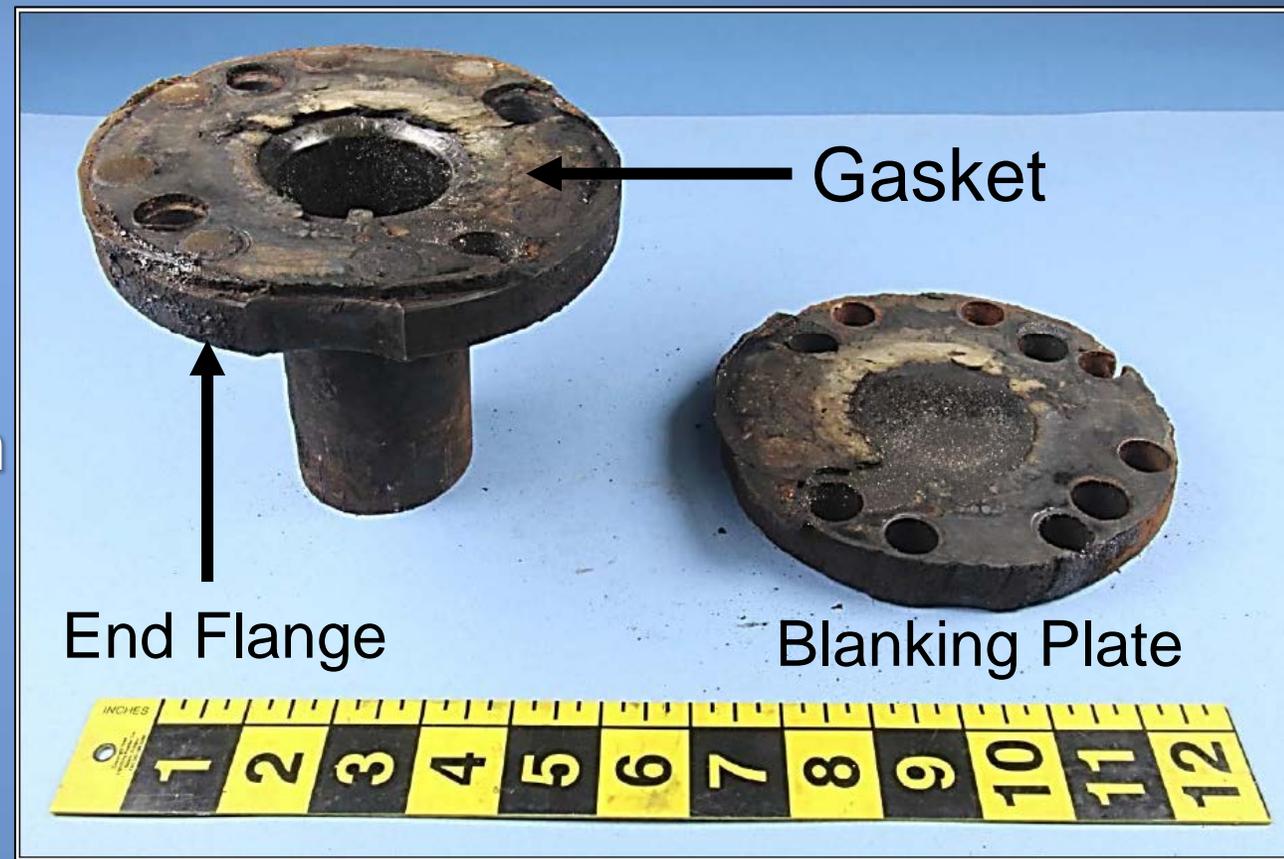
Improper Gasket Material & Nonstandard Blanking Plate

- End flange
 - Four bolt flange
 - OEM design
- Gasket material
 - Silicone rubber composition
 - Not specified composition
- Blanking plate
 - Not OEM design

- Customer information letter not followed
- Improper gasket material
- Non-OEM blanking plate

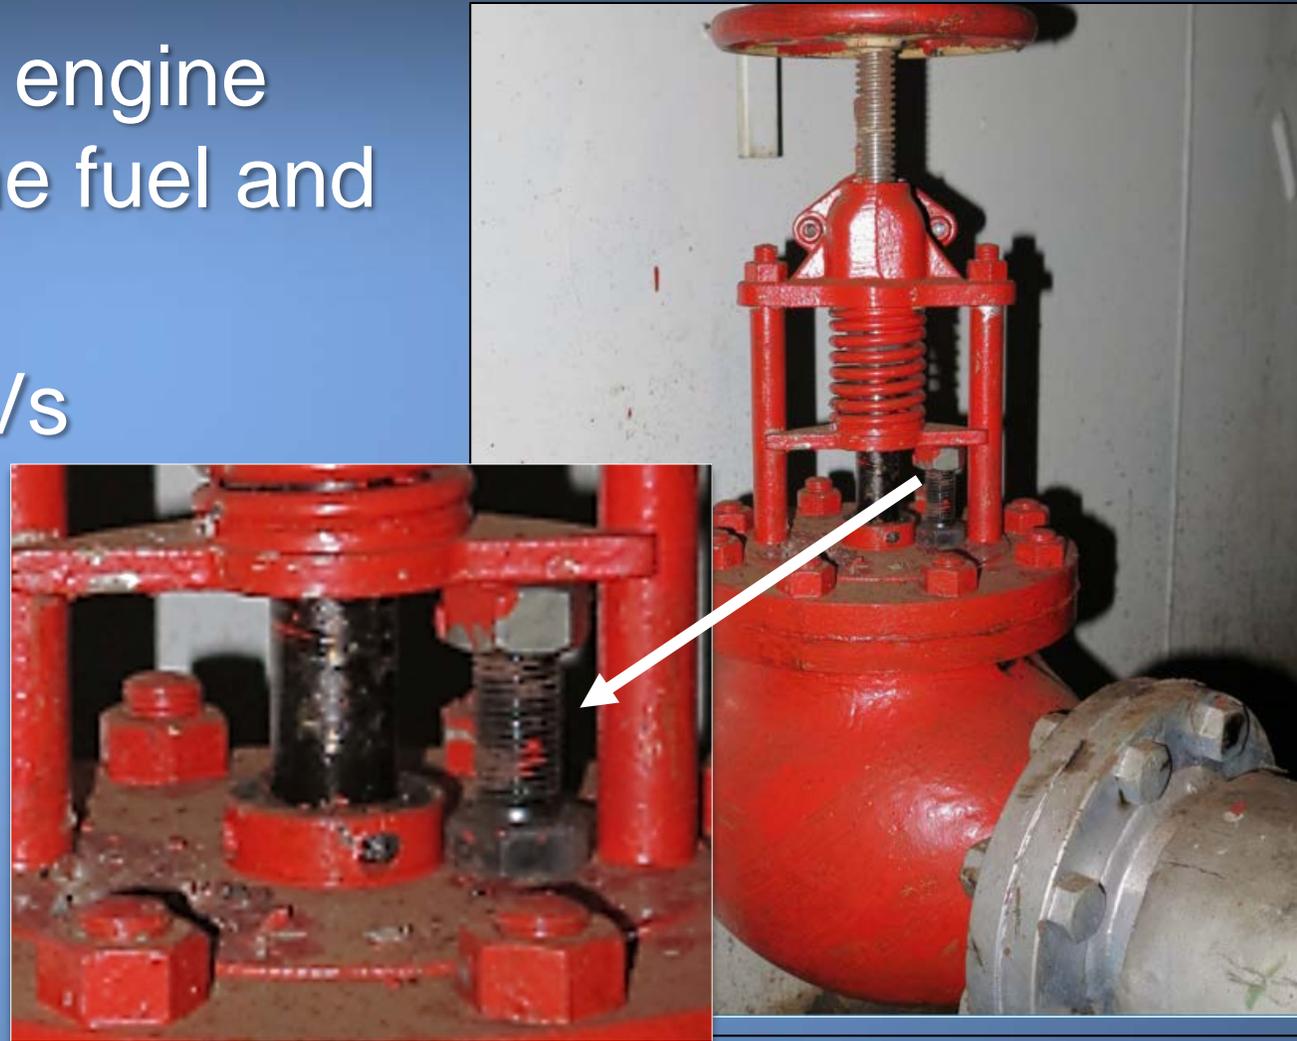
Fuel & Lube Oil Quick Closing Valves (QCVs)

- Designed to seal the main engine room space by securing the fuel and lube oil at the tanks
- Eight fuel and lube oil QCVs blocked open

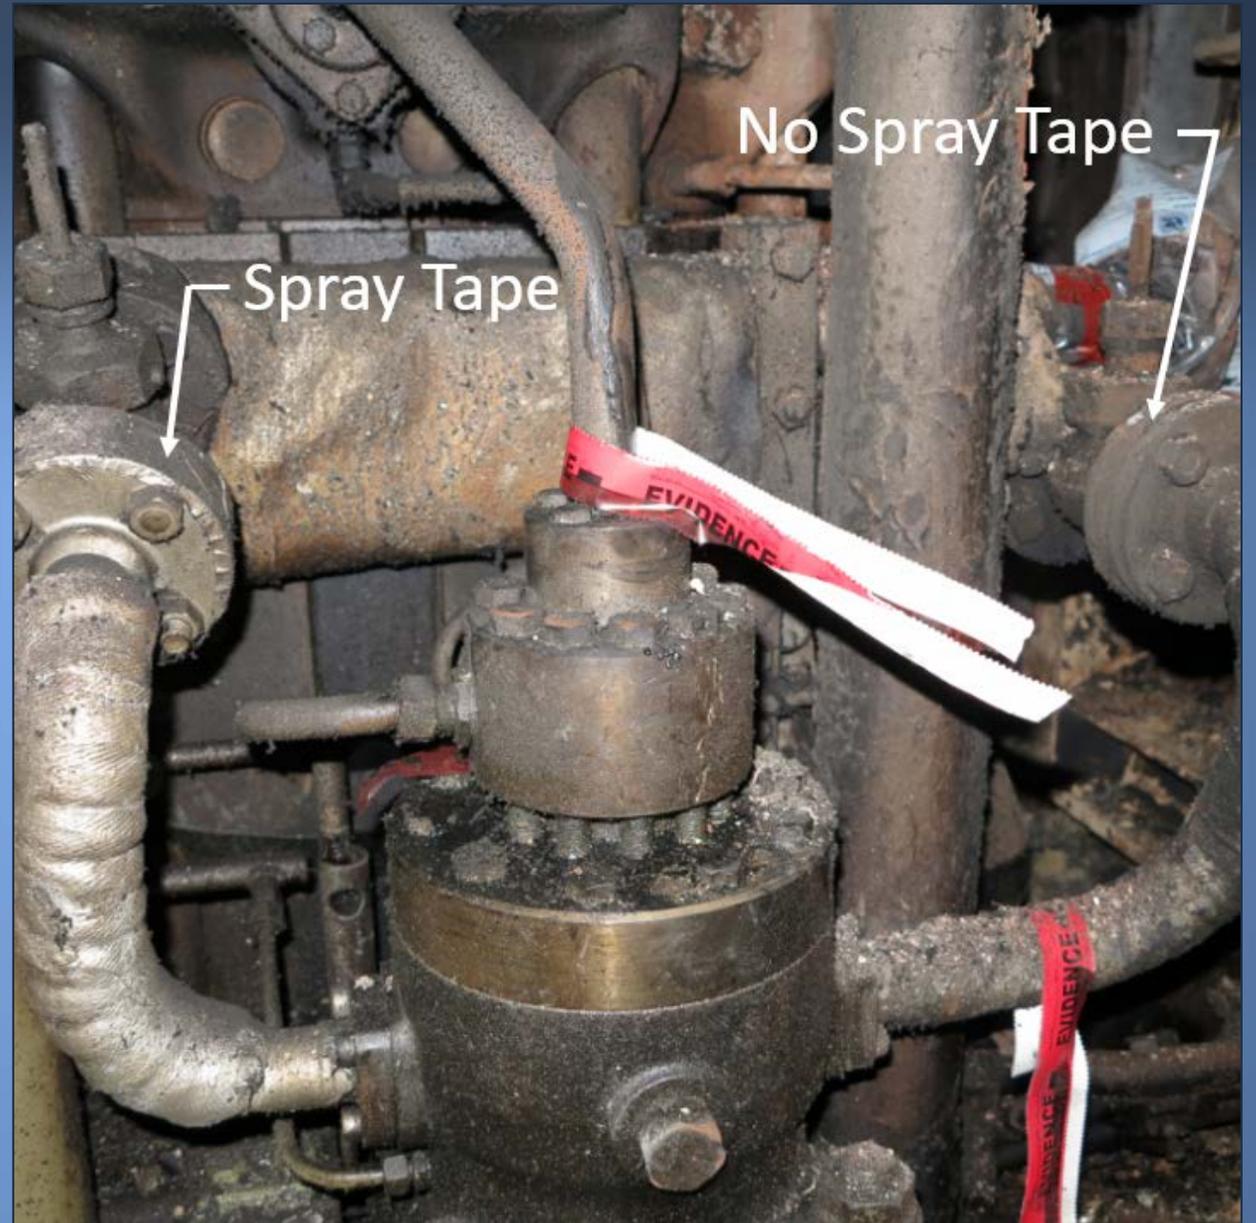
Anti-Spray Tape

- Prevent fuel spray
- Improper installation

All connections need to be equipped with an appropriate splash guard to address this safety issue. Furthermore you should regularly inspect the functionality and correct installation of the splash guards.

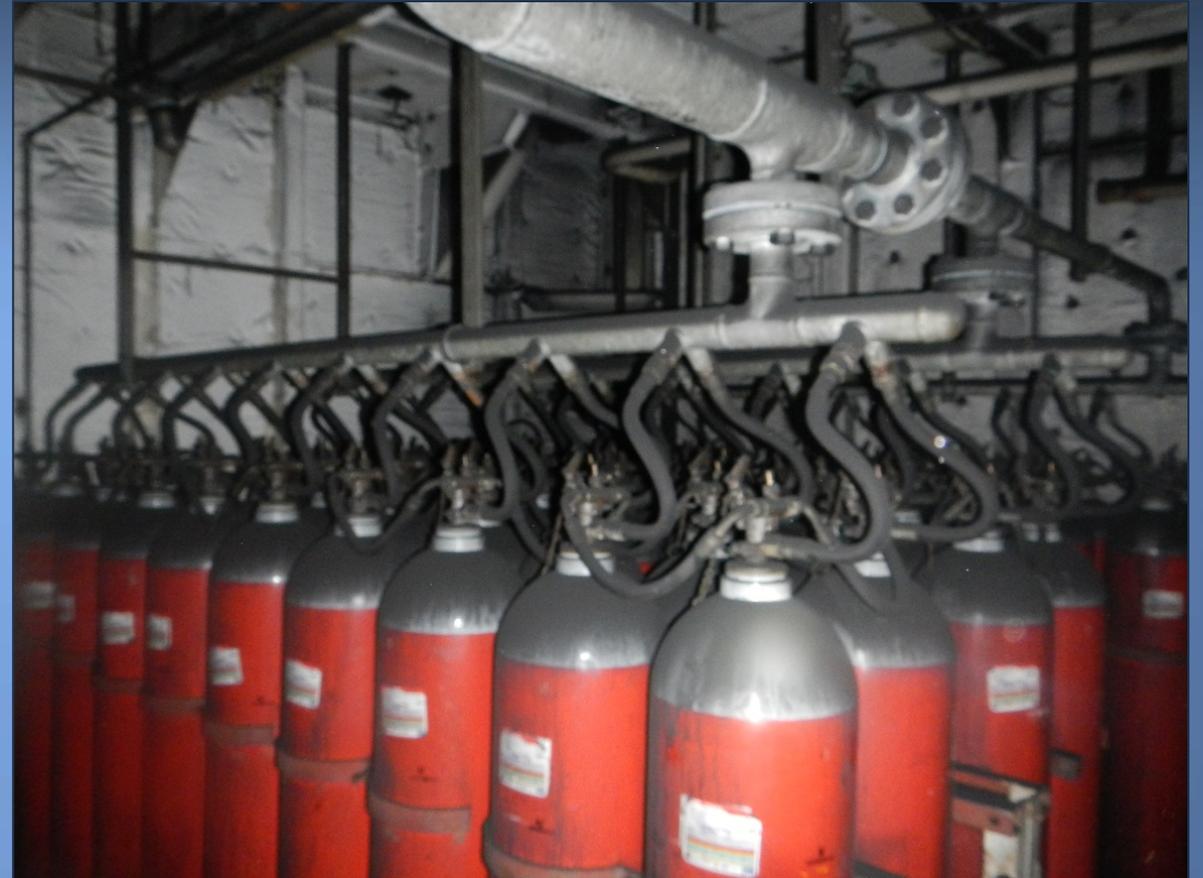
Carbon Dioxide (CO₂) Fixed Firefighting System

- Fire not contained or suppressed by CO₂
 - Heat and smoke spread to adjacent areas
 - Black smoke seen coming from exhaust stacks
- Ventilation dampers not sealed

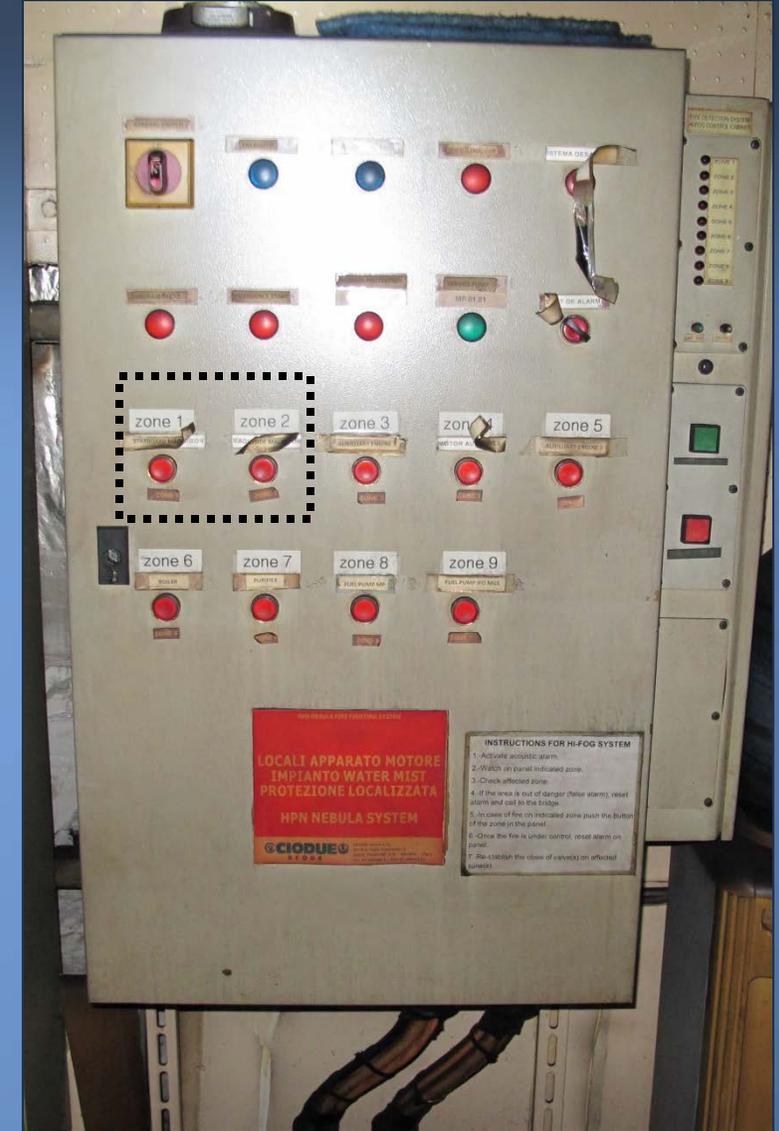
Water-Mist System

- Chief engineer activated water-mist system
- VDR indicated automatic activation of additional zones
- System did not suppress or contain fire in engine room

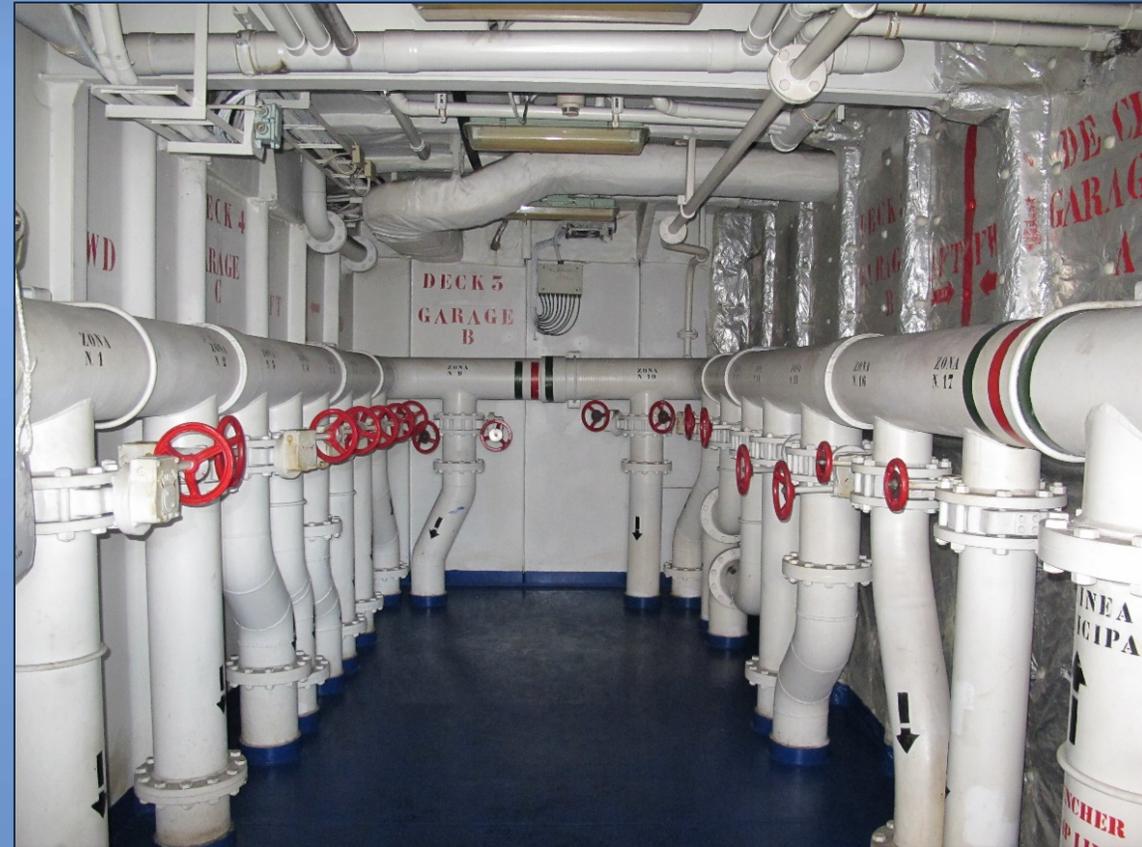
Drencher System

- Same fresh water tanks supplied both systems
 - Last filled in San Juan
 - Found nearly empty postaccident
- Water mist did not suppress fire
 - Multiple activations
 - Reduced water supply

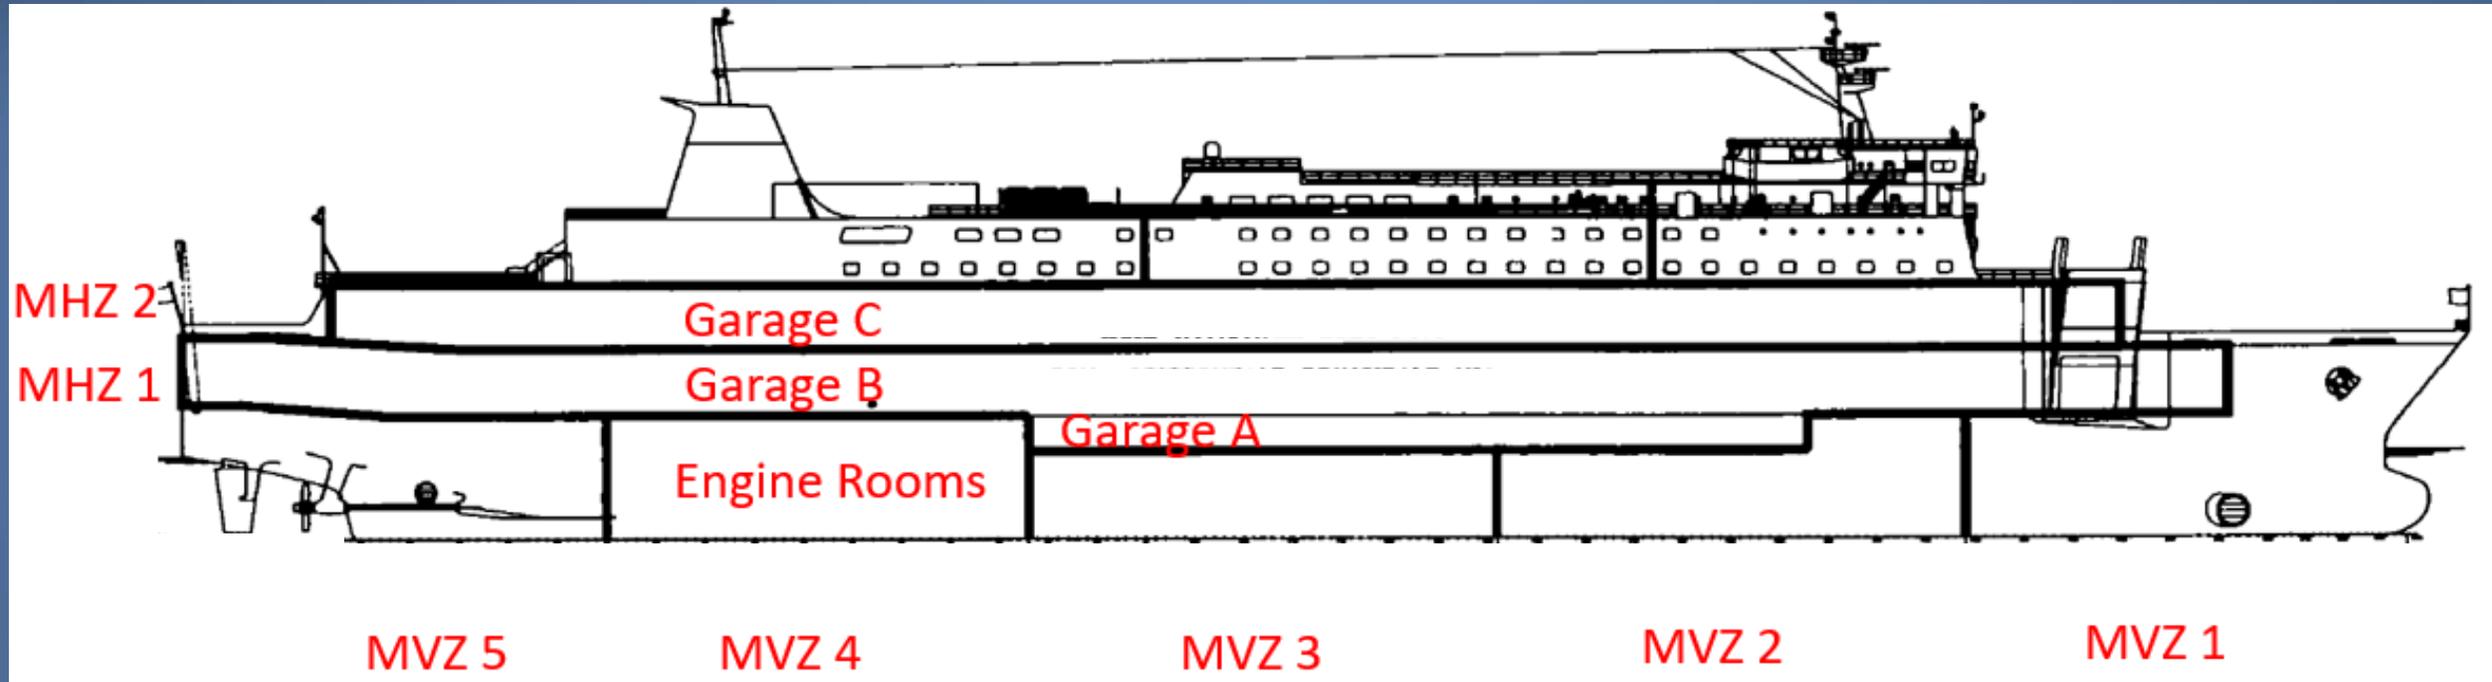
Structural Fire Protection

- A-60 boundary compromised
 - Heat spread to vehicles and cargo on garage deck B
 - Explosion on garage deck B
- Design criteria based on standardized test fires
 - Fire exceeded design criteria
 - Spread to deck above

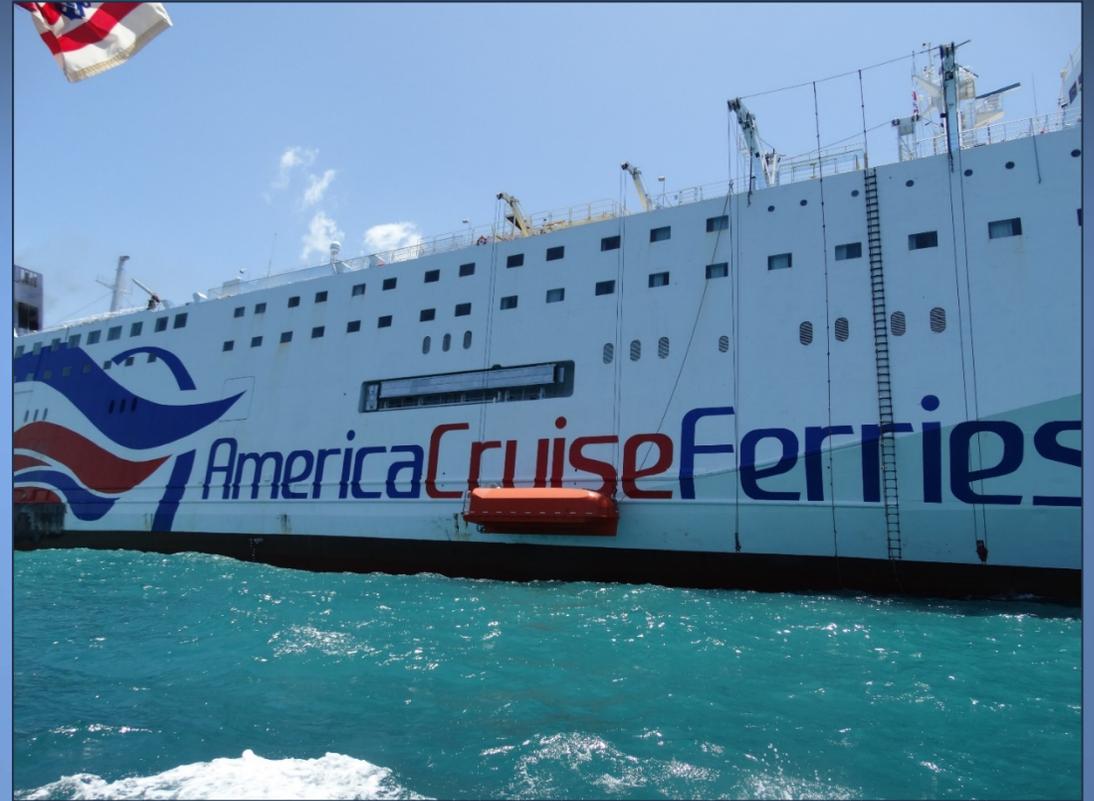
Lifeboats

- Minimal training and familiarization
- Knowledge of lifeboat release hooks lacking
- Increased the risk to crew and passengers

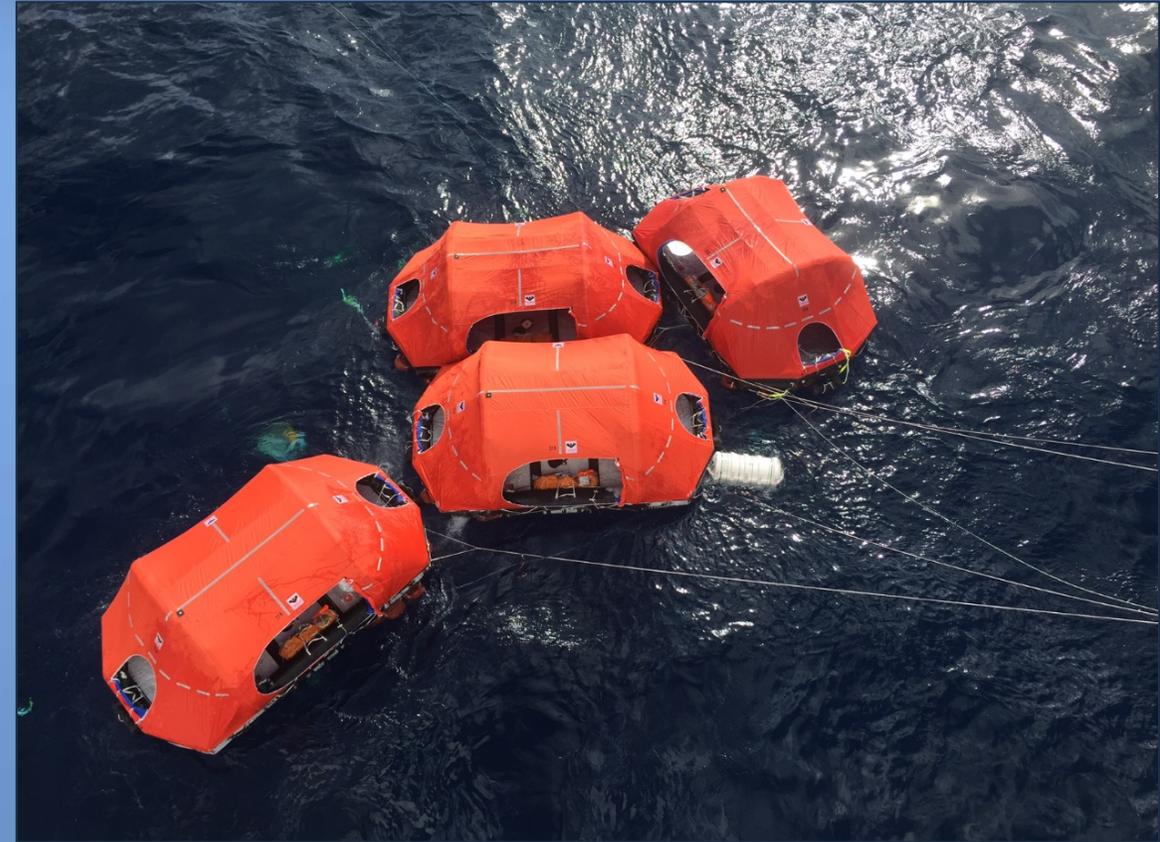
Marine Evacuation System (MES)

- MES liferafts prematurely inflated
 - Containers launched nearly the same time
 - Painters remained attached due to manual launch
 - Tension on painters triggered auto-inflation

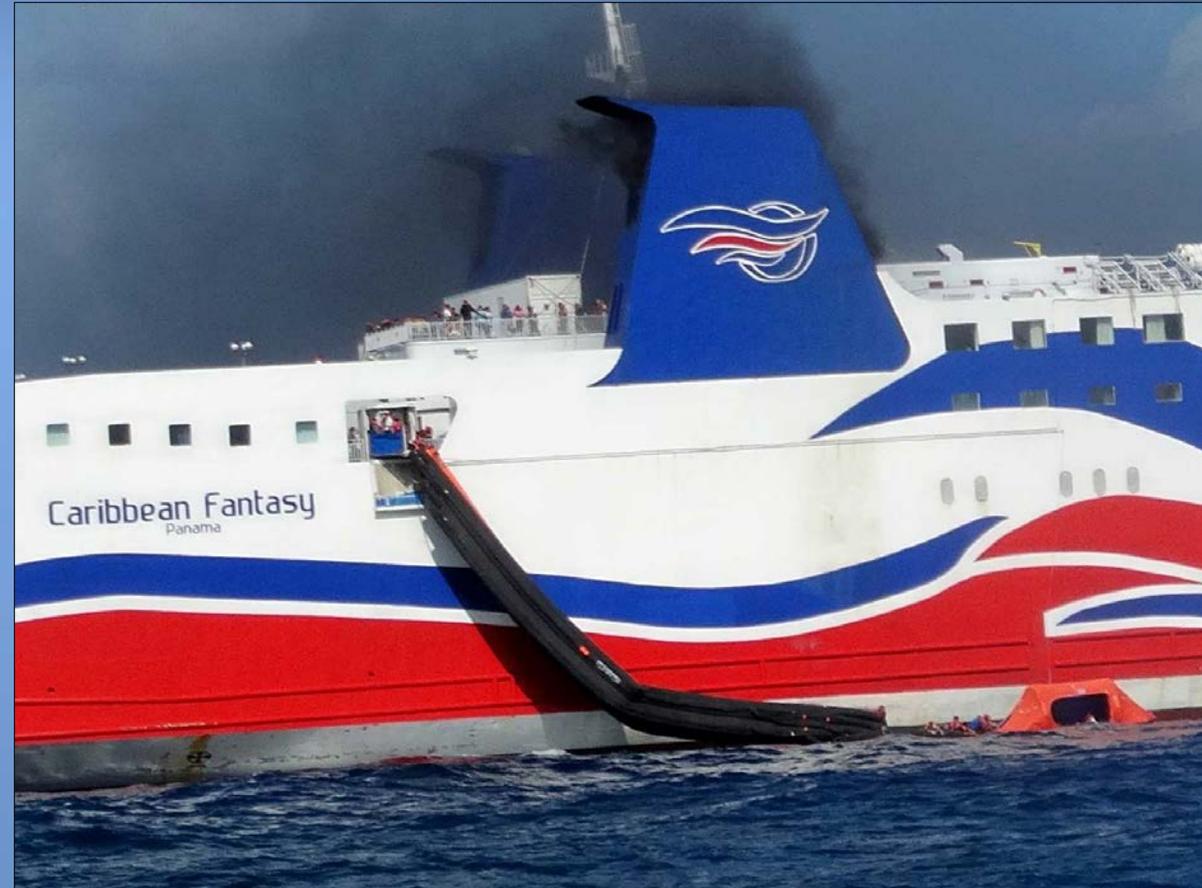
Injuries to Passengers and Crew

- MES deployed at a waterline angle of 54 degrees
- Steep slope, fast speed, abrupt stop
- Five ankle injuries
