National Transportation Safety Board

Fire On Board Small Passenger Vessel *Island Lady*
Pithlachascotee River Near Port Richey, Florida
January 14, 2018

Brian Young, IIC
Office of Marine Safety

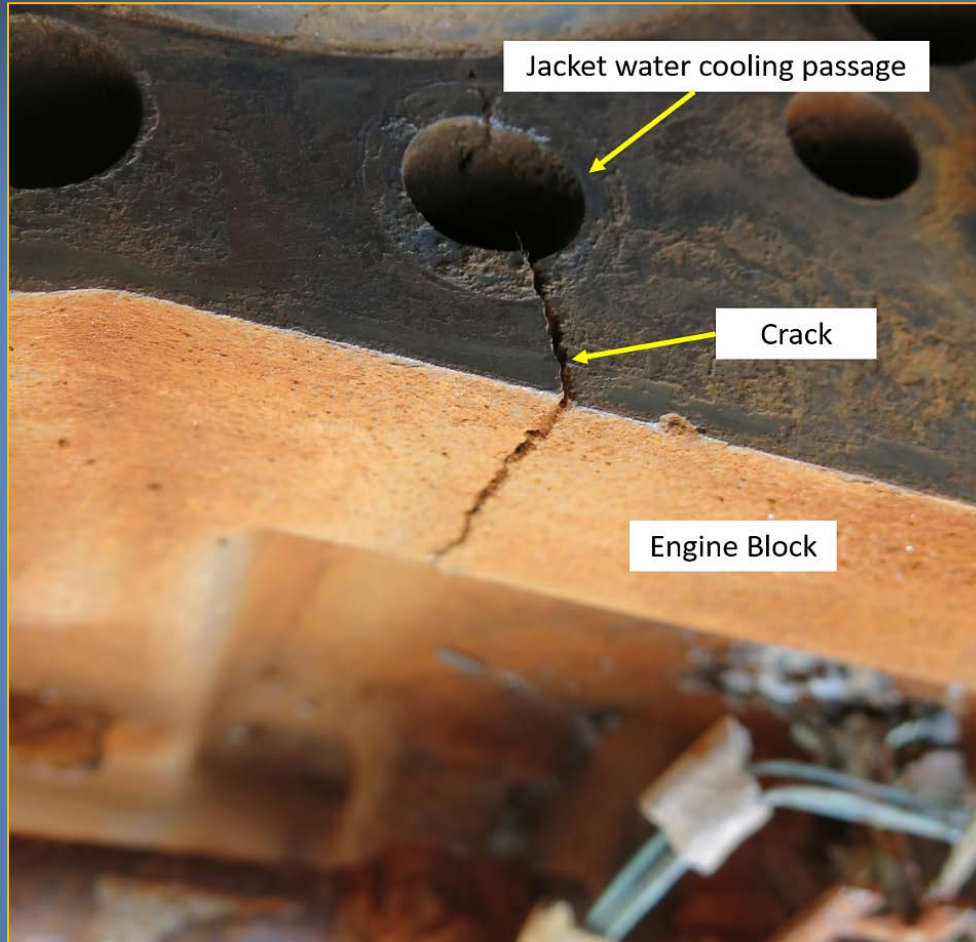
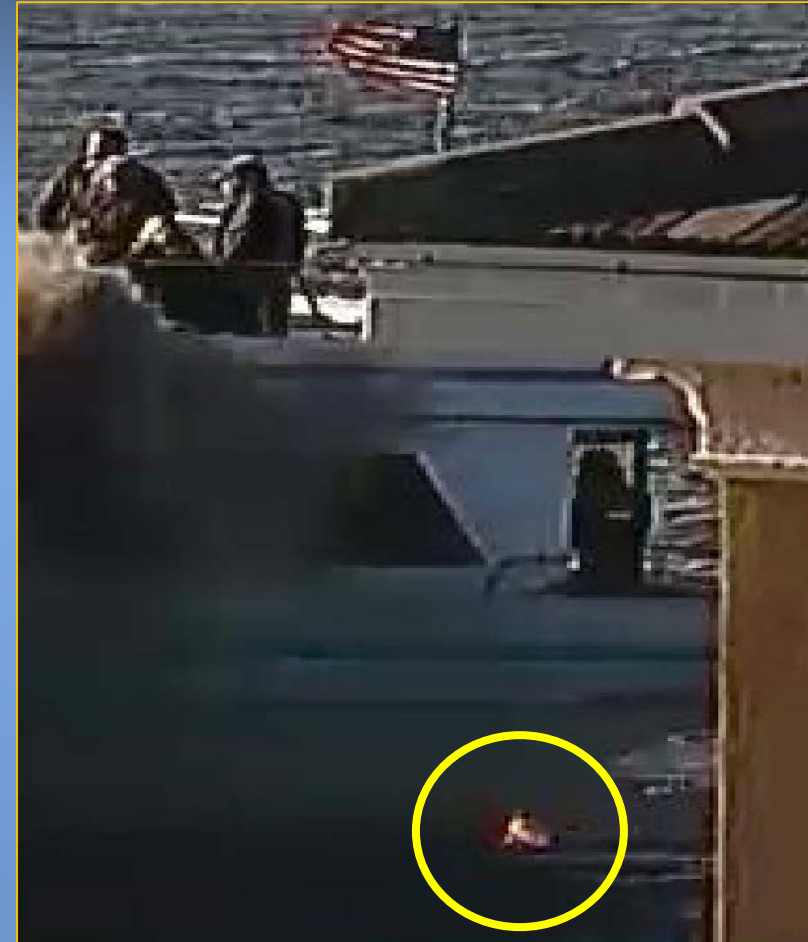
Overheated Engine and Exhaust System

- Fire originated in exhaust tubing in lazarette
 - Loss of raw water
 - Elevated exhaust temperatures, leading to degradation of exhaust tube materials and ignition
- Fire spread to surrounding wood supports

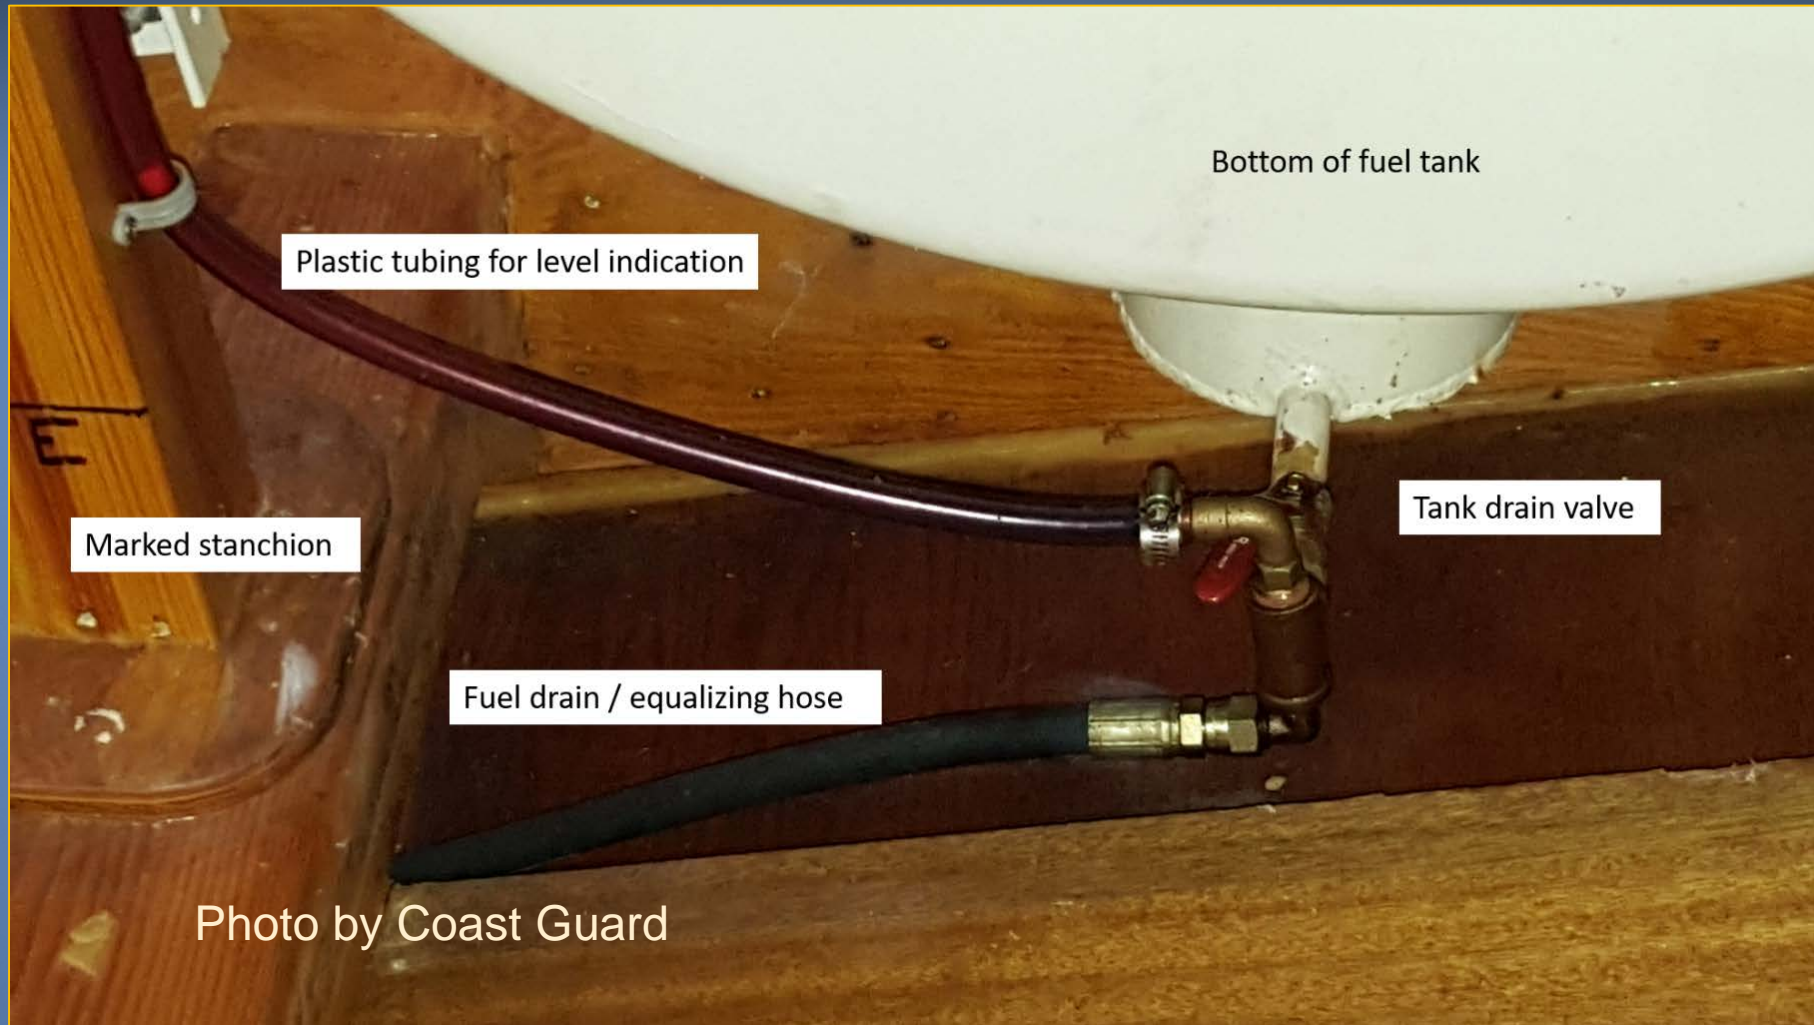
Fuel Tank Level-Indicating System

- Lack of company guidance regarding engine high-temperature alarms
- Lack of fire detection in unmanned spaces with exhaust tubing
- Insufficient preventive maintenance
- Insufficient crew training and documentation
- Inappropriate material and design of fuel tank level-indicator system

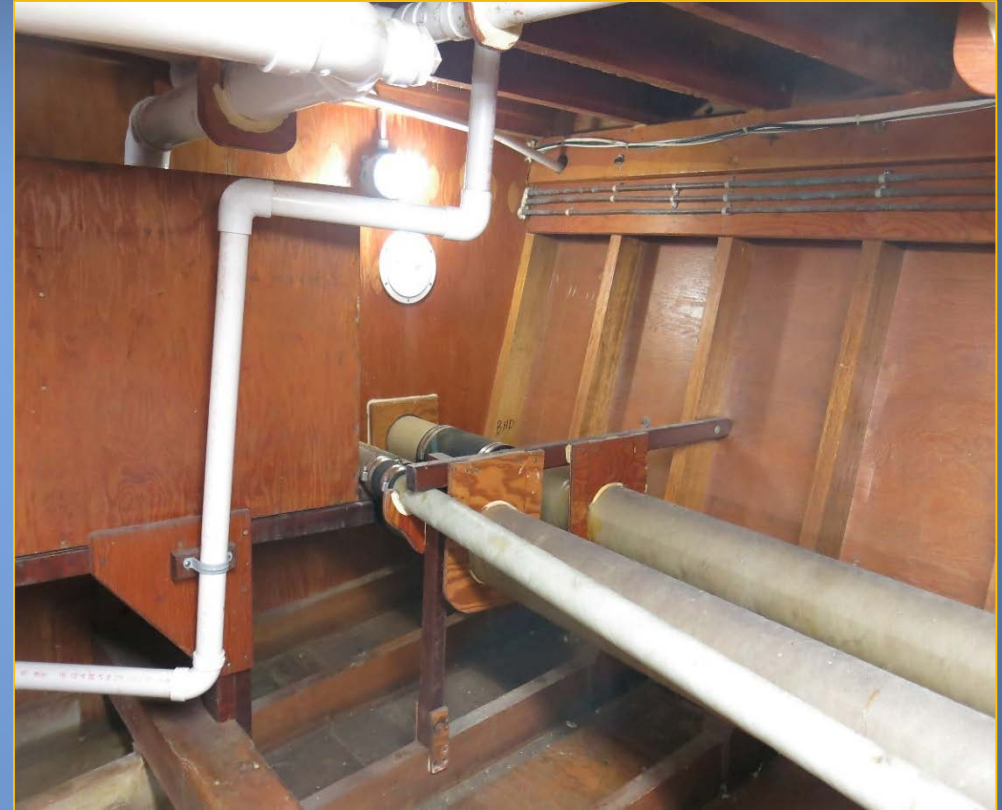
- Detection required only for engine room
- Detection not heard by captain
- Detection not required for lazarette
 - Space not equipped with detection
 - Space unmanned
