National Transportation Safety Board

Vehicle Factors Modification, Condition, and Maintenance

Brian Bragonier

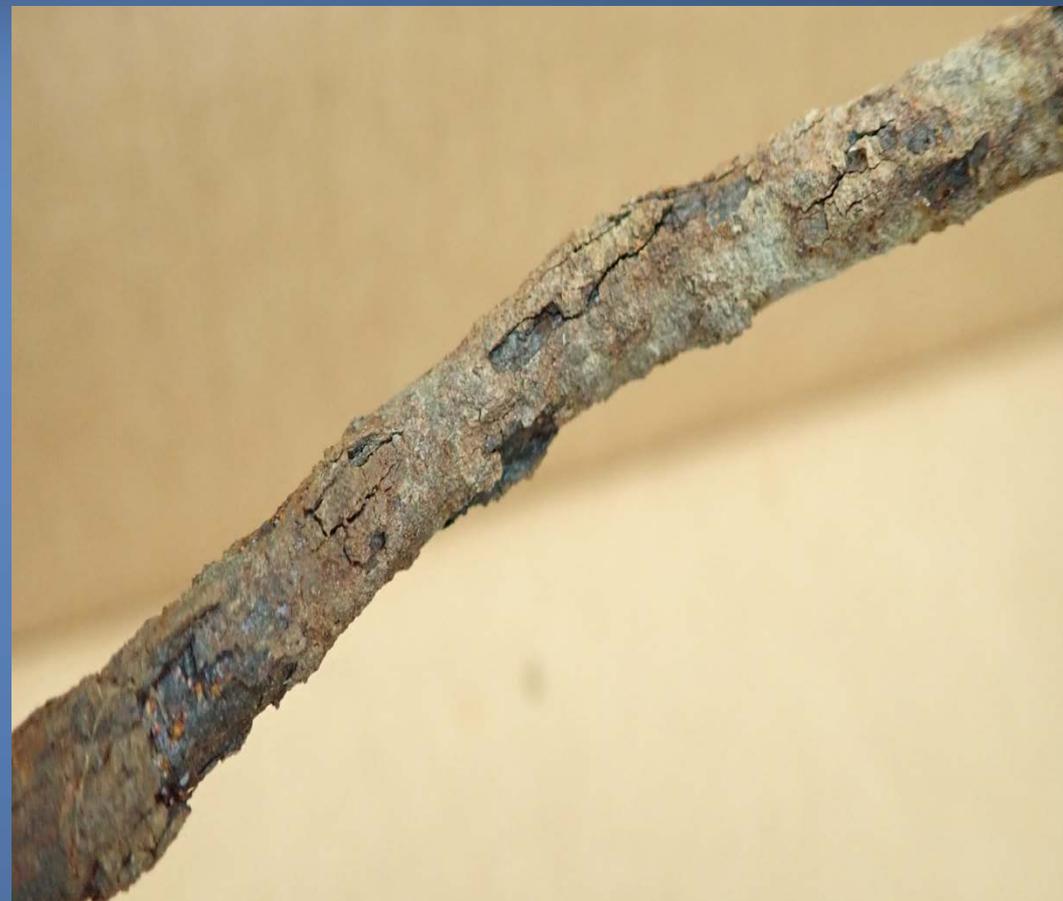
- Brake system corroded and portions potentially unserviceable

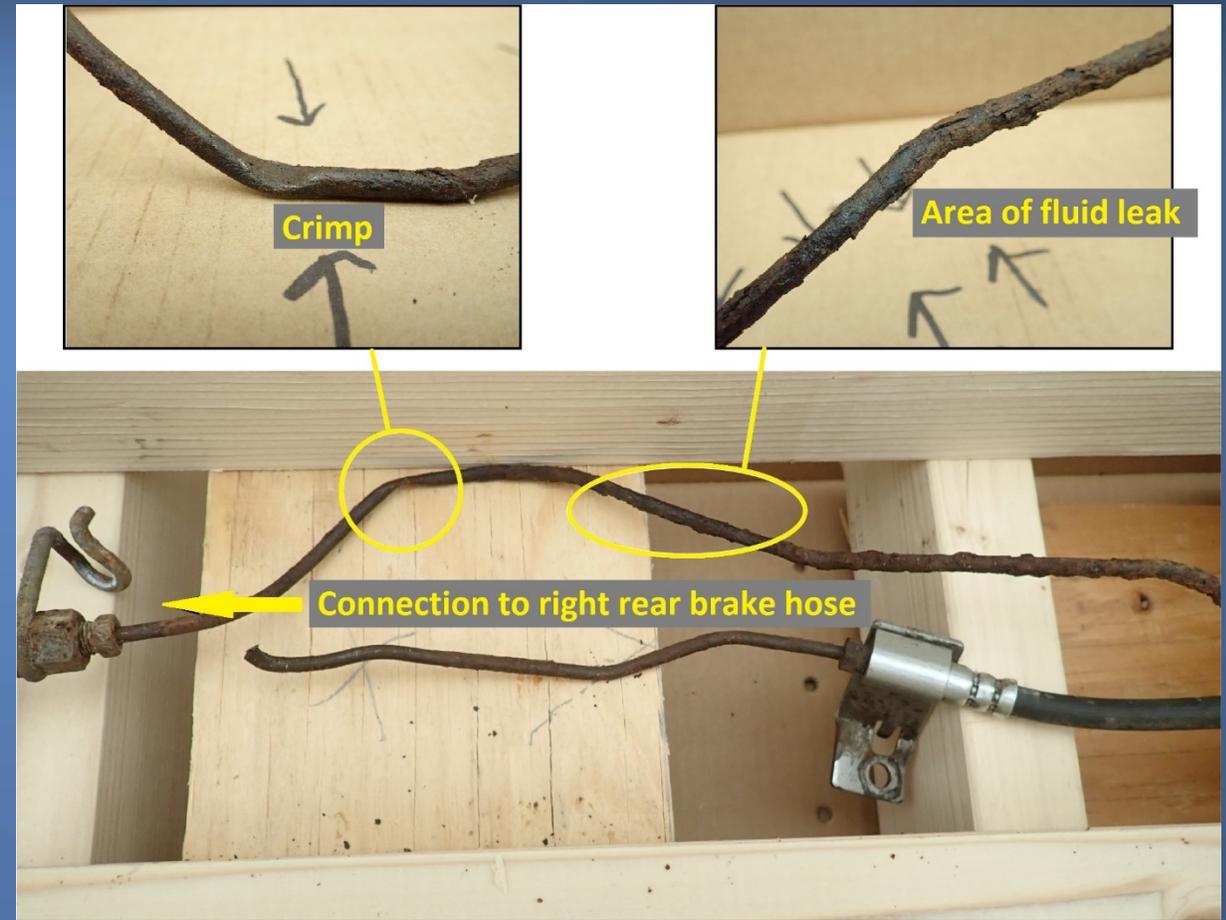
- Crimped rear brake line
 - Restricted flow of brake fluid
- Some areas coated in brake fluid
- Front/rear split system

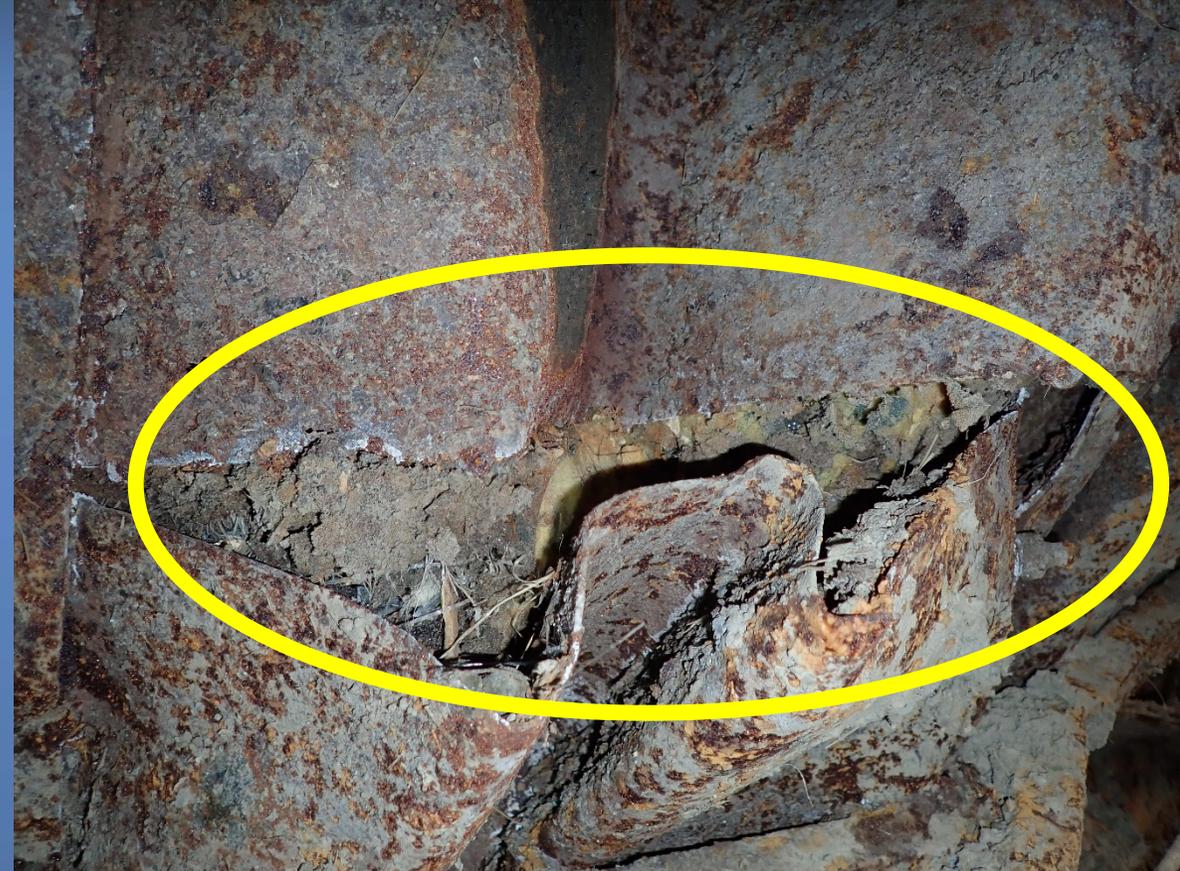
- Chassis severely corroded throughout
 - Body structural support members deteriorated
 - Floorboard rusted through
