National Transportation Safety Board

Descent Below Visual Glidepath and Impact With Seawall

Asiana Flight 214, B777
San Francisco, CA
July 6, 2013

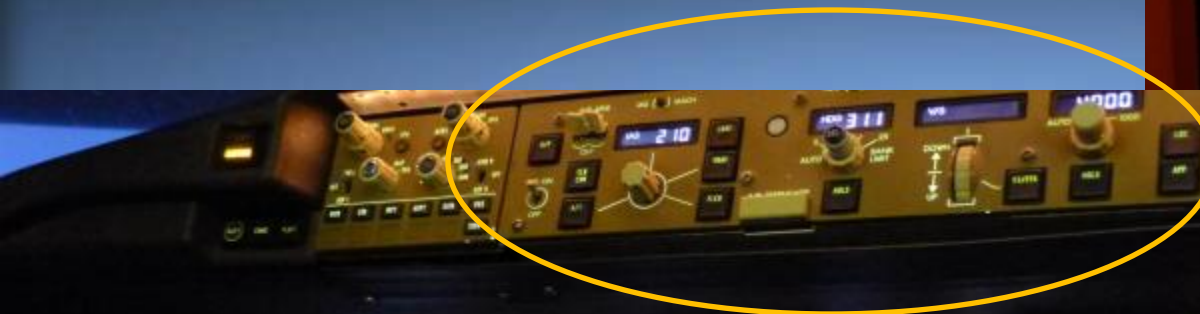
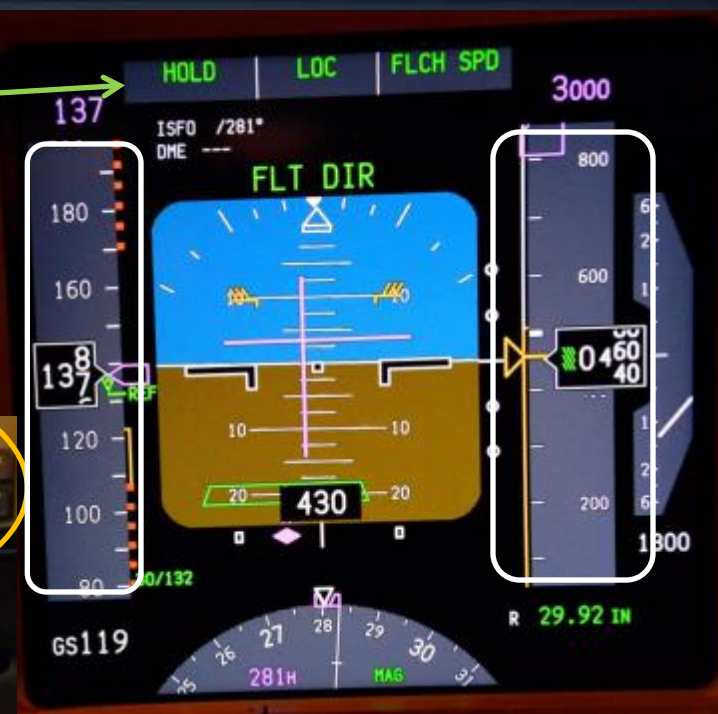
Flight Mode Annunciator

Mode Control Panel

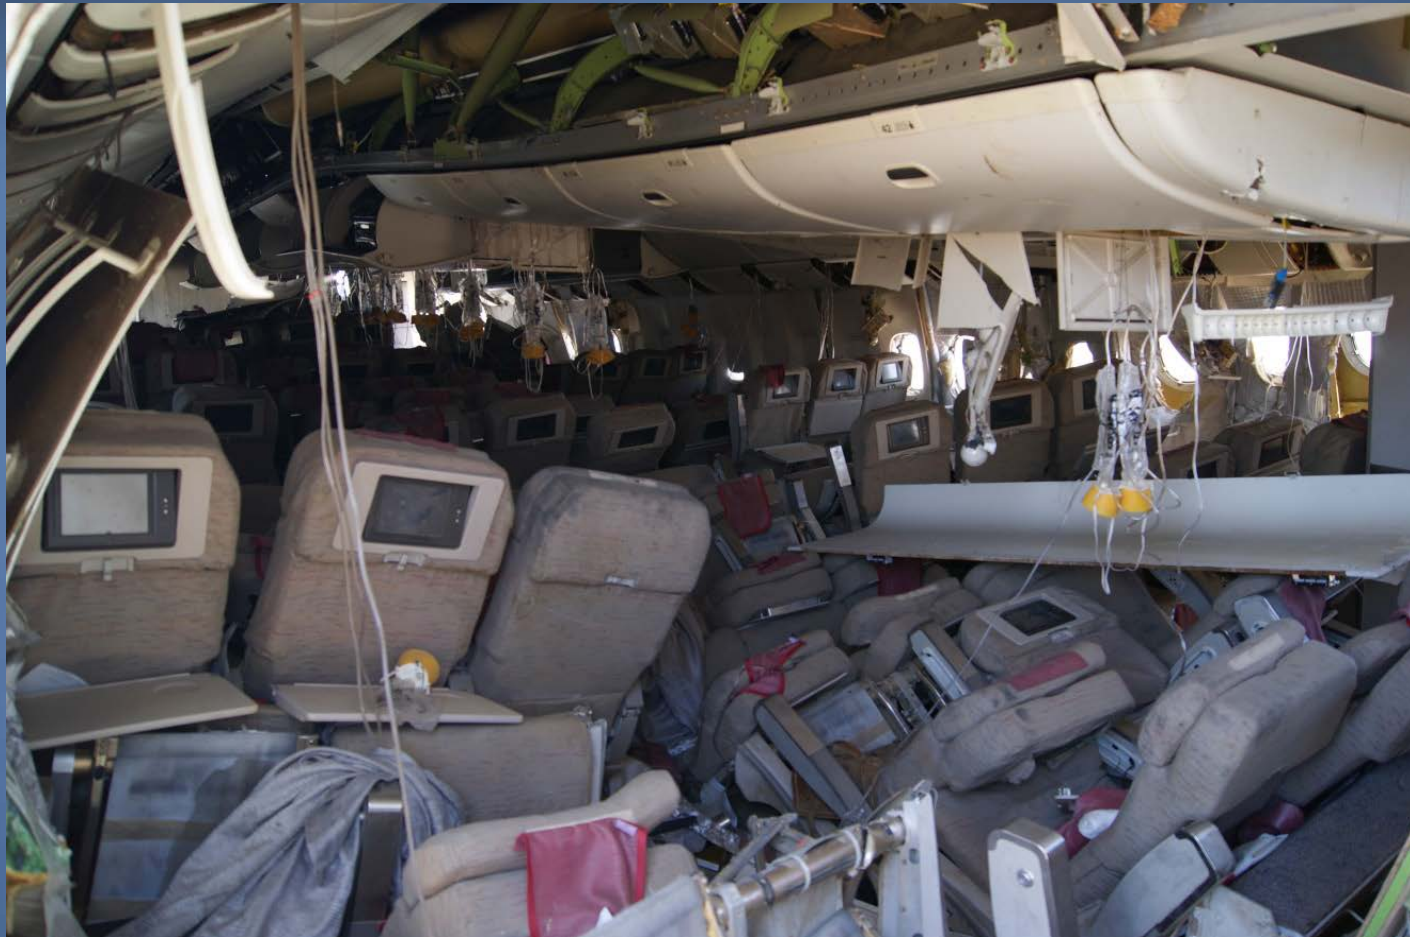
Evacuation and Injuries

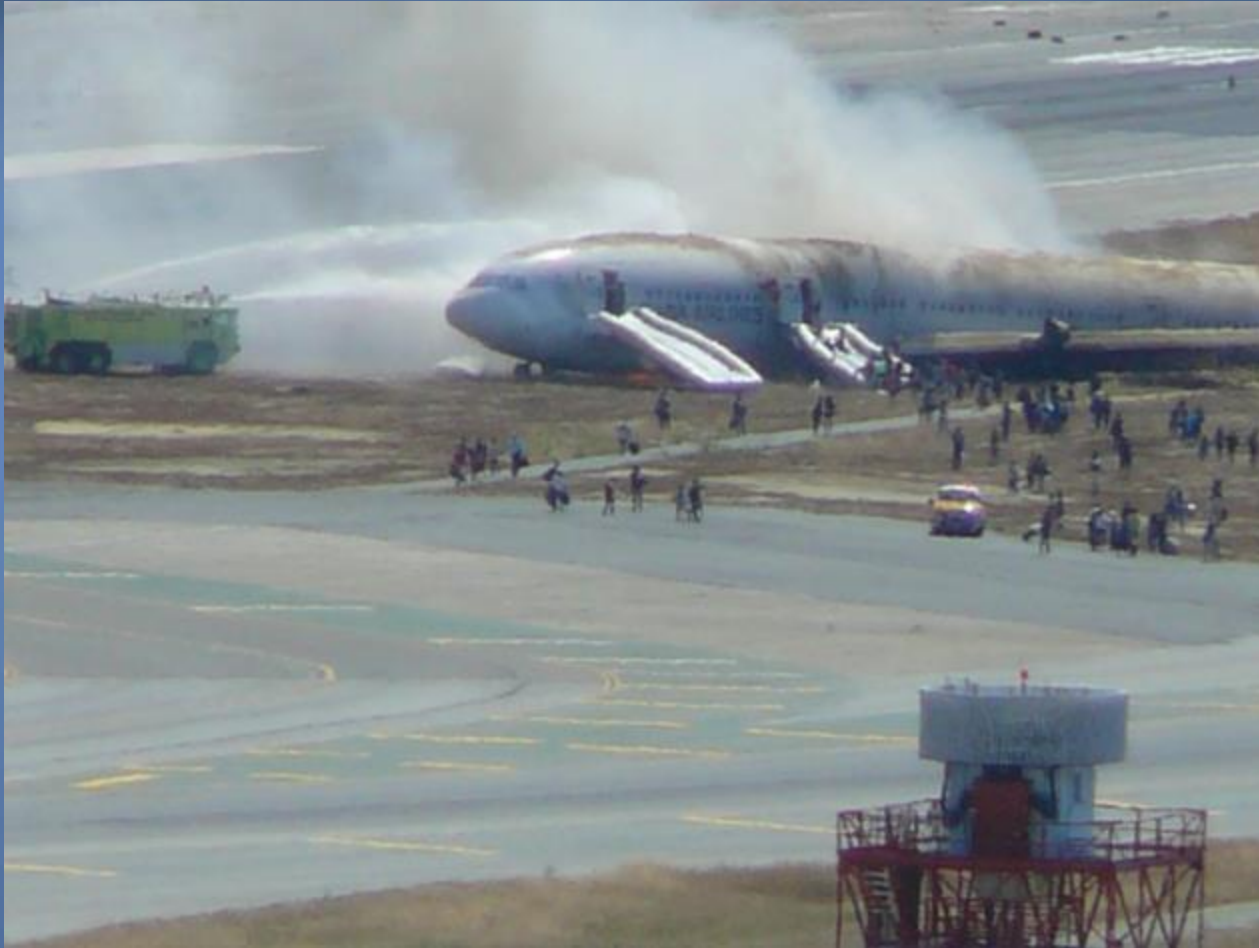
Emergency Response
