National Transportation Safety Board

Emergency Egress and Extrication

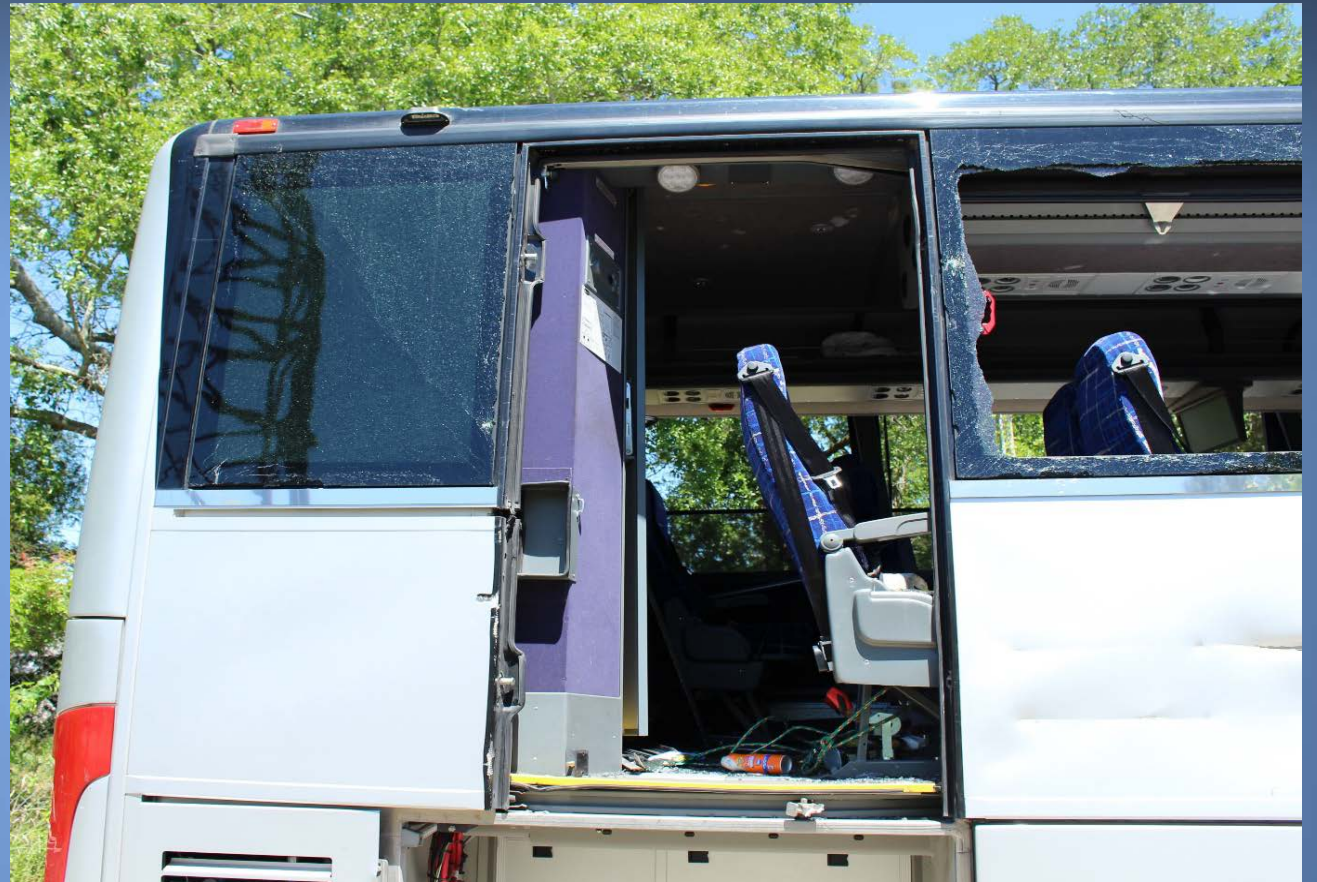
Secondary Door

- Passengers were not aware of the door
- Witness attempted to open the rear door
 - Misplaced the door handle
- First responders were unable to open rear door
