National Transportation Safety Board

High-Profile Grade Crossings

Steven Prouty, PE

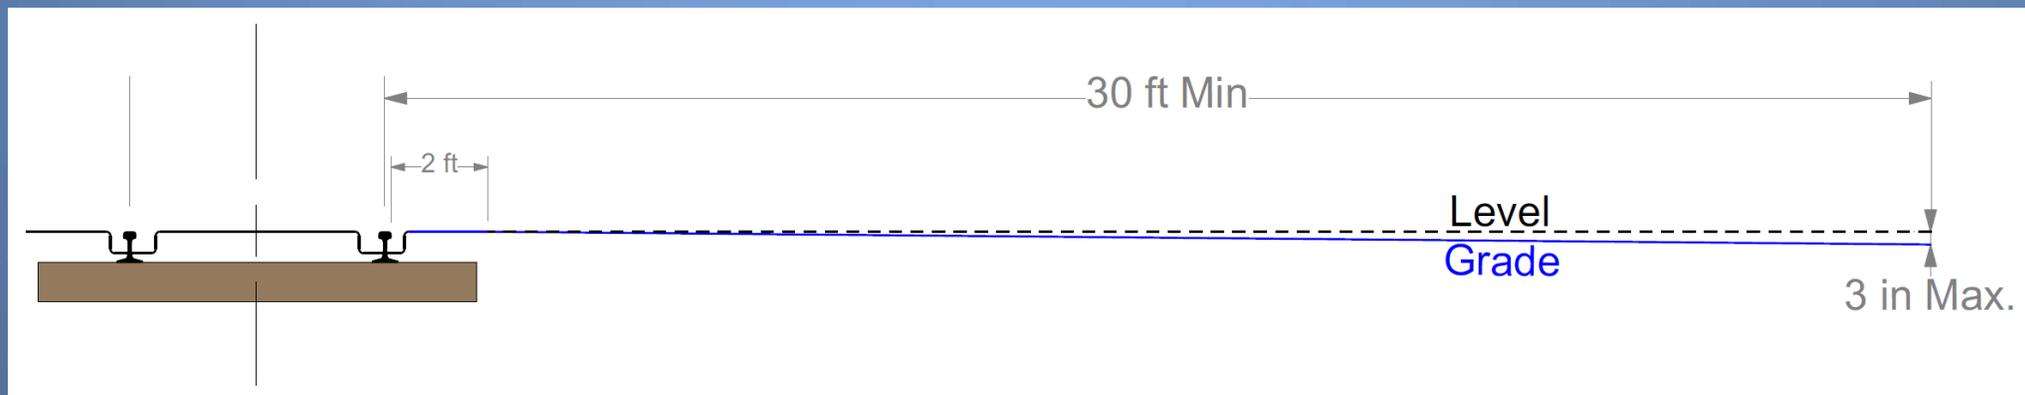
Vertical Profile – Design Guidance

- Crossing surface should be level
 - Between rails and 2 feet outside of rails
- Maximum slope
 - 3 inches above or below top of rails at 30 feet (0.9% grade)
- February 2014 maintenance likely increased track elevation

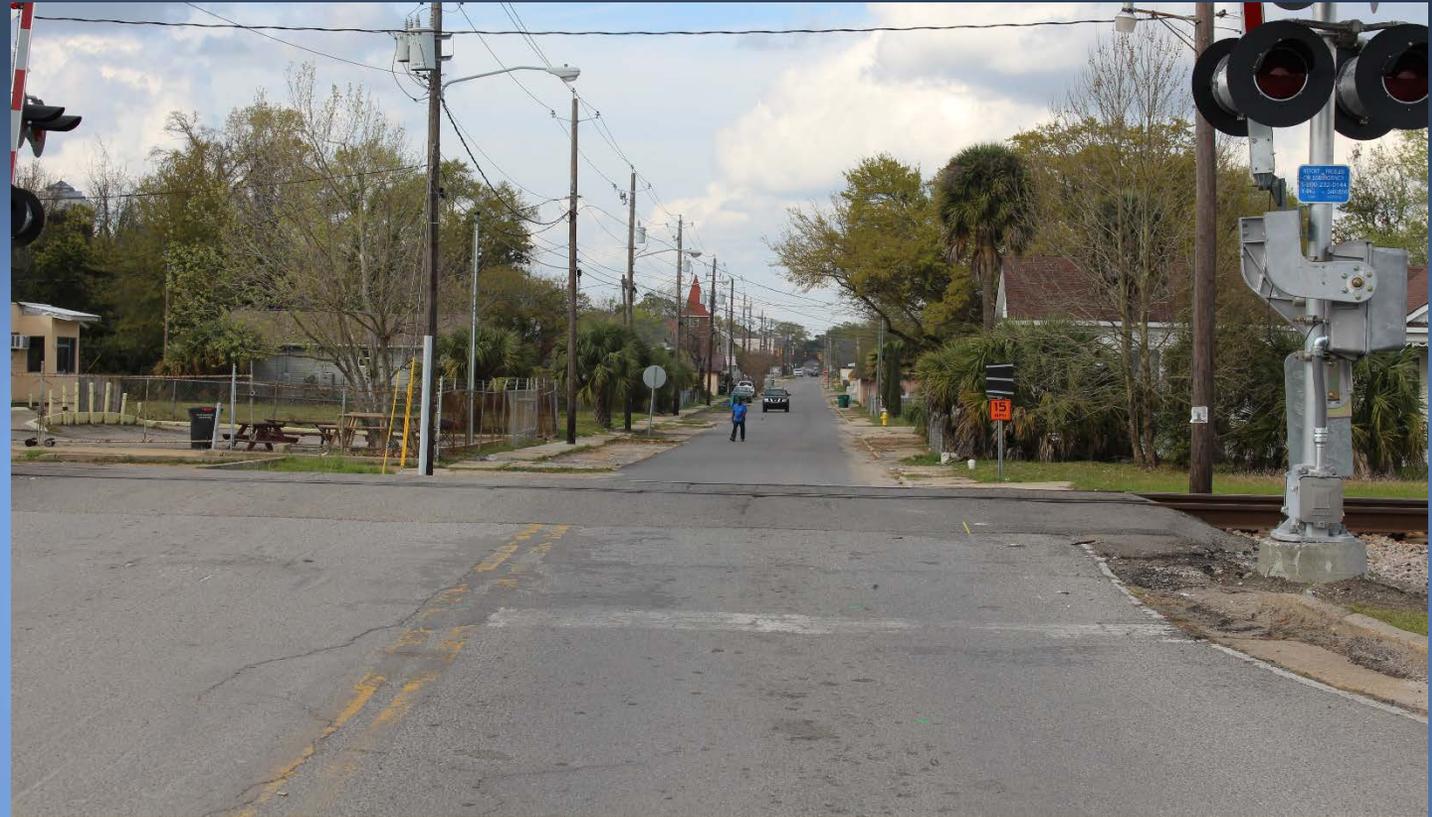
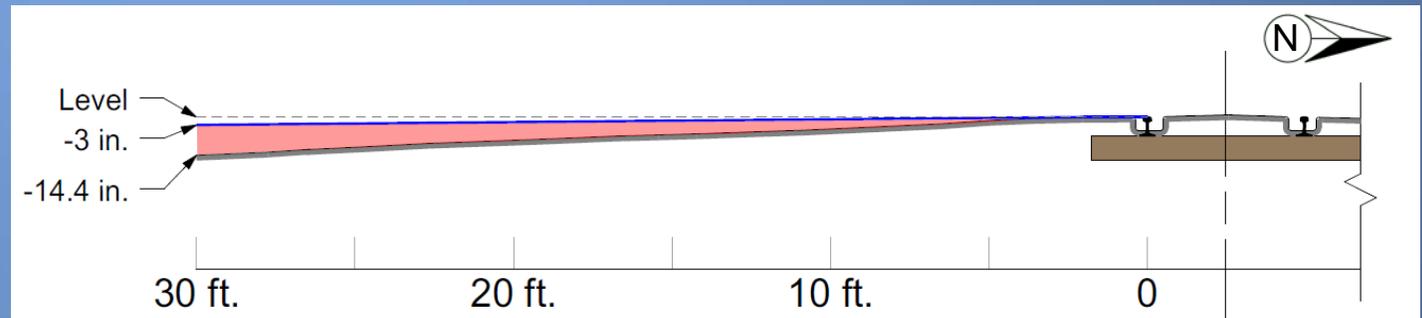
Main Street Grade Crossing (Northbound)

- Average slope: 4.2%
- Maximum slope: 7.5%
- Crossing surface was 14.4 inches below track level at 30 feet

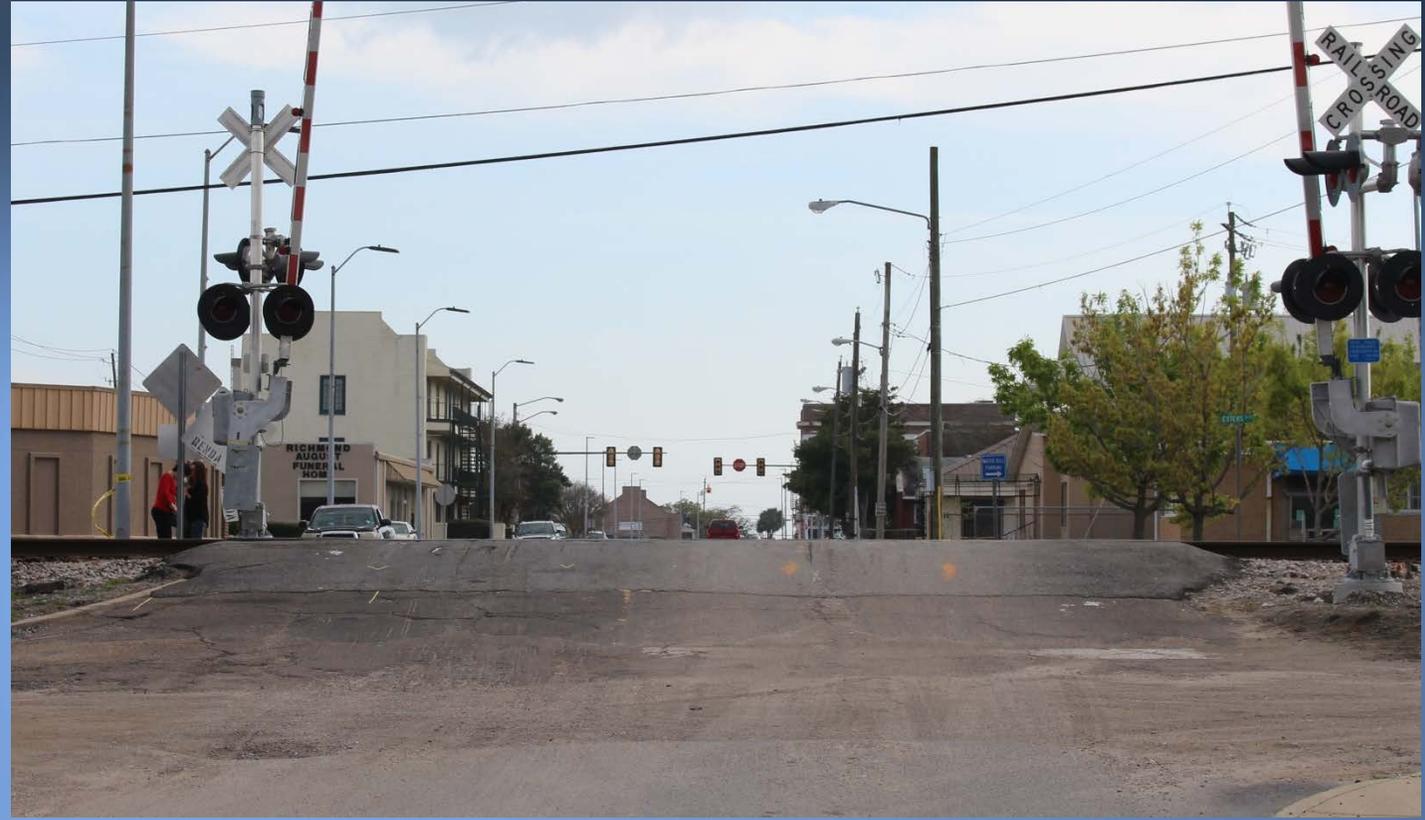
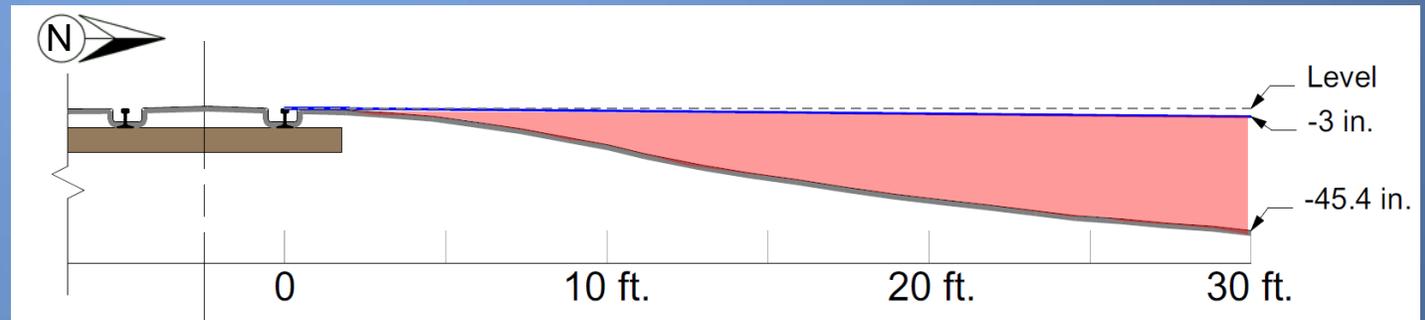
Main Street Grade Crossing (Southbound)

- Average slope: 13.3%
- Maximum slope: 24.4%
- Crossing surface was 45.4 inches below track level at 30 feet

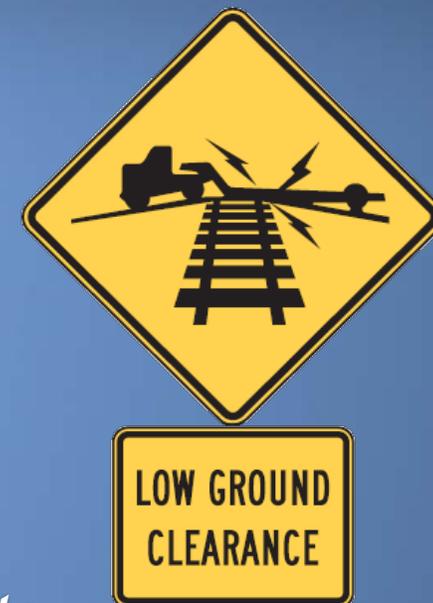
Effectiveness of LGCGC Warning Sign

- Purpose of the sign
 - Is only a warning informing road user of grounding risk
 - Does not indicate appropriate action
 - Does not restrict crossing
- Inconsistent installation of the sign
 - *Manual on Uniform Traffic Control Devices for Streets and Highways* (MUTCD) guidance

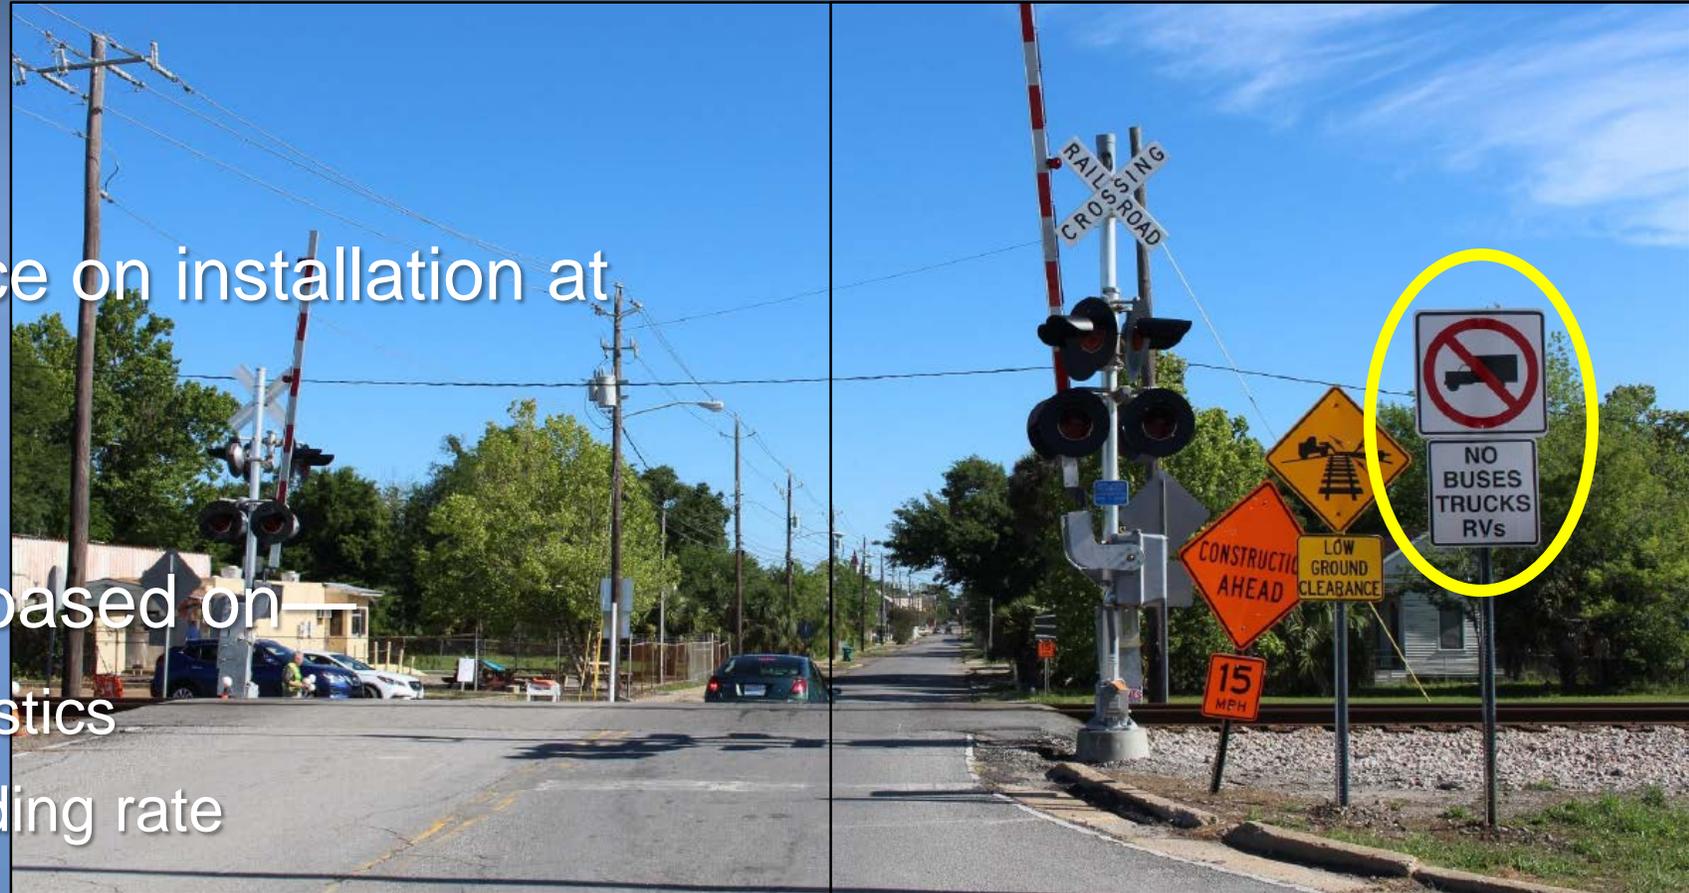
Selective Exclusion Signs

- Postcrash action
- No MUTCD guidance on installation at grade crossings
- Potential guidance based on
 - Roadway characteristics
 - Crash and/or grounding rate

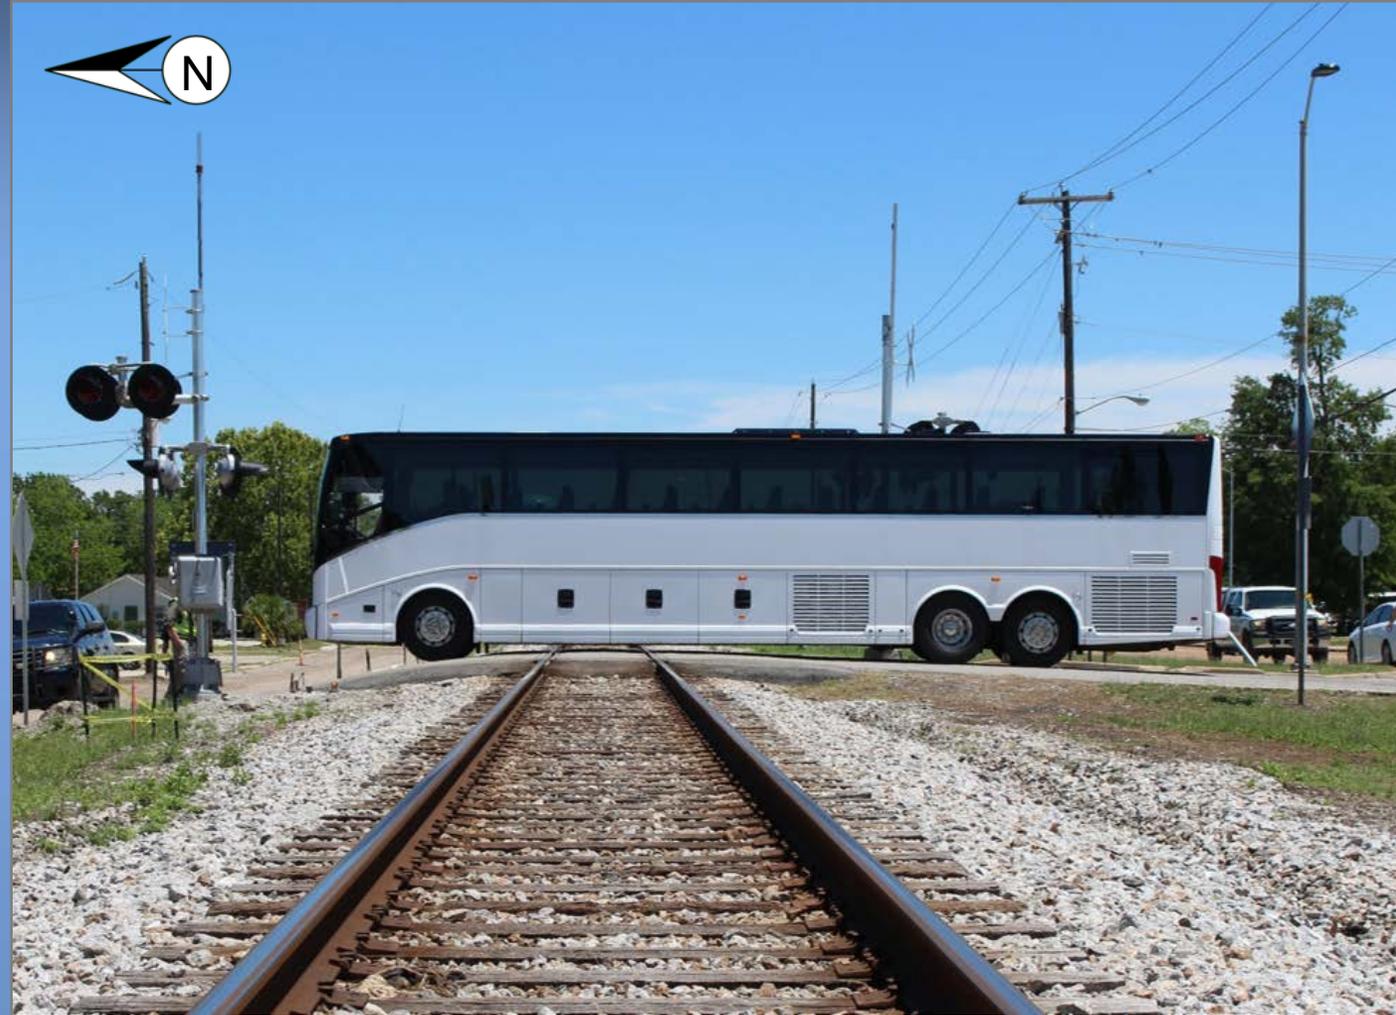
Main Street Grounding History

- 26 prior grounding incidents since March 2012
- 23 groundings occurred after February 2014 maintenance
