National Transportation Safety Board

Building Explosion and Fire
Silver Spring, Maryland
August 10, 2016

Rachael Gunaratnam
Investigator-in-Charge

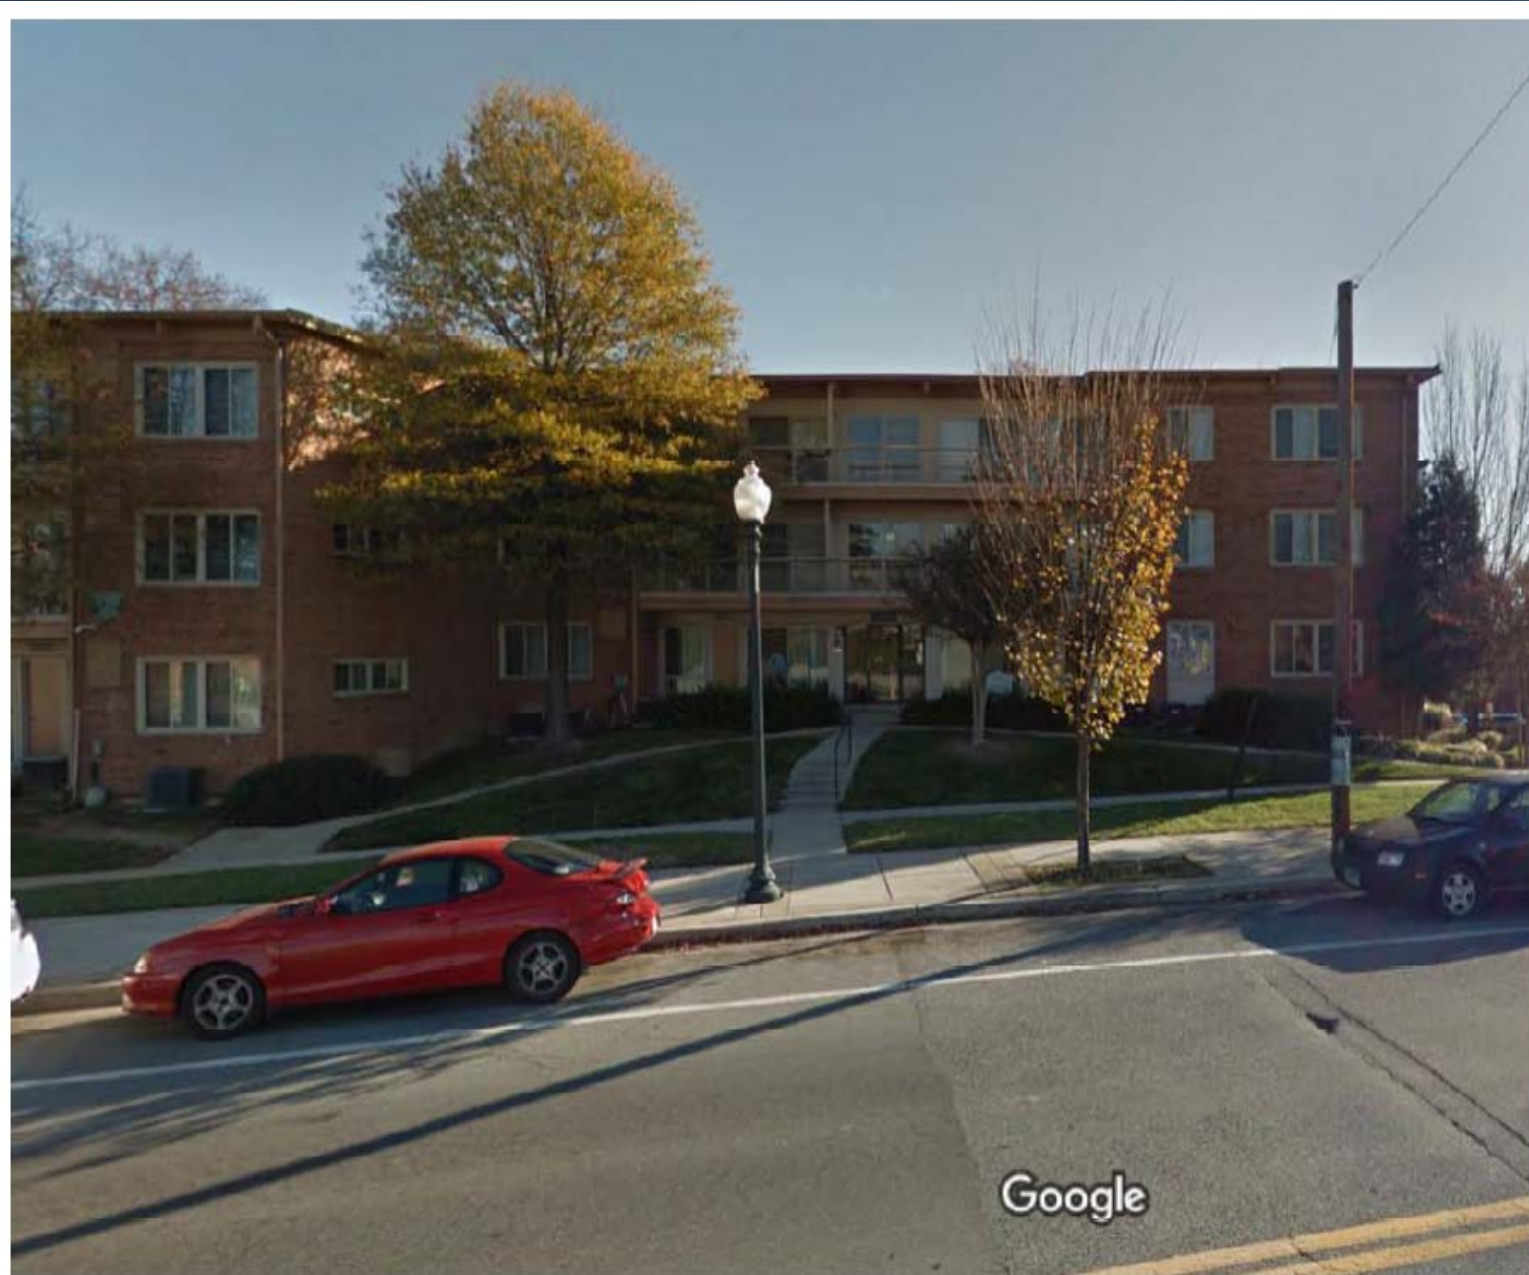
Flower Branch Apartment Complex in November 2015

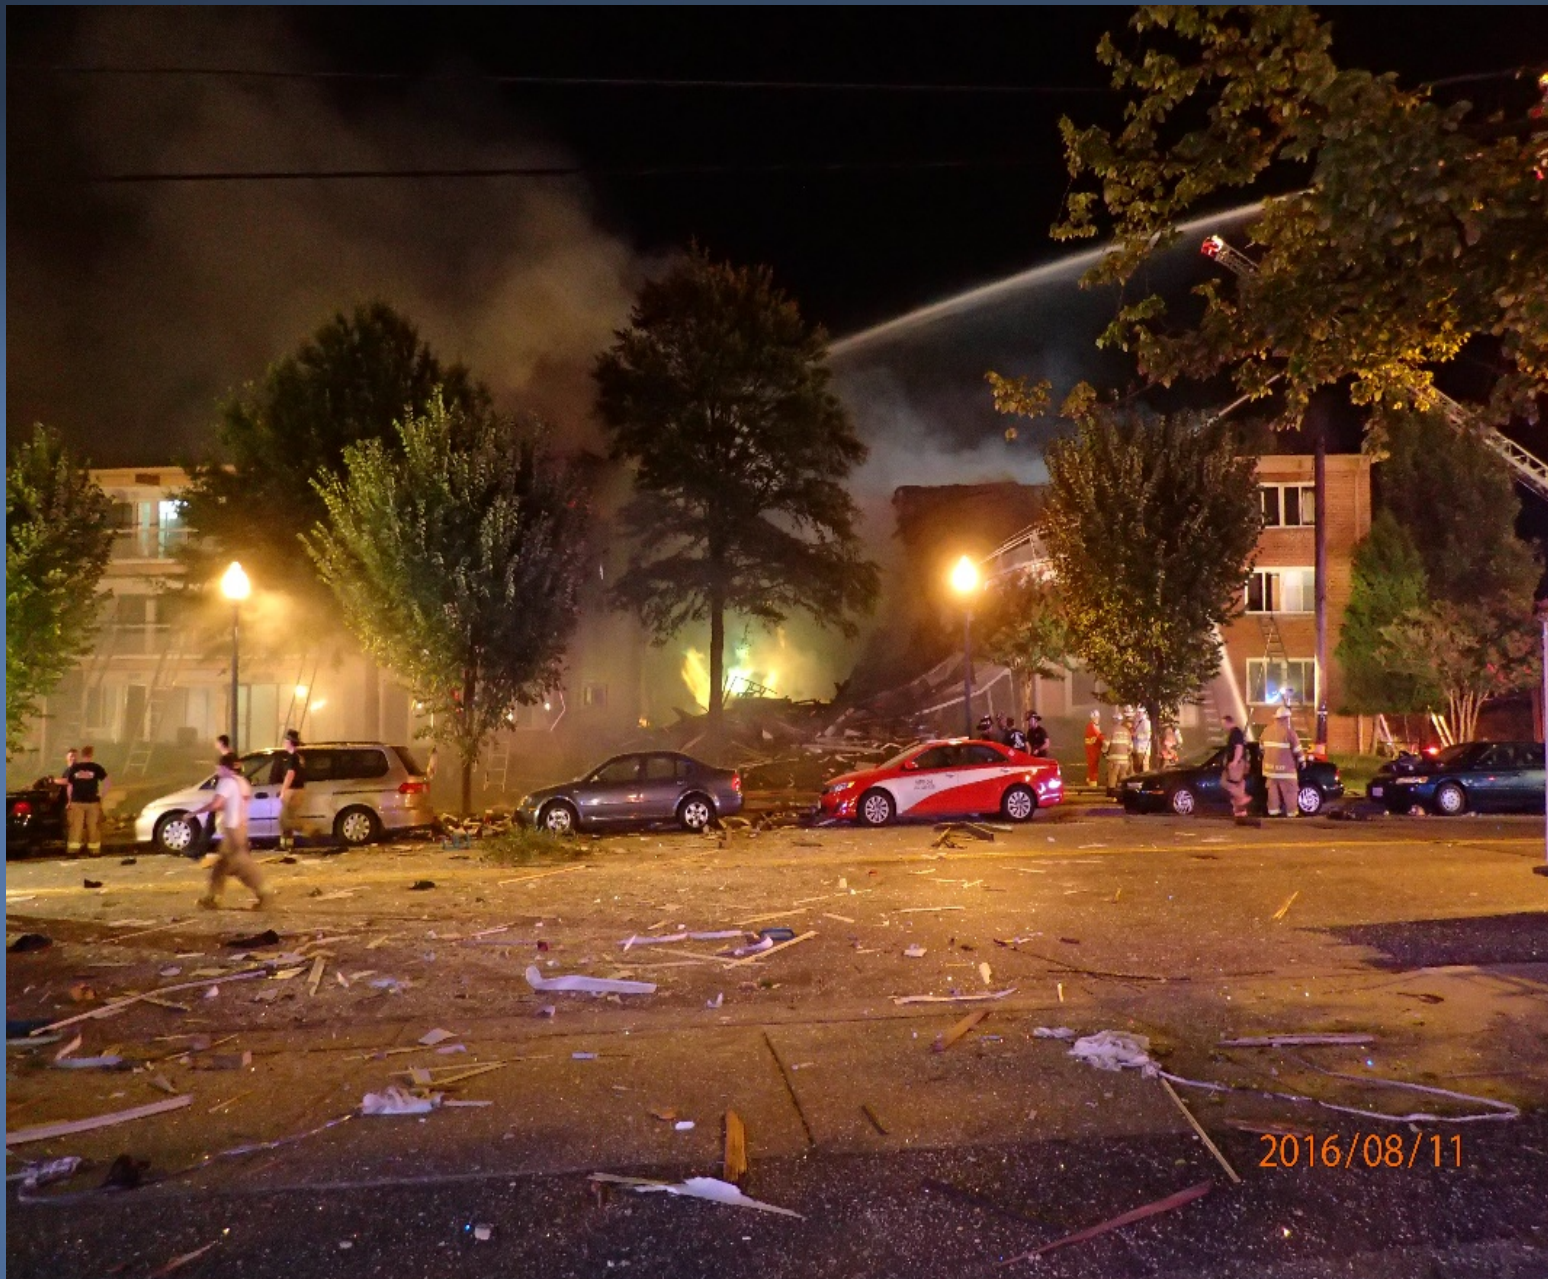
Flower Branch Apartment Complex on August 11, 2016

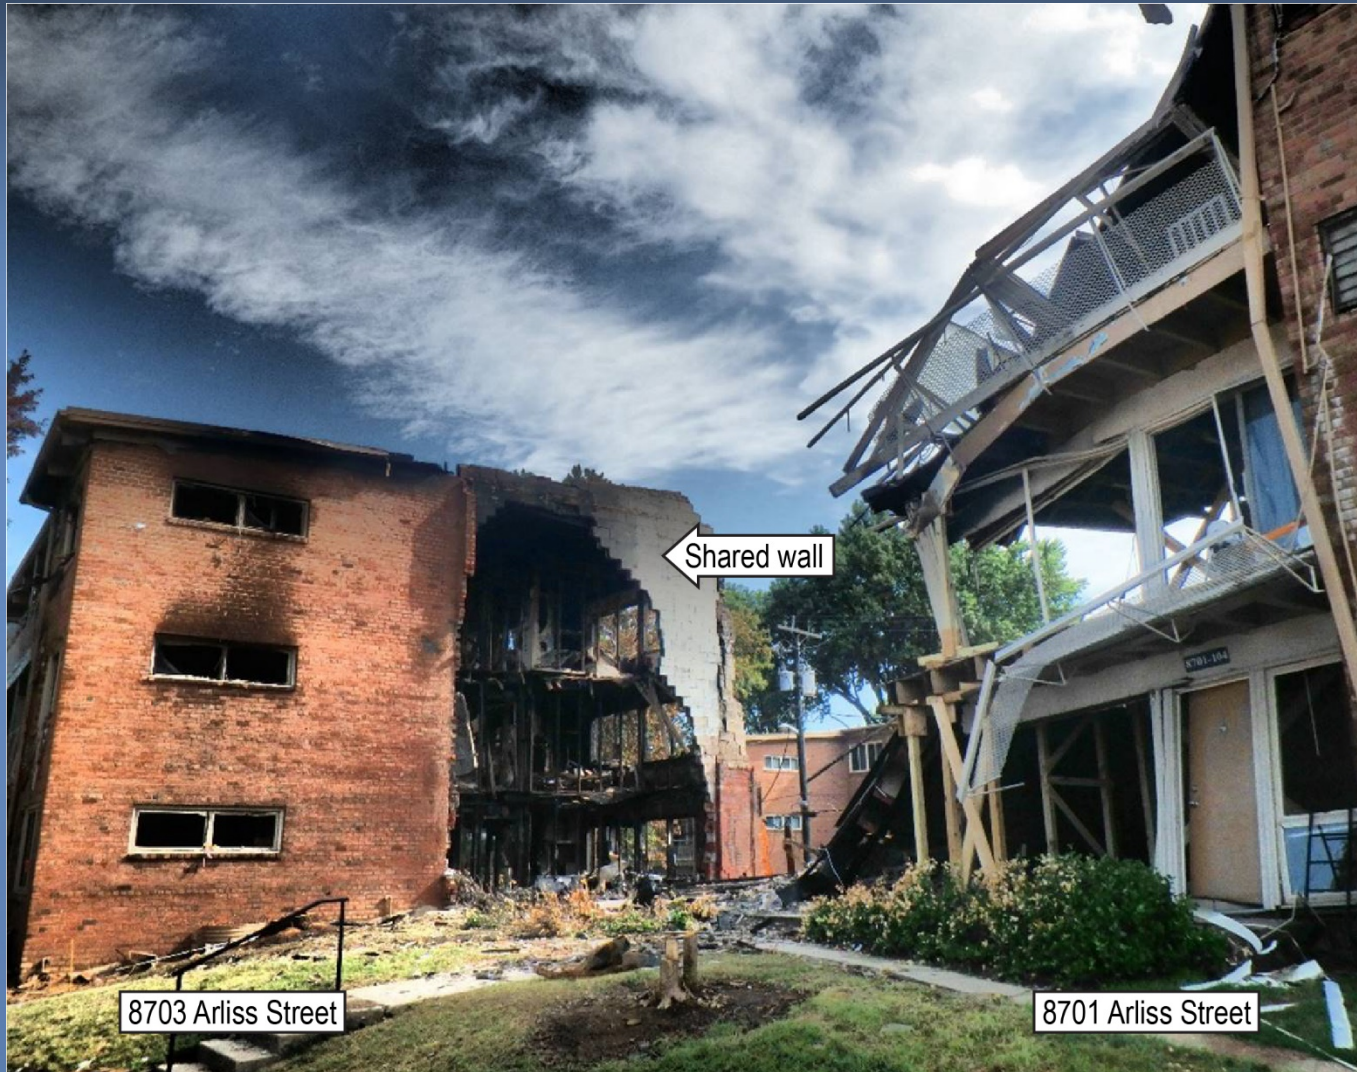
Buildings 8701 and 8703 Arliss Street

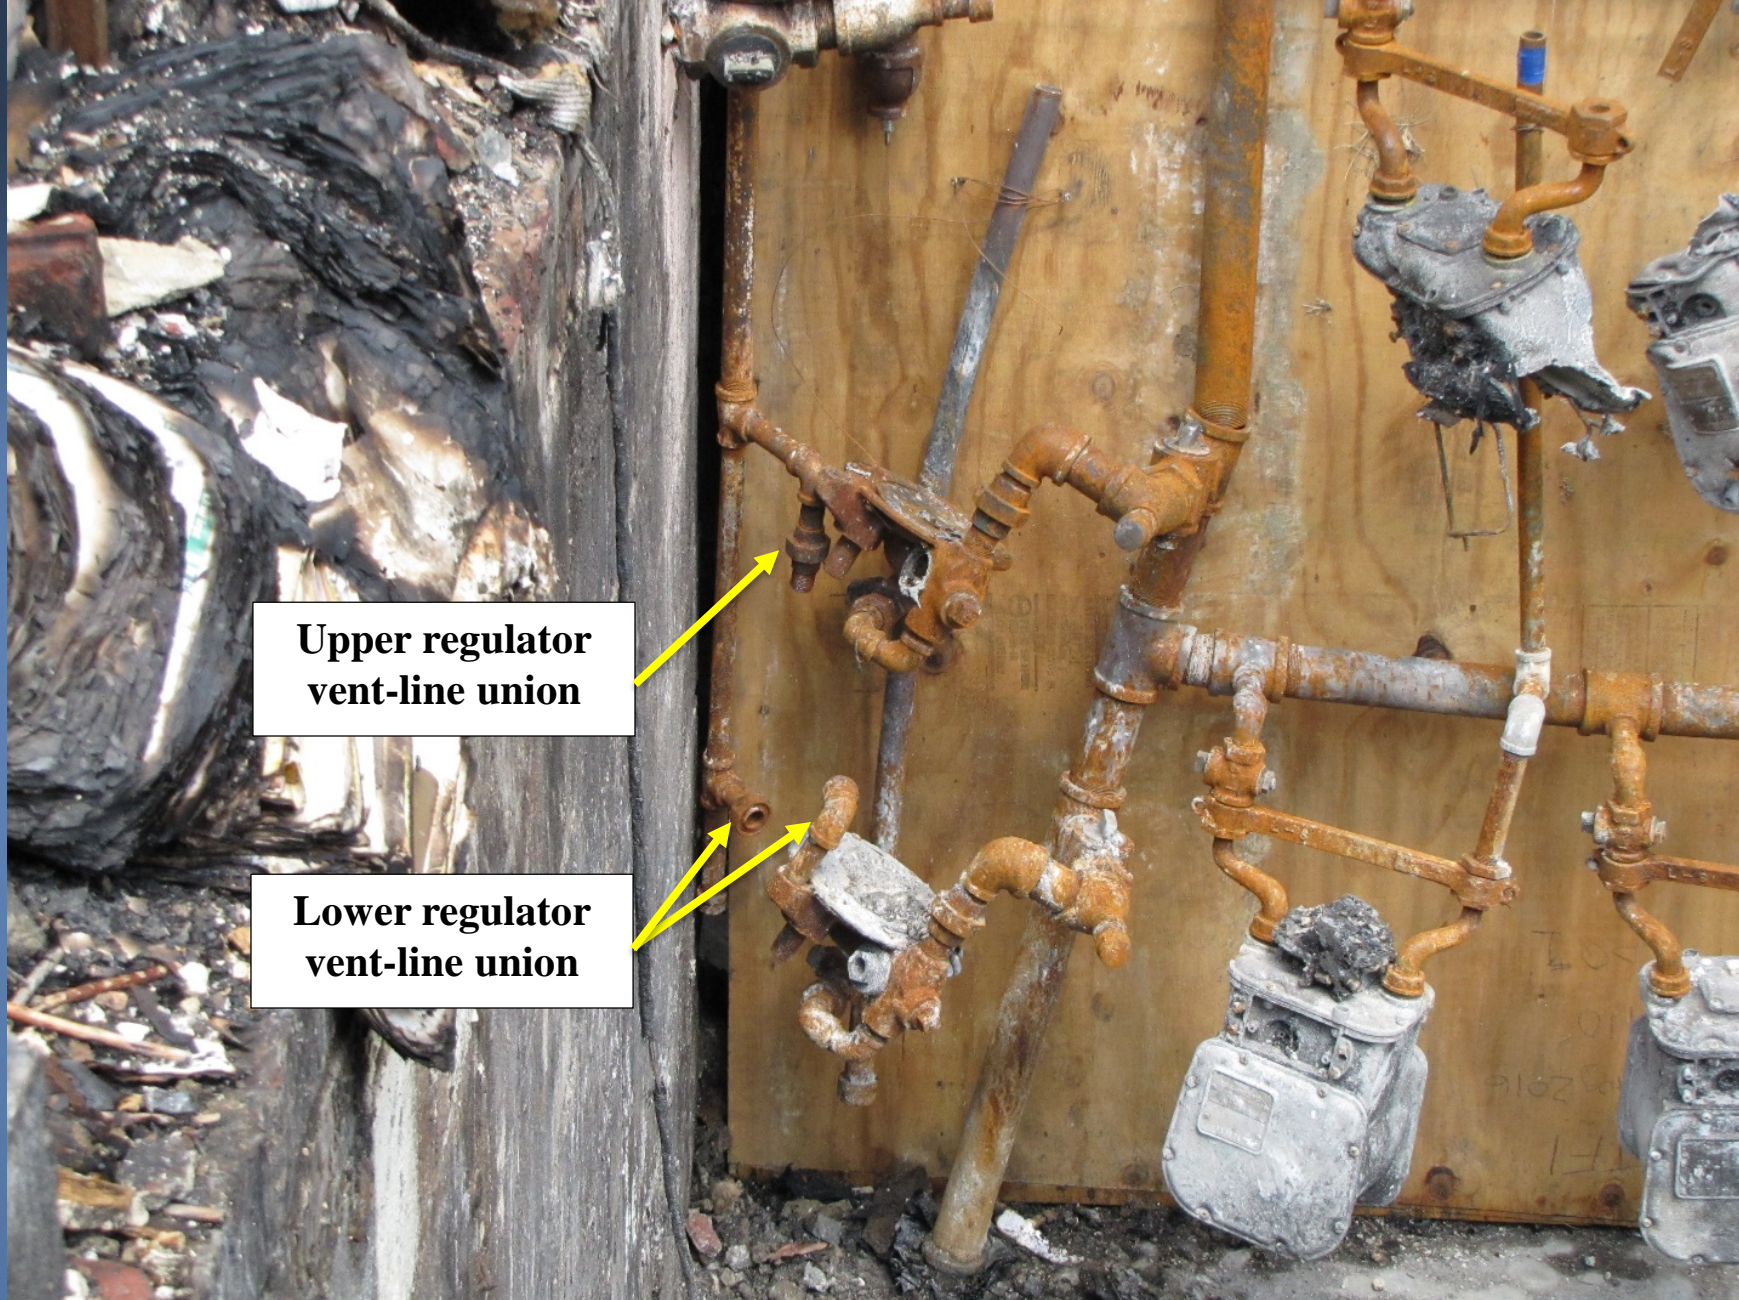
**Upper regulator
vent-line union**

**Lower regulator
vent-line union**

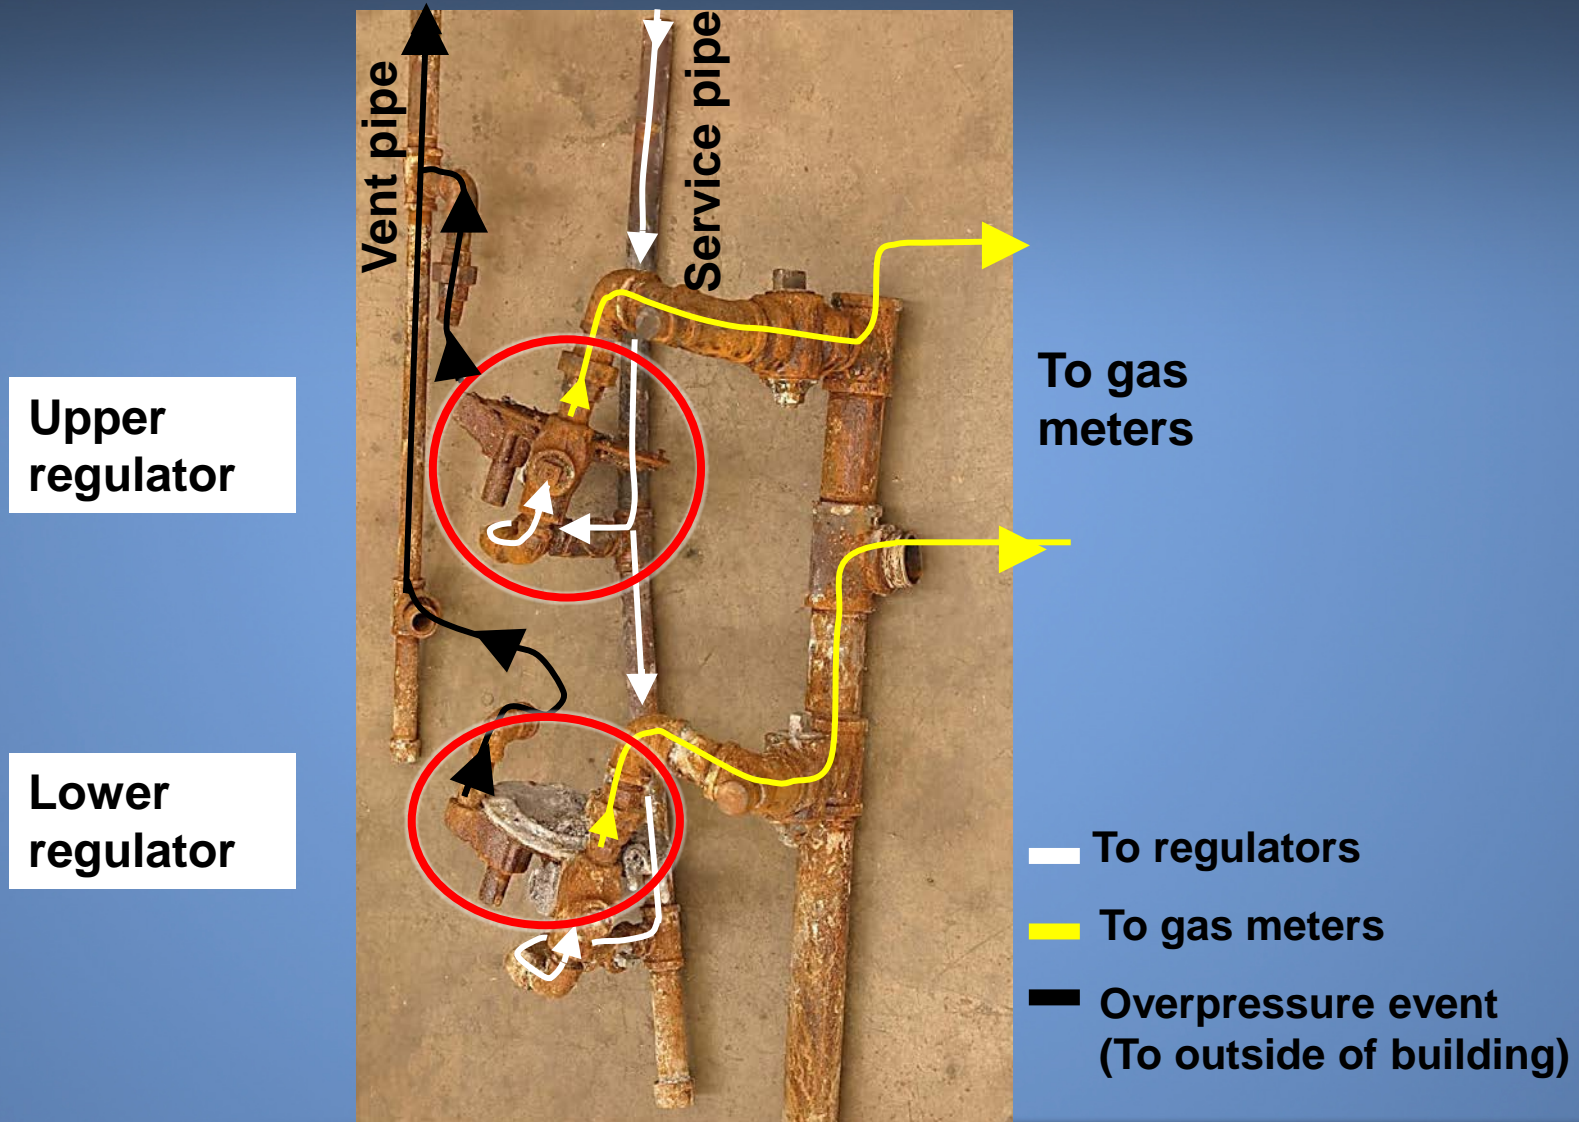
As-received Service Regulators – Gas Flow

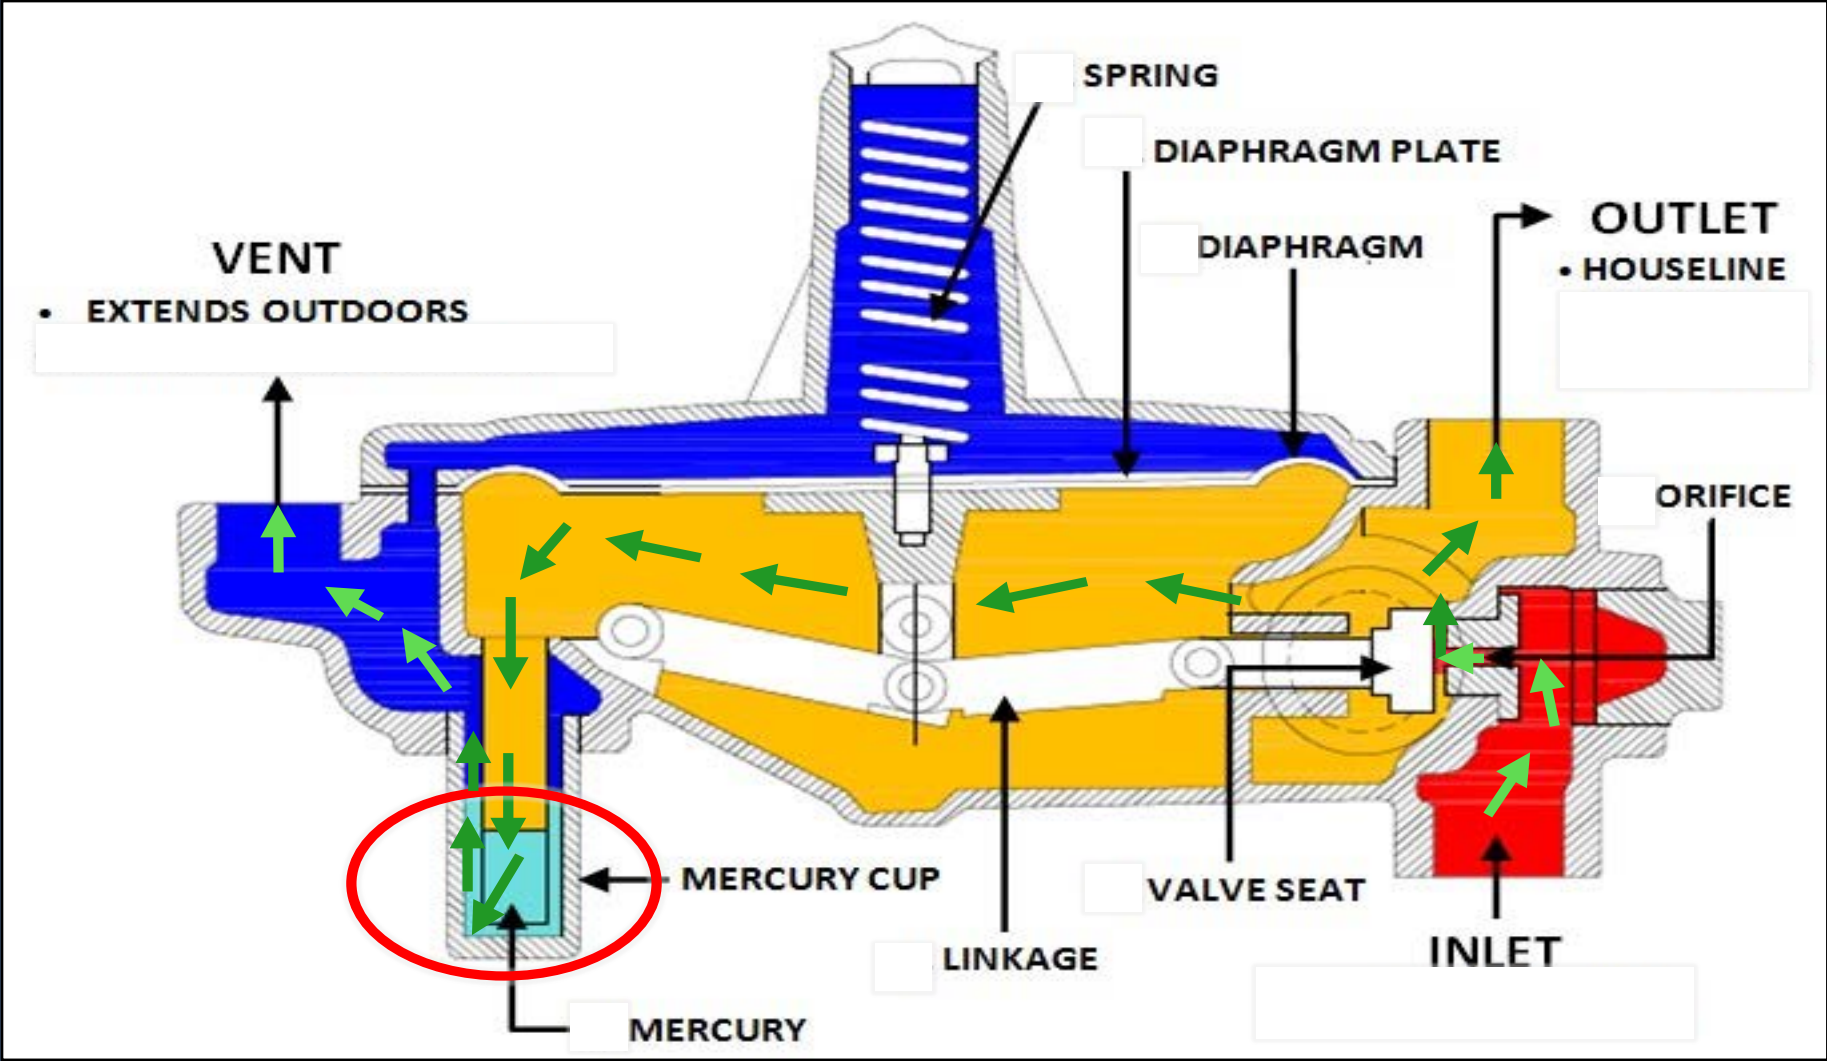
Mercury Service Regulator – Overpressure (Venting)

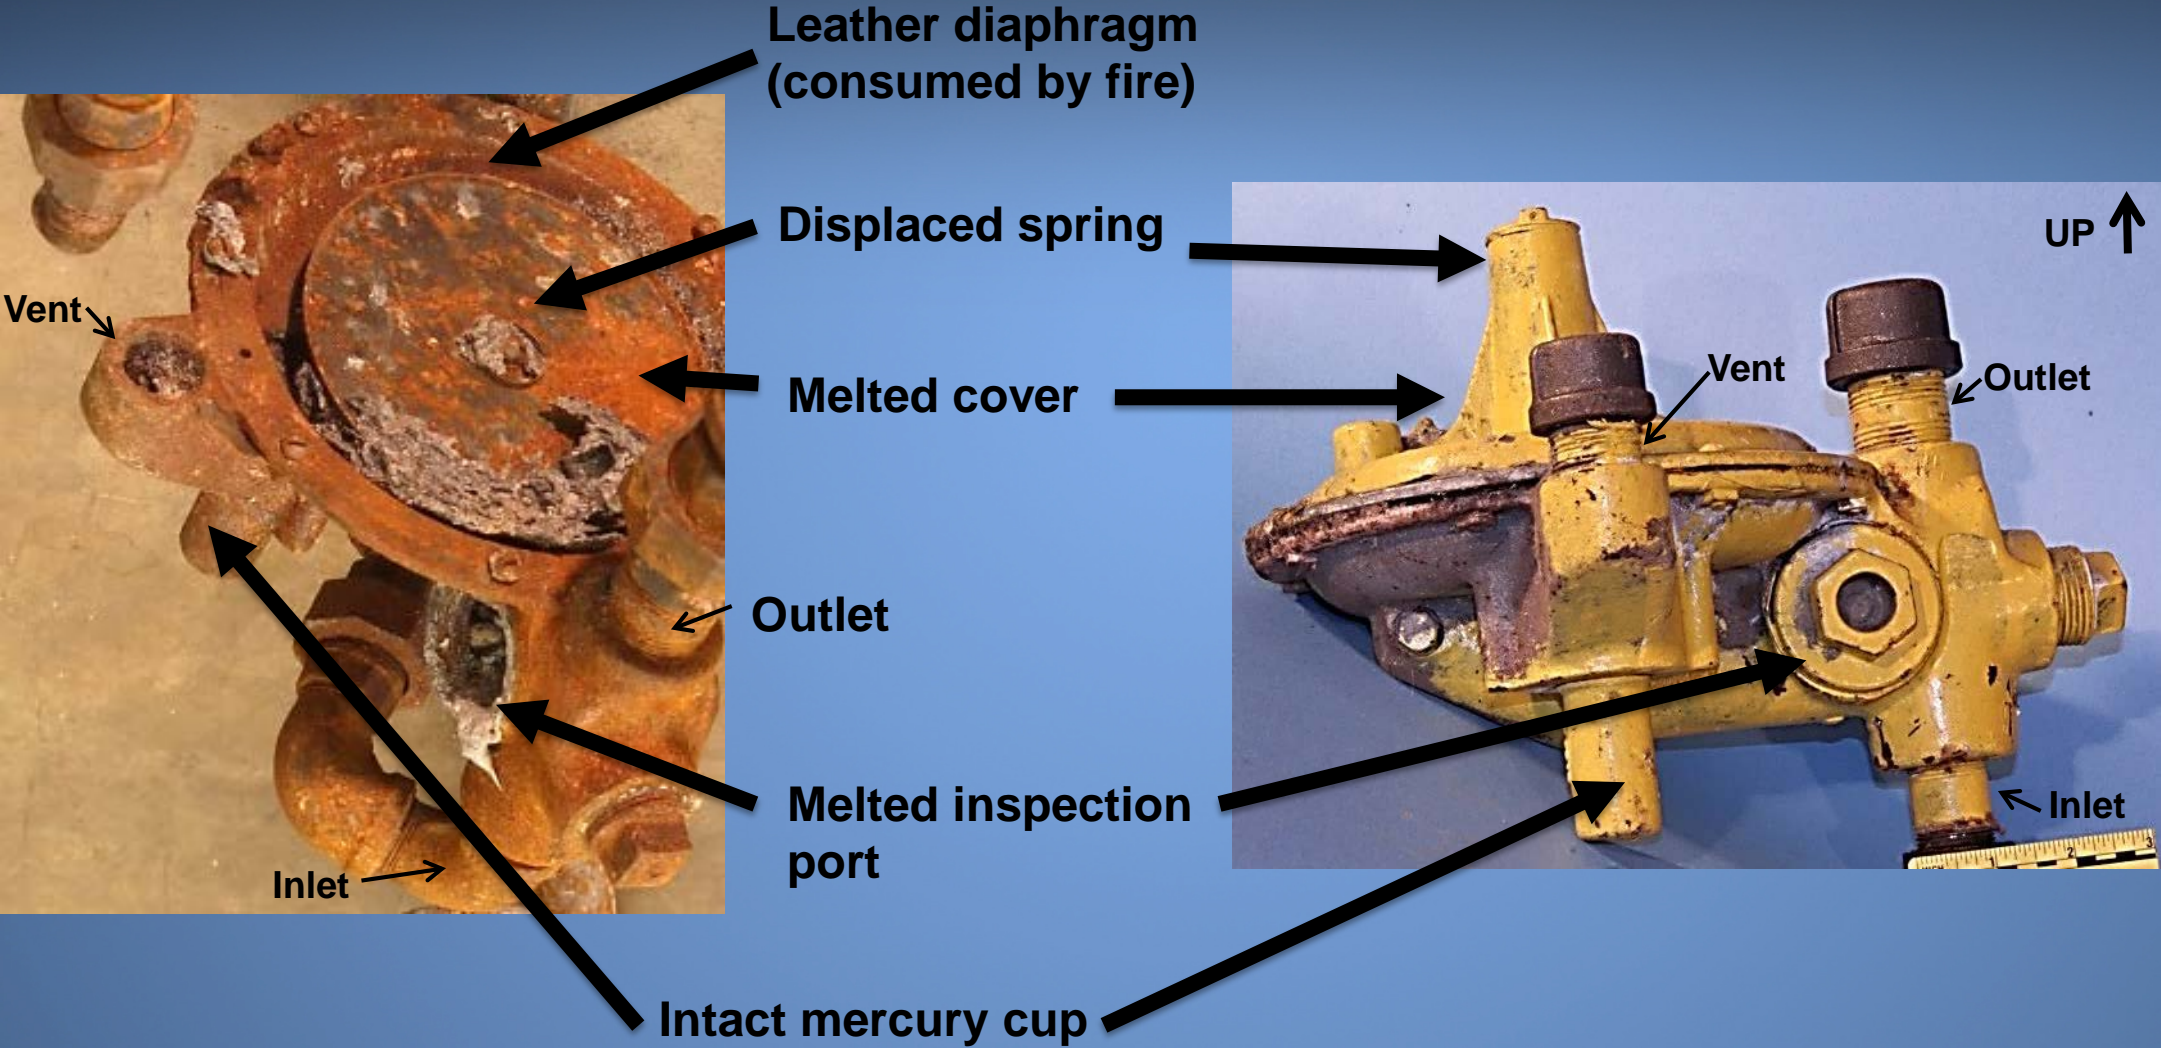
Fire Damaged Upper Regulator

Undamaged Regulator From Other Building

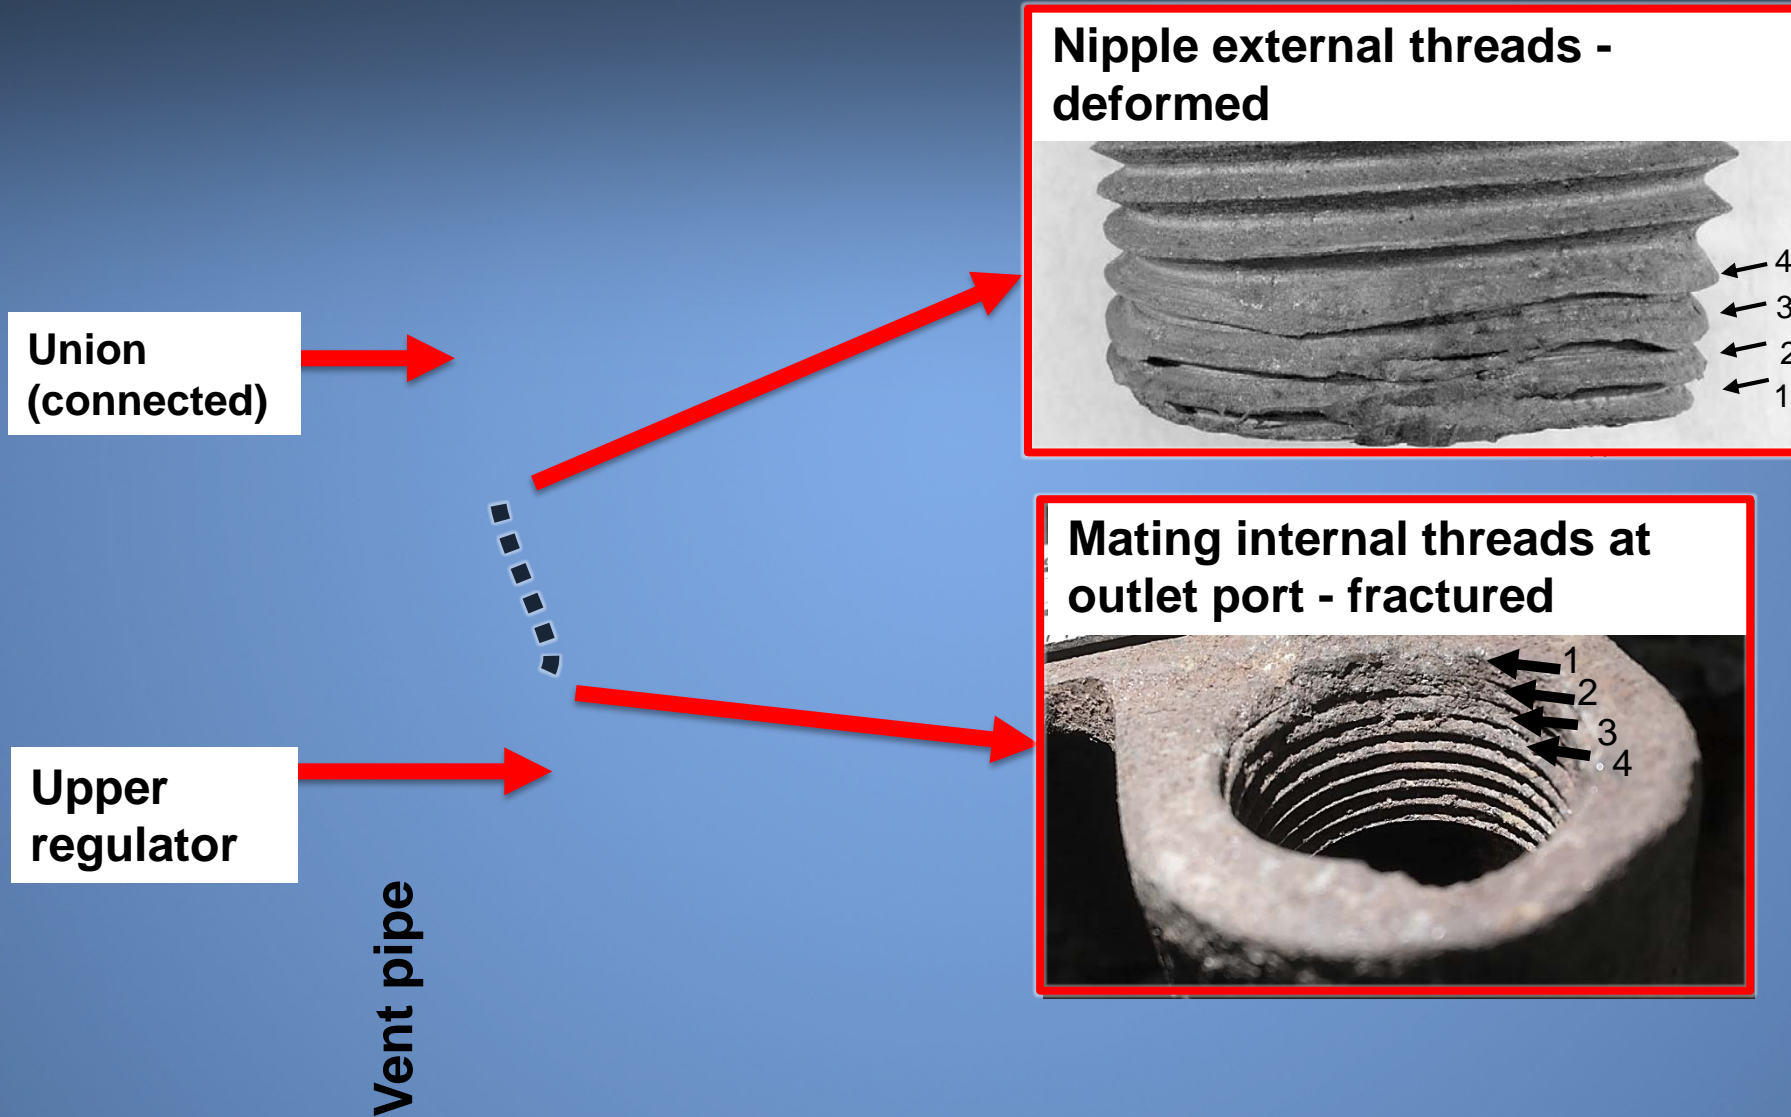
Upper Service Regulator

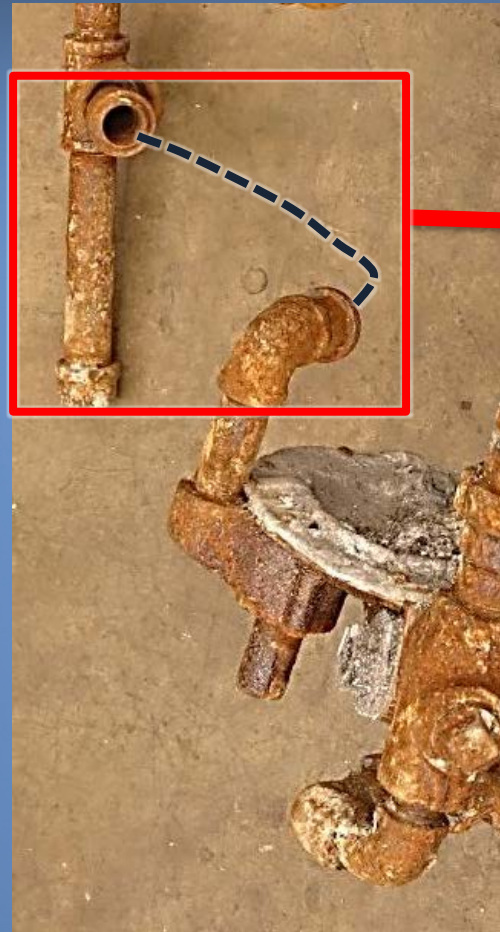
Lower Service Regulator

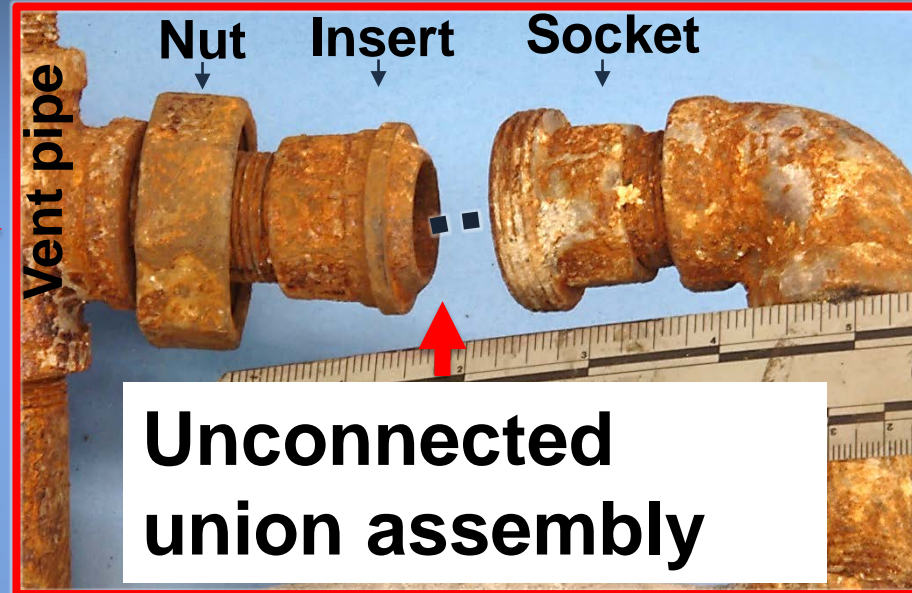
Lower regulator

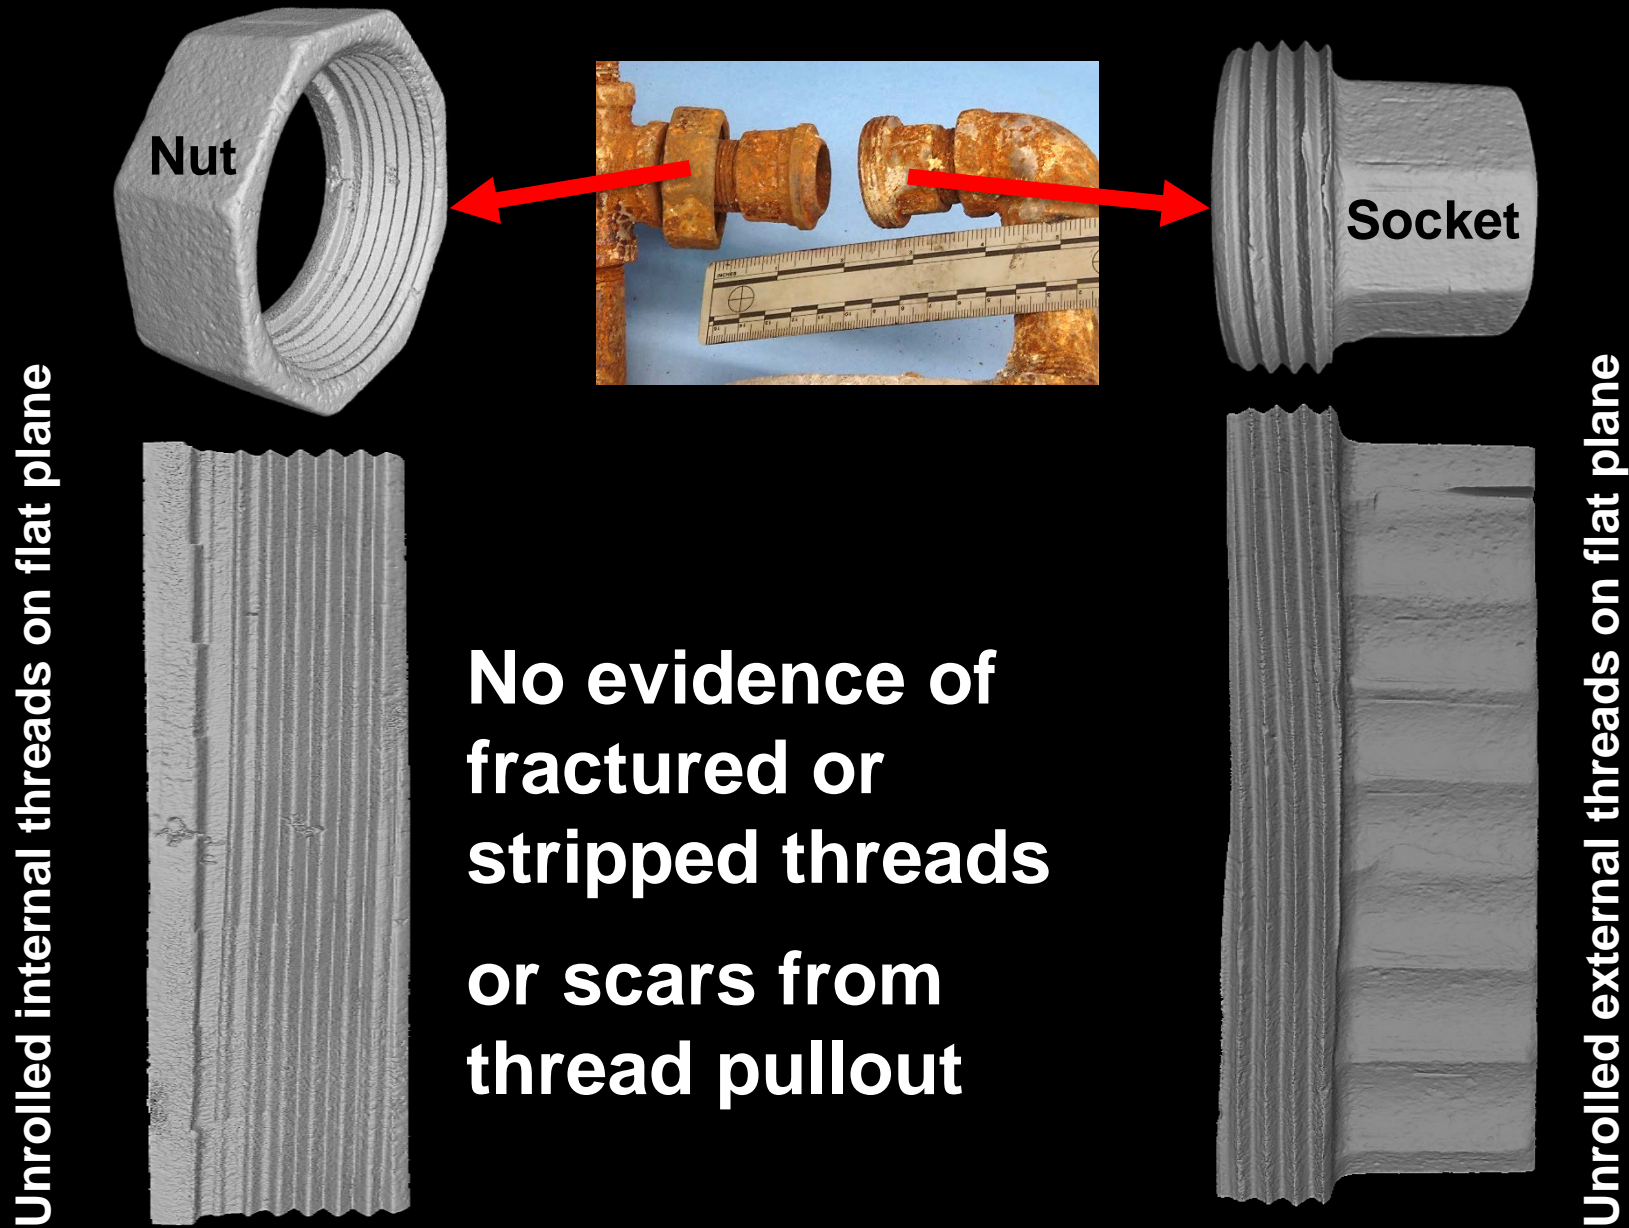
Lower Regulator – Union Assembly X-ray CT Scan

Gas venting from the lower mercury service regulator through the unconnected union assembly allowed gas to accumulate in the meter room to an explosive level, and found an ignition source.

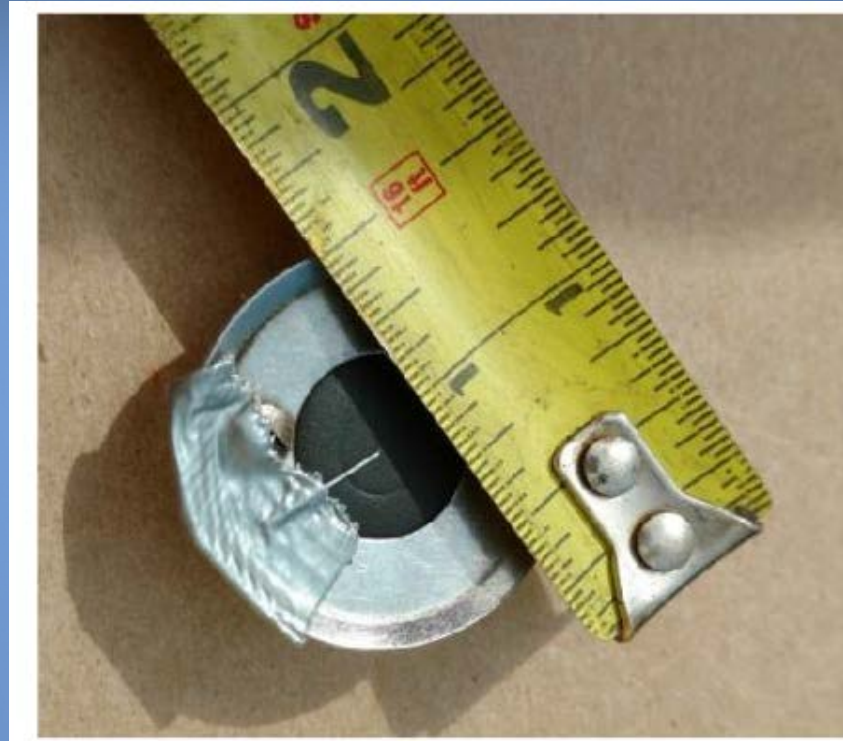
Diaphragm Tear

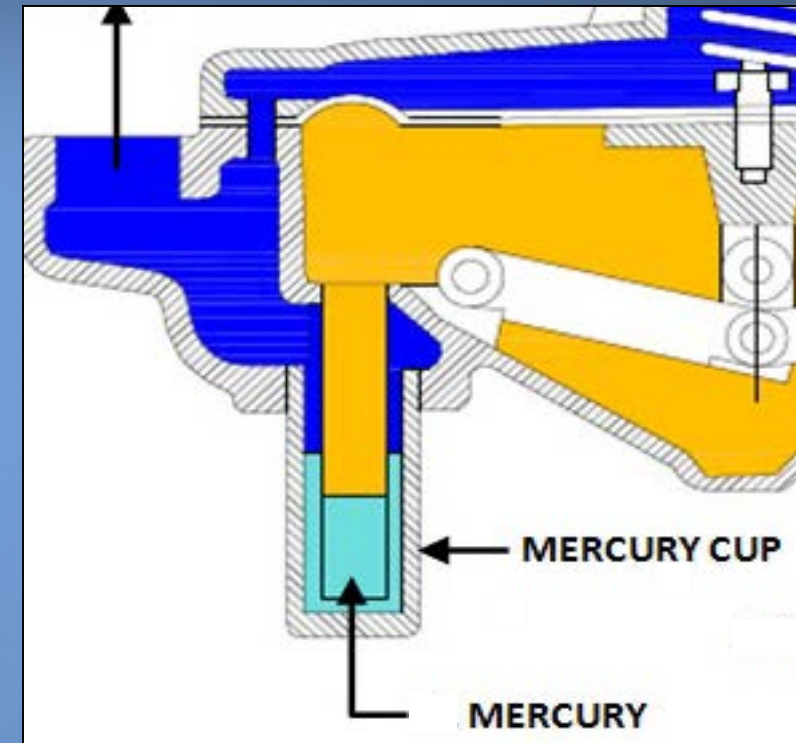
Obstruction to the Valve Seat

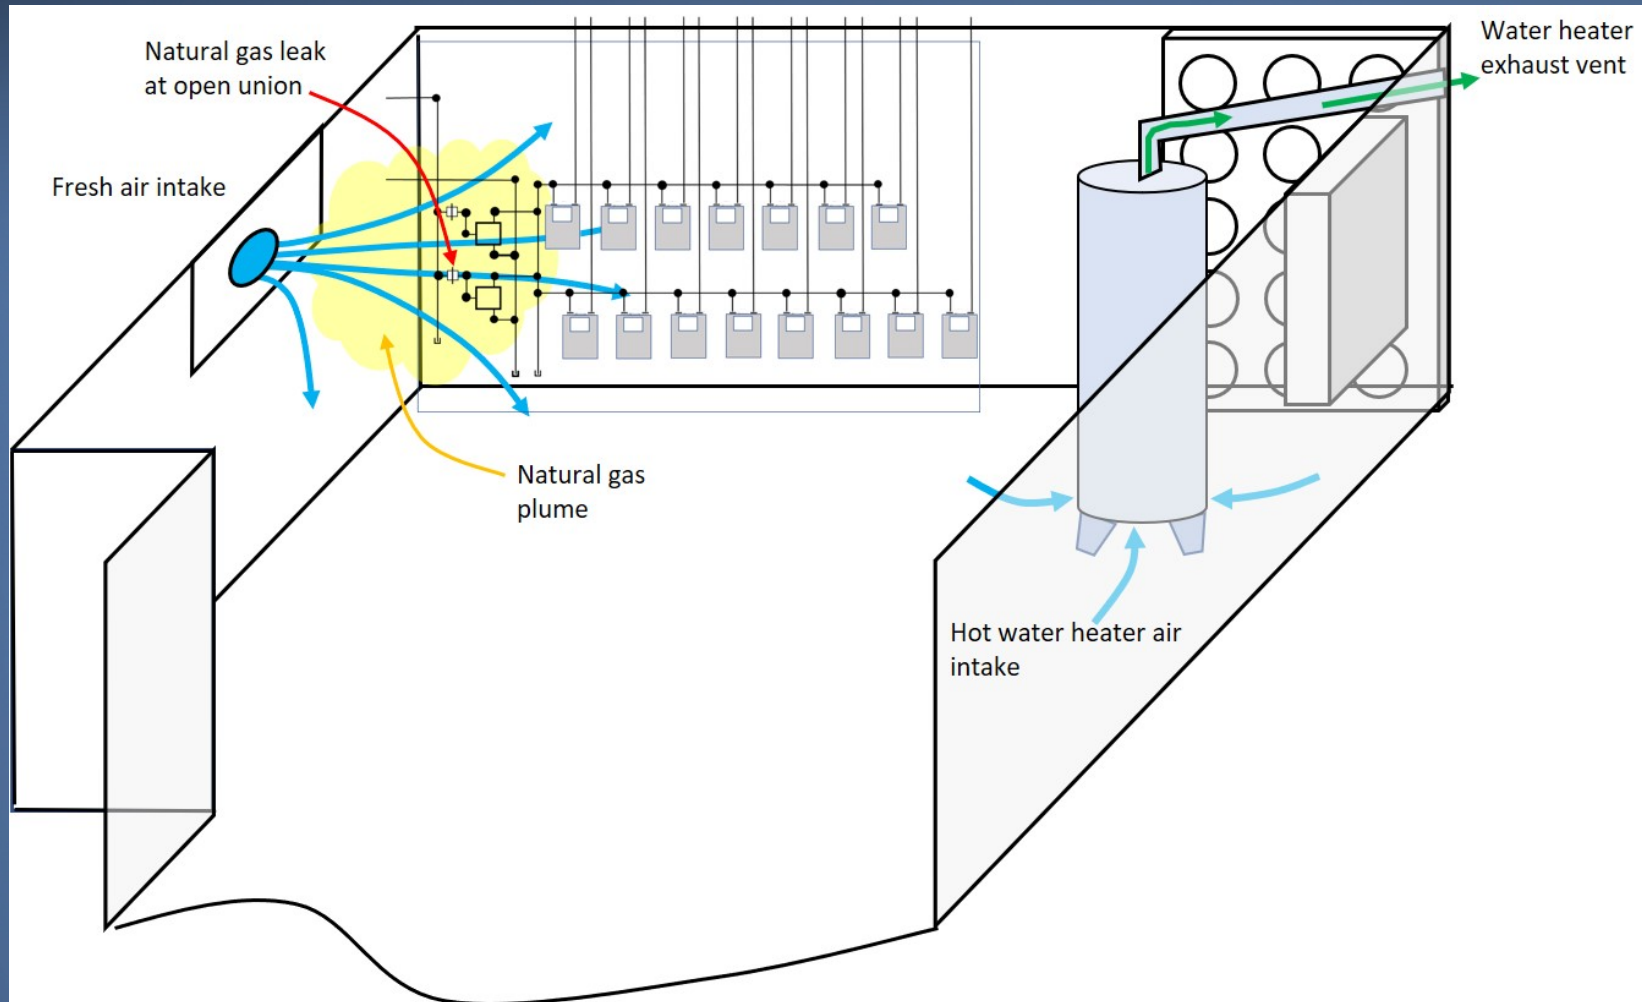
Natural Gas Accumulation

- 8:42 p.m.: Meter room alarm armed
- 11:51 p.m.: Explosion occurred
- Lowest flow rate could create an explosive atmosphere
