**National
Transportation
Safety Board**

Front Axle Housing Failure Analysis

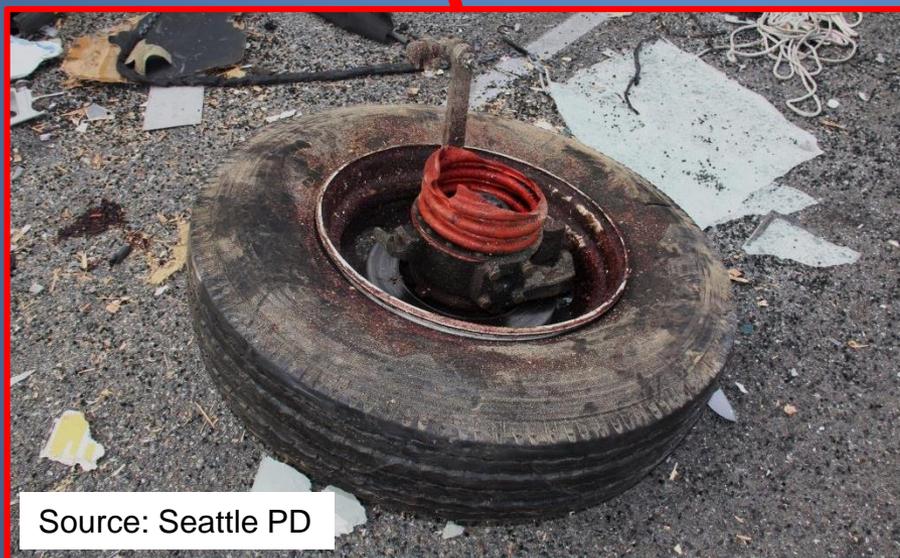
Separated wheel
filled with red
gear oil

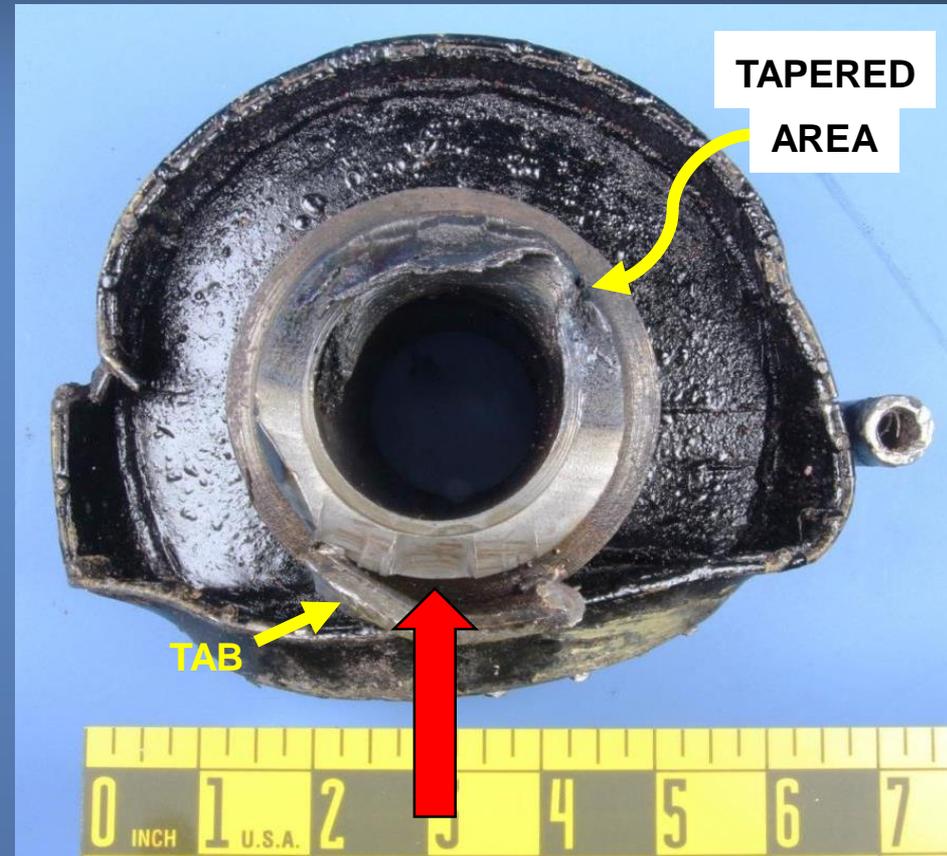
Axle Housing Failure Mechanism

- Fractured due to fatigue cracking
- Initiation at bottom of the axle housing
- Multiple initiation fatigue cracking

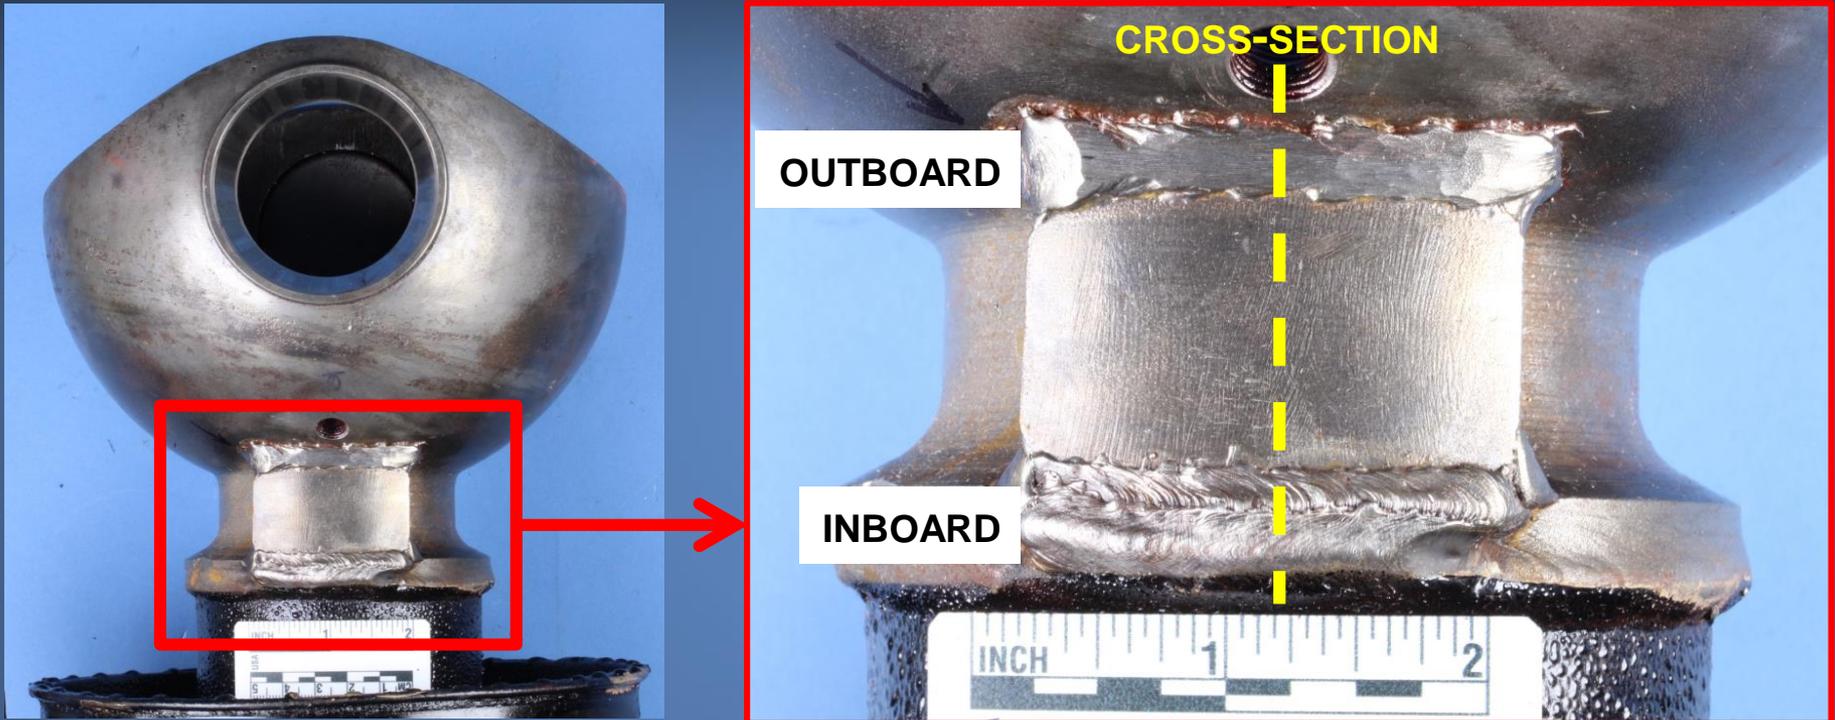
Tab Failure

- Multiple initiation fatigue cracking
 - Led to axle housing fracture
- Axle housing fracture caused
 - Left front wheel separation
 - Vehicle loss of control
- Tab welded at highest stress location
 - Poorly executed weld installation
 - Did not stiffen area to prevent failure

Cross-section prepared through intact right knuckle, including tab.

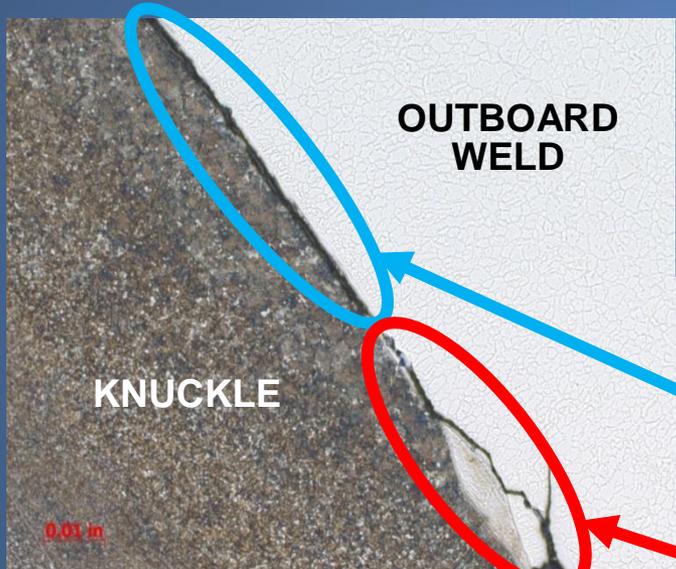
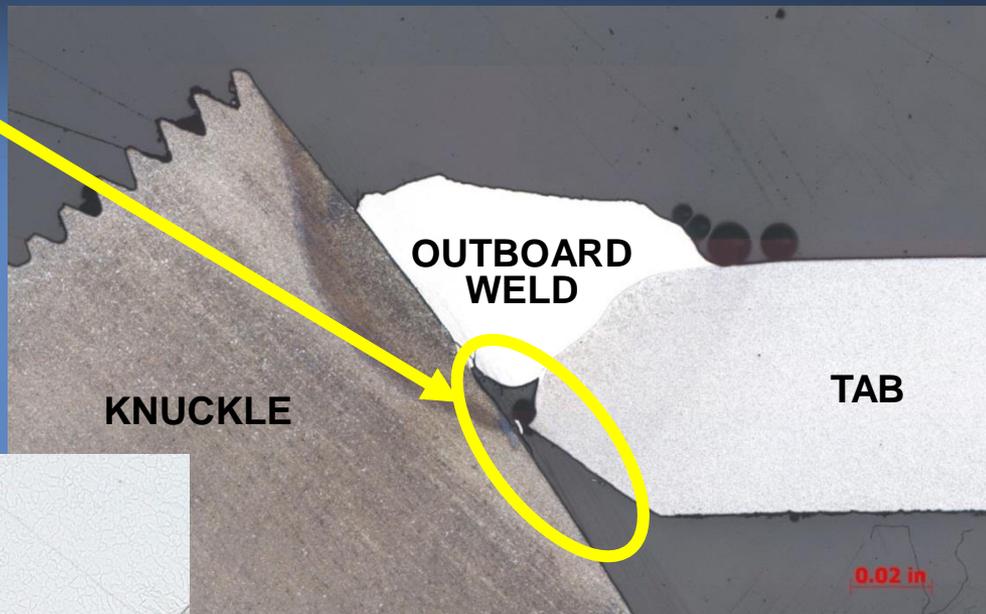
Tab Failure

- Lack of penetration

- Lack of fusion
- Cracking

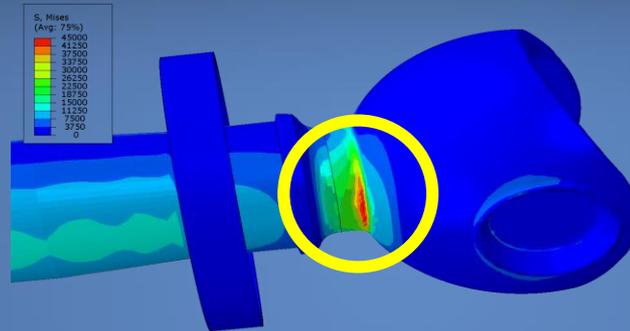
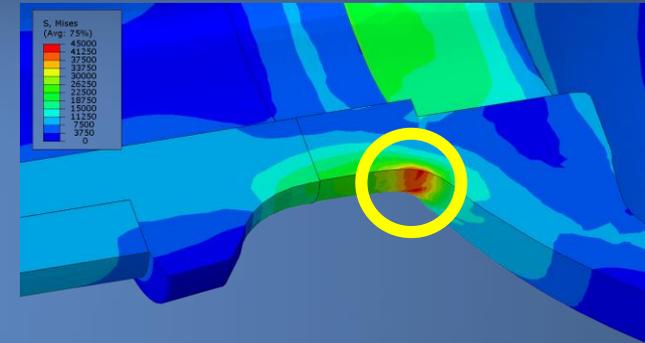
No tab

- Stress concentration in tapered area

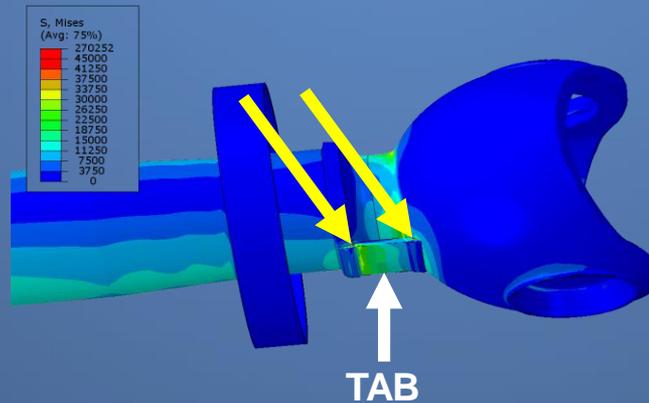
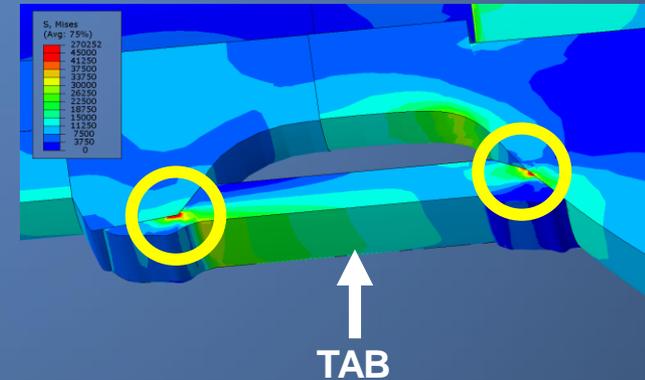
Tab installed

- Stress concentrations at weld interfaces
