**National
Transportation
Safety Board**

Rail Accidents Involving Crude Oil and Ethanol Releases

Paul L. Stancil

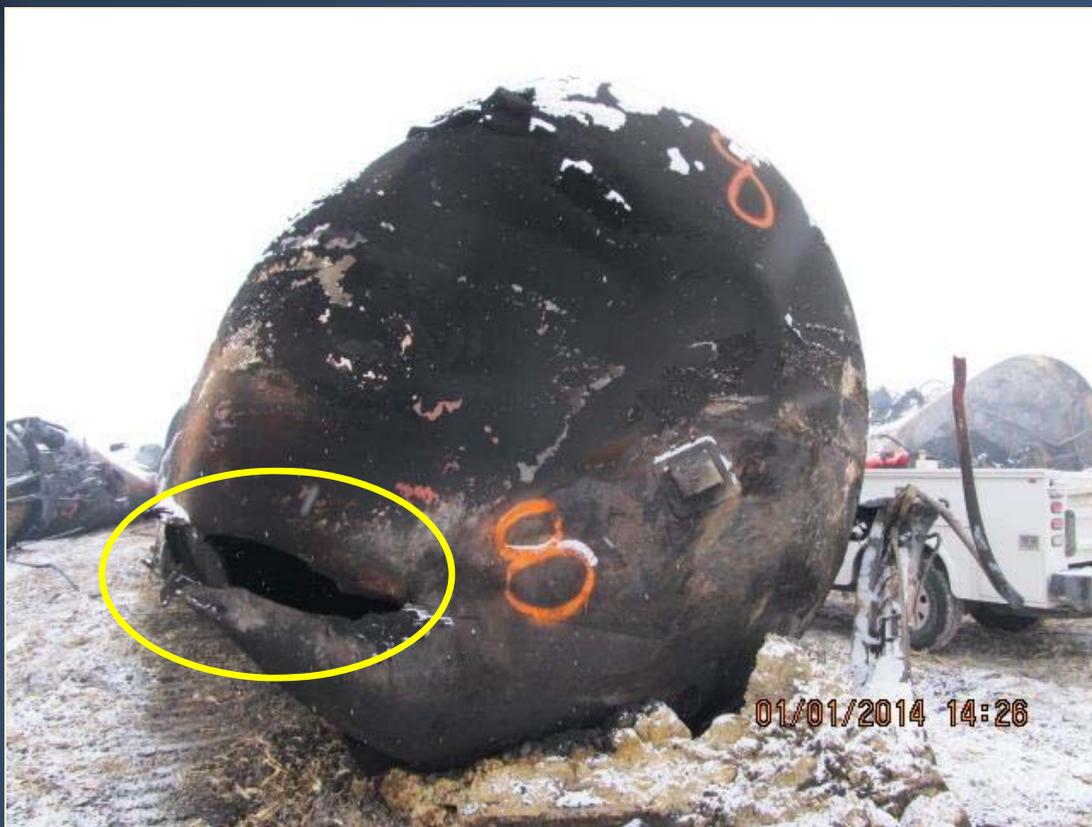
Lac-Mégantic, QC, 2013

Head Puncture

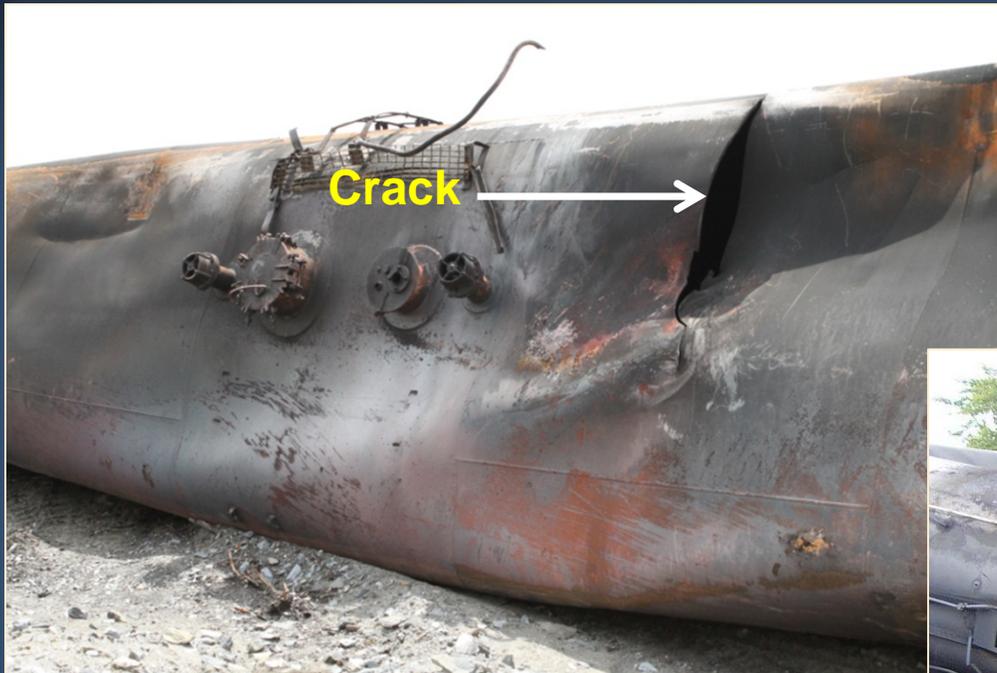
Cherry Valley, IL, 2009

Shell Cracking and Tearing

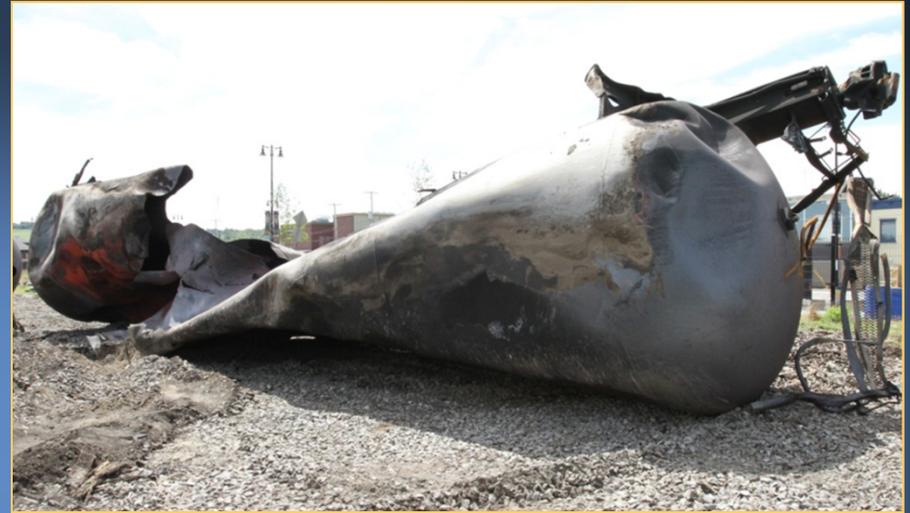
Lac-Mégantic, QC, 2013

Loss of Containment Volume

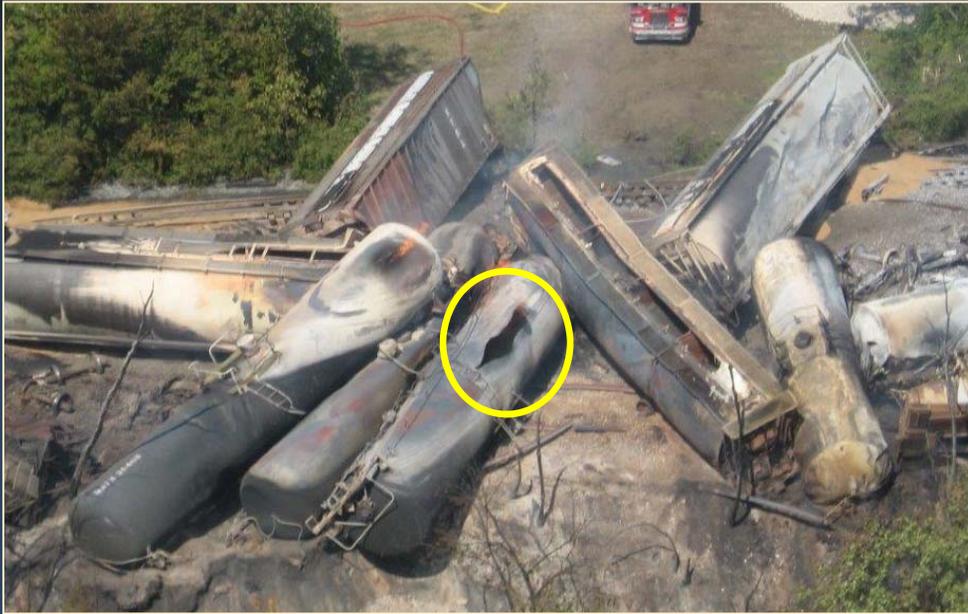
Columbus, OH, 2012

Thermal Failure and Fireball Release

- No tank jacket
- No thermal protection
- Insufficient pressure relief capacity

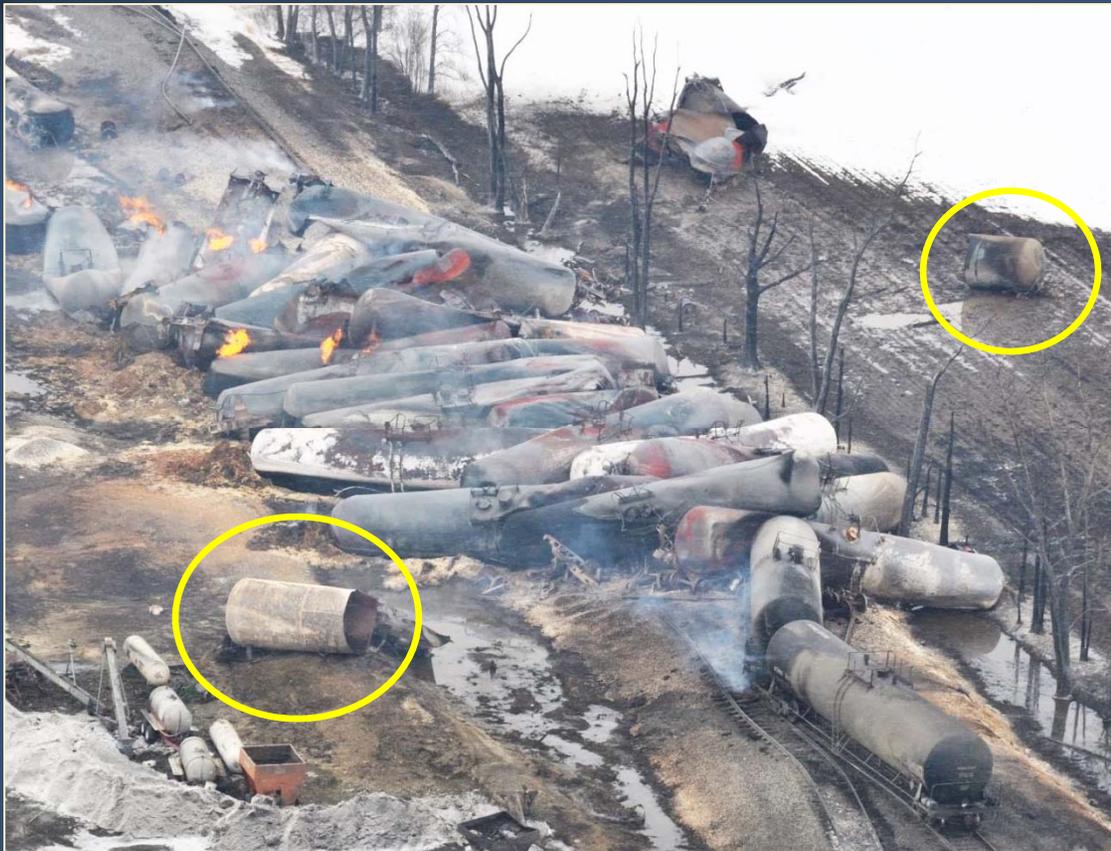
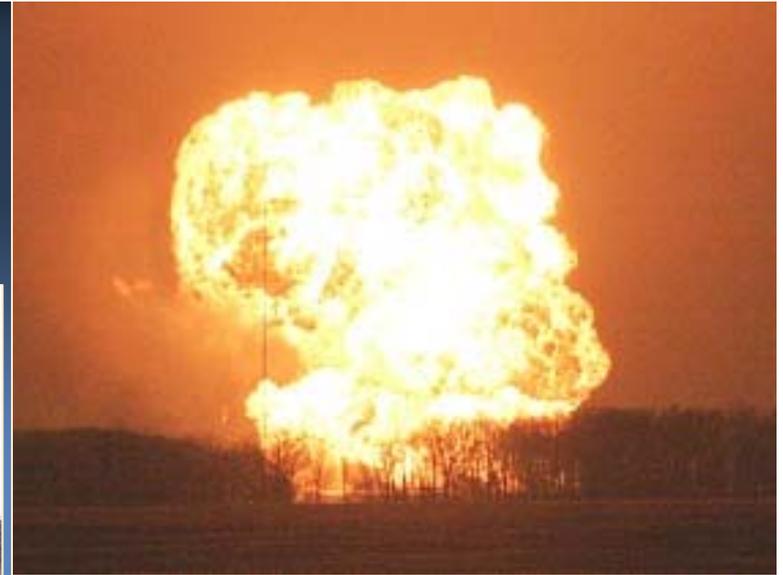
Arcadia, OH, 2011

Energetic Ruptures

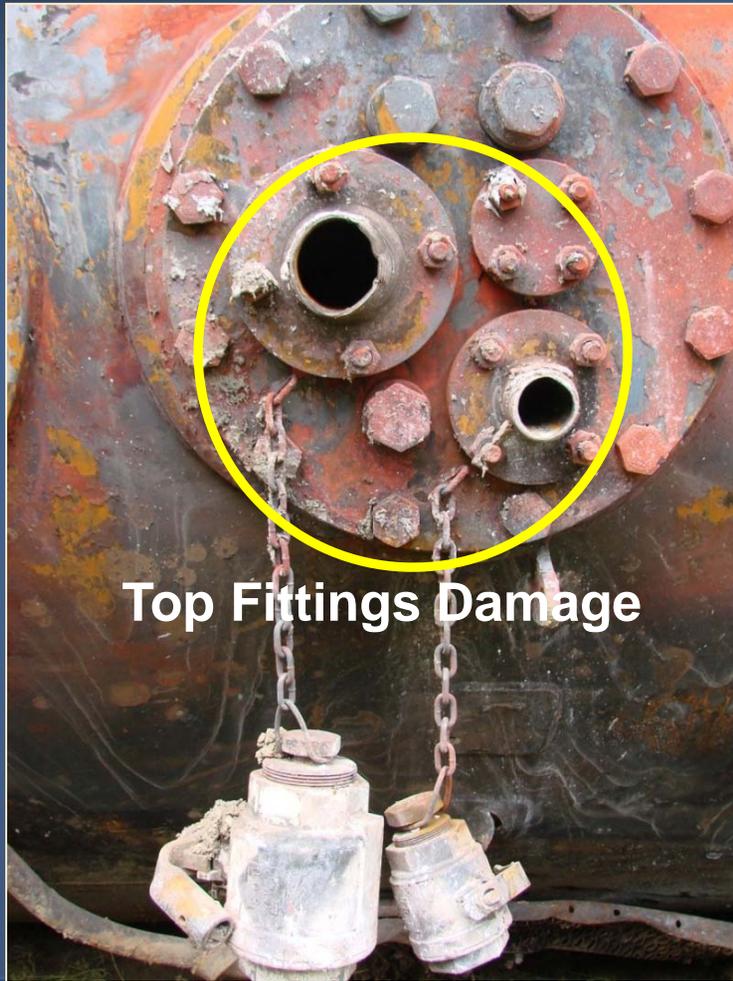
Cherry Valley, IL, 2009

Top and Bottom Fittings Vulnerability

- Fittings not adequately protected

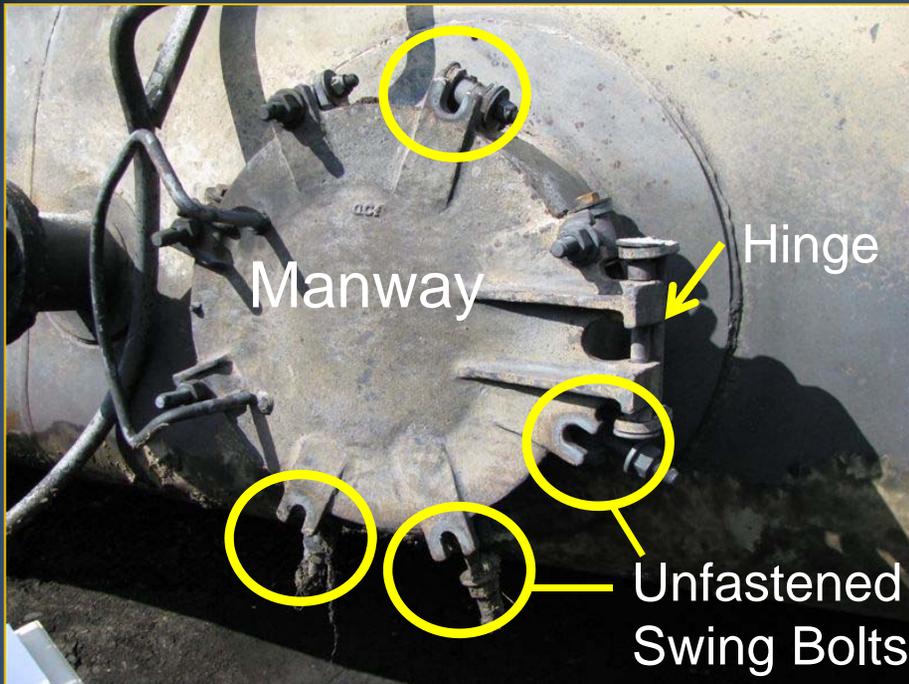
Lac-Mégantic, QC, 2013

Top Fittings Failures
