## **Collision of Metrolink Train 111 with Union Pacific Train LOF 65-12**

Opening Statement

Chatsworth, California  
September 12, 2008

DCA 08 MR 009

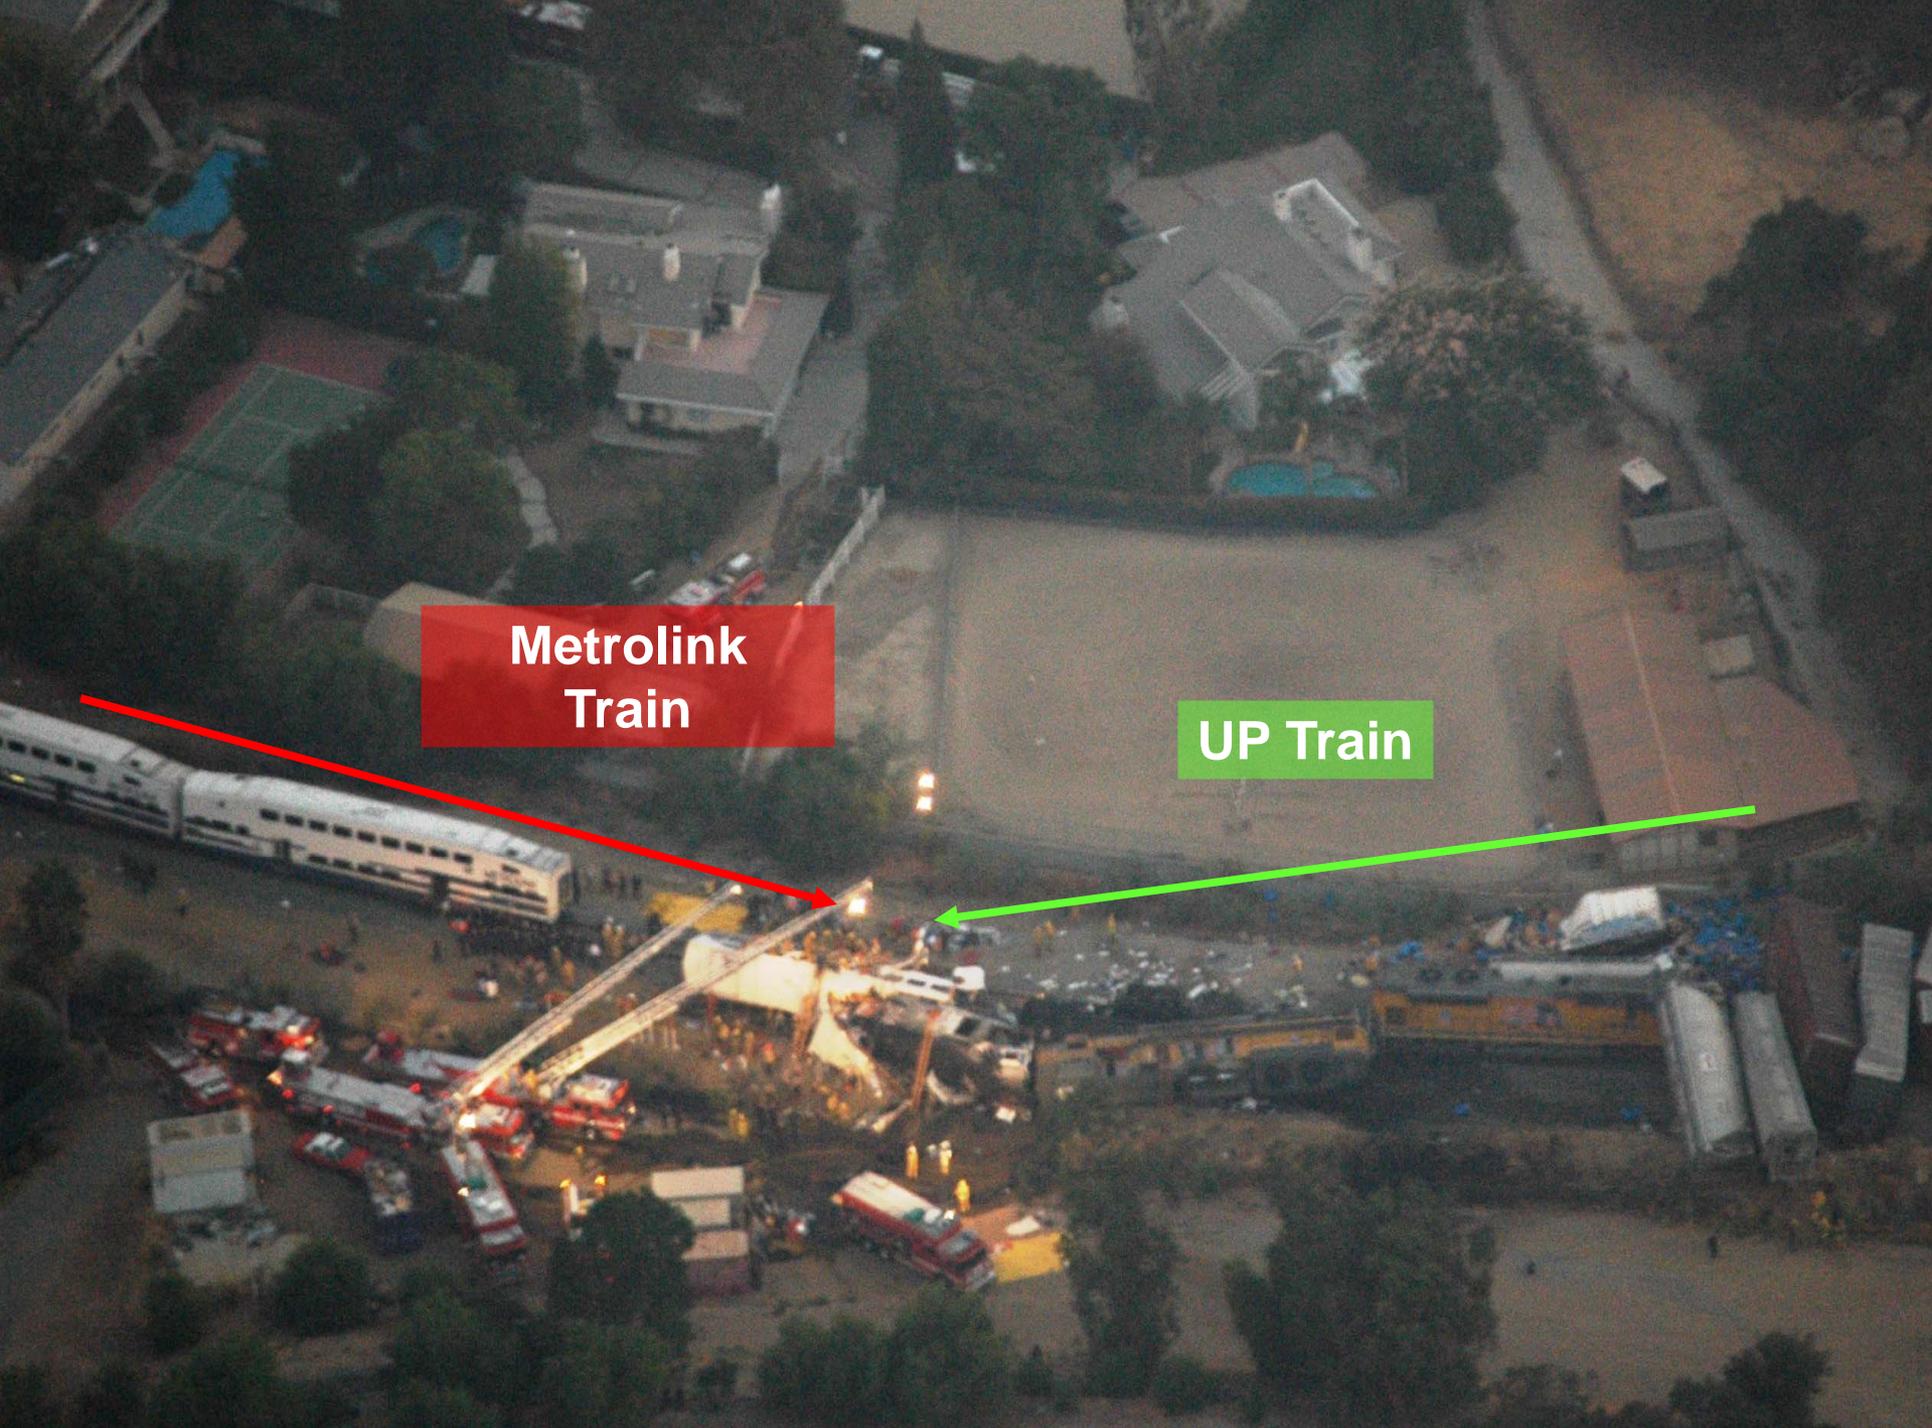
**Metrolink  
Train**

**UP Train**

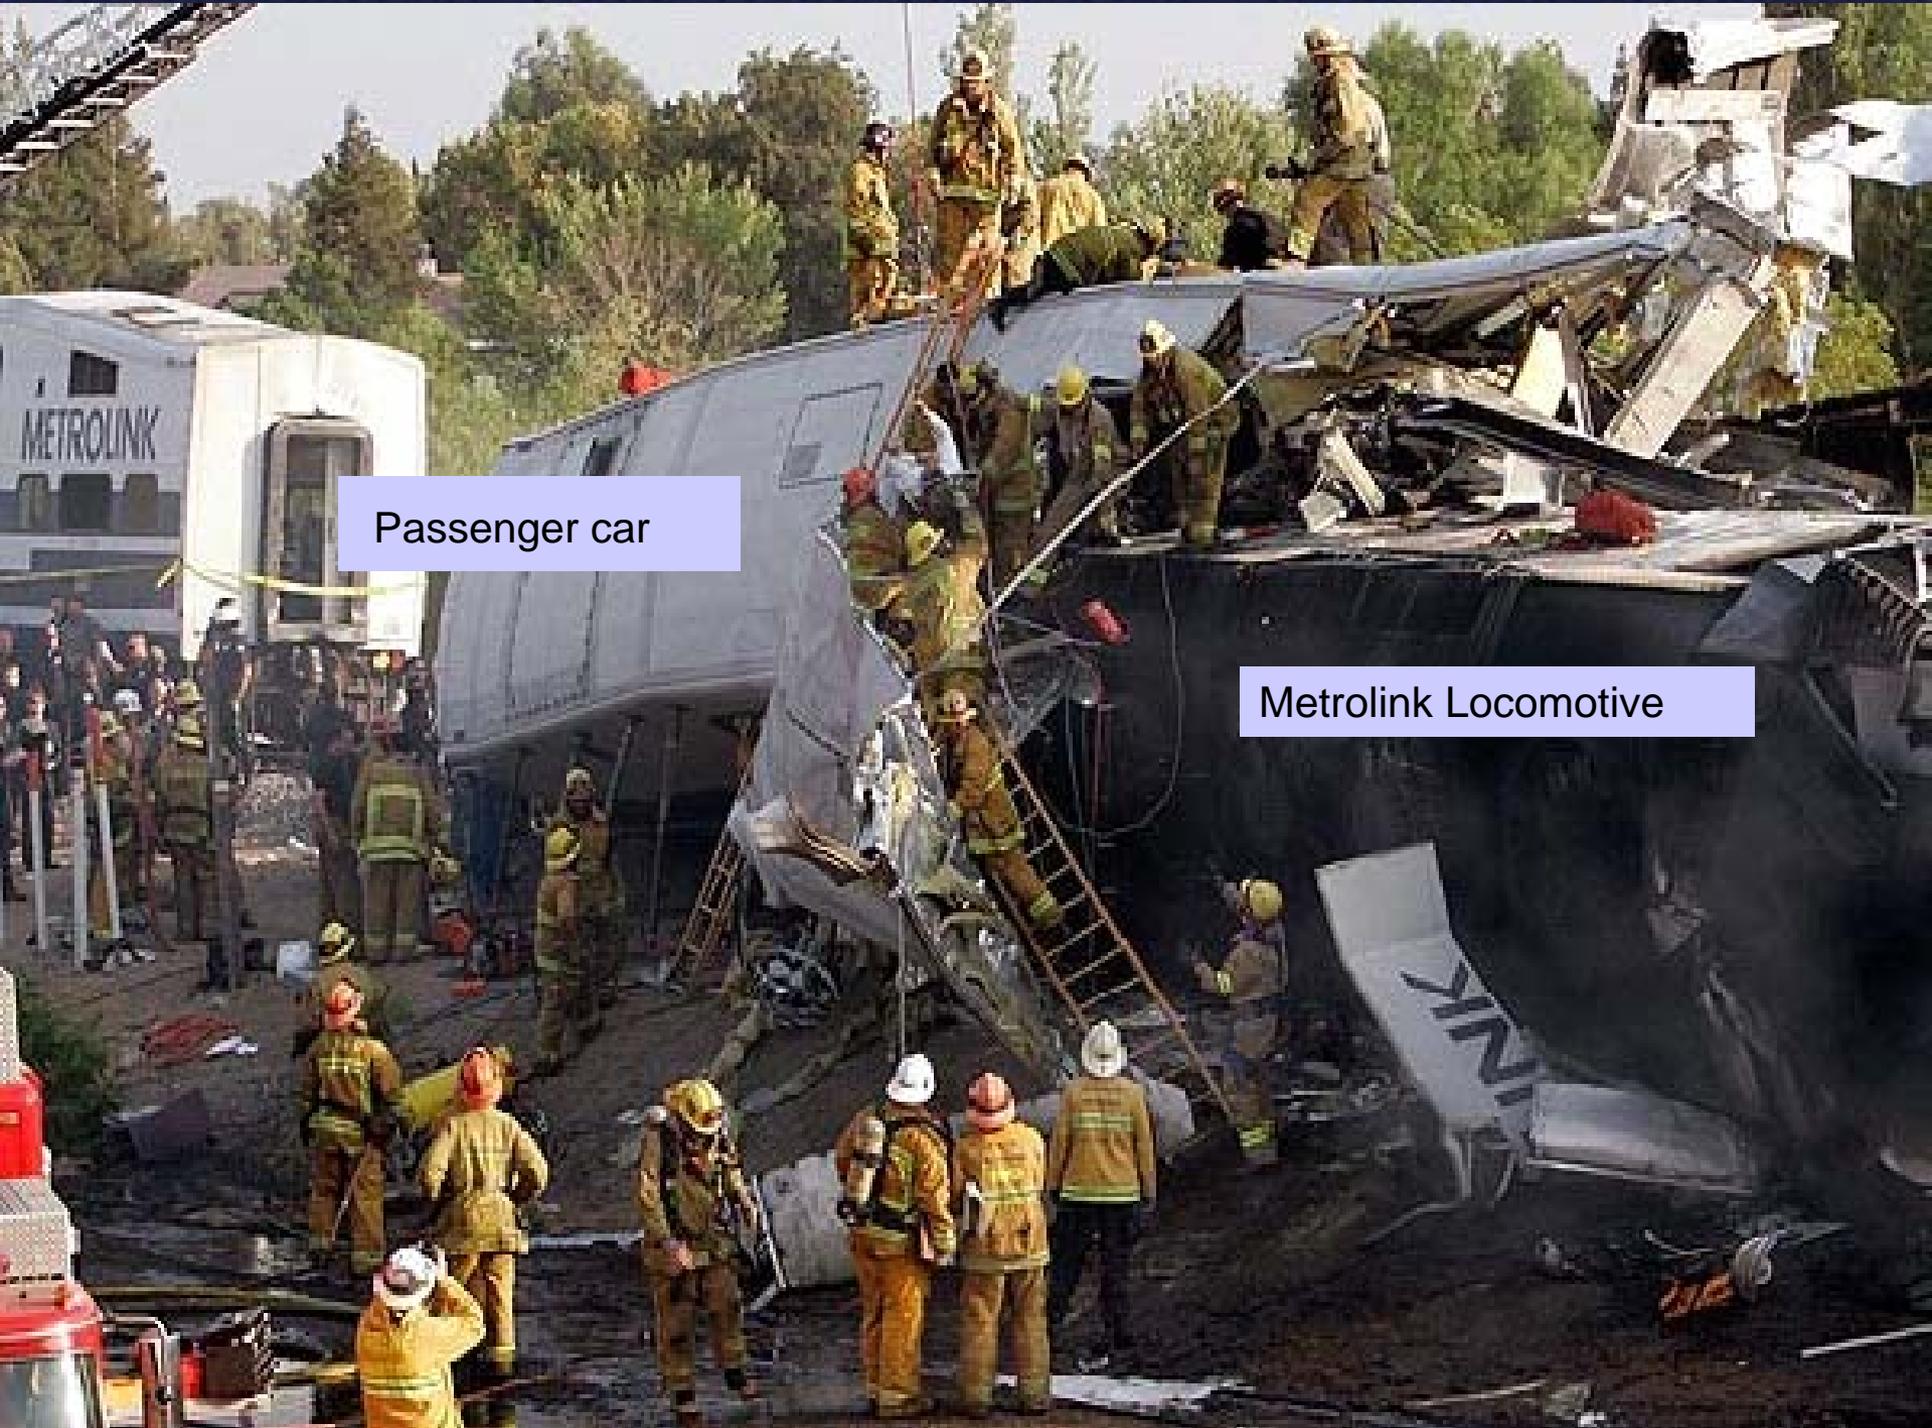
Passenger car

Metrolink Locomotive

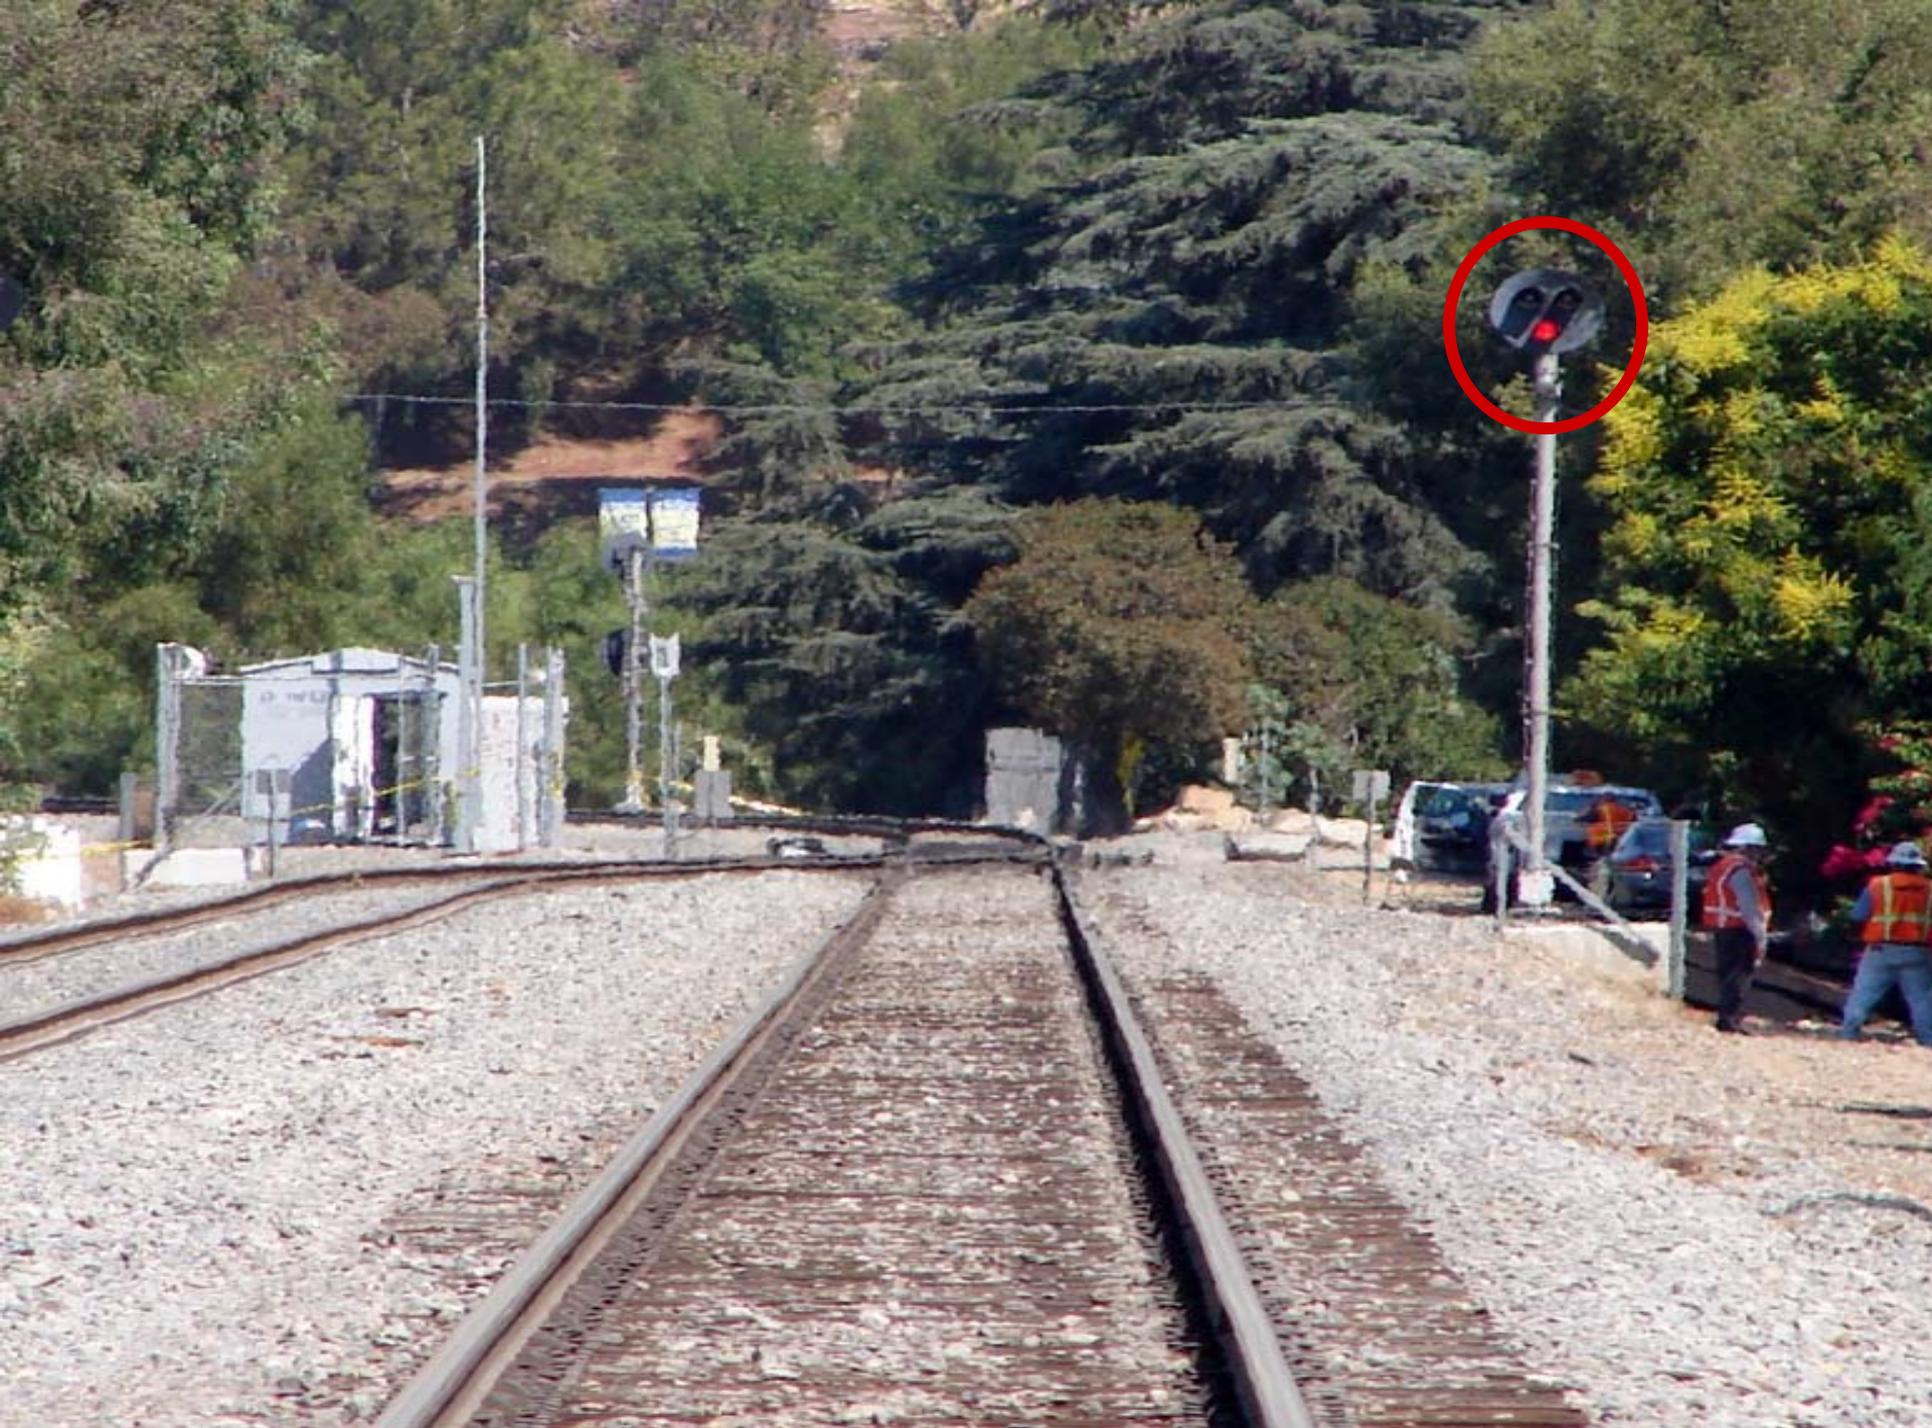
- Metrolink train 111 failed to stop at CP Topanga and ran through the switch that was lined for UP LOF 65-12 to move into the siding. As a result the Metrolink train entered into the path of the opposing UP train
- UP LOF 65-12 operating eastward at 41 mph had just exited tunnel 28.
- Metrolink train 111 operating at 43 mph continued into the 6 degree curve and collided with UP LOF 65-12.
