**NTSB** National Transportation Safety Board

*Office of Railroad, Pipeline and  
Hazardous Materials Safety*

# **DOT-111 Tank Car Design**

Paul L. Stancil, CHMM

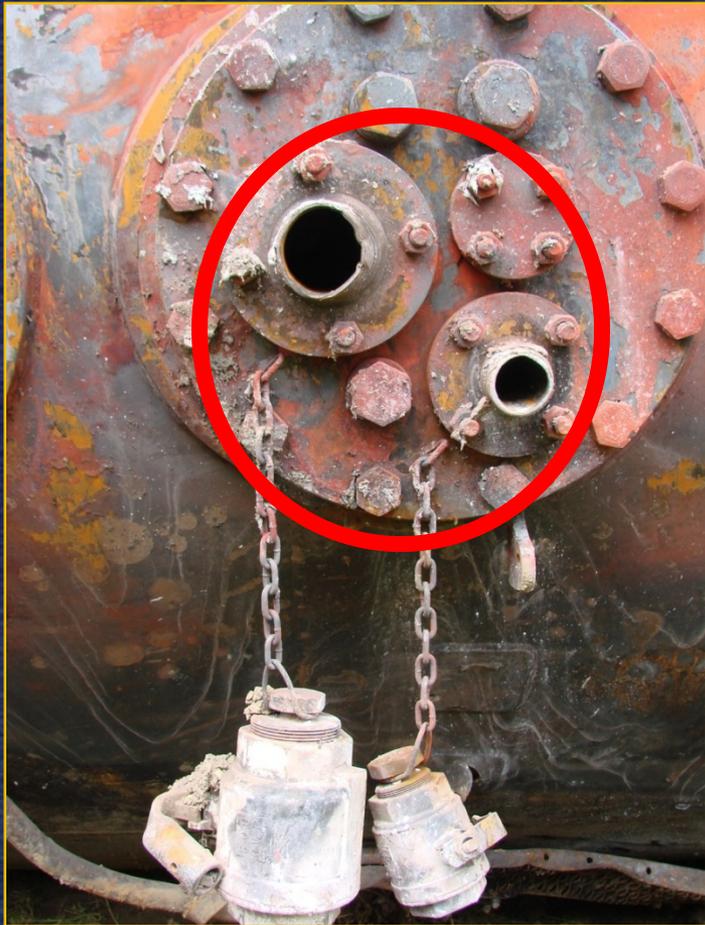
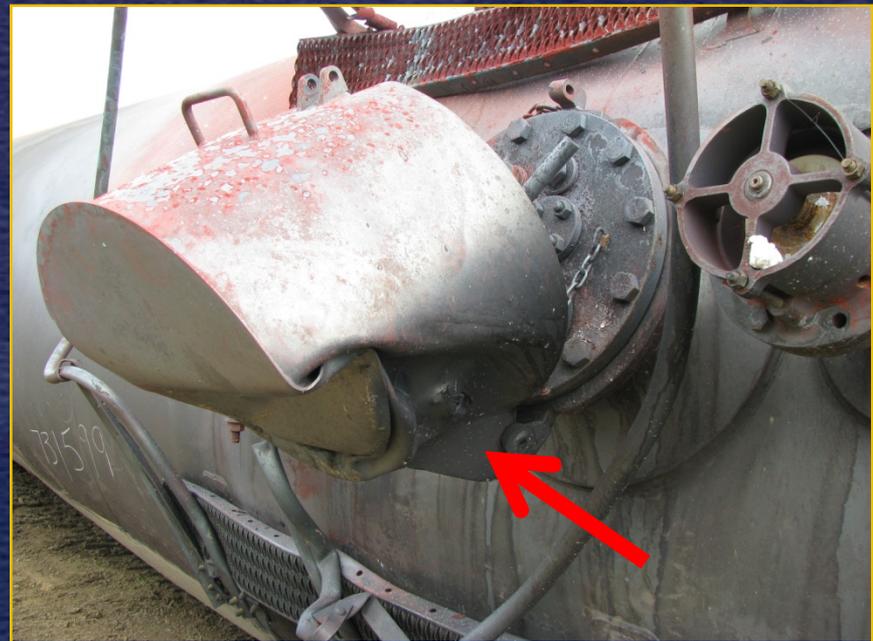
# Top Fittings Protection

- DOT-111 housings not effective in preventing impact damage

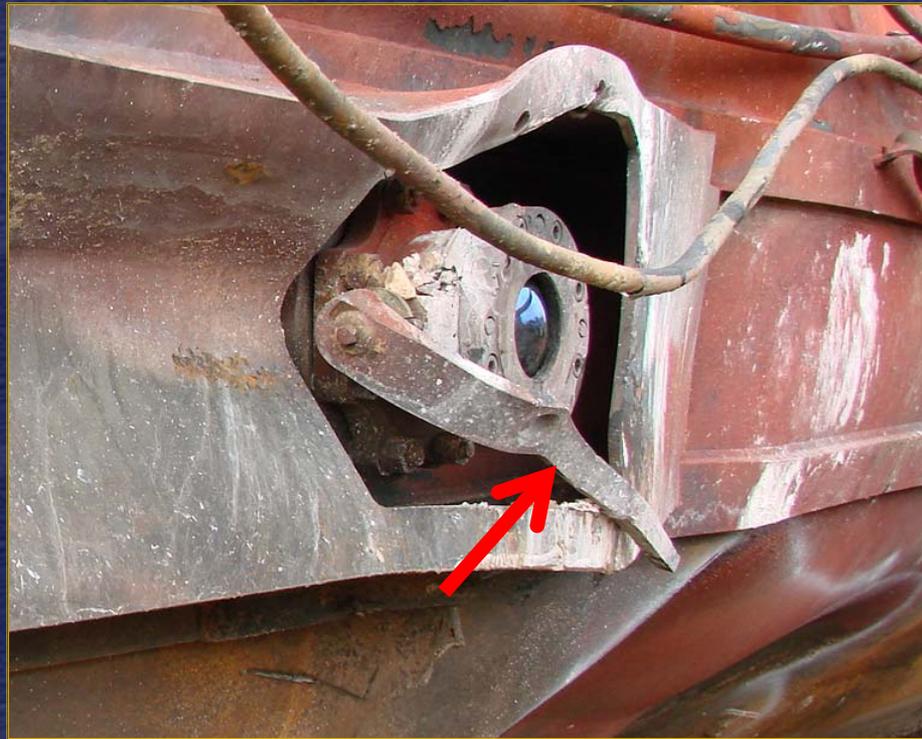
CIT Configuration

- Valve operating mechanisms compliant with current design requirements
- Handles became caught by objects and debris and caused valves to open
- Operating handles too robust and did not break free on impact
- Existing standards and regulations insufficient to ensure that bottom outlet valves remain closed during accidents
