NTSB National Transportation Safety Board

Continental Airlines Flight 1404

Survival Factors
Mark George

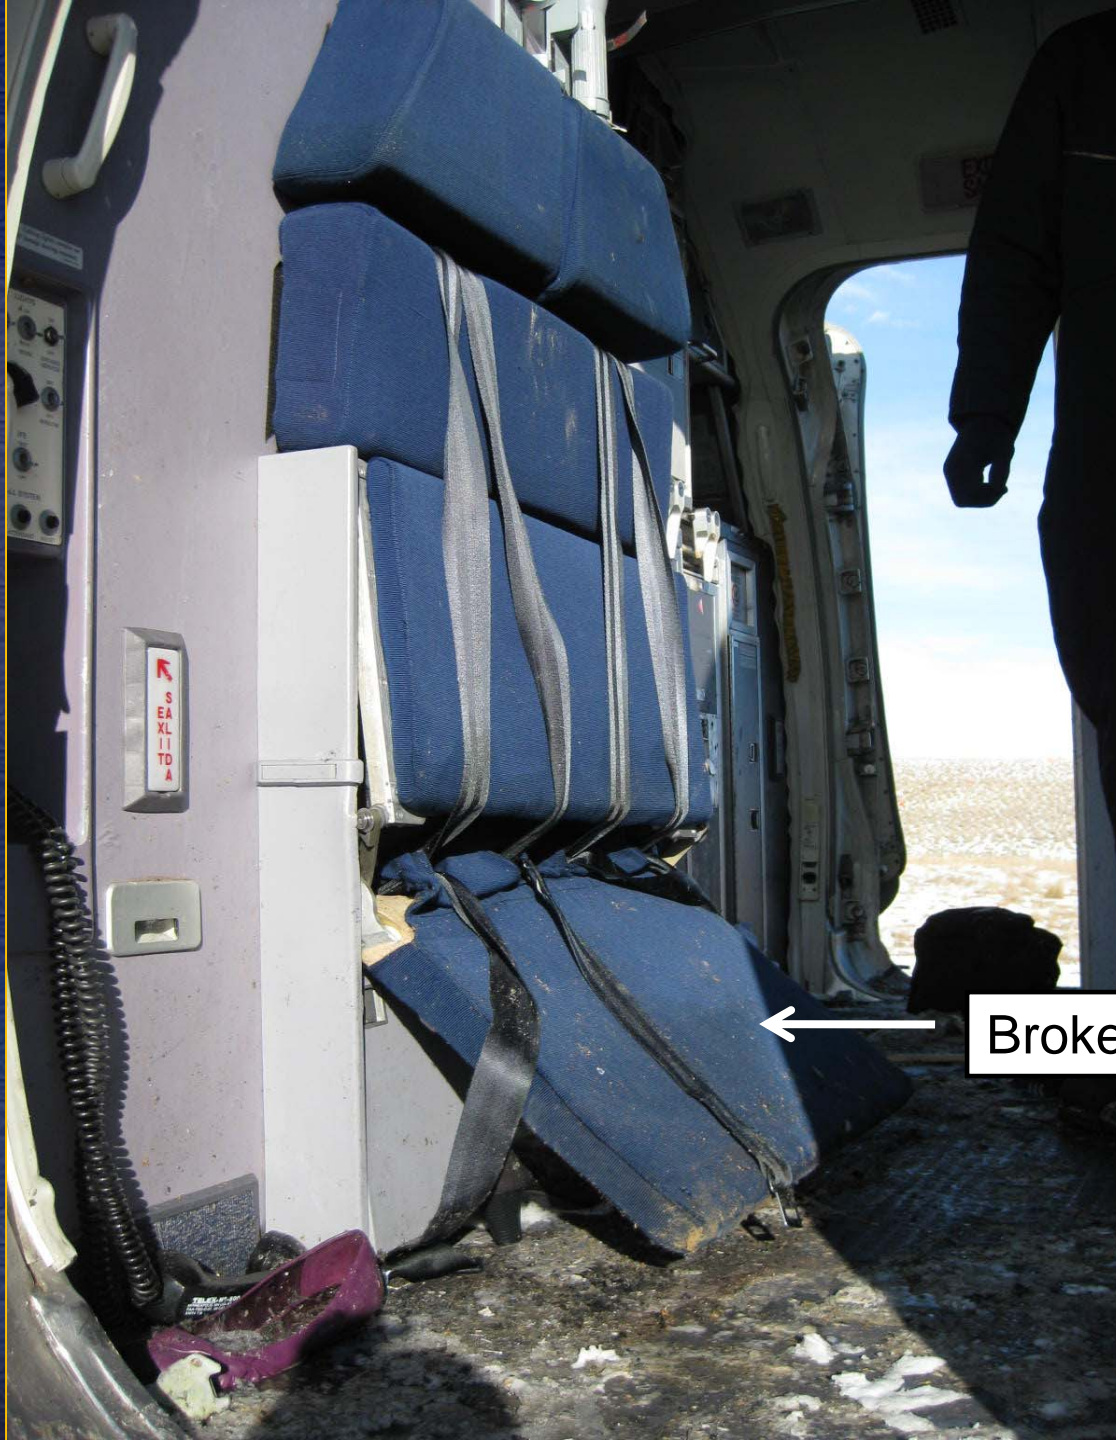
Broken seat pan

Cabin Crew Jumpseat

- Materials laboratory examination
 - Pre-existing metal fatigue
- Routine visual inspections
 - Structure
 - Function
 - Cannot detect fatigue cracks
- Crewmember safety
 - Conduct emergency evacuations

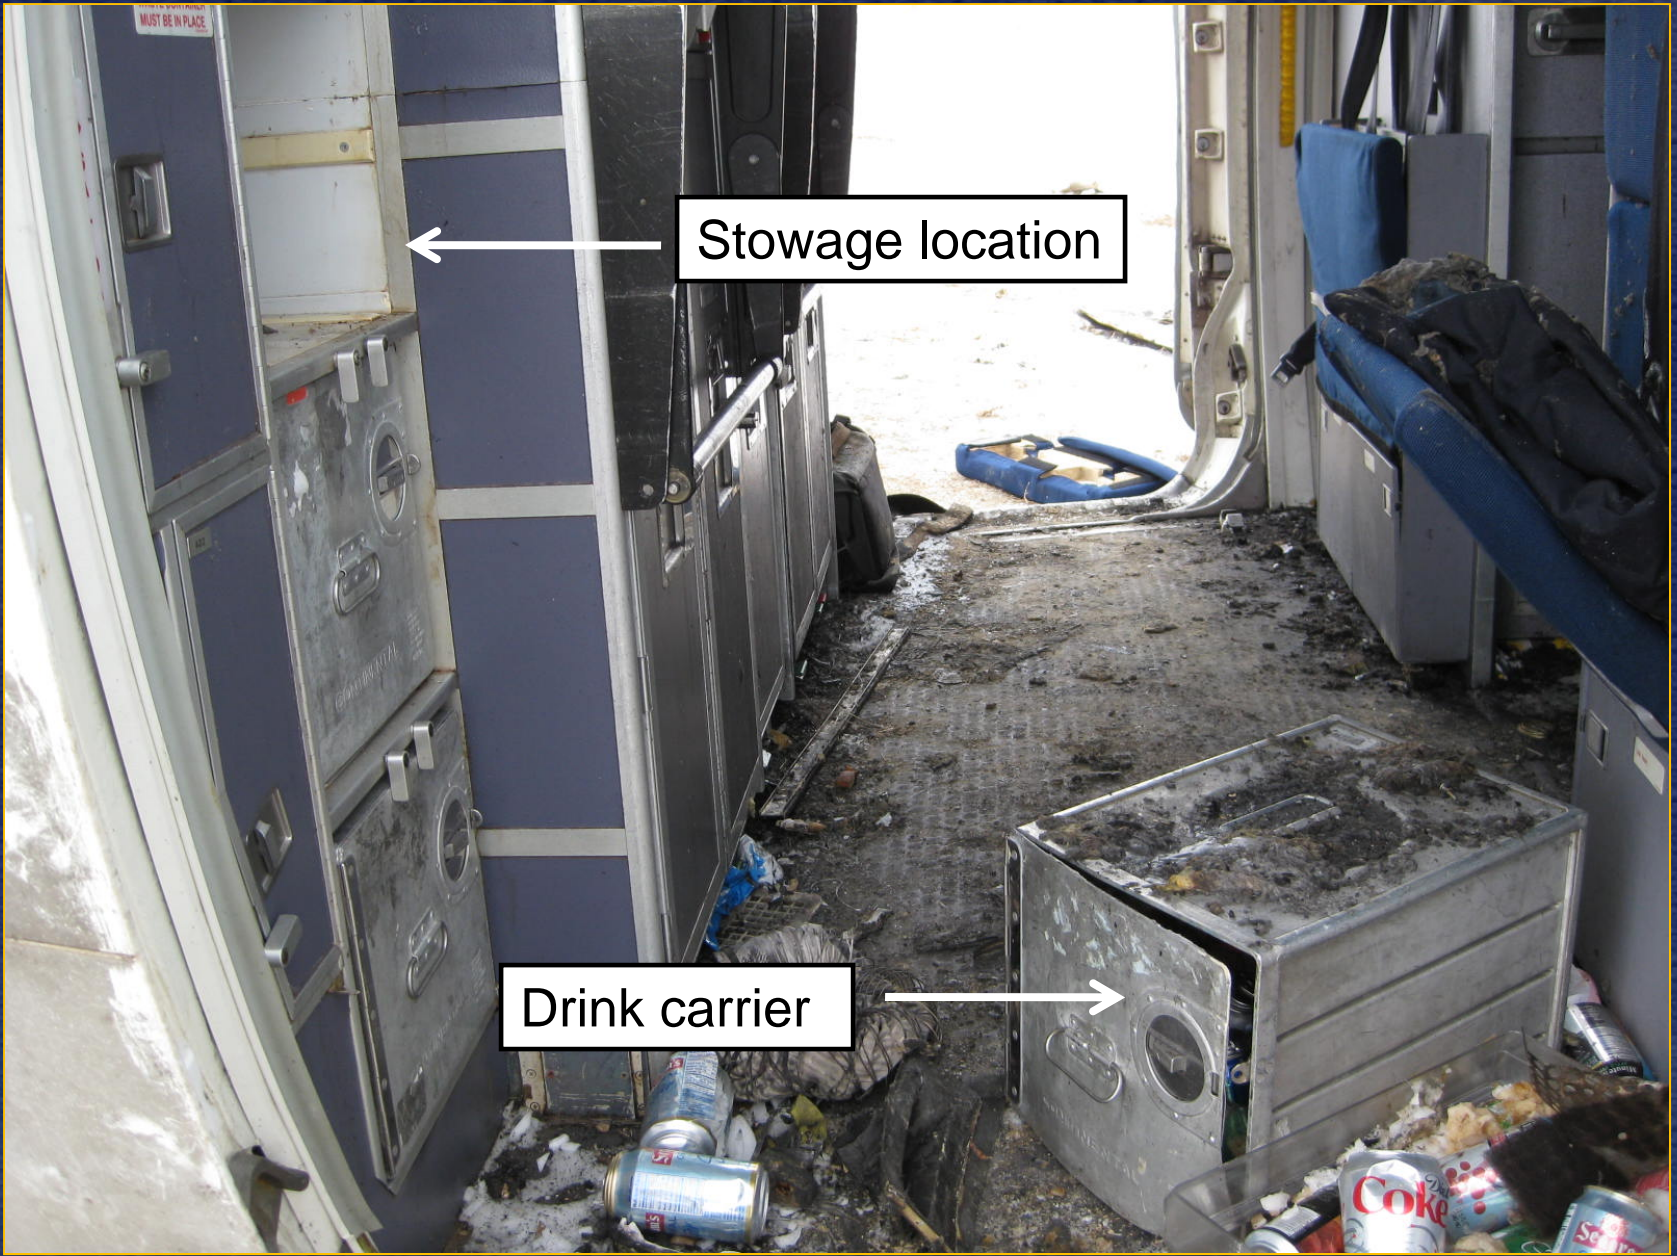
Stowage location

Drink carrier

Aft Galley Restraints

- Aft galley latch affixed with adhesive
 - No mechanical fastener
- Carrier directly behind flight attendant jumpseat
- Manufacturer issued service bulletin
 - Addition of mechanical fasteners
 - Applies to Continental only
- Boeing and galley manufacturer queried
 - Unknown number of similar installations

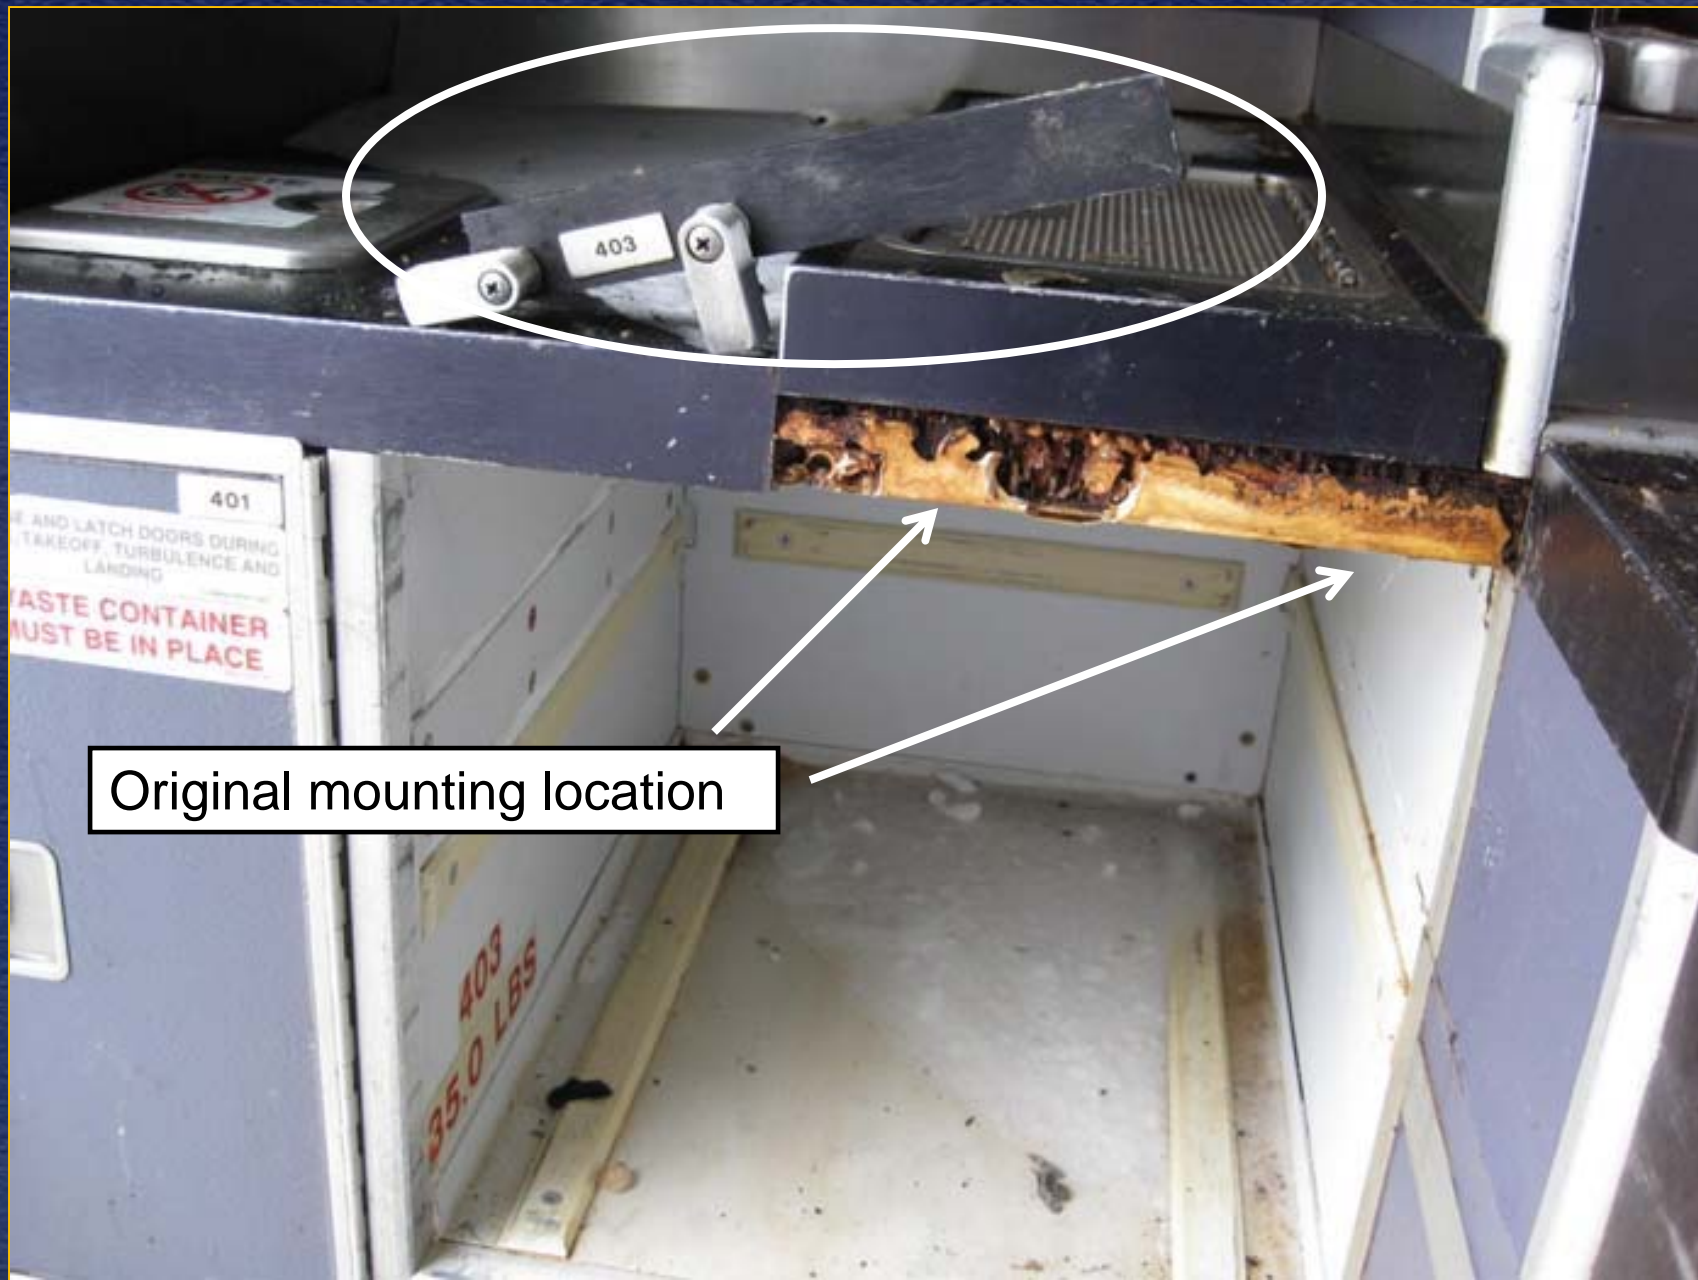
Original mounting location
