NTSB National Transportation Safety Board

Office of Highway Safety

Motorcoach Emergency Egress

Wilmer Accident Situation

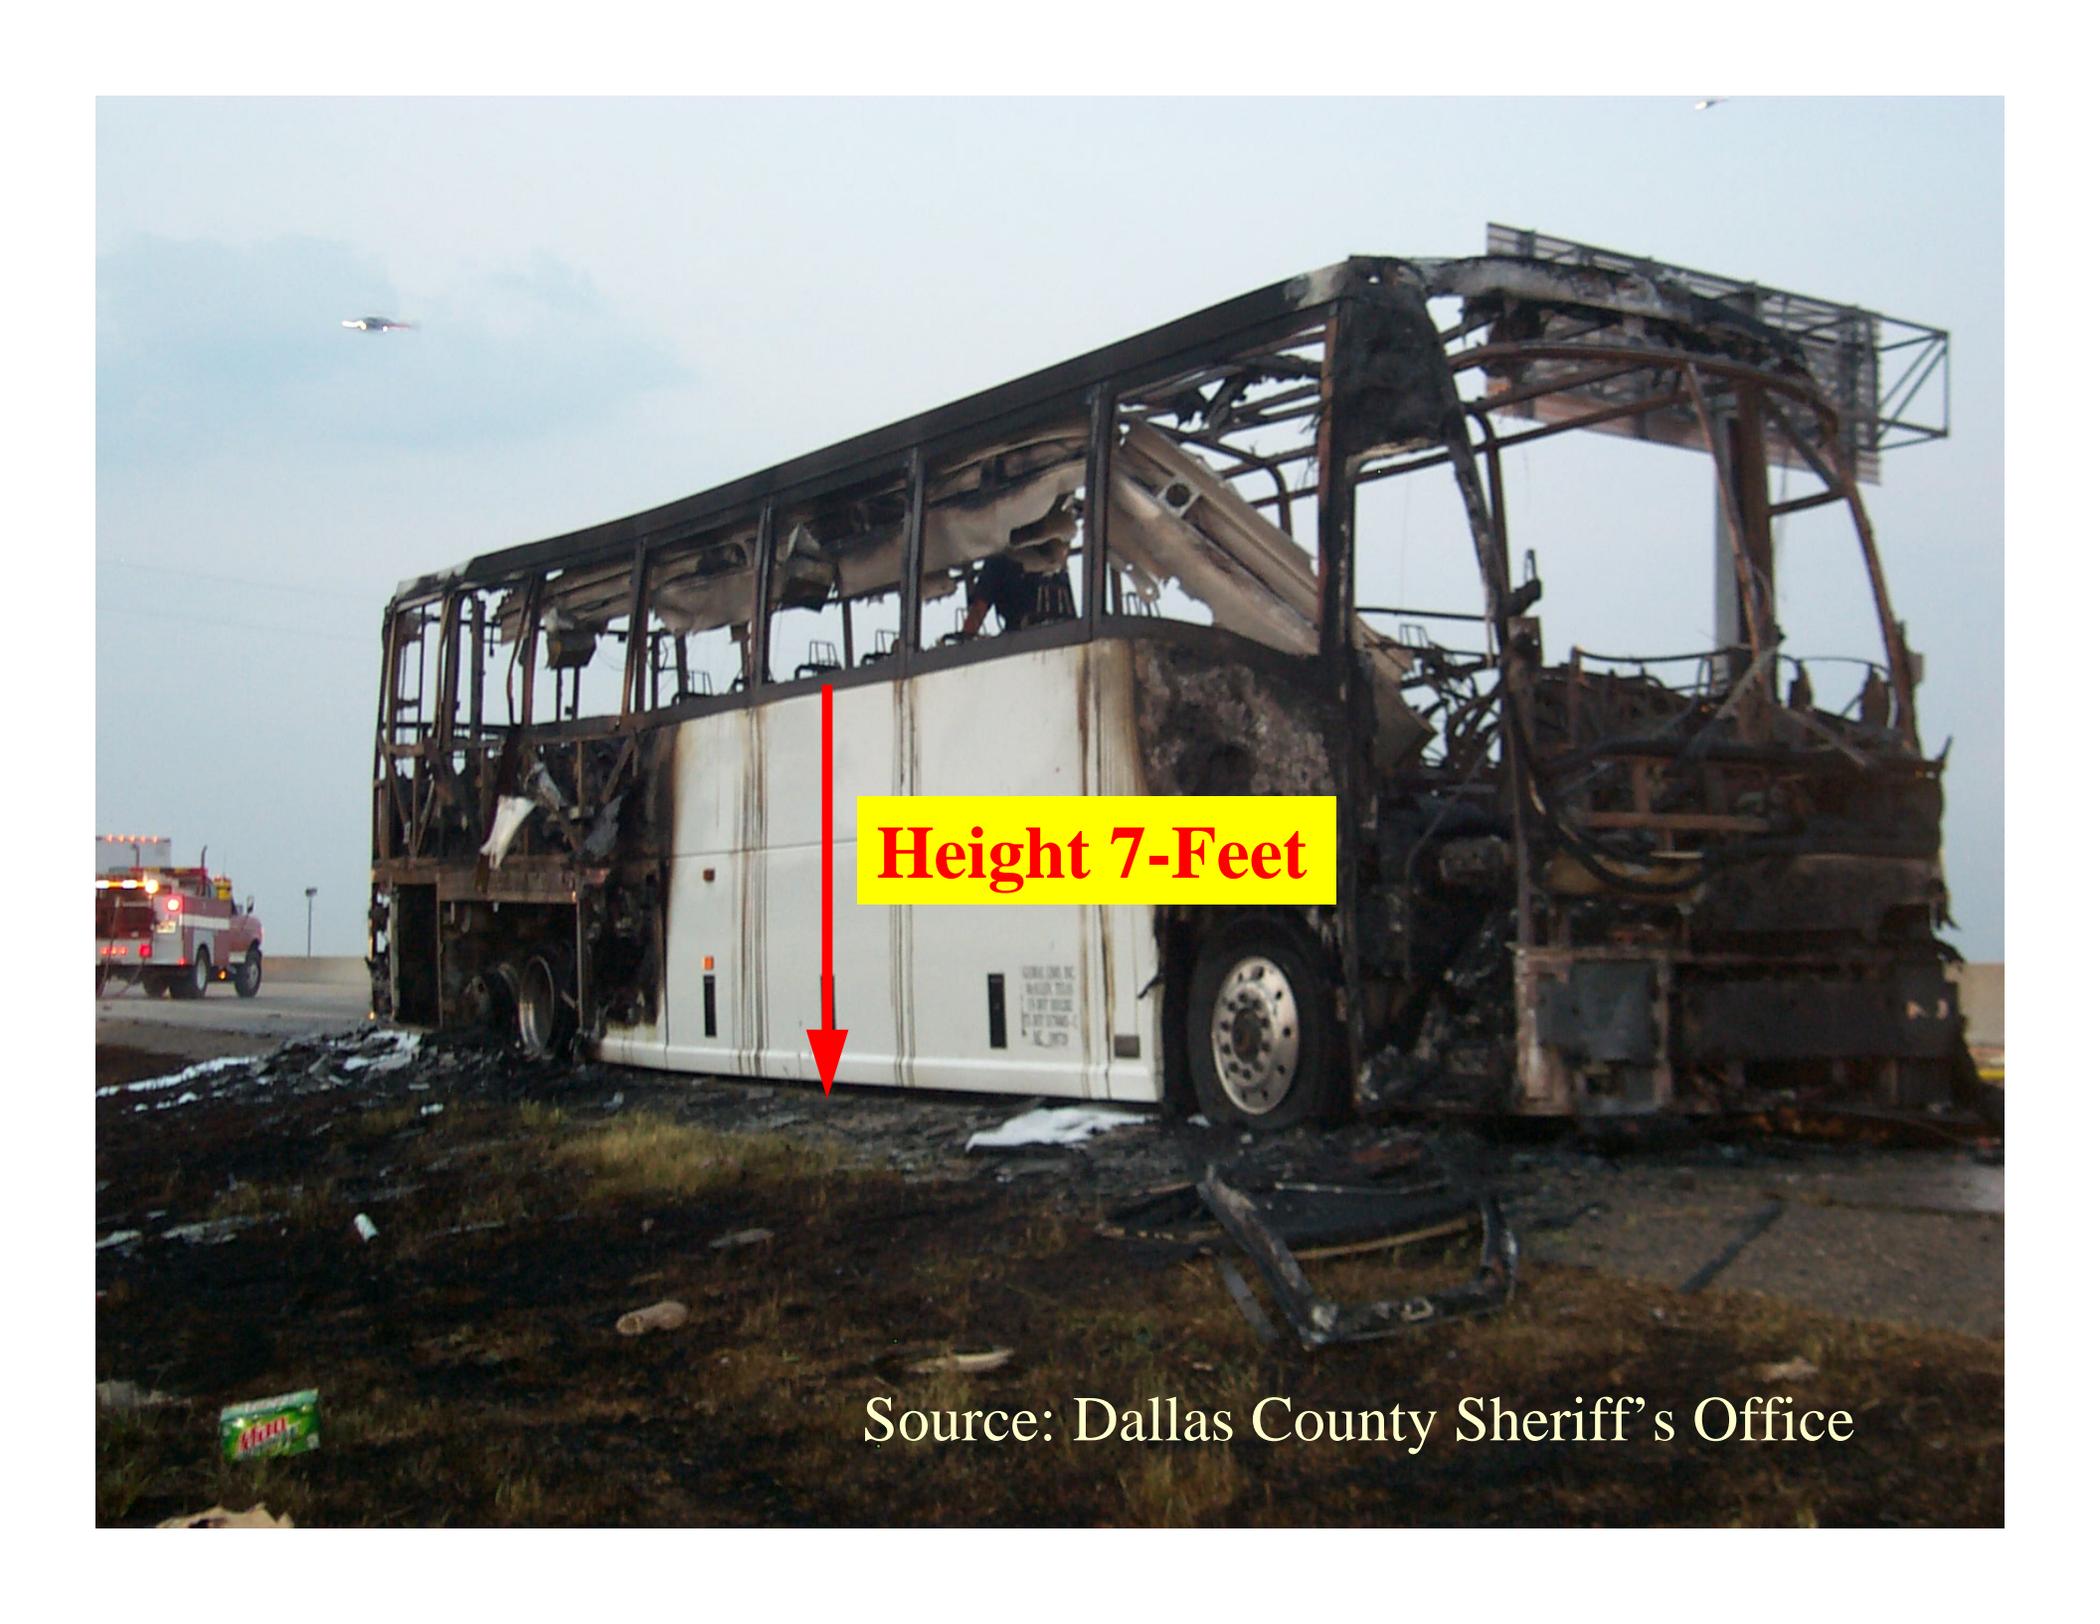
Window Exit Issues

- Rescuers cannot open windows from outside
- Windows impede evacuation

Height 7-Feet
