## **ABX Air Ground Fire**

# Conductivity of Oxygen Hoses

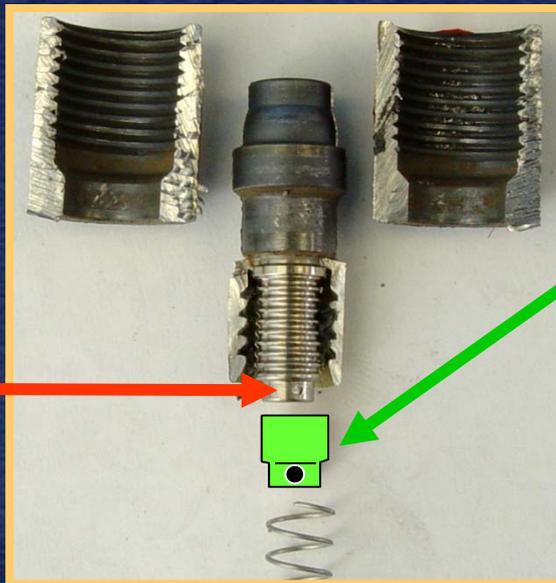
- In mid-1990s, Boeing received leakage reports
  - Electrical current heated internal spring
  - PVC hose material melted
- Hose redesign
  - Plastic spacer added to interrupt current path
  - Production change and service bulletins issued in 1999

Original conductive hose hooked spring to hole

New plastic spacer with hole to attach spring

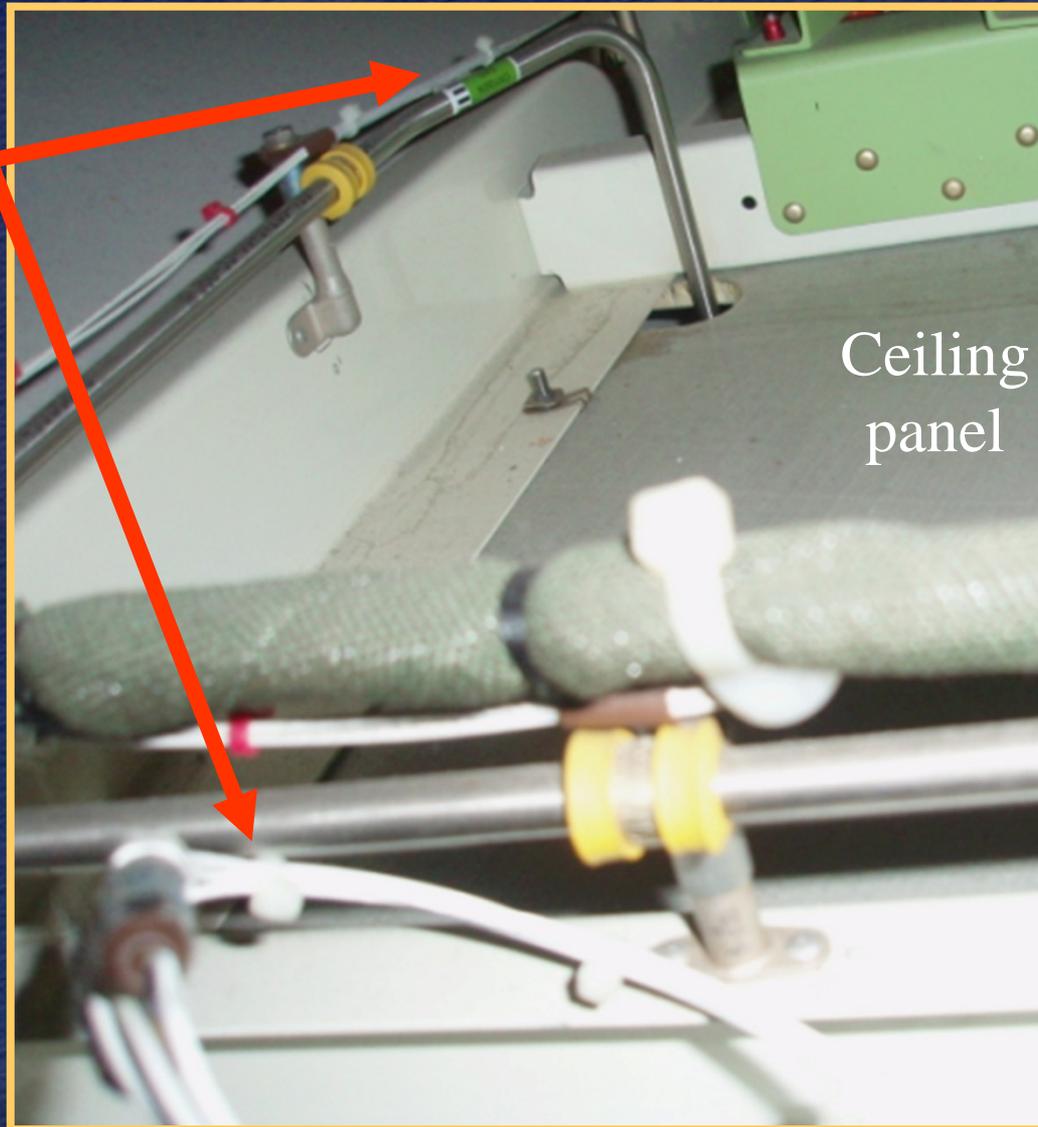
Wires  
touch  
oxygen  
supply tube

- Inadvertent wire contact found previously
- Wires contacted critical oxygen tubing
  - Continuing problem
- Conductive oxygen tubing needs protection
  - Physical isolation
  - Nonconductive sleeving
  - Nonconductive coating

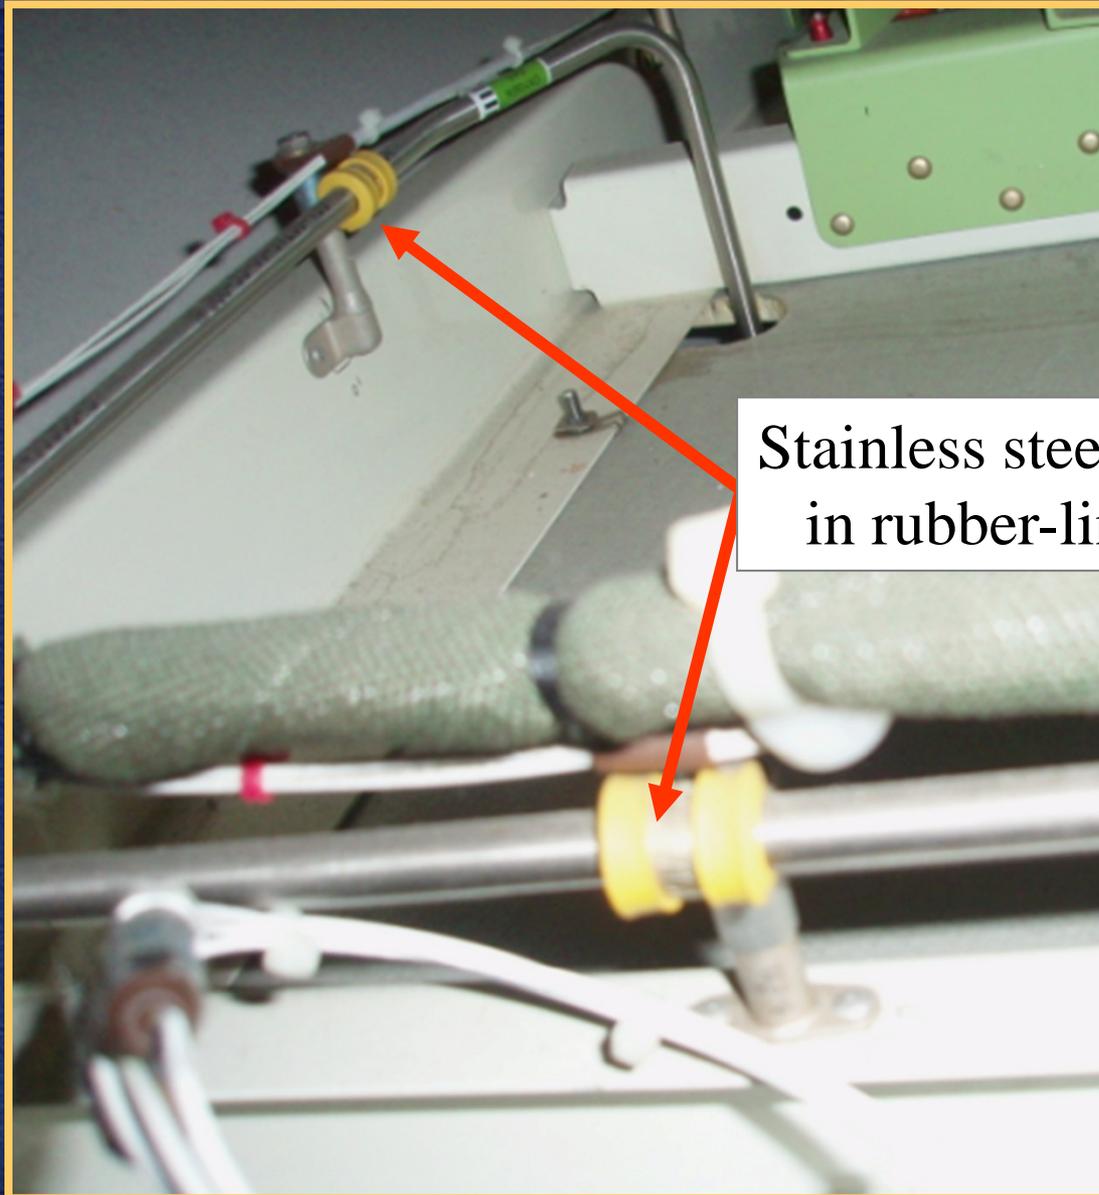
Stainless steel supply tube  
in rubber-lined clamps

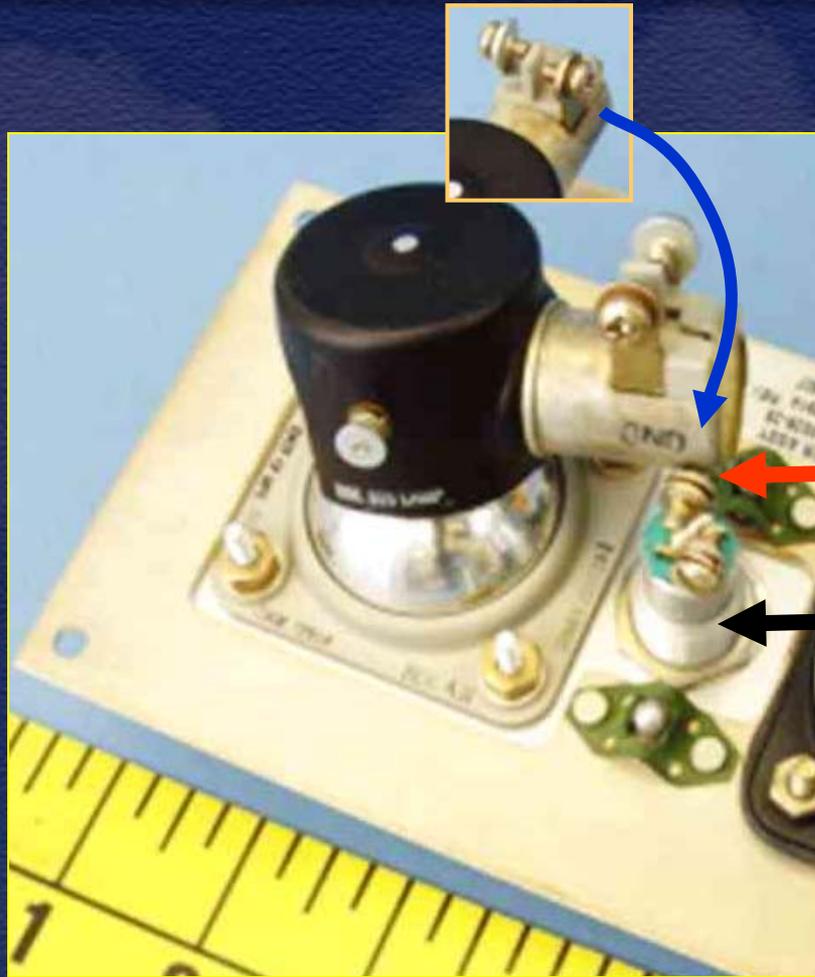
Potential arc

Switch

Rotation of light assembly

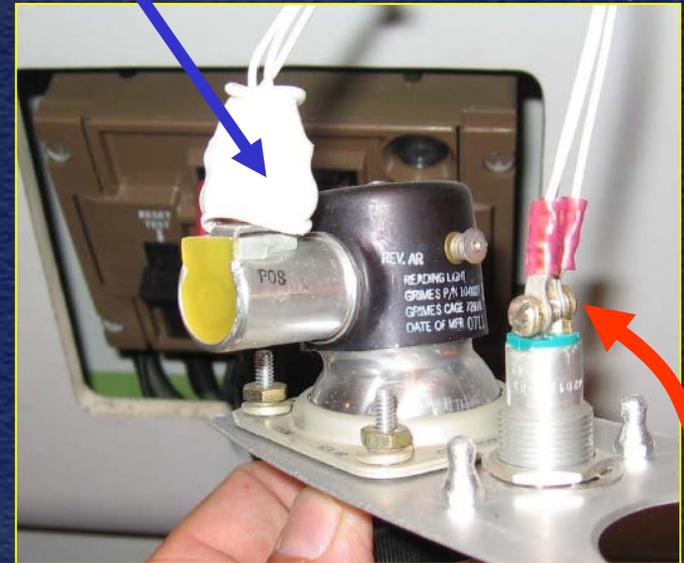
Rubber boot, per design
