NTSB National Transportation Safety Board

*Office of Railroad, Pipeline and
Hazardous Materials Safety*

Storm Water Drainage

Dan Walsh, P.E.

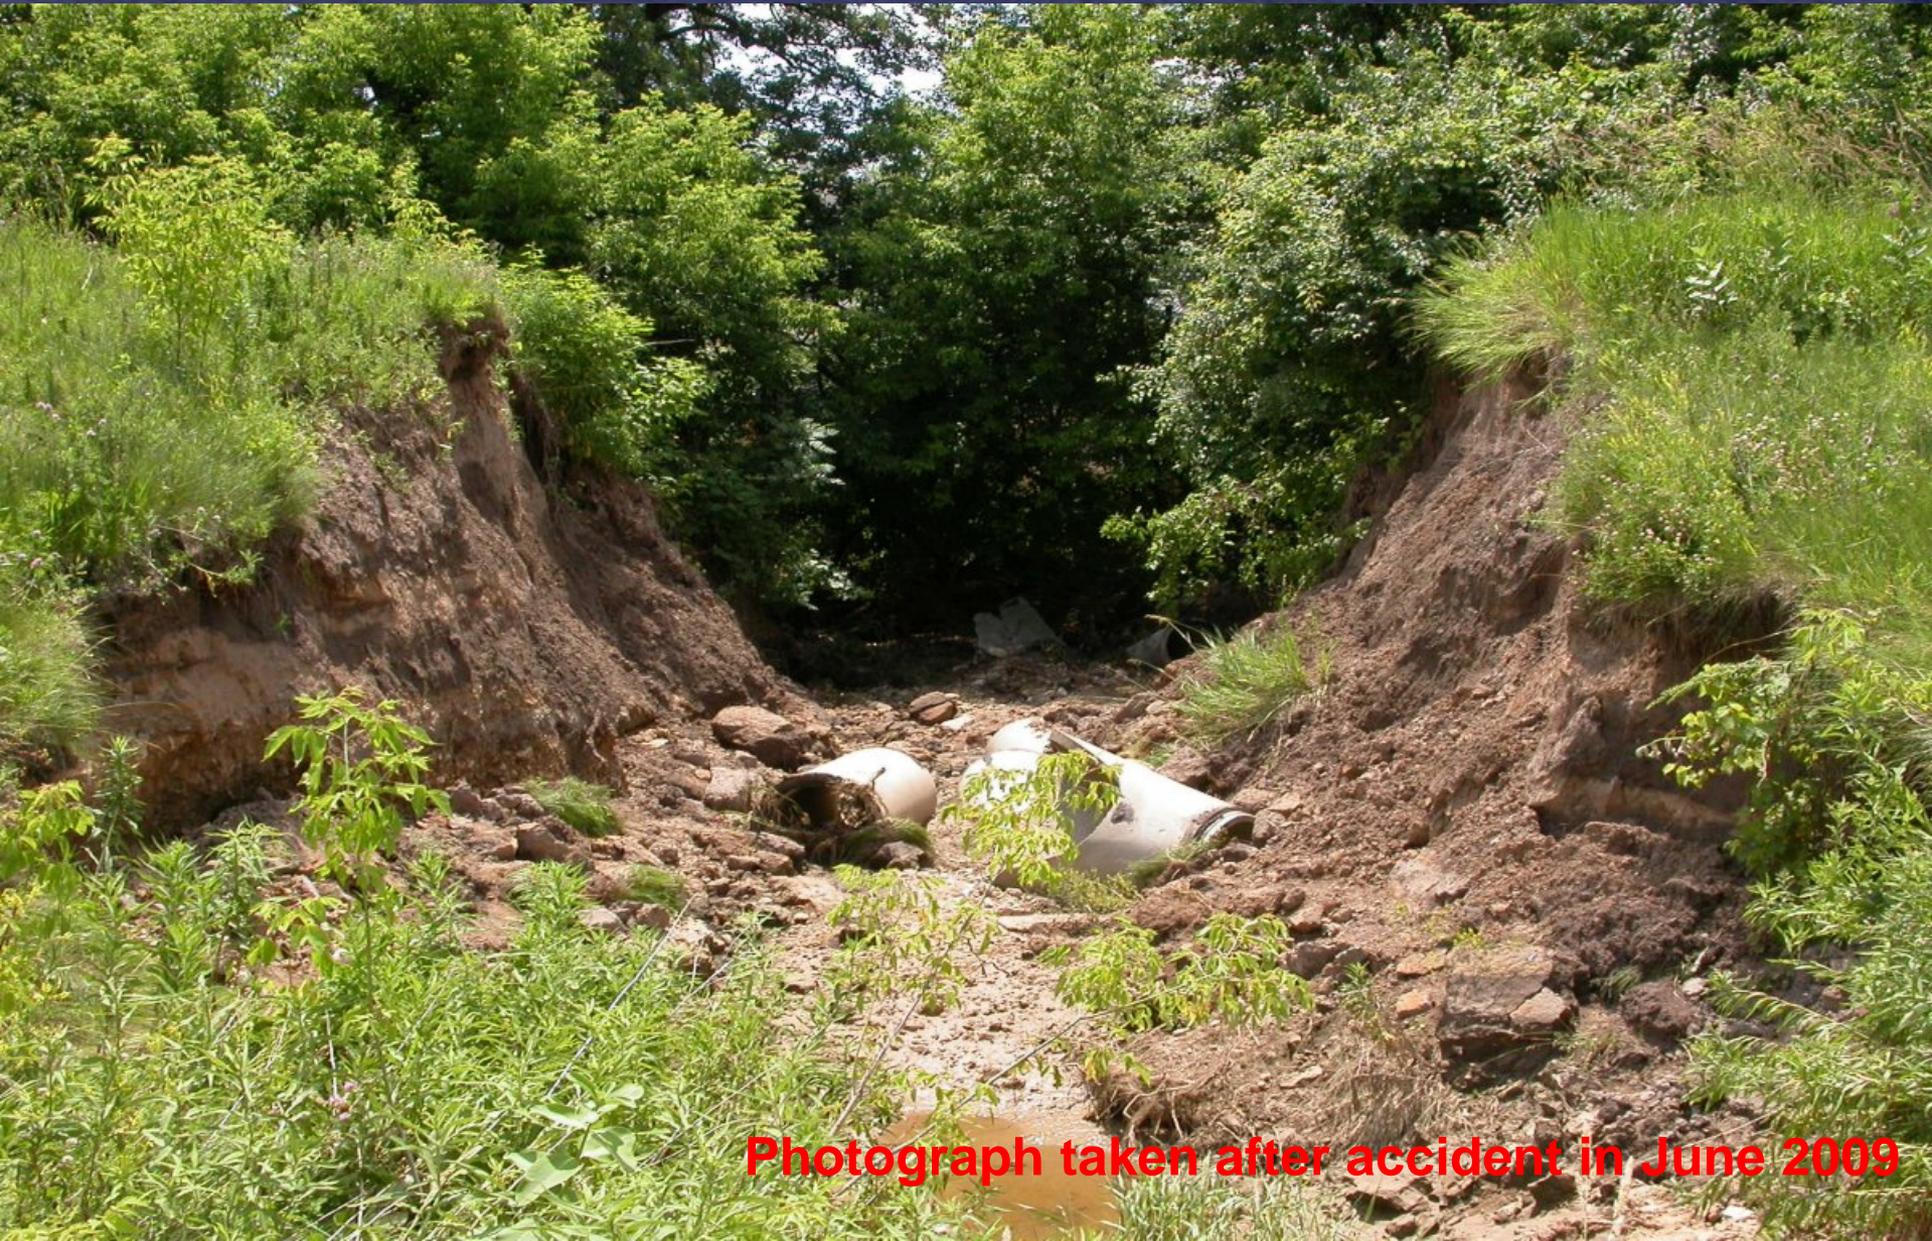
Breach in Detention Pond

Photograph taken after accident in June 2009

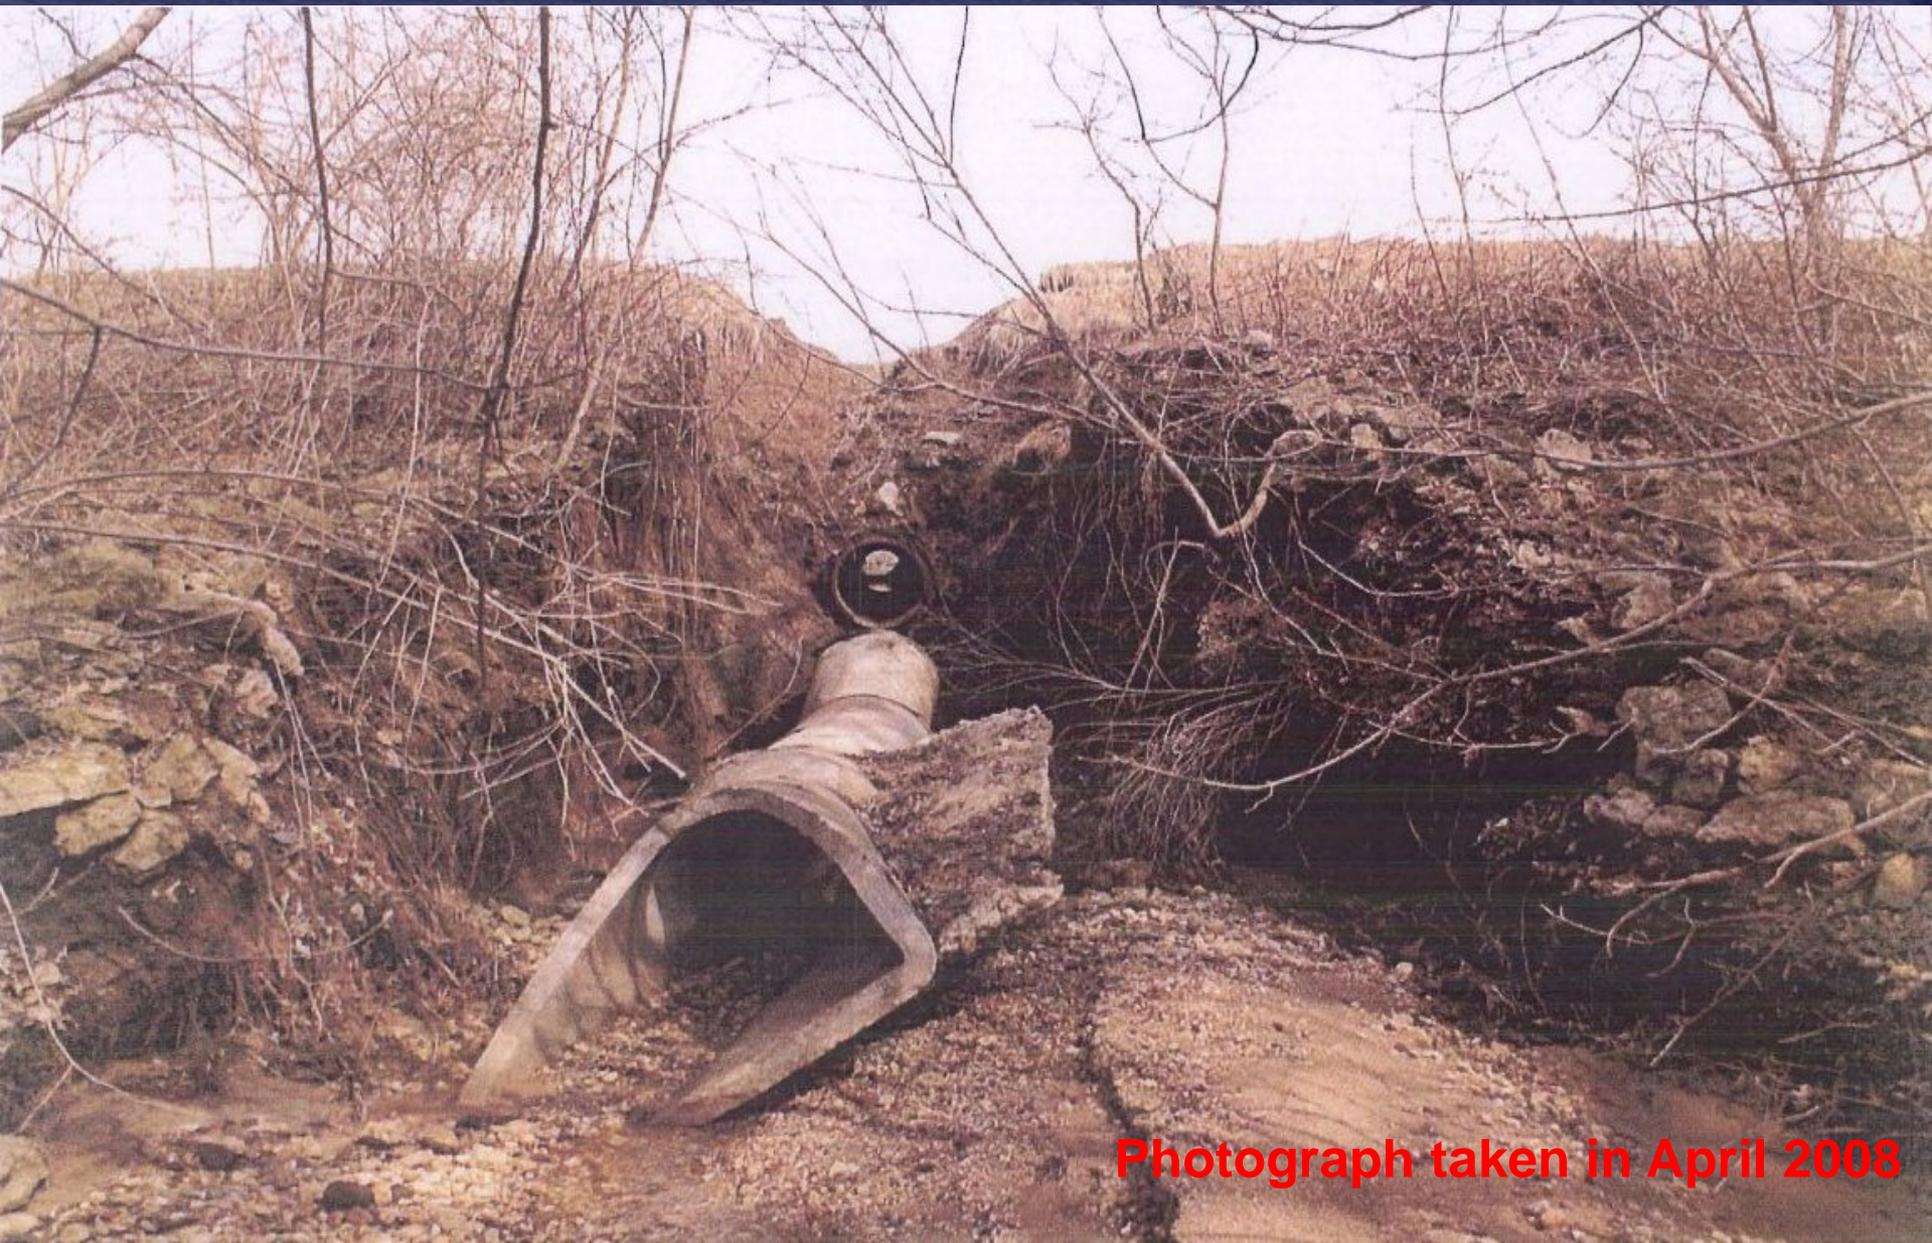
Pond Deterioration

Photograph taken in April 2008
