Airworthiness and Maintenance

Crash of Cessna 550

Airworthiness/Maintenance Records

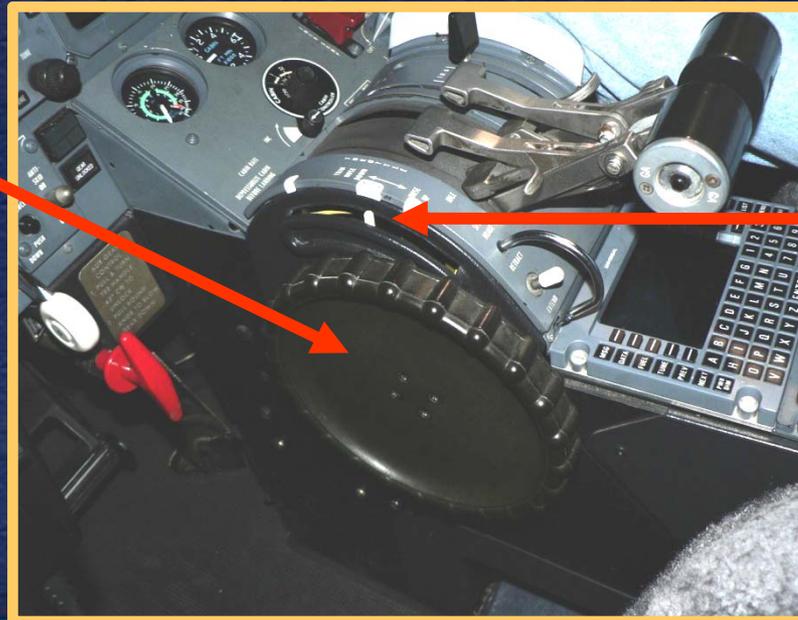
Control
hand-wheel

Pitch trim
indicator

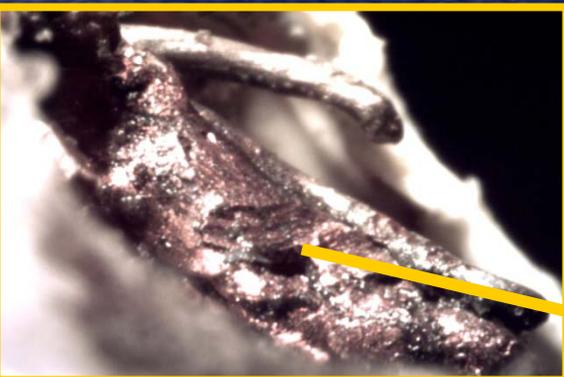
Pitch Trim Wiring in Yoke and Shaft

Bundle changed by SB 550-24-14, January 1992

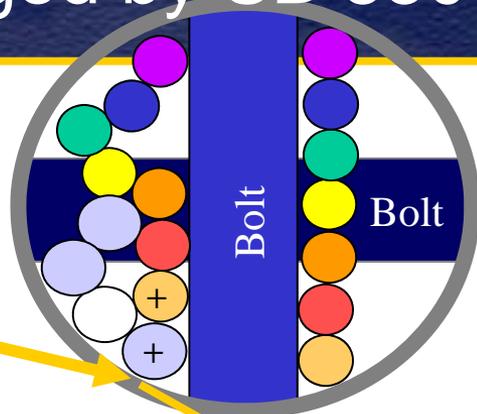
Pitch trim wire short circuited

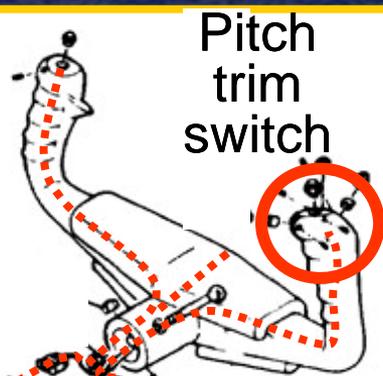
Wires chafe in corner

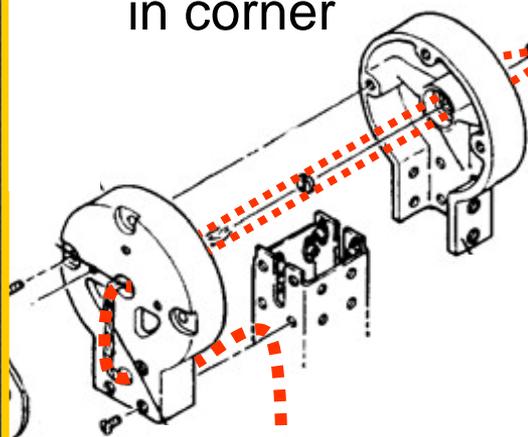
Pitch trim switch

As-found, with wires pressed into shaft

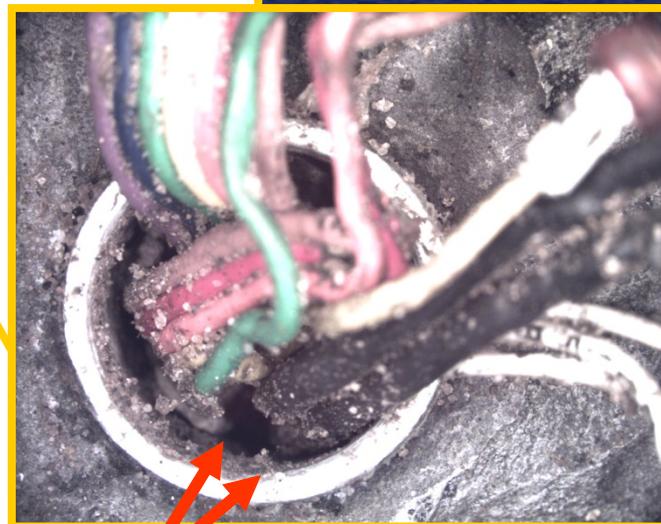
Red lines represent wire routes

Two repair sleeves

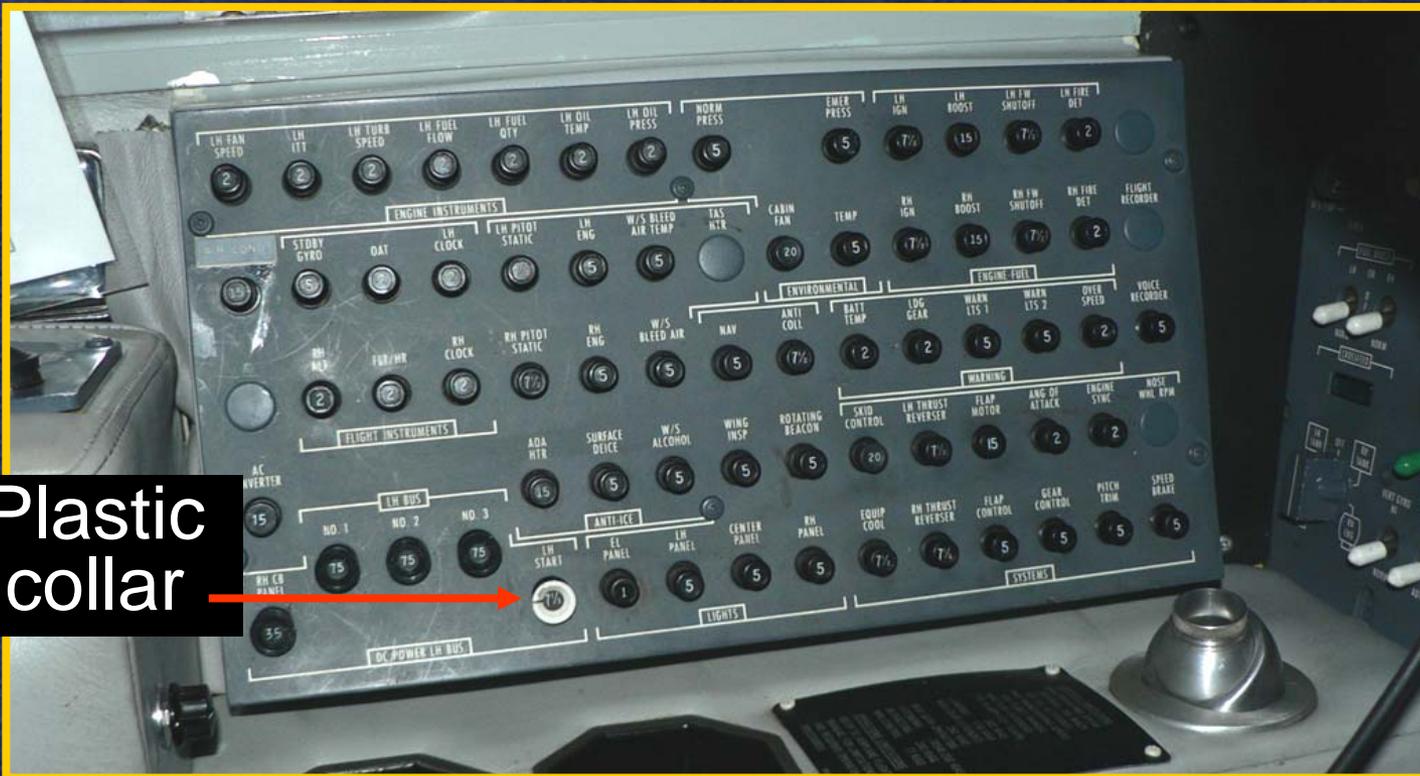
- Marlin Air and Penn Cove pilots tried to pull C/Bs
- Individual C/Bs hard to locate and to pull
- Colored collars assist identification and grasp
